COLVER DAM

NDI I.D. PA- 0437

PHASE I INSPECTION REPORT  
NATIONAL DAM INSPECTION PROGRAM

AUGUST 1981

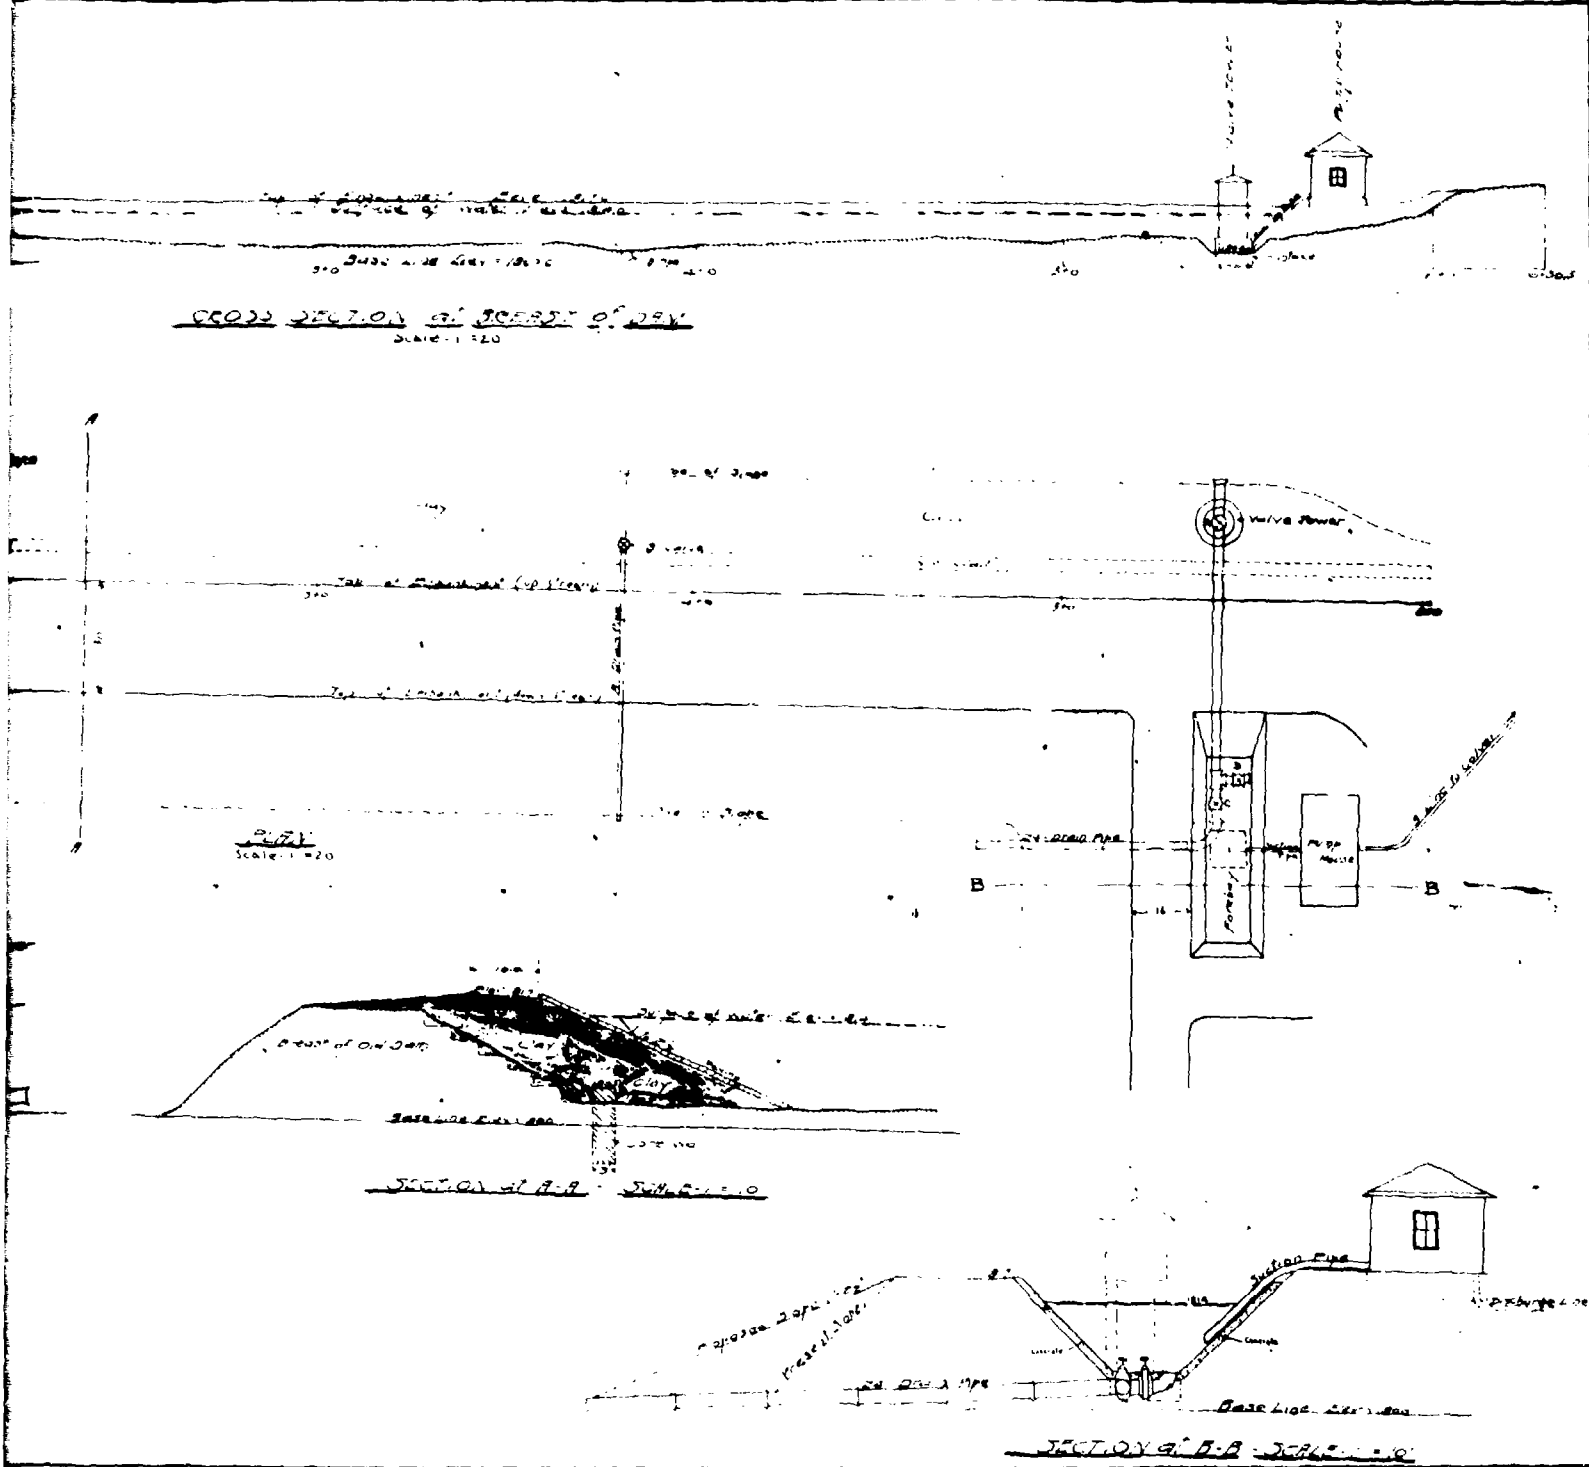
PLATE 3

(2) Appurtenant Structures. The appurtenant structures consist of an open-channel spillway (see Plate 4) located at the right abutment and a low level outlet (see Plate 3) located near the left abutment. The spillway is 85 feet wide. A three-foot-high masonry wall is located on the left side of the spillway channel at the spillway embankment junction. According to the 1913 design drawings, the low level outlet consisted of a 24-inch-diameter pipe located through the embankment near the left abutment. According to the dam tender, in 1979 the outlet pipe was extended by approximately 400 feet by a corrugated metal pipe to discharge into the spillway discharge channel at the right abutment.
