**HATHAWAY POND DAM**

NDI No. PA 00050

**PHASE I INSPECTION REPORT**  
**NATIONAL DAM INSPECTION PROGRAM**

Hathaway Pond Dam, Susquehanna County, Pennsylvania  
NDI No. PA 00050, PennDER No. 58-06  
West Branch of Lackawanna River  
Inspected 30 October 1980

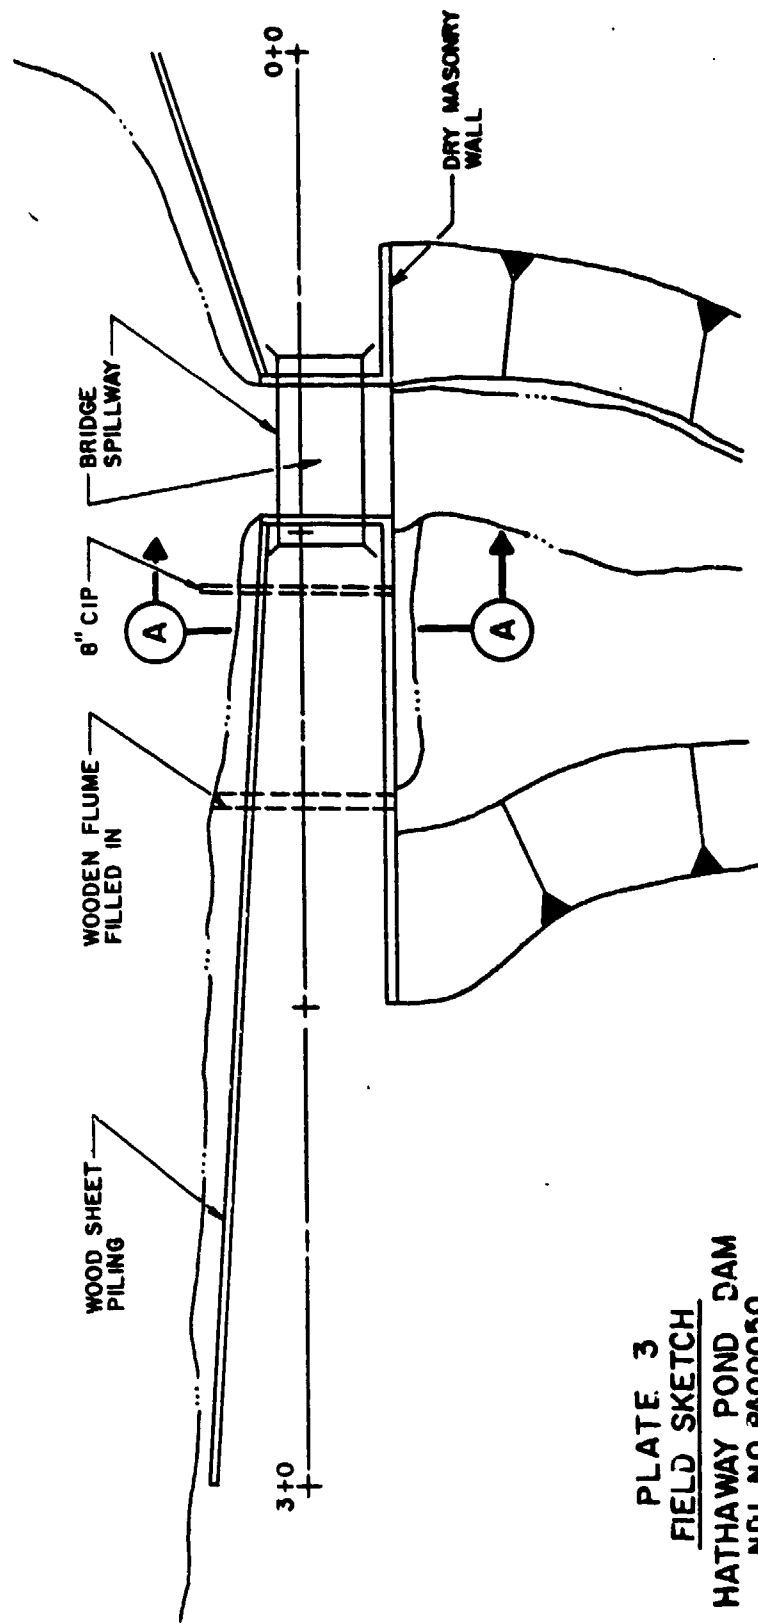
PLATE 3  
FIELD SKETCH  
HATHAWAY POND DAM  
NDI NO. PA00050  
PENNS. DER. NO. 58-06  
SCHEMATIC - NOT TO SCALE

- b. Dam - The entire embankment is covered with trees and brush. The wood sheet piling on the upstream face of the dam is deteriorated. A seep is located approximately 50 feet to the right of the spillway near the toe of the dam.
