Special Report 81-31

December 1981

ROOF MOISTURE SURVEY: RESERVE CENTER  
GARAGE, GRENIER FIELD, MANCHESTER, N.H.

W. Tobiasson, B. Coutermarsh and A. Greateorex

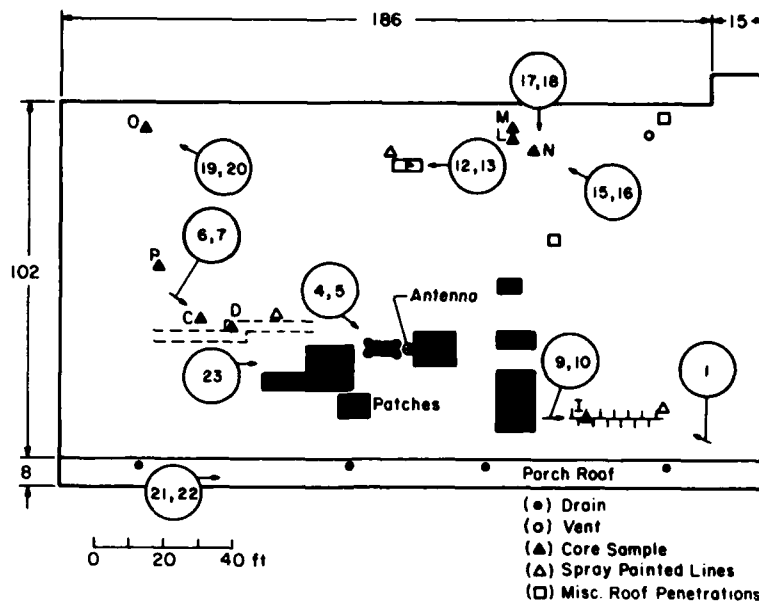
Figure 2. Plan view of roof. Circled numbers refer to figures in this report; arrows indicate viewing direction.

plastic bags and returned to the laboratory where they were weighed, oven dried at 120°F and reweighed. Moisture contents thus determined are presented in Table 1 and the thickness of each component is presented in Table 2. Sample locations are shown in Figure 2 along with the viewing direction of each photograph and thermogram included in this report.
