**FINAL ENGINEERING REPORT
IMPROVEMENT PROGRAM FOR THE
C-141 NAVIGATION SELECTOR PANEL**

January 1982

Henry L. Riser, Jr.

ARINC Research Corporation
a Subsidiary of Aeronautical Radio, Inc.
2551 Riva Road
Annapolis, Maryland 21401
Publication 2315-11-1-2635

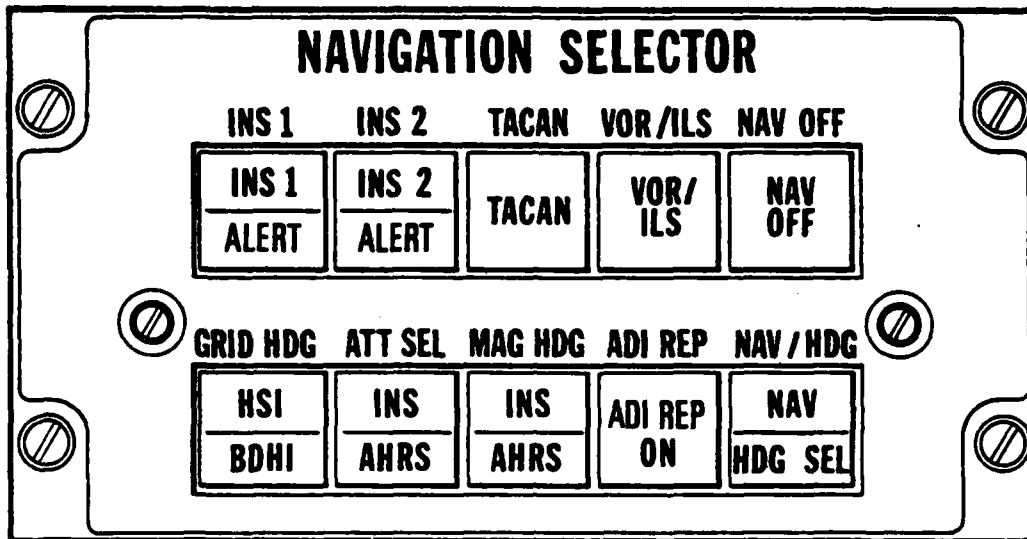
Figure 1-1. NAVIGATION SELECTOR PANEL (FRONT VIEW)

The Navigation Selector Panel (NSP) for the C-141 aircraft has experienced chronic switch-assembly failures that have had an adverse effect on the availability of navigation systems. The failures are primarily of the lighted push-button switches and, to a lesser degree, the printed circuit board. Problems include sticking push buttons, shorting of internal switch contacts, and failure of the push-button retainer mechanism, which allows the push buttons to fall out of the switch housings. Printed circuit board failures include burned tracks and components.

The NSP (see Figure 1-1) consists of nine lighted push-button switches and one indicator mounted in two rows. Two NSPs are used on each C-141 aircraft to provide the pilot and copilot a means of switching navigation signals on their respective flight instruments. The NSP controls a bank of remotely located relays that perform the system switching. In addition, the unit contains relays for lamp testing and dimming, which are driven by lamp testing and dimming signals from the aircraft's electrical system. The NSP also contains a circuit board with diodes and resistors that control the electrical current to the lamps. A more complete description of the system can be found in the Technical Manual, Intermediate Maintenance Instructions with Illustrated Parts Breakdown, T.O. 5N6-9-9-2, dated 1 December 1979.

As a result of efforts conducted under Tasks 1 and 2, the Jay-E1 Mark 8 series switch was selected as the replacement for the present switch. The first step under this task was to order the appropriate switches from Jay-E1. The indicator and four alternate action switches required for the
