# DYNAMIC SEALS FOR ADVANCED HYDRAULIC SYSTEMS

Robert B. Olsen  
Vought Corporation  
P.O. Box 225907  
Dallas, Texas 75265

August 1981

Final Report for Period July 1978 - March 1981

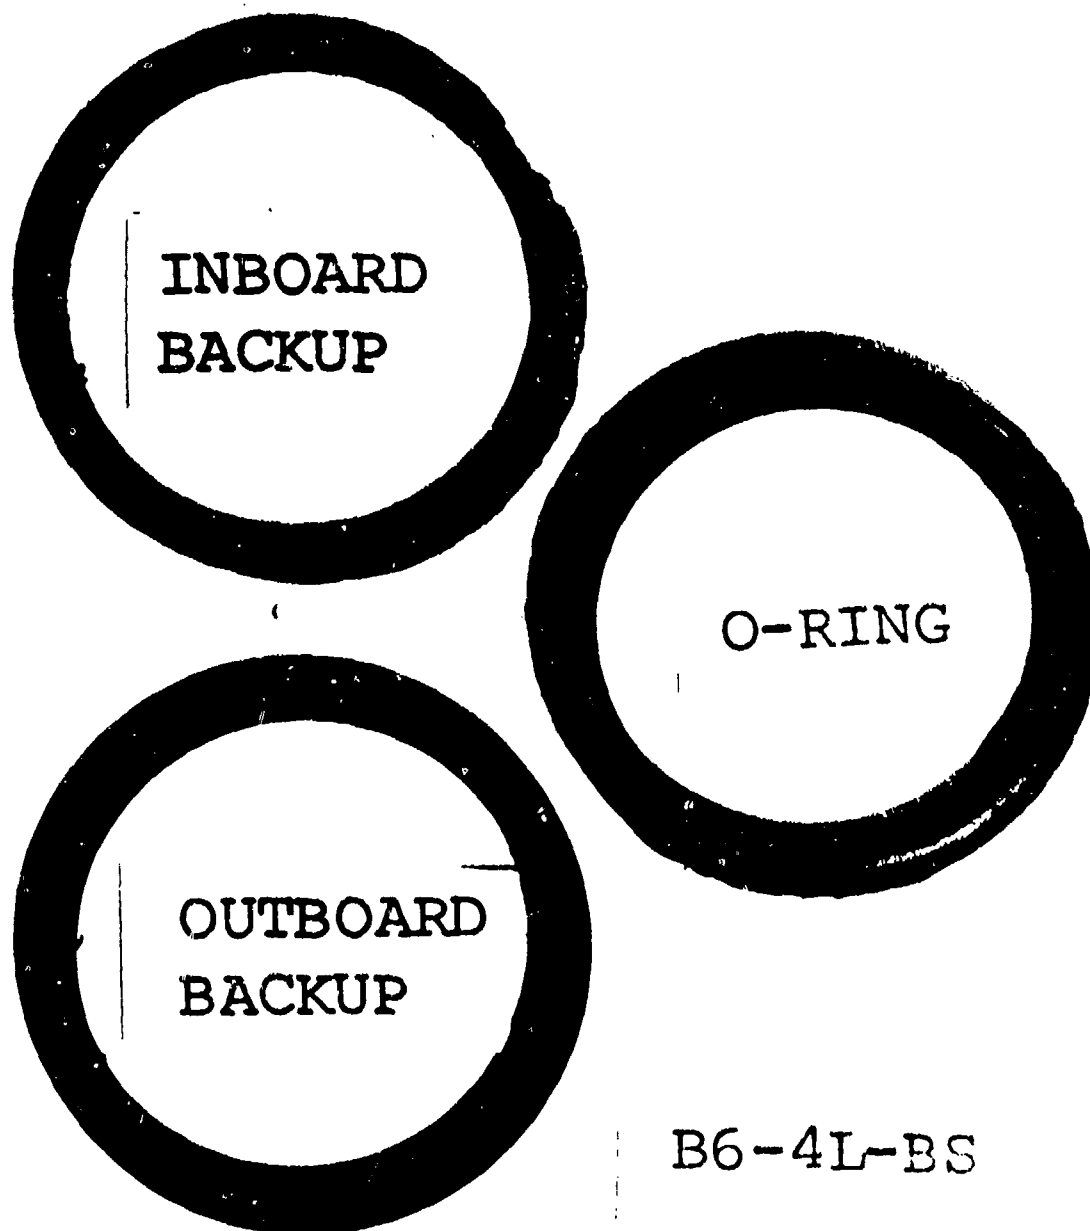
Figure 39. Candidate B6 After Backup Screening Test.  
Two stage backup has high wear on unfilled TFE inboard  
backup. O-ring condition is poor.

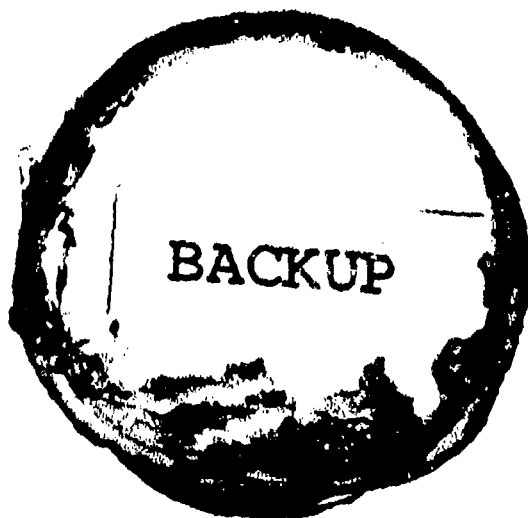
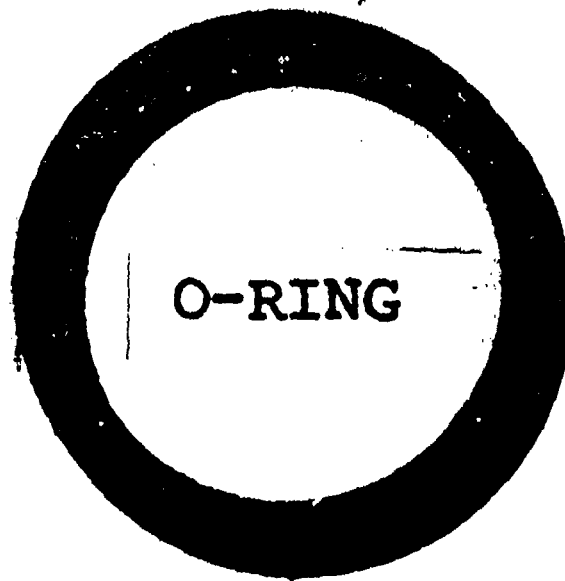
B8-5R-BS

Figure 40. Candidate B8 After Backup Screening Test. Triangle shape backup of unfilled TFE has worn almost thru. O-ring condition is excellent.

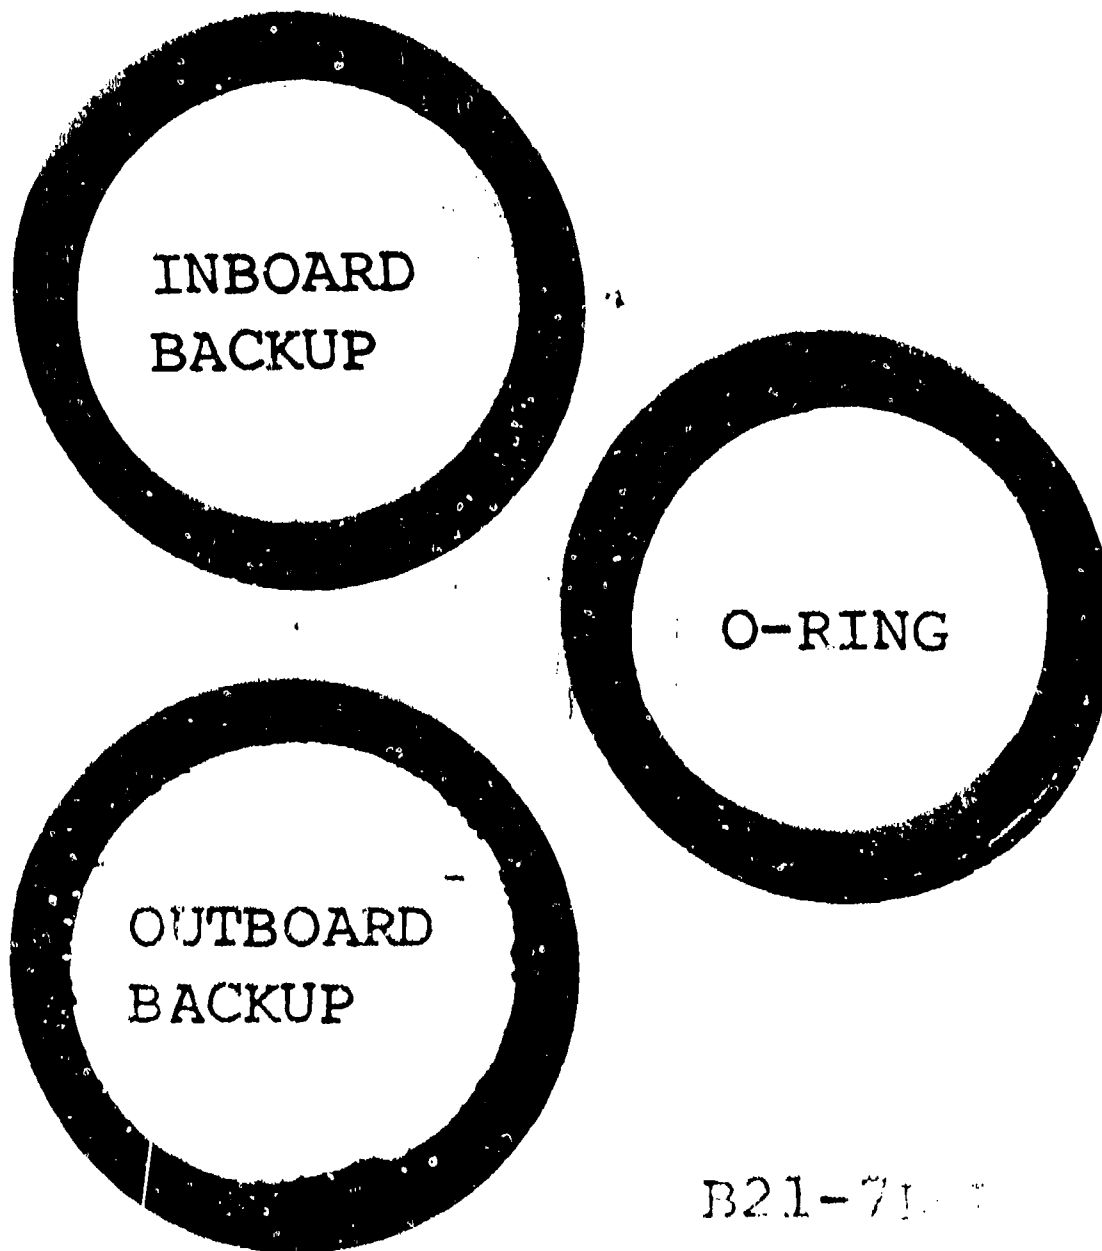
B21-71

RESULTS: See Figure 52. Completed  $2.76 \times 10^6$  endurance cycles and 68415 impulse cycles at conclusion of test. The backup ID had worn to approximately .998 inches. The O-ring had nibbling on the ID and had twisted in the groove. Leakage was 15 drops in 1000 cycles. Light rod wear was evident. Diametral clearance was .0032.

Figure 52. Candidate B21 After Backup Screening Test.  
O-ring condition is poor.

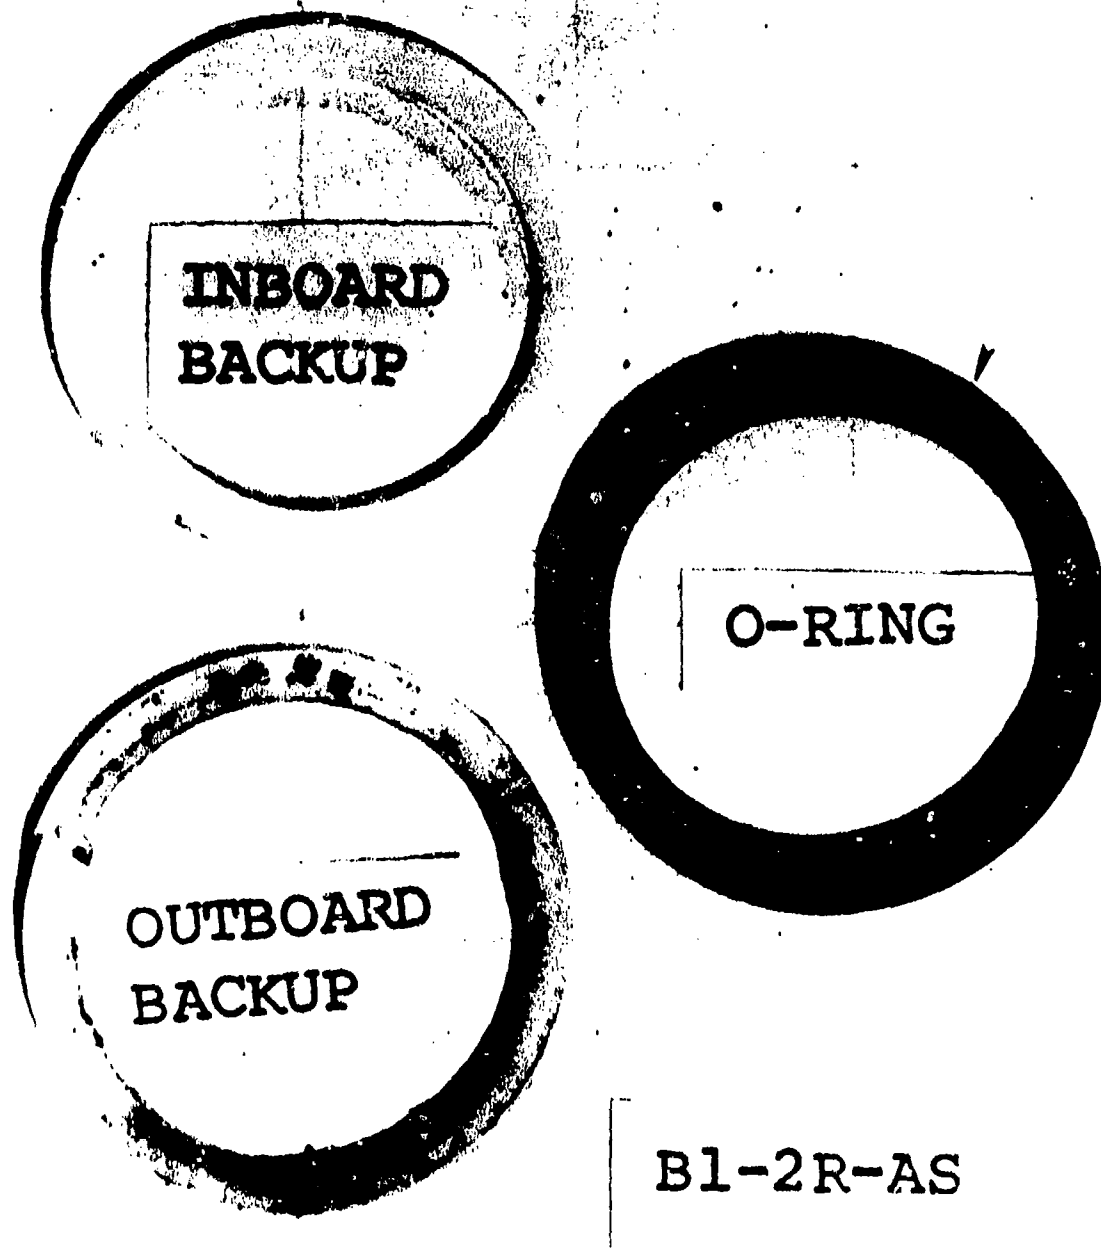
Figure 56. Candidate B1 Backup After Additional Screening Test. Suffered catastrophic failure after  $2.08 \times 10^6$  endurance plus 86014 impulse cycles. Arrow denotes severe nibbling on O-ring.

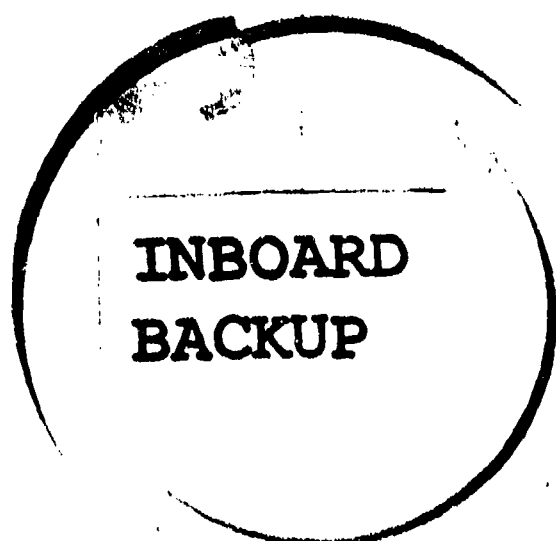
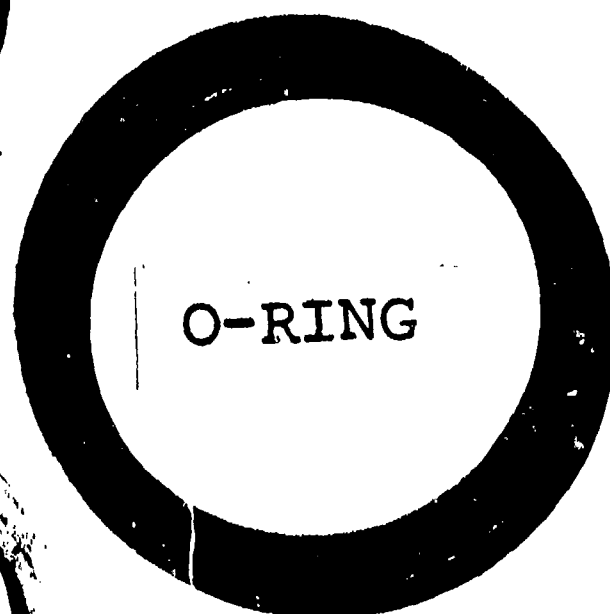
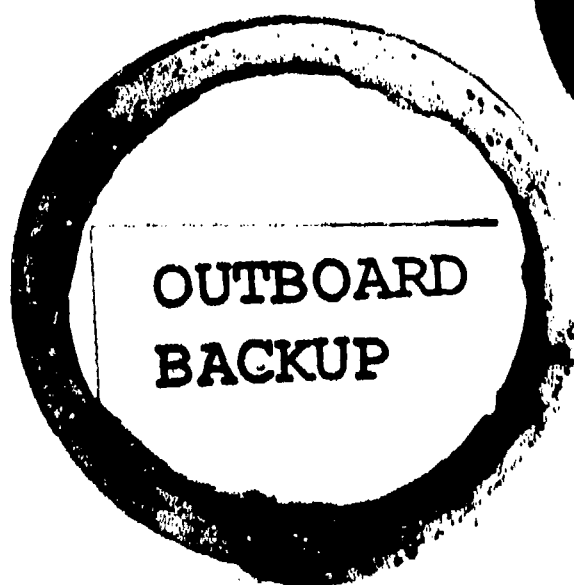
B1-2L-SS

Figure 57. Typical Appearance of MS28774-214 Backups and M83461/1 O-ring Used With Scraper Candidates - No Impulse Testing. O-ring condition was good for 6 of 8 seals.

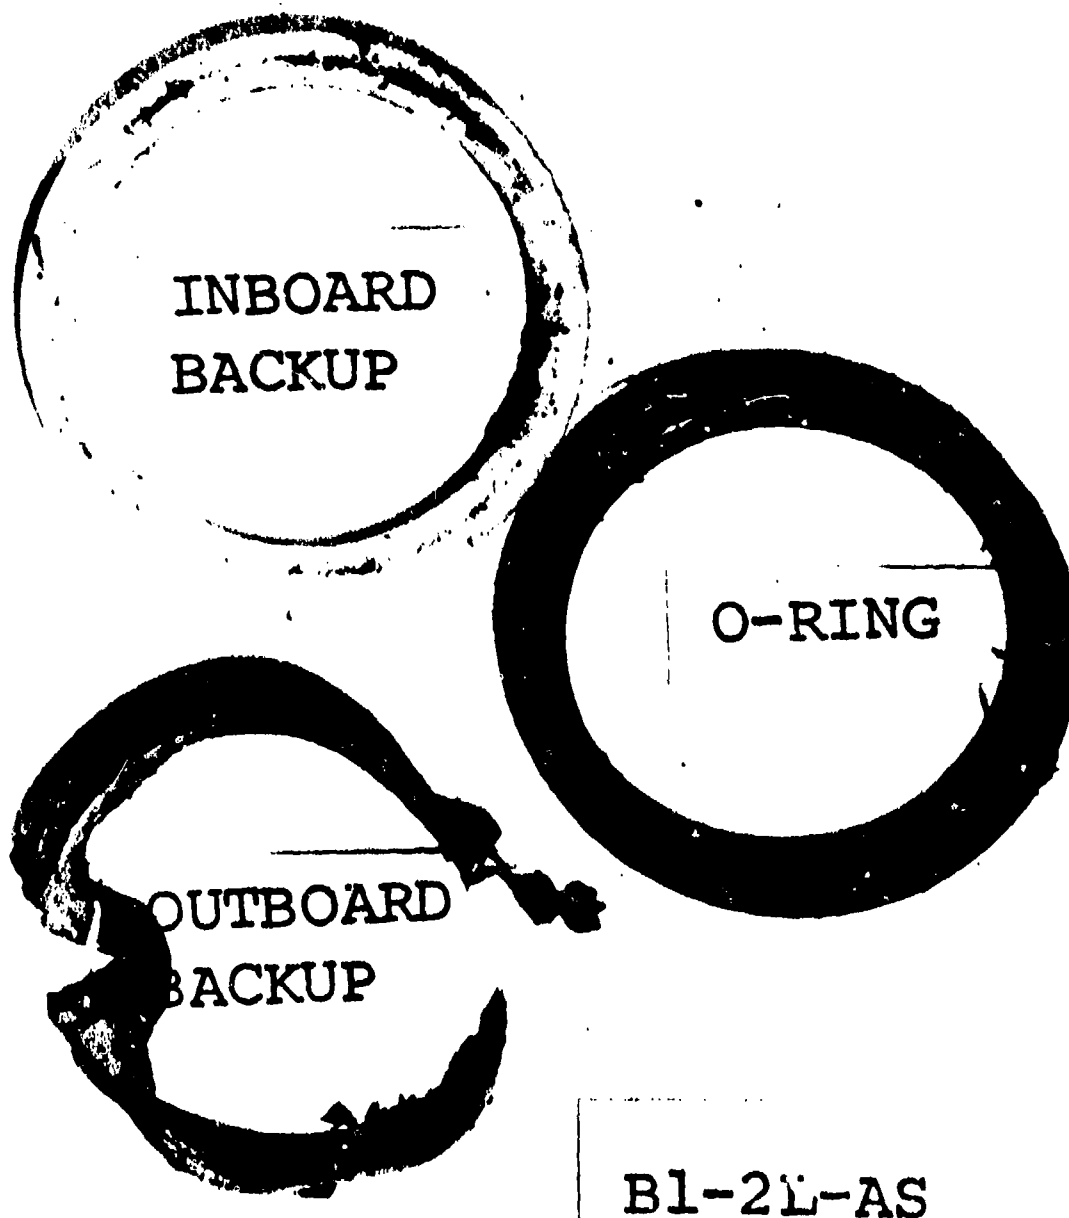
Figure 58. Typical Appearance of MS28774-214 Backups and M83461/1-214 O-ring Used With Scraper Candidates - With Impulse Testing. This seal is typical of the seven MS28774-214/M83461/-214 rod seals used with the scraper candidates during the Additional Screening Tests. Compare with Figure 57 which did not have impulse testing.

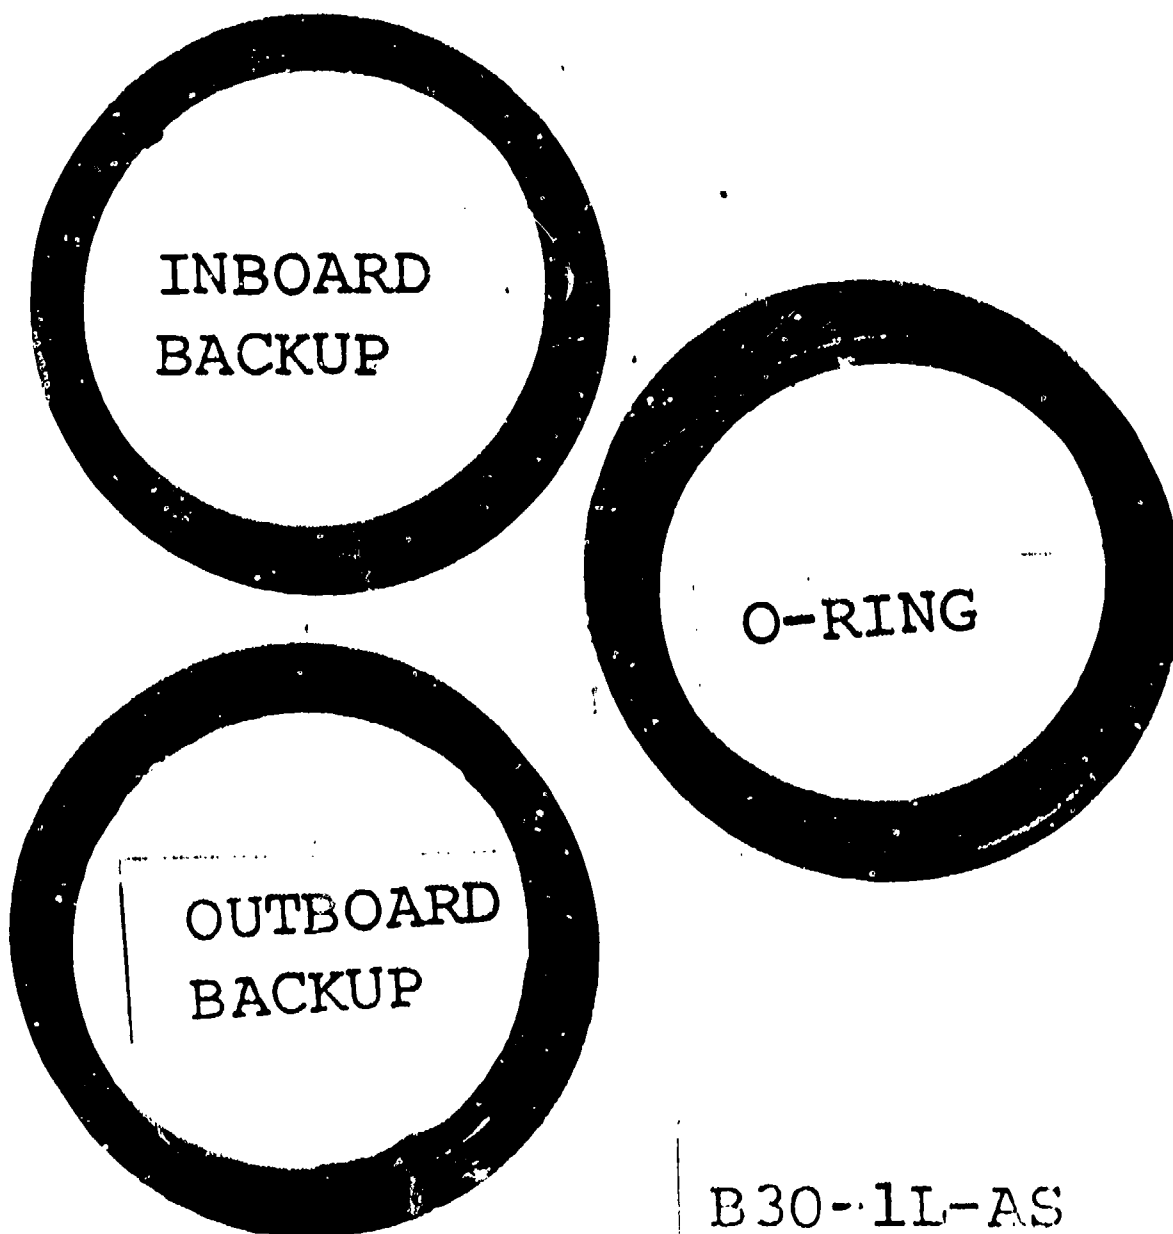
RESULTS: See Figure 66. O-ring is in excellent condition with no damage. O-ring ID has increased to approximately .998 as is typical with this type of backup. The backup has very little wear with .86 percent reduction in cross section. The ID is approximately .997 corresponding to the rod diameter of .9978. Diametral clearance was .0041. The piston rod was discolored by the MoS<sub>2</sub> in the backup. Rod wear is moderate with axial wear marks around the circumference at least as deep as the original 7 RMS finish. Static leakage was 0. Dynamic leakage was 2 drops.

Figure 66. Candidate B30 Backup After Additional Screening Test. O-ring is in excellent condition.

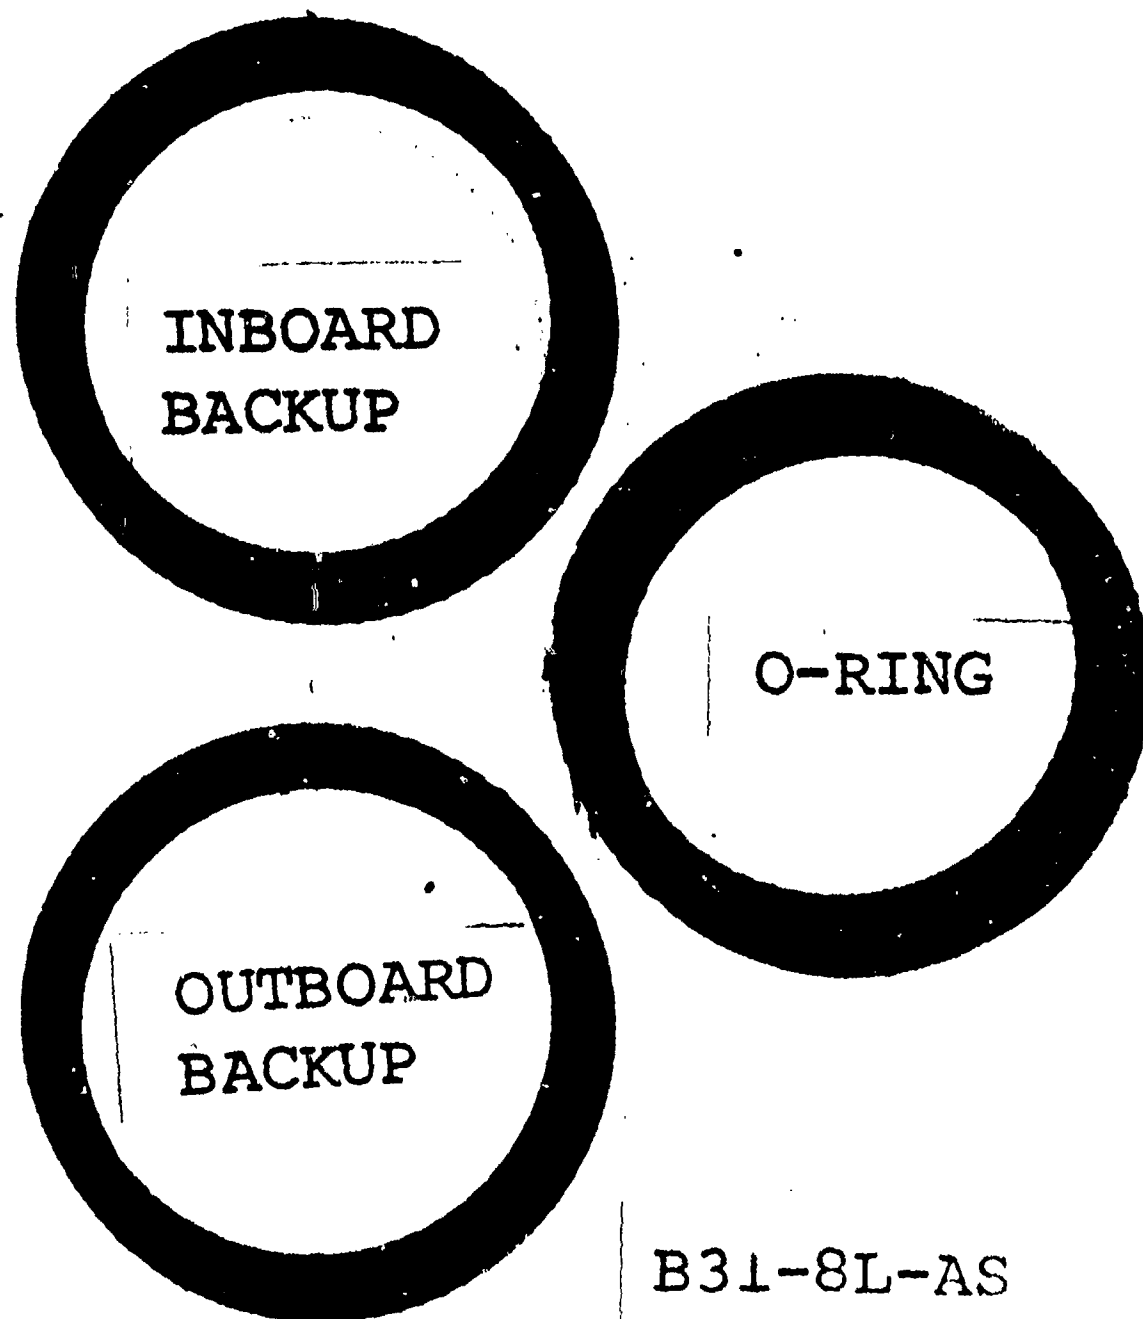
RESULTS: See Figure 67. Backup has moderate wear (8.9 percent). O-ring has milled and is nibbled over a large area of what was the ID. O-ring is classified as poor. Diametral clearance was .0045. Rod finish is dulled and characterized by axial wear marks which are at least as deep as the original 9 RMS finish. Rod wear is classified as high. Average static leakage was 53 ml/day (Blocks 13 thru 29). Dynamic leakage exceeded 300 ml leakage (failure).

Figure 67. Candidate B31 Backup After Additional Screening Test.  
Seal finished test but failed due to leakage.

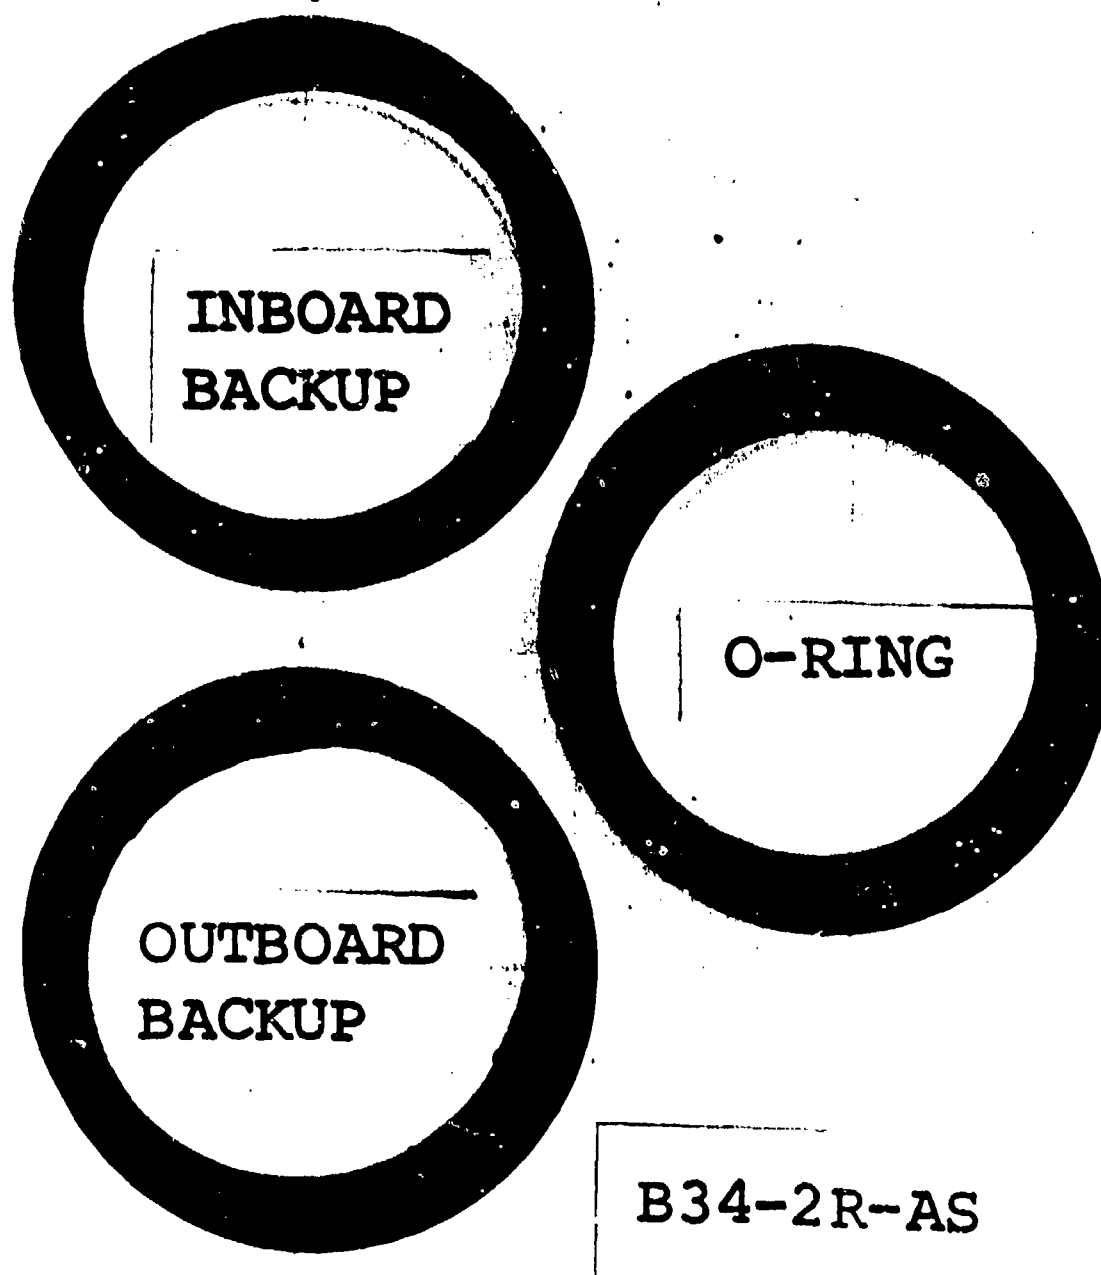
RESULTS: See Figure 70. The O-ring has some nibbling around the ID and is classified as good condition after exposure to 1,292,012 endurance plus 25000 impulse cycles. The outer backup was not worn. The piston rod wear was very light. Diametral clearance was  $.0043$ . Static leakage was 0. Dynamic leakage was 2 drops.

Figure 70. Candidate B34 Backup After Additional Screening Test. O-ring condition is fair. Dynamic leakage was 2 drops in  $1.29 \times 10^6$  endurance cycles.

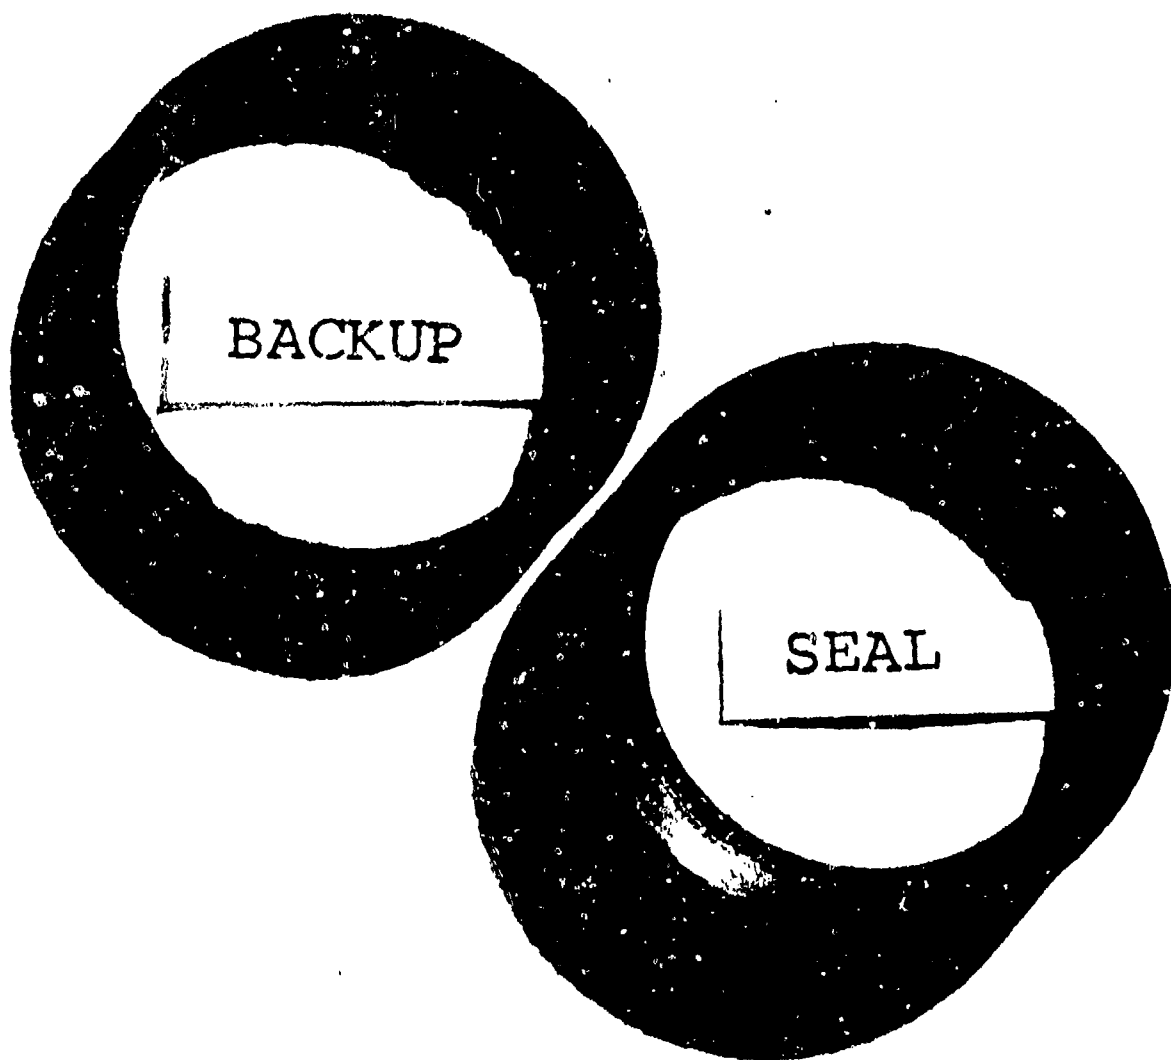
RS13-5R-RS

RESULTS: See Figure 112. The seal and backup were in good condition. The backup exhibited some wear. Leakage was 1 drop static, 1 drop during low temperature, and 1 drop dynamic. The rod had very light wear in the area in contact with the seal.

Figure 112. Candidate RS13 After Single Stage Rod Seal Screening Test. Seal is Dowty 1109 nitrile. Backup is unfilled TFE.

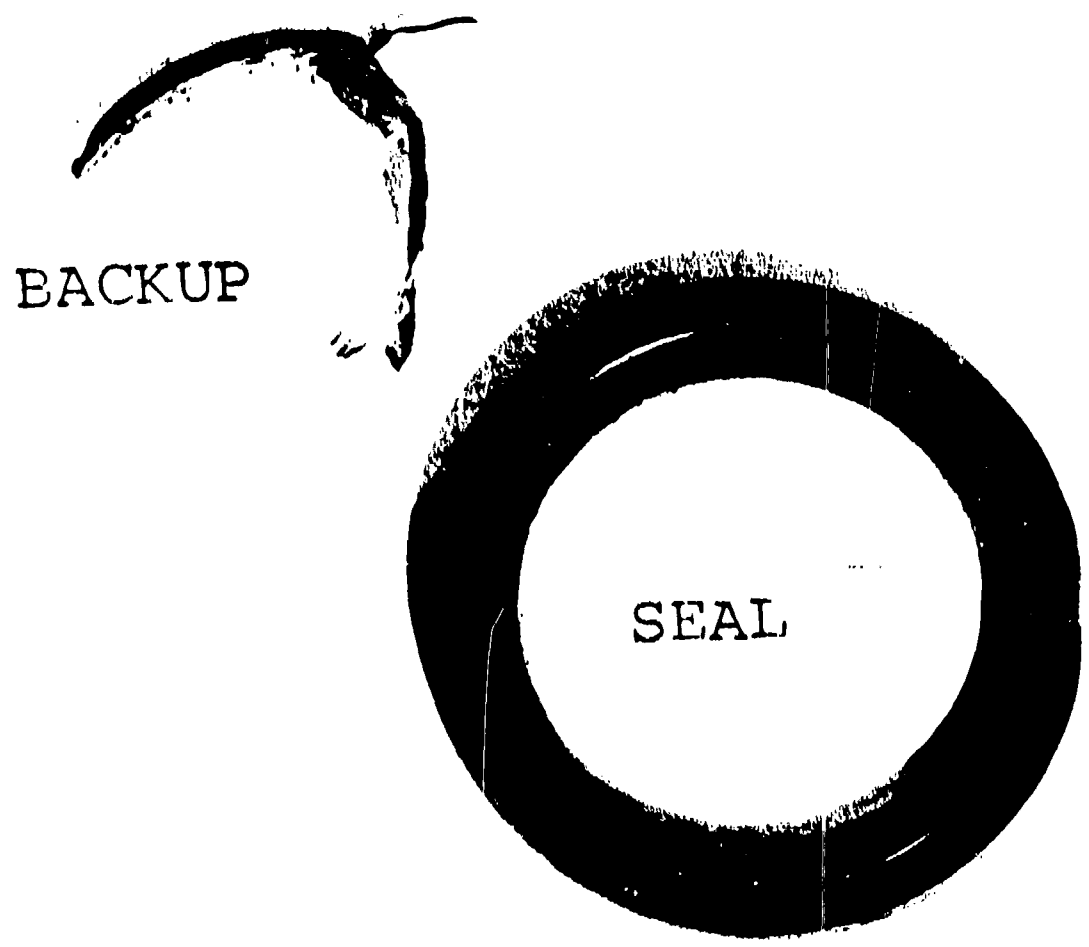
RESULTS: See Figure 117. Seal and backups were in good condition. The outboard backup exhibited some loss of cross section due to extrusion. Static leakage was 1 drop. Low temperature leakage was 2 drops. Dynamic leakage was 2.2 cc. No rod wear occurred due to seal or backups.

Figure 117. Candidate RS26 After Single Stage Rod Seal Screening Test. Seal is Revonoc 6200, backups are Revonoc 18158.

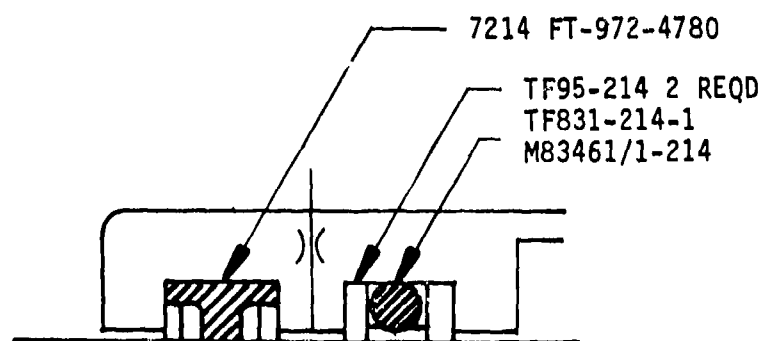
Figure 127. TRS18-V Two Stage Rod Seal

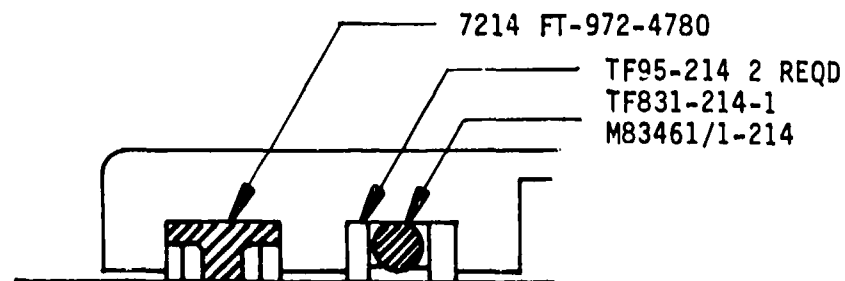
Figure 128. TRS18-UV Two Stage Rod Seal

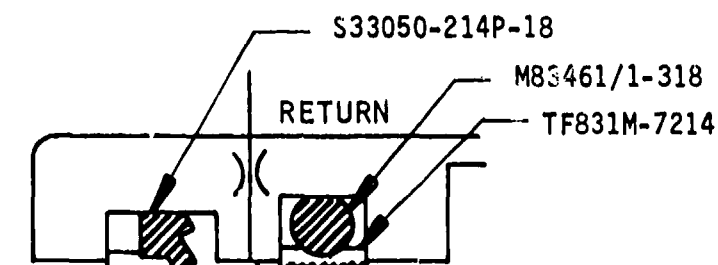
Figure 129. TRS19-V Two Stage Rod Seal

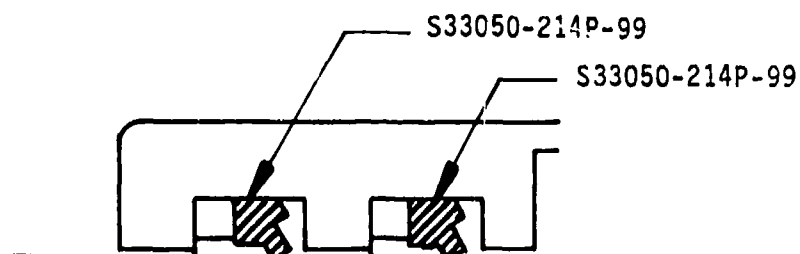
Figure 130. TRS20-UV Two Stage Rod Seal

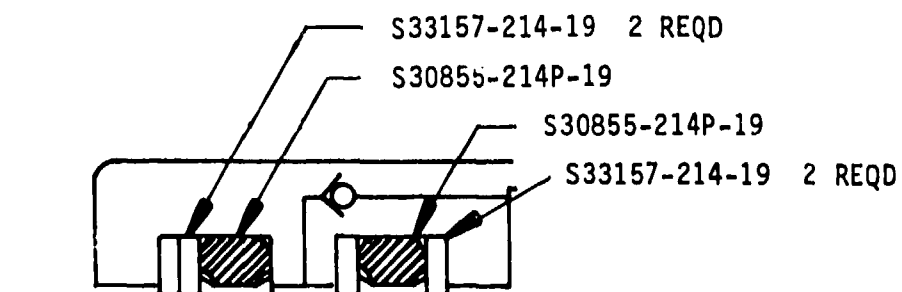
Figure 131. TRS21-SV Two Stage Rod Seal

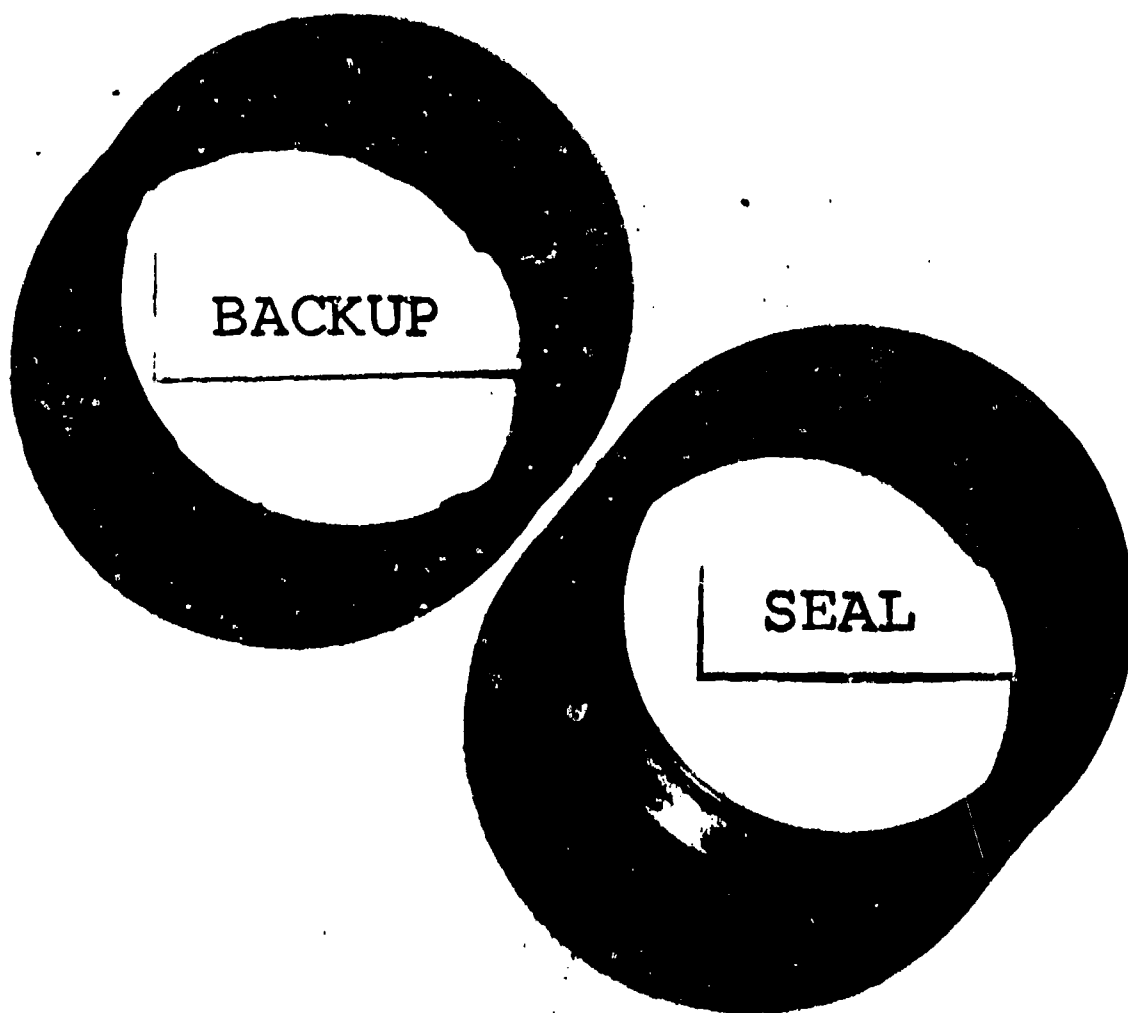
TRS4-SV-3R-TR  
2ND STAGE

Figure 133. Candidate TRS4-SV (2nd Stage) After Two Stage Rod Seal Screening Test. Seal had no leakage during test.

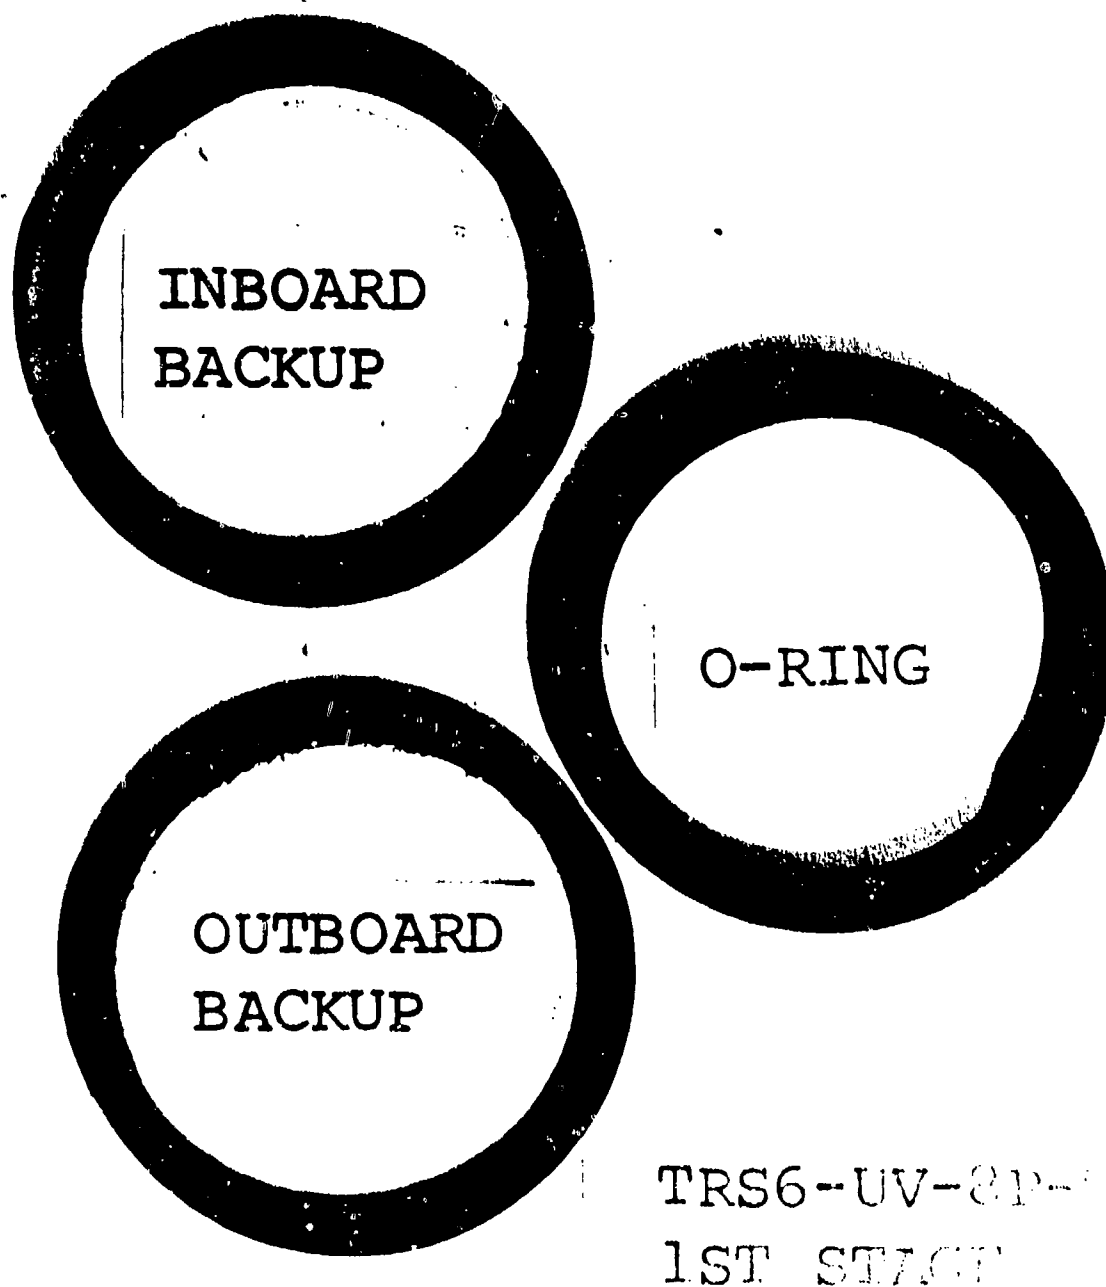
Figure 134. Candidate TRS6-UV (1st Stage) After Two Stage Rod Seal Screening Test. O-ring is in excellent condition.

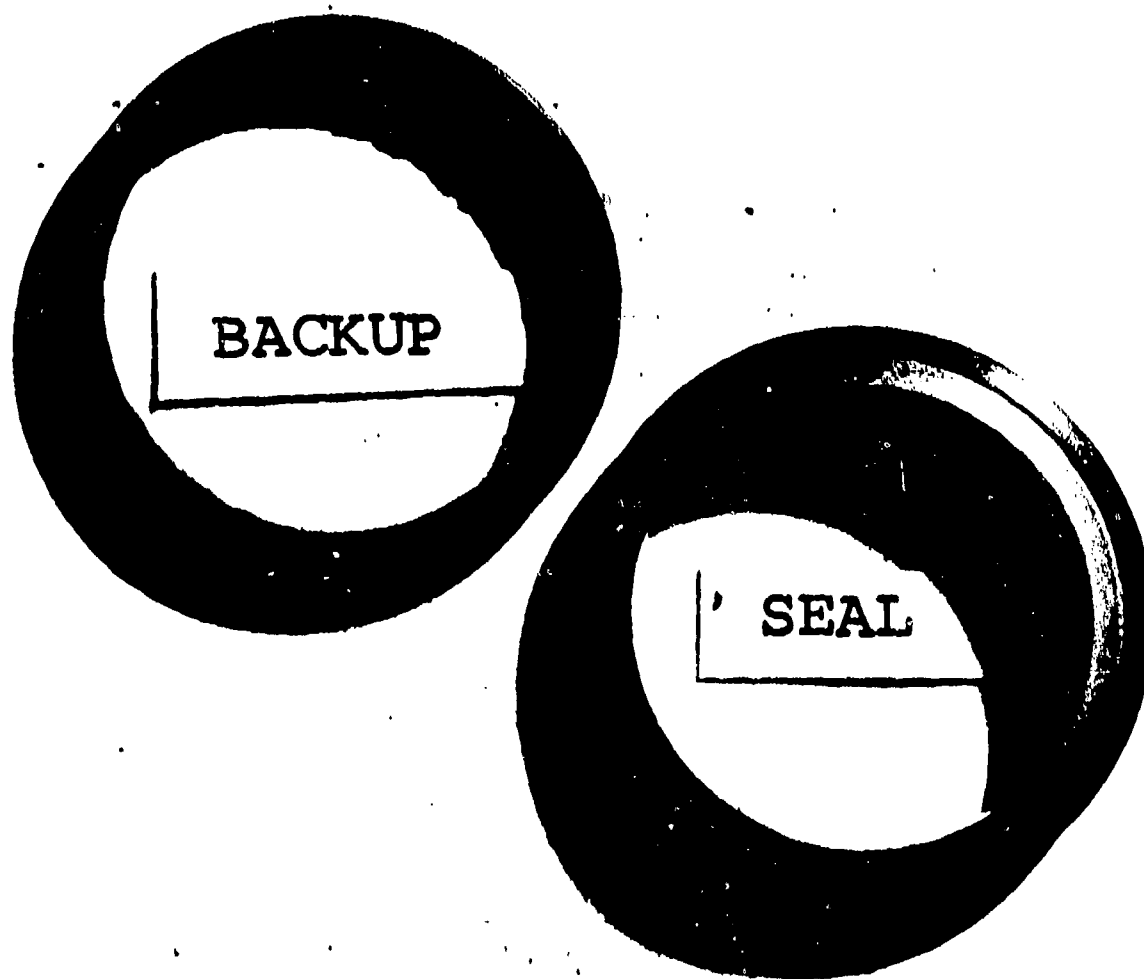
TRS13-V-5R-TR  
1ST STAGE

Figure 138. Candidate TRS13-V (1st Stage) After Two Stage Rod Seal Screening Test. Seal and backup were in excellent condition after test.

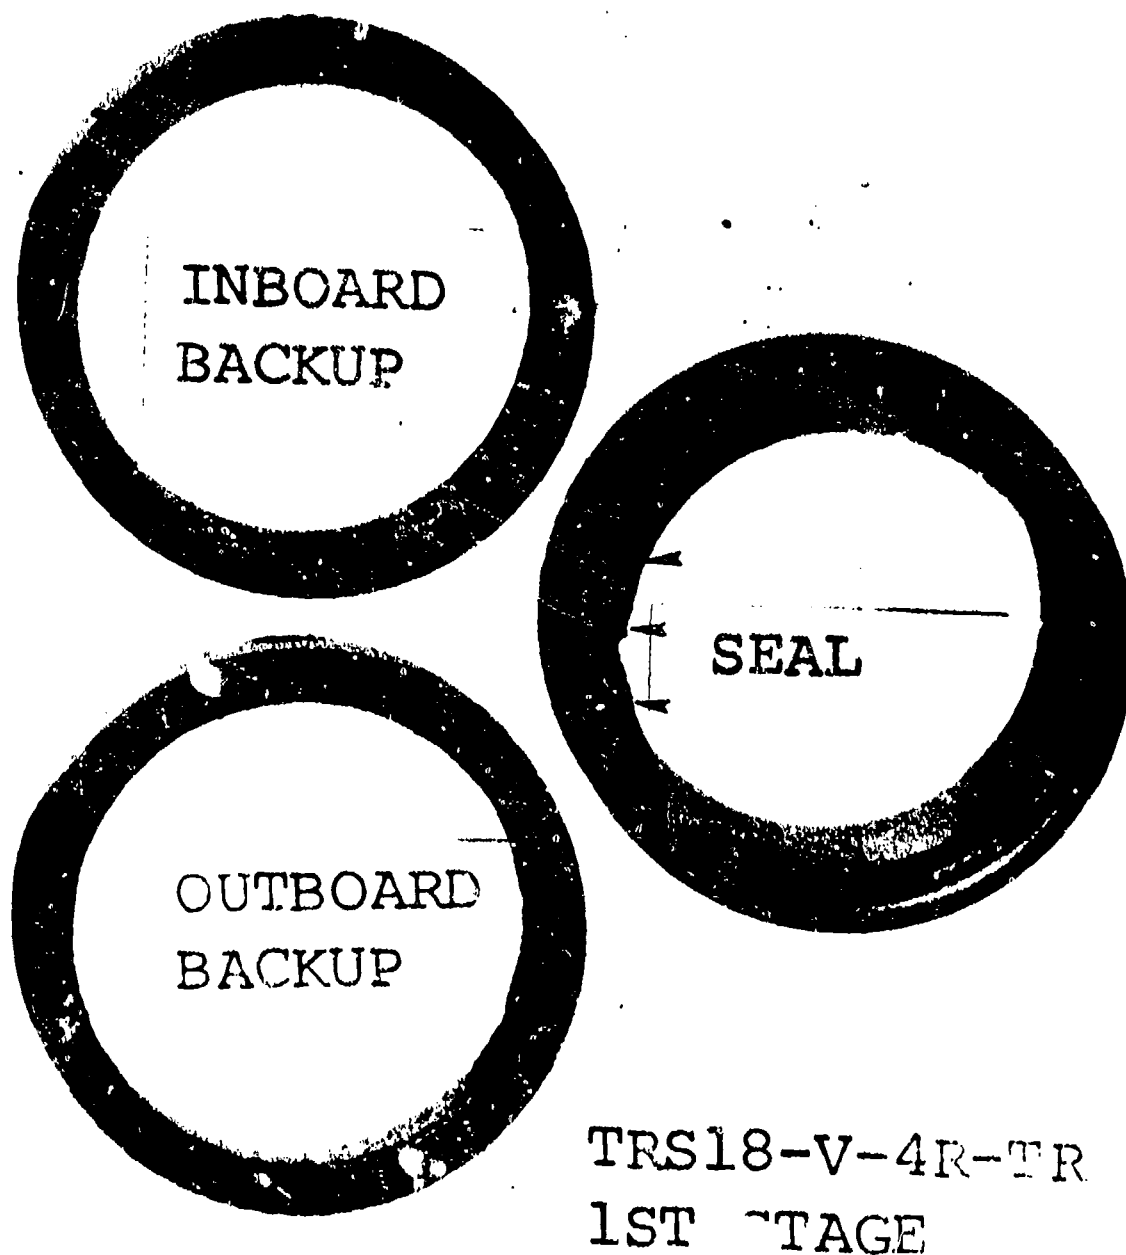
TRS18-V-4R-TR  
1ST STAGE

Figure 142. Candidate TRS18-V (1st Stage) After Two Stage Rod Seal Screening Test. Arrows denote area where seal was worn through.

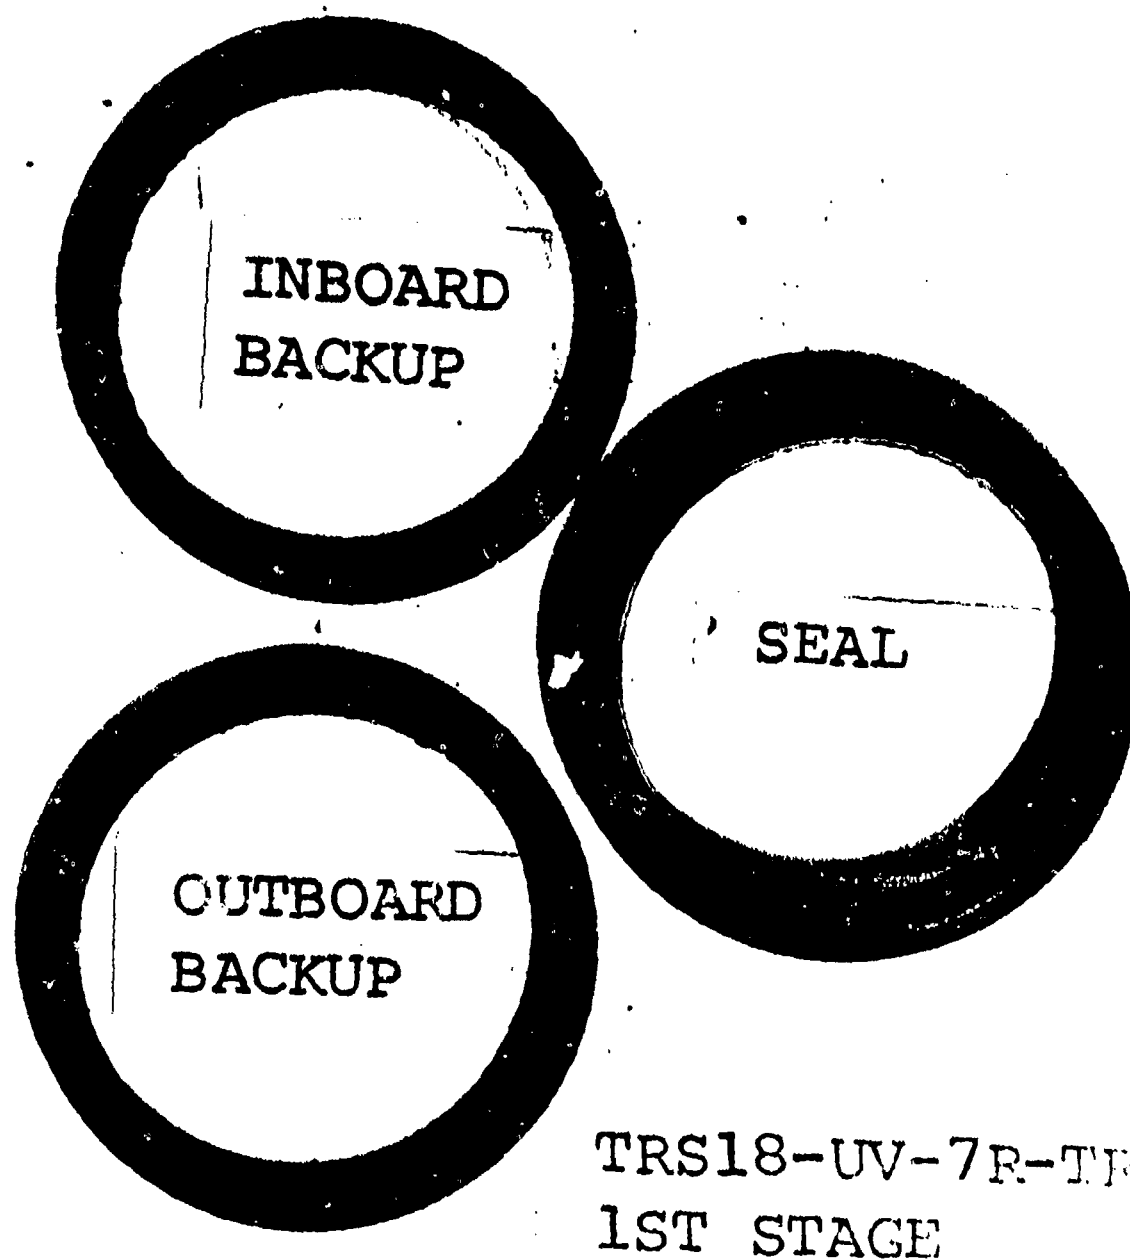
Figure 144. Candidate TRS18-UV (1st Stage) After Two Stage Rod Seal Screening Test. The cap seal is cracked around the ID and has begun to separate.
