# DYNAMIC SEALS FOR ADVANCED HYDRAULIC SYSTEMS

Robert B. Olsen  
Vought Corporation  
P.O. Box 225907  
Dallas, Texas 75265

August 1981

Final Report for Period July 1978 - March 1981

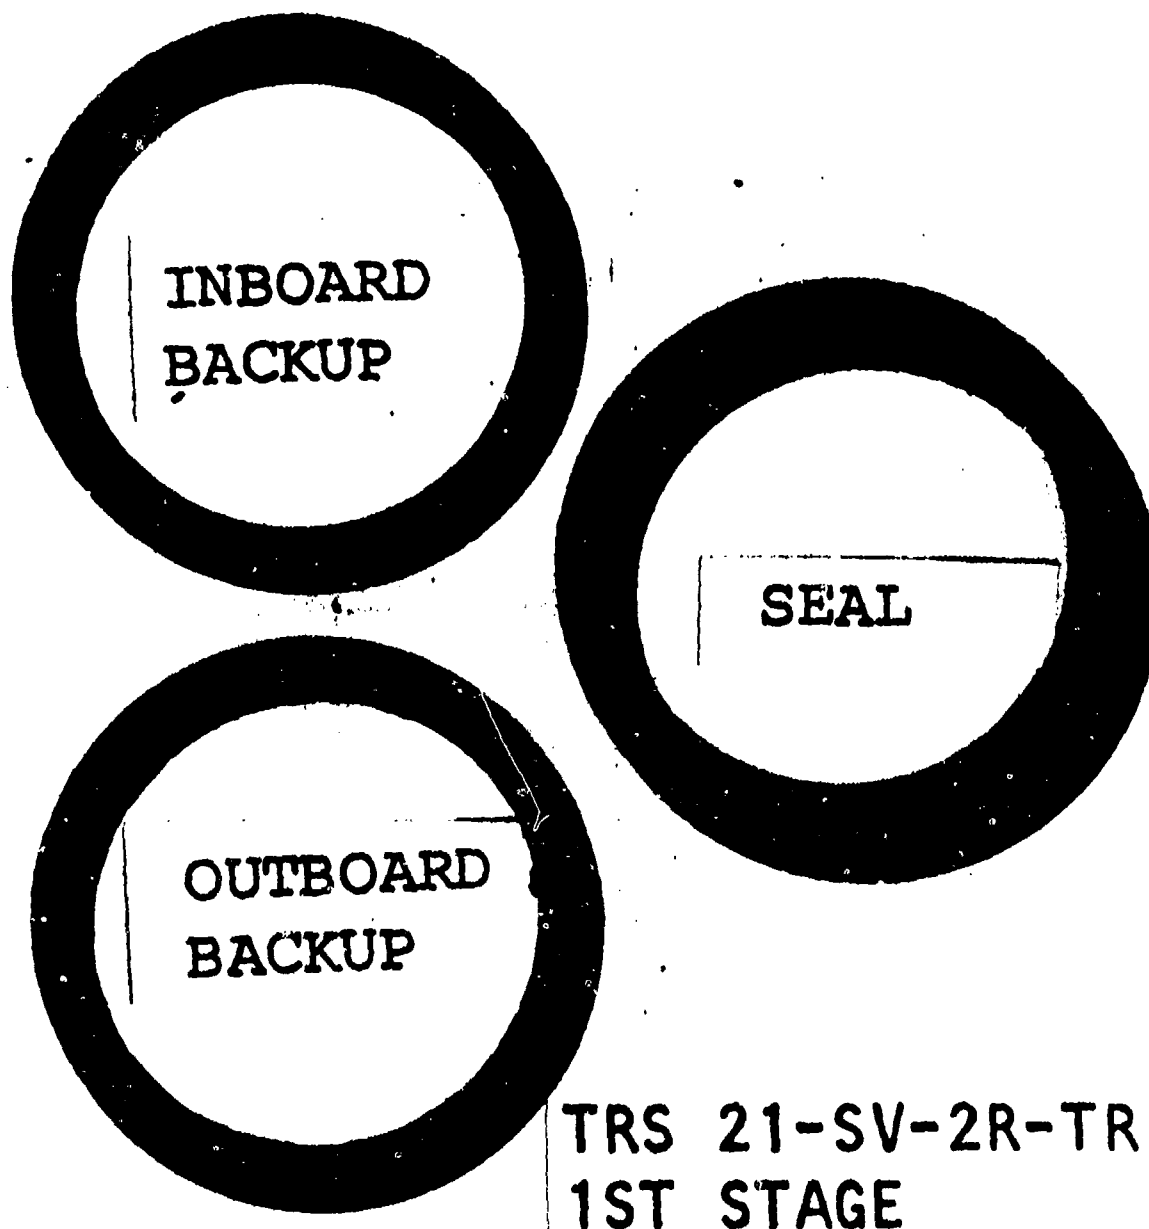
Figure 151. Candidate TRS21-SV (1st Stage) After Two Stage Rod Seal Screening Test. "Plus" seal and backups are Shamban Code 19.

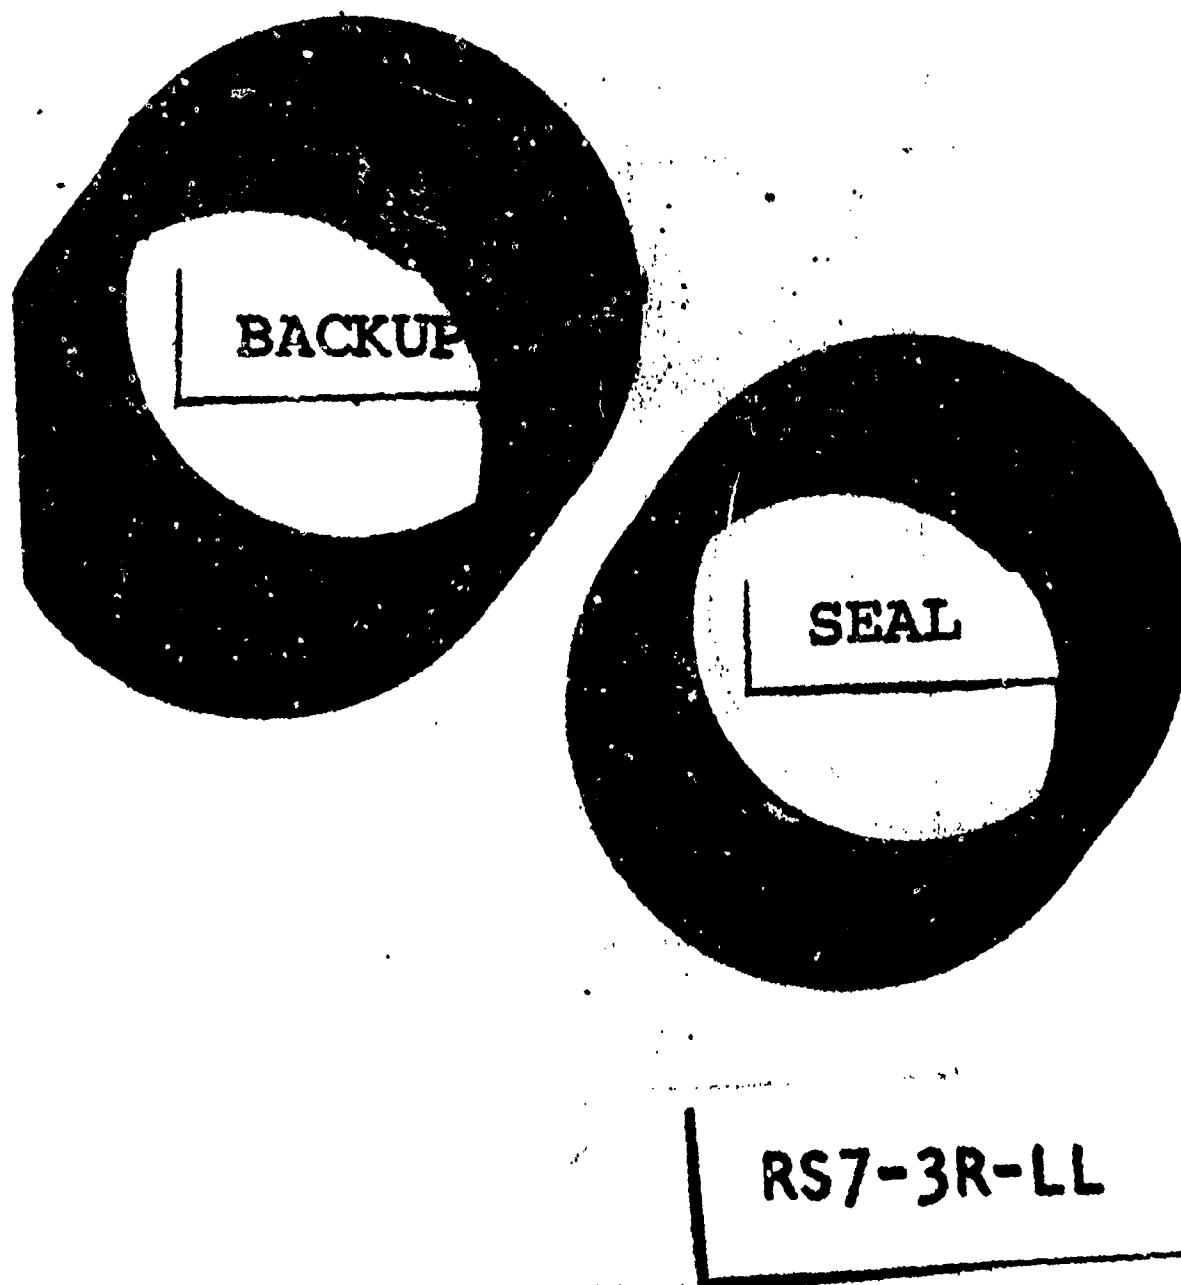
See Figure 159. There is no evidence of nibbling or any damage to the elastomer. The ID of the plastic portion of the seal conforms to the rod diameter of .9976. Some discoloration of the chrome occurred due to the MoS<sub>2</sub> filler in the seal. Leakage for Candidate RS7 was 11.1 ml static, .1 ml low temperature, and 7.35 ml dynamic.

Figure 159. Candidate R:7 After Long Life Test. Seal and backup are in excellent condition.

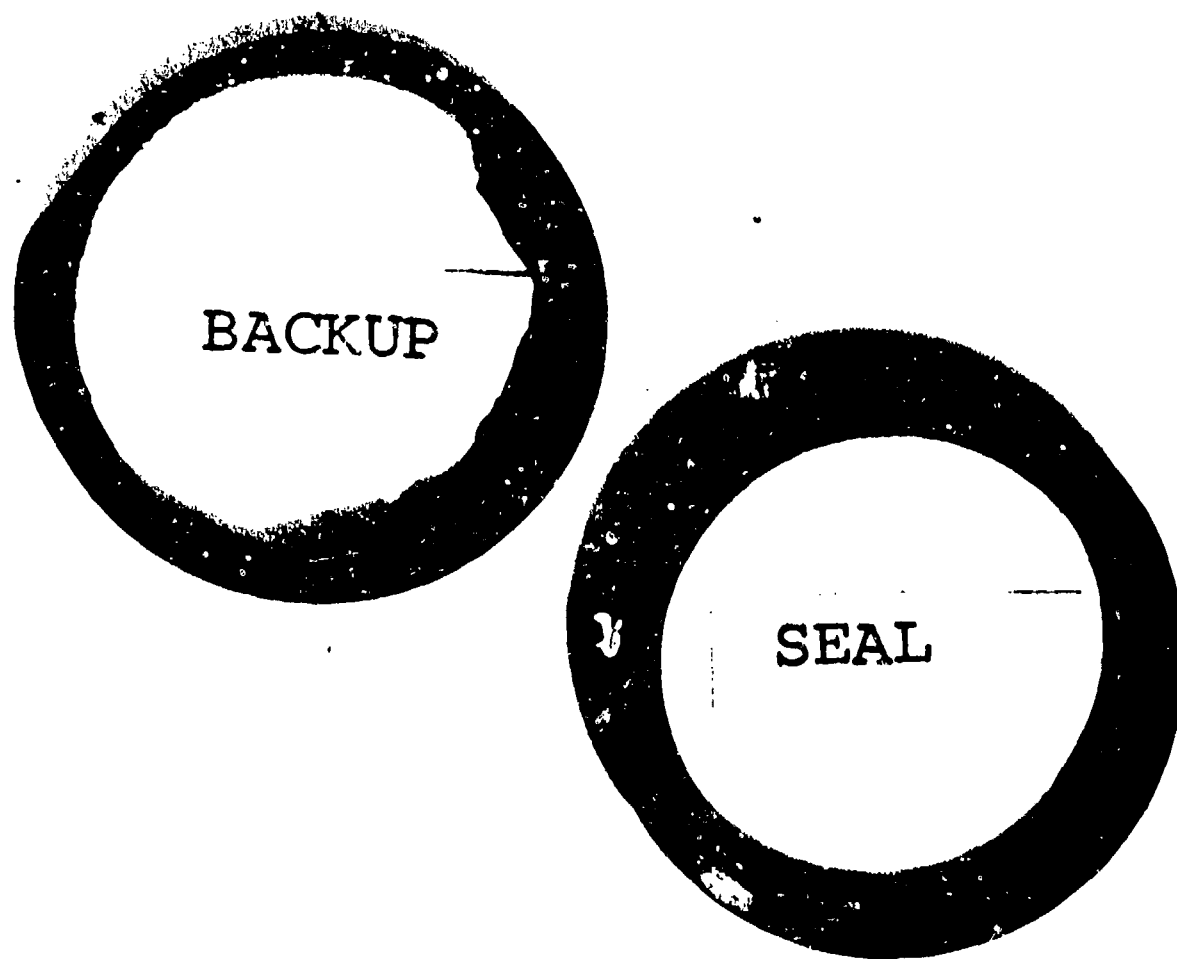
TRS4-UV-8R-LL  
1ST STAGE

Inboard Seal. See Figure 160. The trapezoid backup is very worn with a reduced cross section averaging .083 inches versus .109 min for a new backup. The ID is a loose fit on a 1.005 diameter plug gage. The elastomer fits on a .982 diameter plug gage and exhibits a uniform light nibbling or fretting around the ID next to the backup.

Figure 160. Candidate TRS4-UV (1st Stage) After Long Life Test. The backup cross section has worn approximately 25 percent and the ID is greater than 1.005 inch.

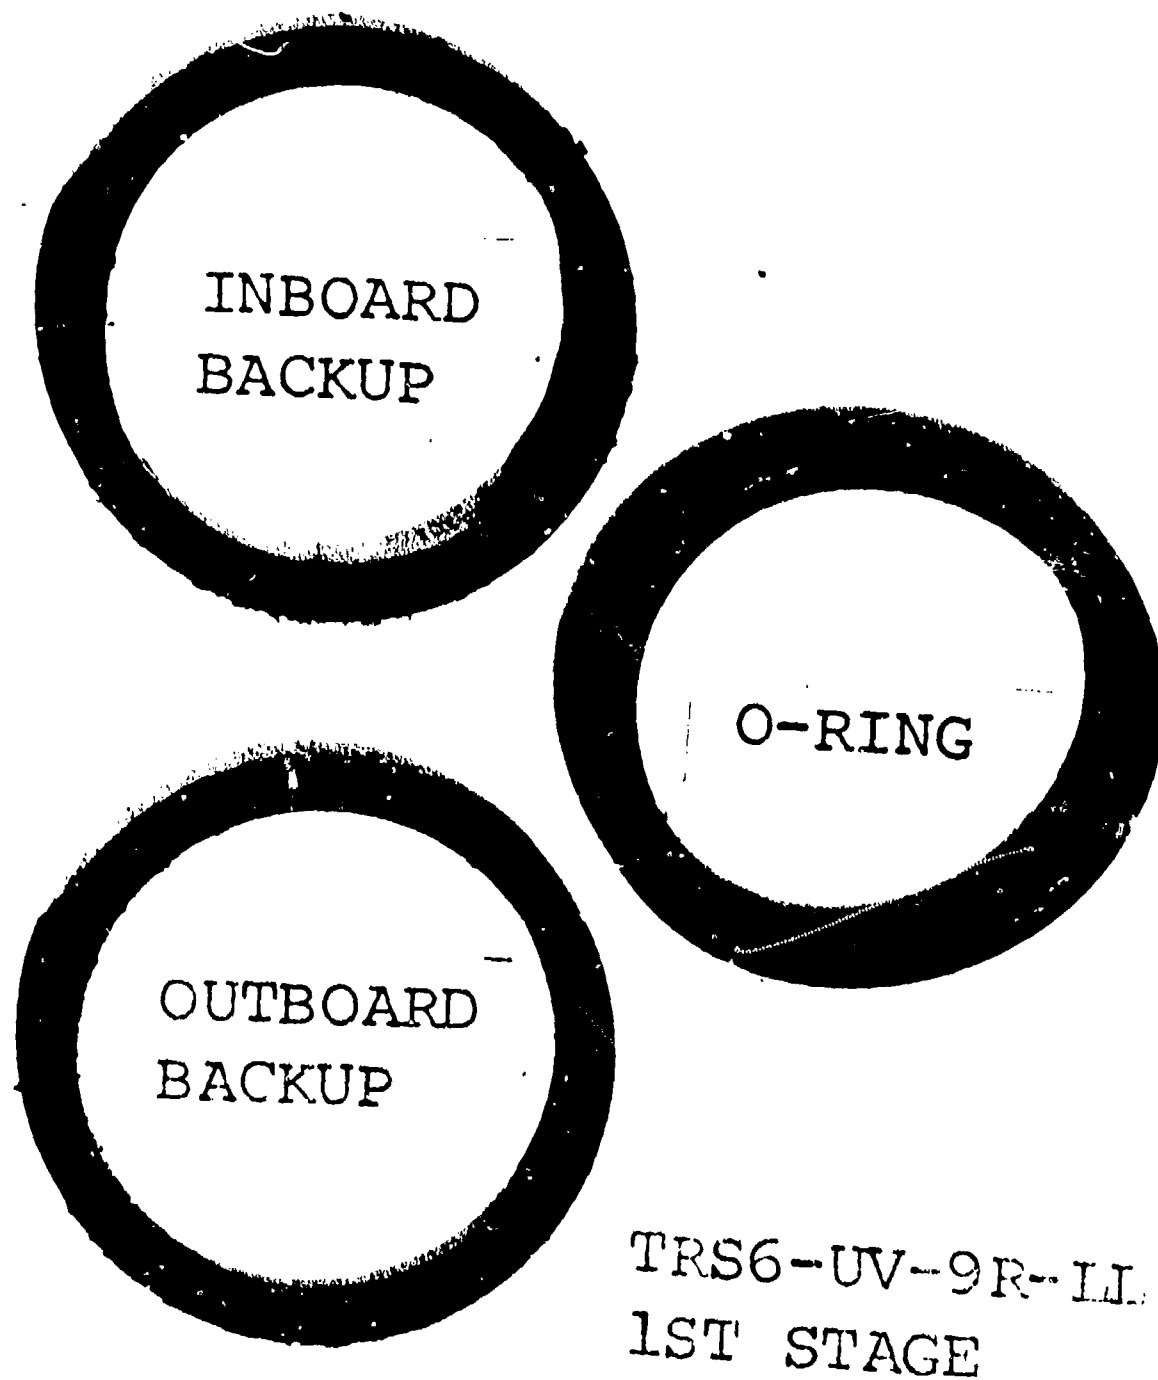
Inboard Seal. See Figure 162. The inboard backup is extruded toward the cylinder indicating pressure between seals. The O-ring has rolled and shows much fretting and nibbling over much of the outboard side. The outboard backup ID is loose fit on a 1.0042 diameter plug gage. Cross section of outer backup is .1101 versus .118 minimum for a new backup.

Figure 162. Candidate TRS6-UV (1st Stage) After Long Life Test. O-ring is in poor condition.

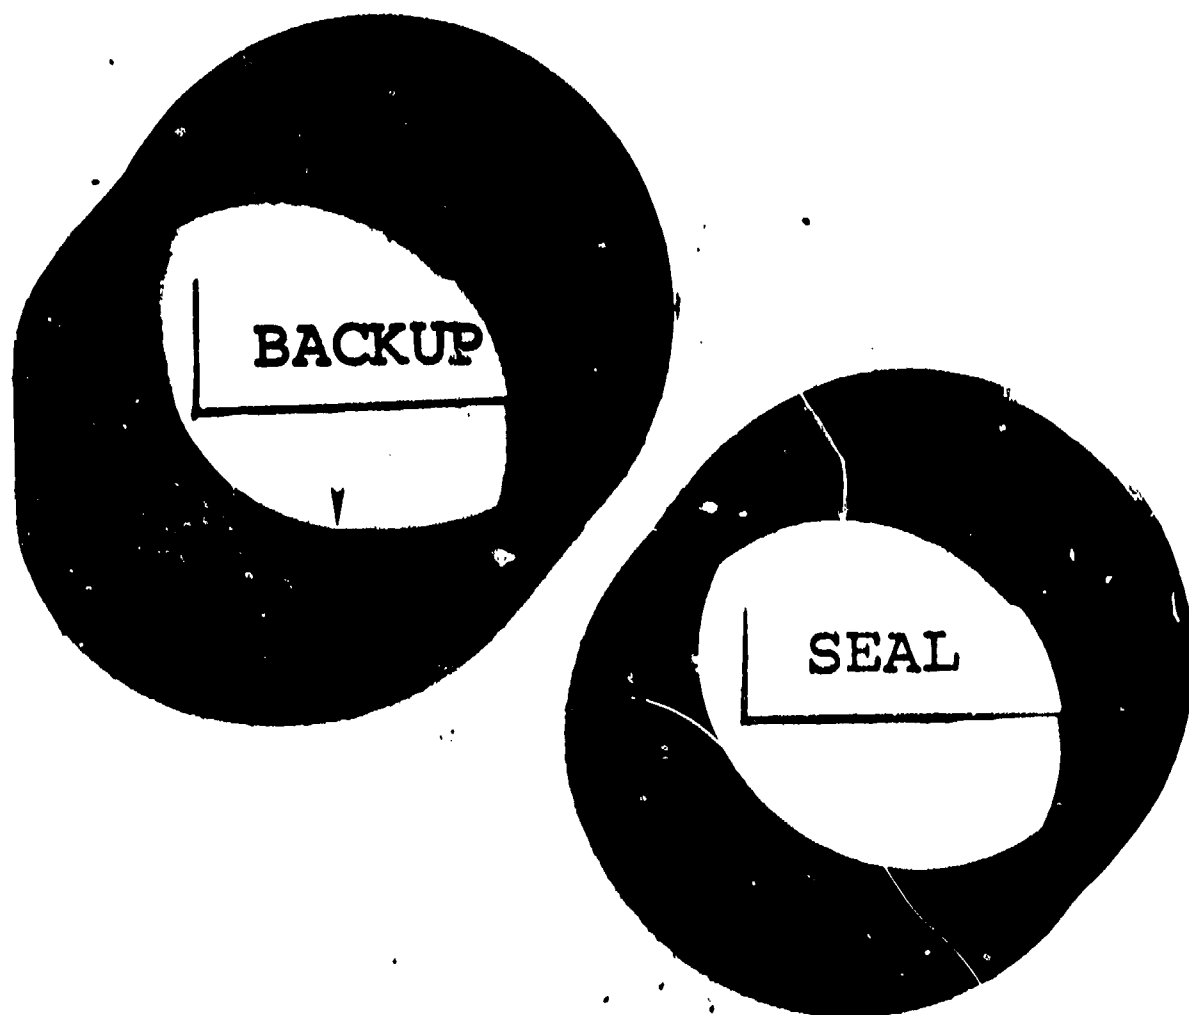
TRS20UV-10R-III  
1ST STAGE

See Figures 164 and 165. The inboard and outboard seals were in excellent shape upon conclusion of testing. The elastomers exhibited no wear or damage. The rod has a uniform pattern of axial wear marks that are deeper than the .12 to 15 RMS grind marks on unworn portions of the rod. No leakage was recorded for the static, low temperature, or dynamic conditions.

Figure 164. Candidate TRS20-UV (1st Stage) After Long Life Test. Seal and backup are in excellent condition. Backup was nicked (arrow) during removal.

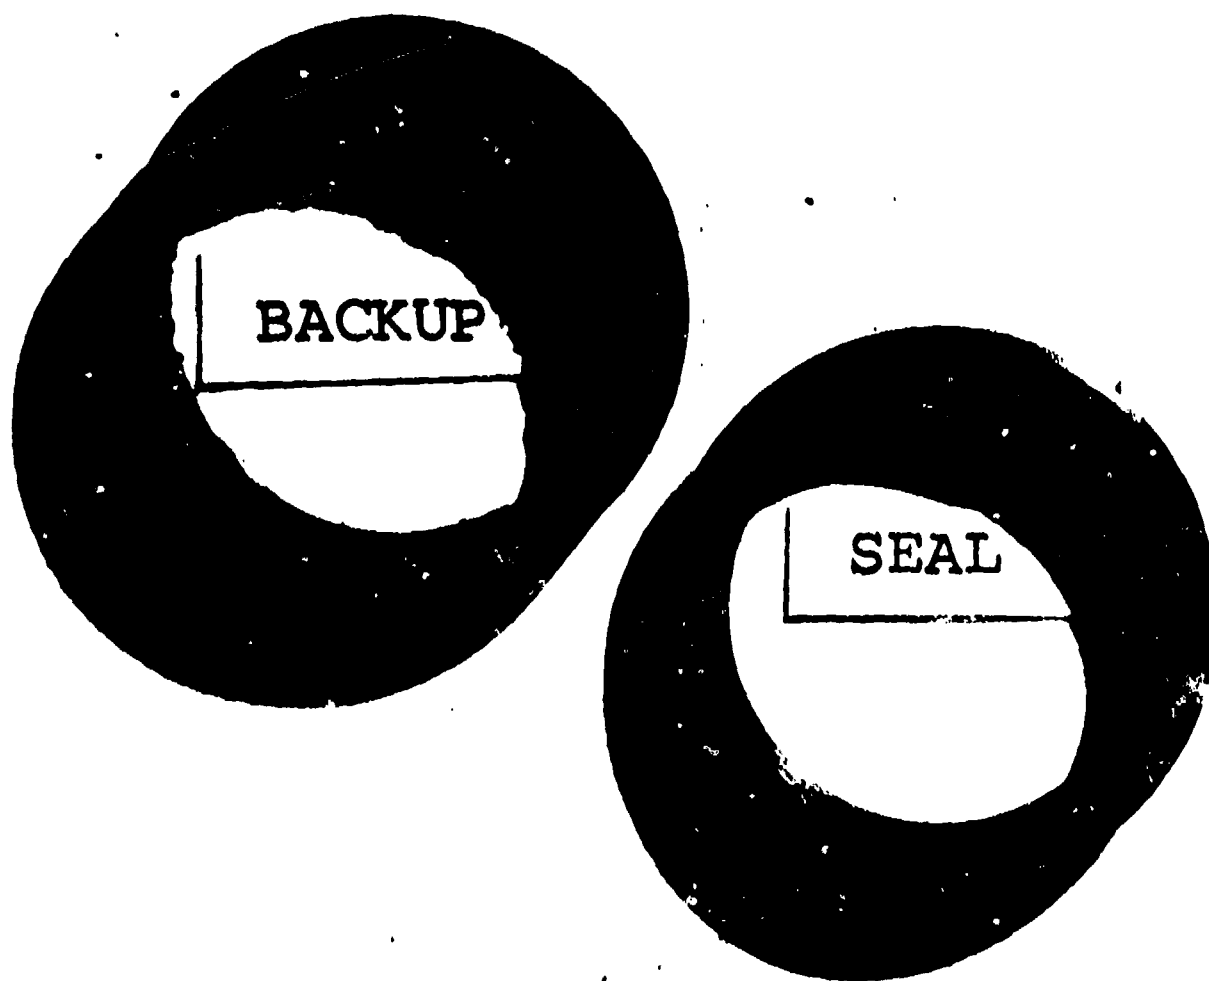
TRS20-UV-10R-11.  
2ND STAGE

Figure 165. Candidate TRS20-UV (2nd Stage) After Long Life Test. Two stage installation had zero external leakage.

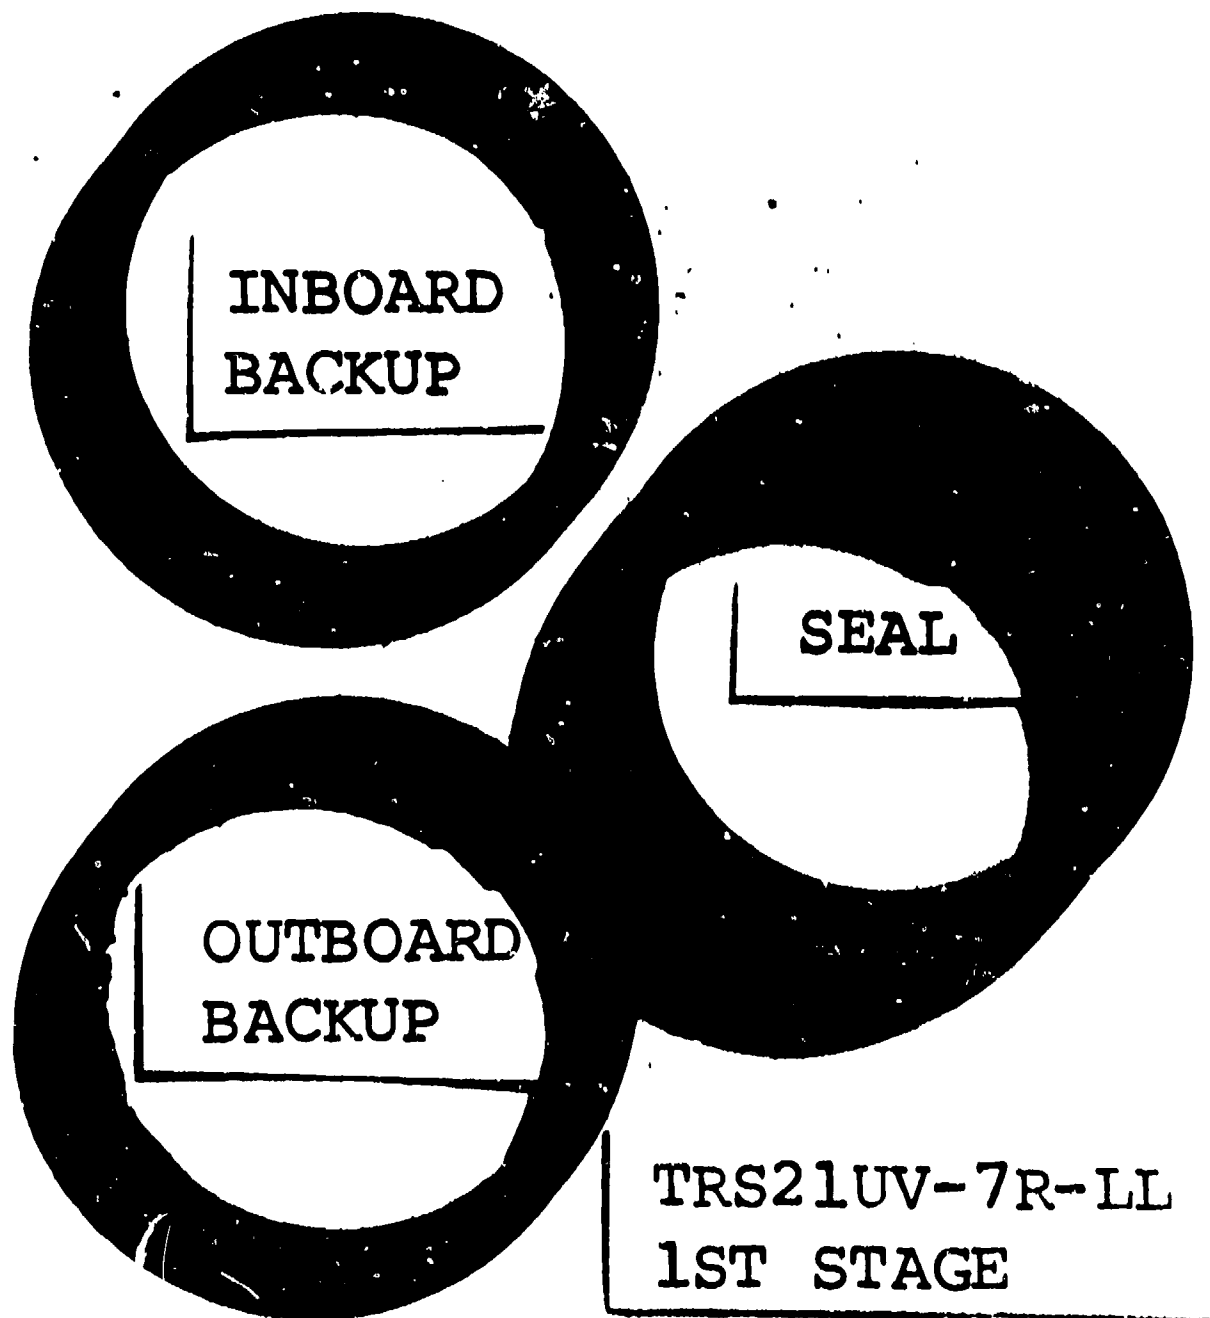
Figure 166. Candidate TRS21-UV (1st Stage) After Long Life Test. Seals is in excellent condition.

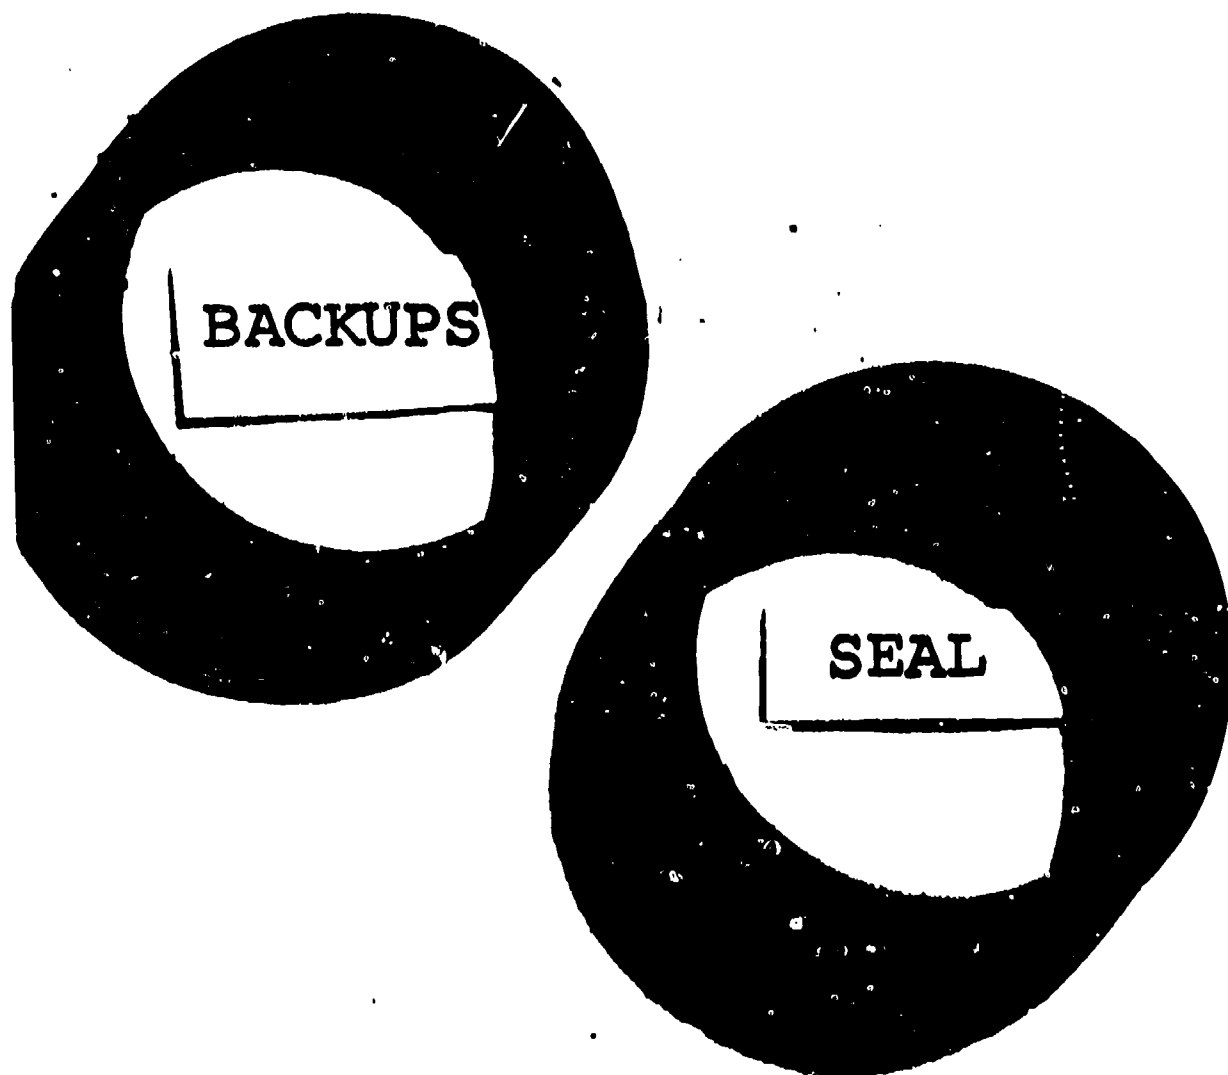
TRS21UV-7R-LL  
2ND STAGE

Figure 167. Candidate TRS21-UV (2nd Stage) After Long Life Test. No external leakage occurred.

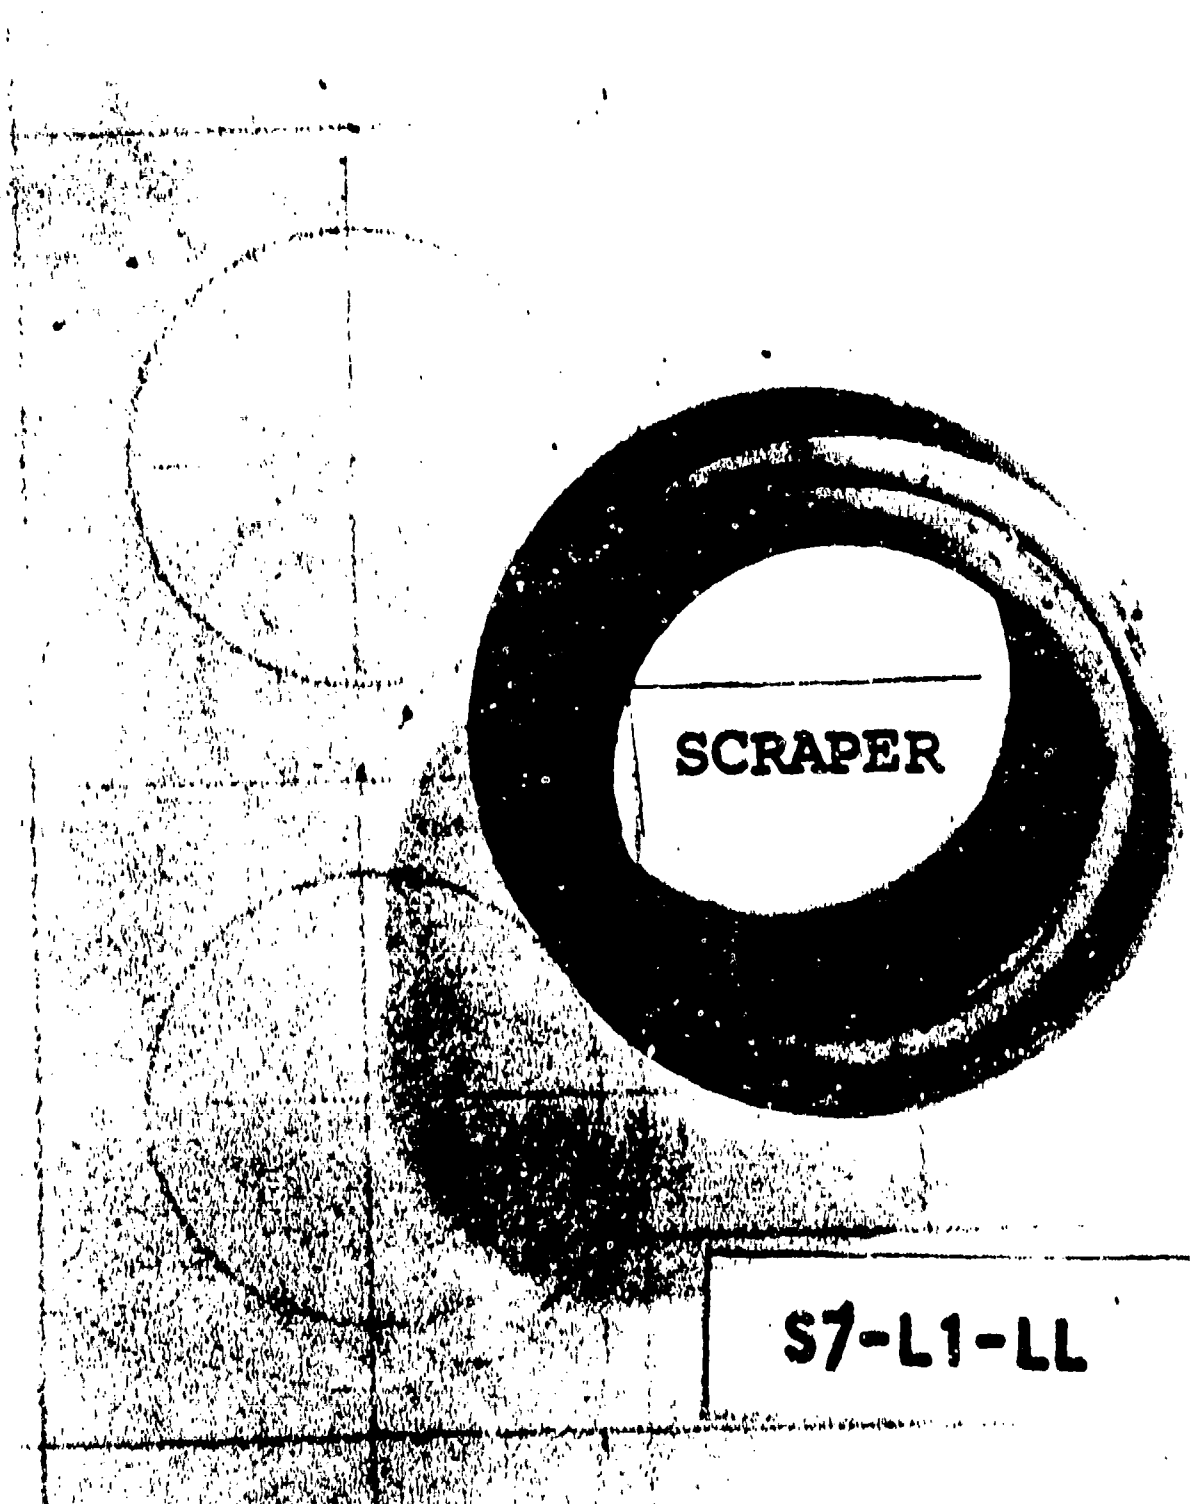
This scraper candidate was installed to evaluate rod wear on four of the seal test assemblies. Upon conclusion of tests, none of the four samples exhibited any wear or damage. Rod wear was not increased by the addition of a scraper. See Figure 168 for typical appearance of scrapers following test.

Figure 168. Candidate S7 Scraper After Long Life Test.  
This sample is representative of the four samples of S7  
in the Long Life Test.

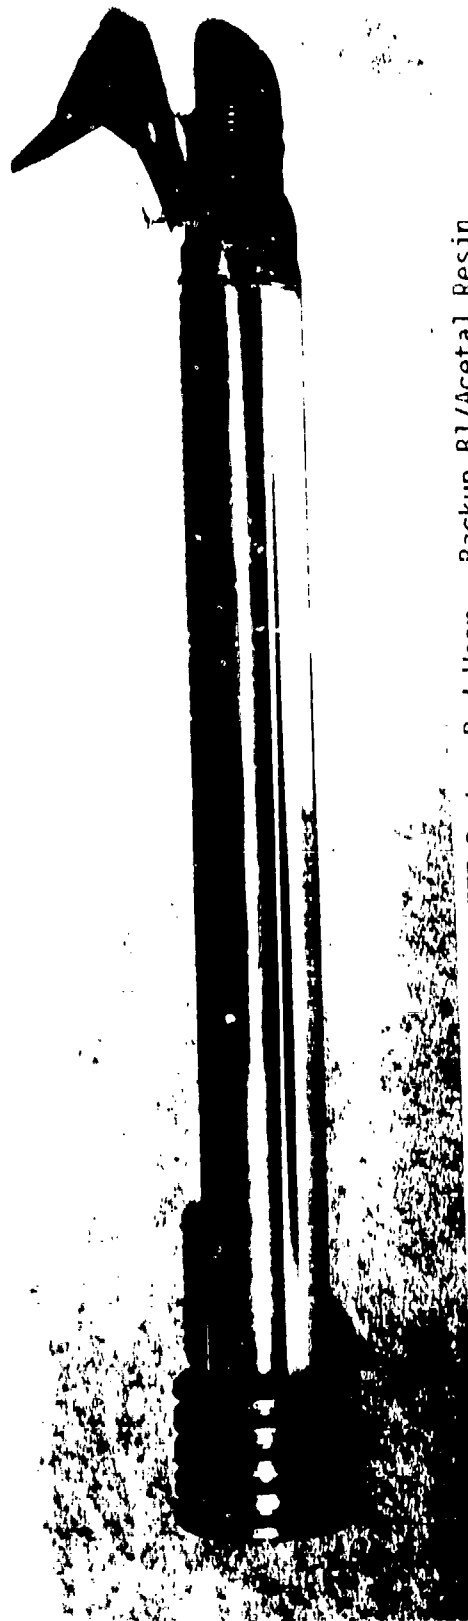
Figures 201 thru 209, show the rod condition for the various materials after  $13.31 \times 10^6$  cycles of the Long Life Tests.

Figure 201. Unfilled TFE Backup Rod Wear. Backup B1/Acetal Resin Scraper rod wear is low after 13.31 x 10<sup>6</sup> cycles.

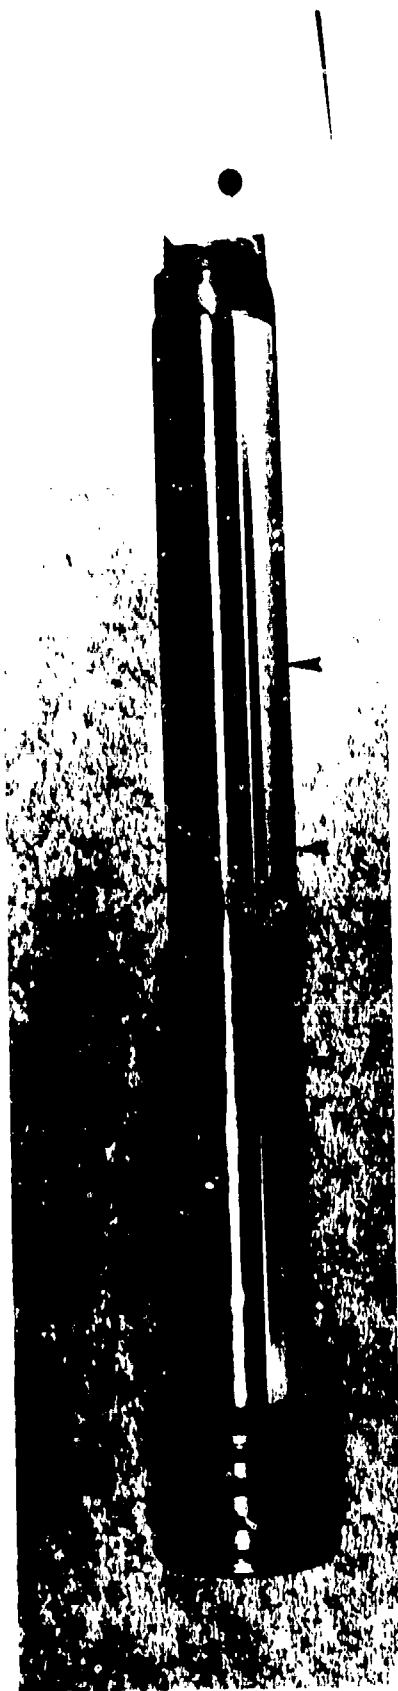
Figure 202. Revonoc 18158 Backup/Acetal Resin Scraper Rod Wear. Going from left to right, arrows denote area contacted during 1 and 2 percent stroke cycling by seal (B22), seal plus scraper, and scraper (S7). (13.31 x 10<sup>6</sup> cycles).

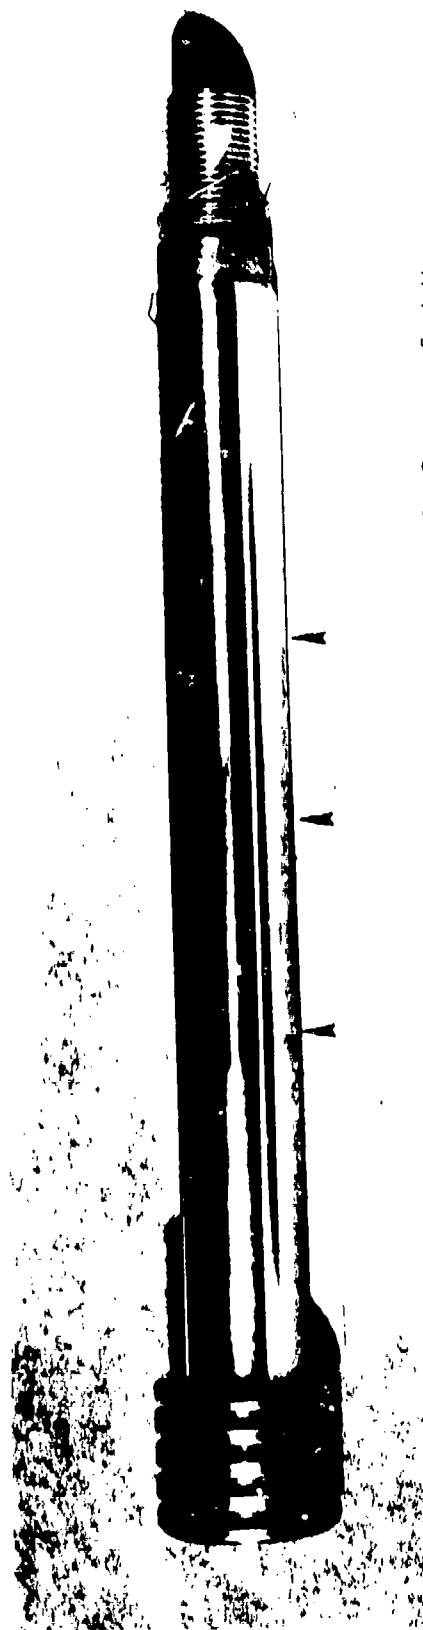
Figure 203. Shamban Code 19 Backup/Acetal Resin Scraper Rod Wear. Going from left to right. Arrows denote area contacted during 1 and 2 percent stroke cycling by seal (B35), seal plus scraper, and scraper (S7). CRES end cap. (13.31 x 10<sup>6</sup> cycles).

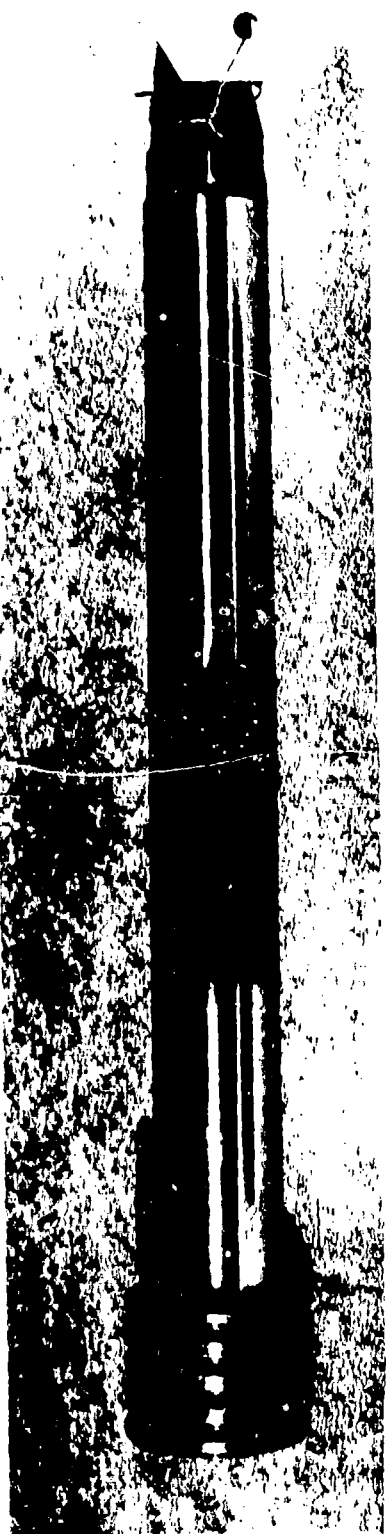
Figure 204. Backup B35 Shamban Code 19 Backup/Aluminum Bronze End Cap Rod Wear. Compare with Figure 203 and 205.

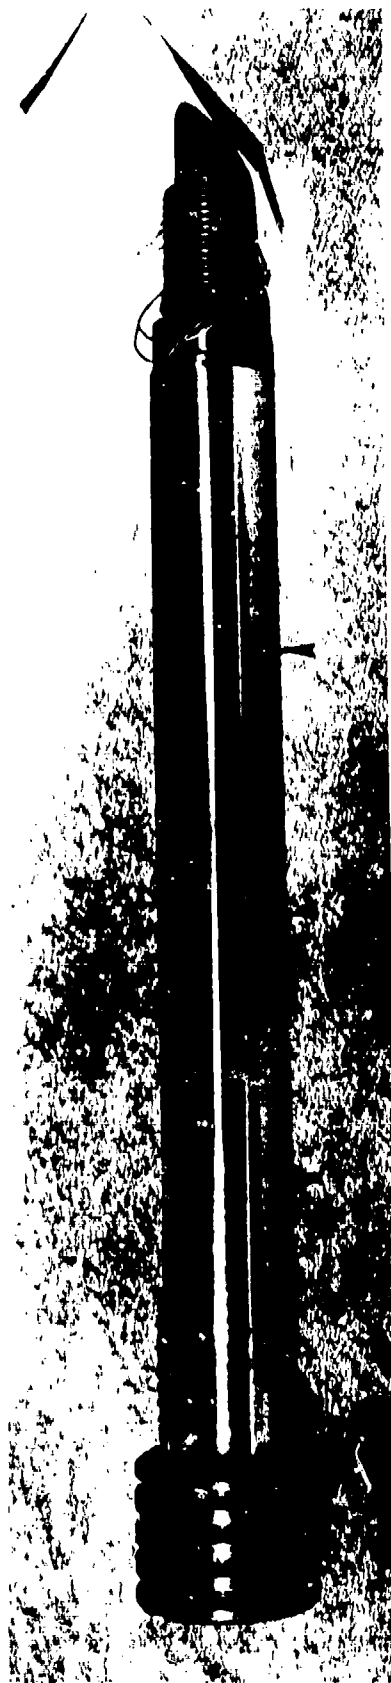
Figure 207. Revonoc 18158 Two Stage Seal Rod Wear. Going from left to right, arrows denote area contacted during 1 and 2 percent stroke cycling by inner seal, both seals, and outer seal (TRS4-UV,  $13.31 \times 10^6$  cycles).

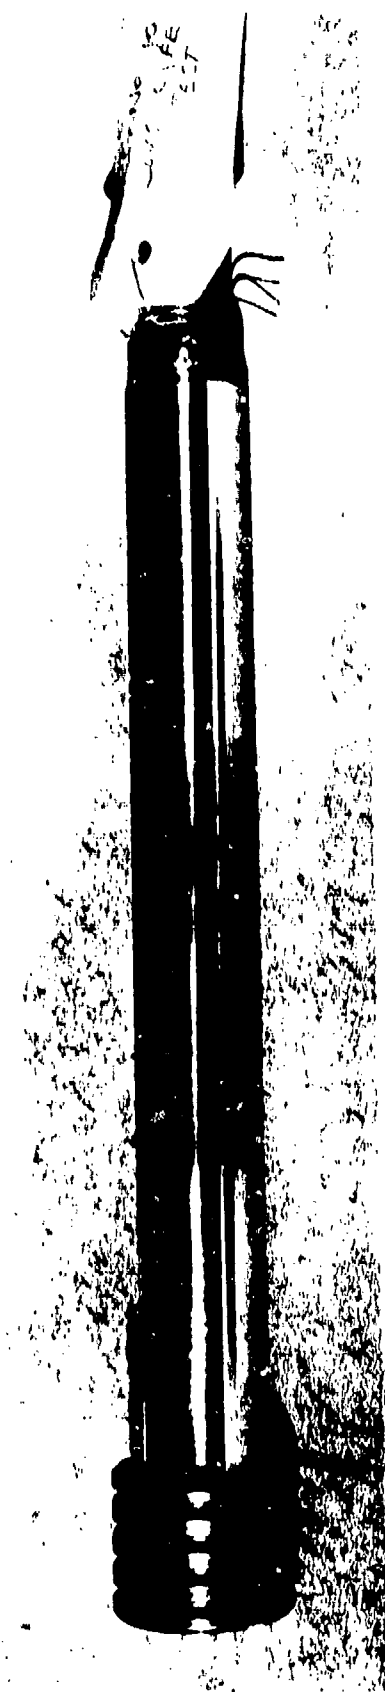
Figure 208. Shamban Code 99 Two Stage Seal Rod Wear. Going from left to right, arrows denote area contacted during 1 and 2 percent stroke cycling by inner seal, both seals, and outer seal (TRS20-UV, 13.31 x 10<sup>6</sup> cycles).
