AFWAL-TR-82-8029

RAIN EROSION EVALUATION AND ANALYSIS OF
SELECTED COATED MONOLITHIC POLYCARBONATE
TRANSPARENCY MATERIALS

May 1982

Final Report for Period July 1980 - December 1981

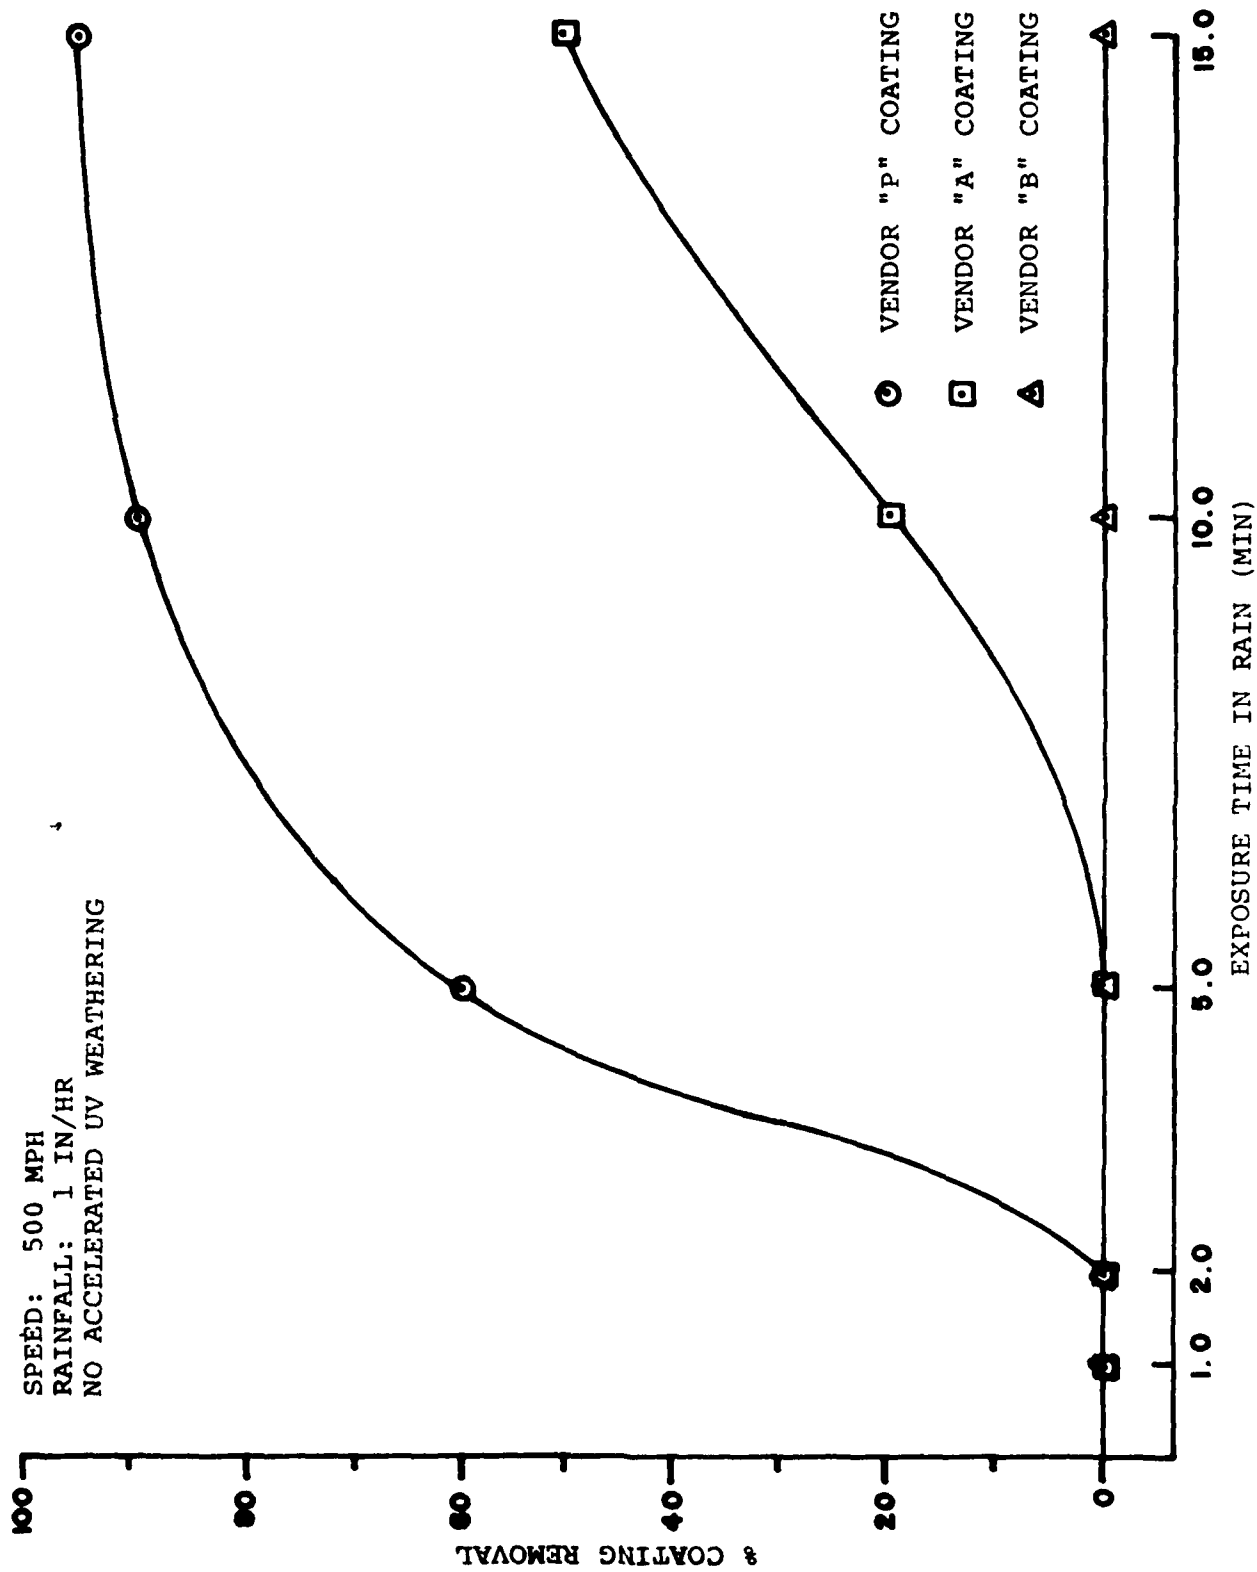
Figure 3. Percent Coating Removal vs. Time in Rain.

Visual examination, under a lighted magnifier, of the coated monolithic polycarbonate specimens exhibited initiation of coating removal from the Vendor P specimens occurring during the interval between two and five minutes of rainfield exposure. Vendor A specimens exhibited initiation of coating removal in the interval between five and ten minutes of rainfield exposure. Vendor B specimens exhibited surface pitting but no coating removal after 15 minutes of rainfield exposure. The worst case data is shown in Figure 3. The rain erosion data for specific specimens is shown in Appendix A, Tables A-1 through A-3.

Coating removal in the Vendor B material was nearly zero percent, being independent of rainfield exposure time as well as UV radiation exposure effects (Figures 3, 4, and 5). The fact of no substantial coating removal on the Vendor B material could be associated with the existence of high adhesion forces between the coating and substrate interface. This may be deduced from Figure B-8B as well as from Figures B-7A and B-9C, where the coating itself was eroded prior to being delaminated from the substrate surface.

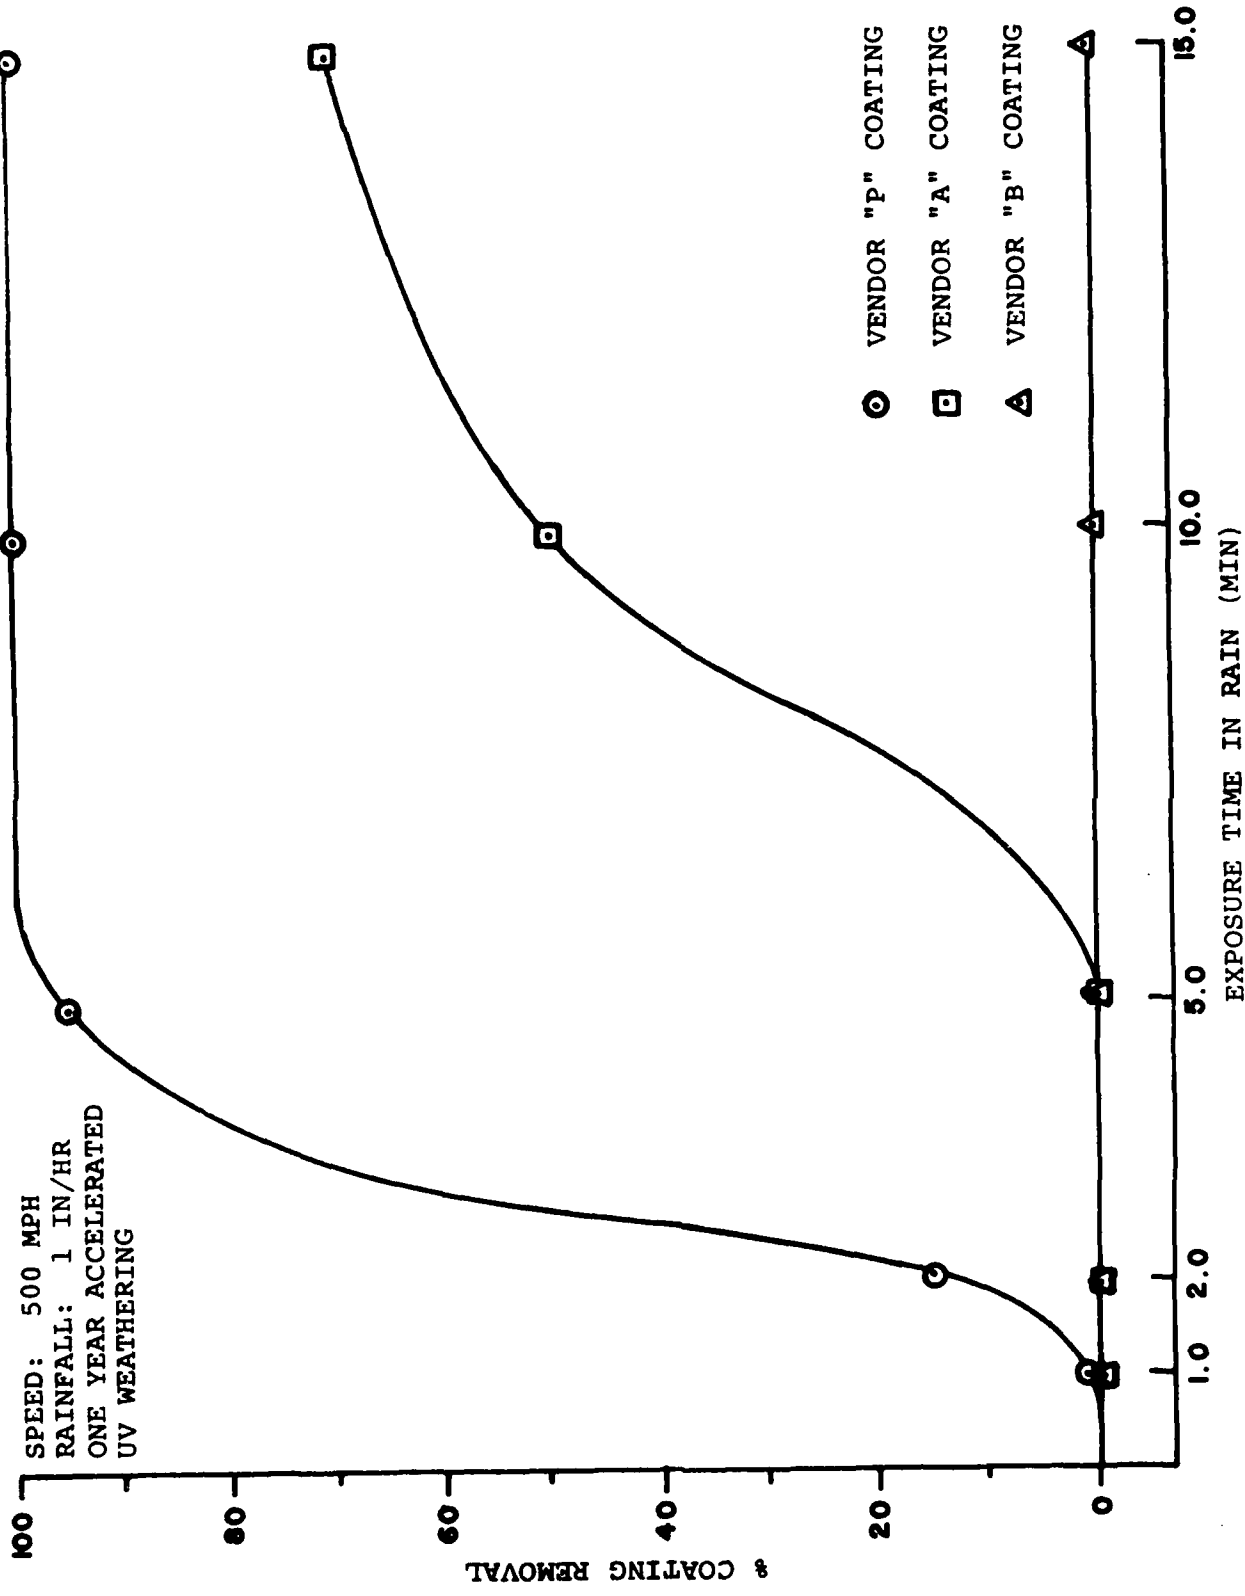
Figure 4. Percent Coating Removal vs. Time in Rain.

The Vendor P specimens exhibited initiation of coating removal during the zero to one-minute interval of rainfield exposure. Vendor A specimens exhibited increased coating removal in the five to ten-minute interval of rainfield exposure. Vendor B specimens exhibited severe pitting of the coating surface at the 15-minute interval but no observable coating removal. The worst case data is shown in Figure 4. The rain erosion data for specific specimens is shown in Appendix A, Tables A-4 through A-6.

The effects of UV exposure on the subsequent rain erosion behavior of the Vendor P, A, and B materials were evaluated through the kinetic behavior of coating removal and surface characterization obtained by SEM observations. Exposure of Vendor P material to accelerated UV weathering resulted in a reduced incubation of 0.5 minutes. The incubation time of the Vendor A material was not affected by accelerated UV weathering exposure; however, coating removal rate did increase with UV exposure time as shown by comparing Figures 3 and 4. Furthermore,

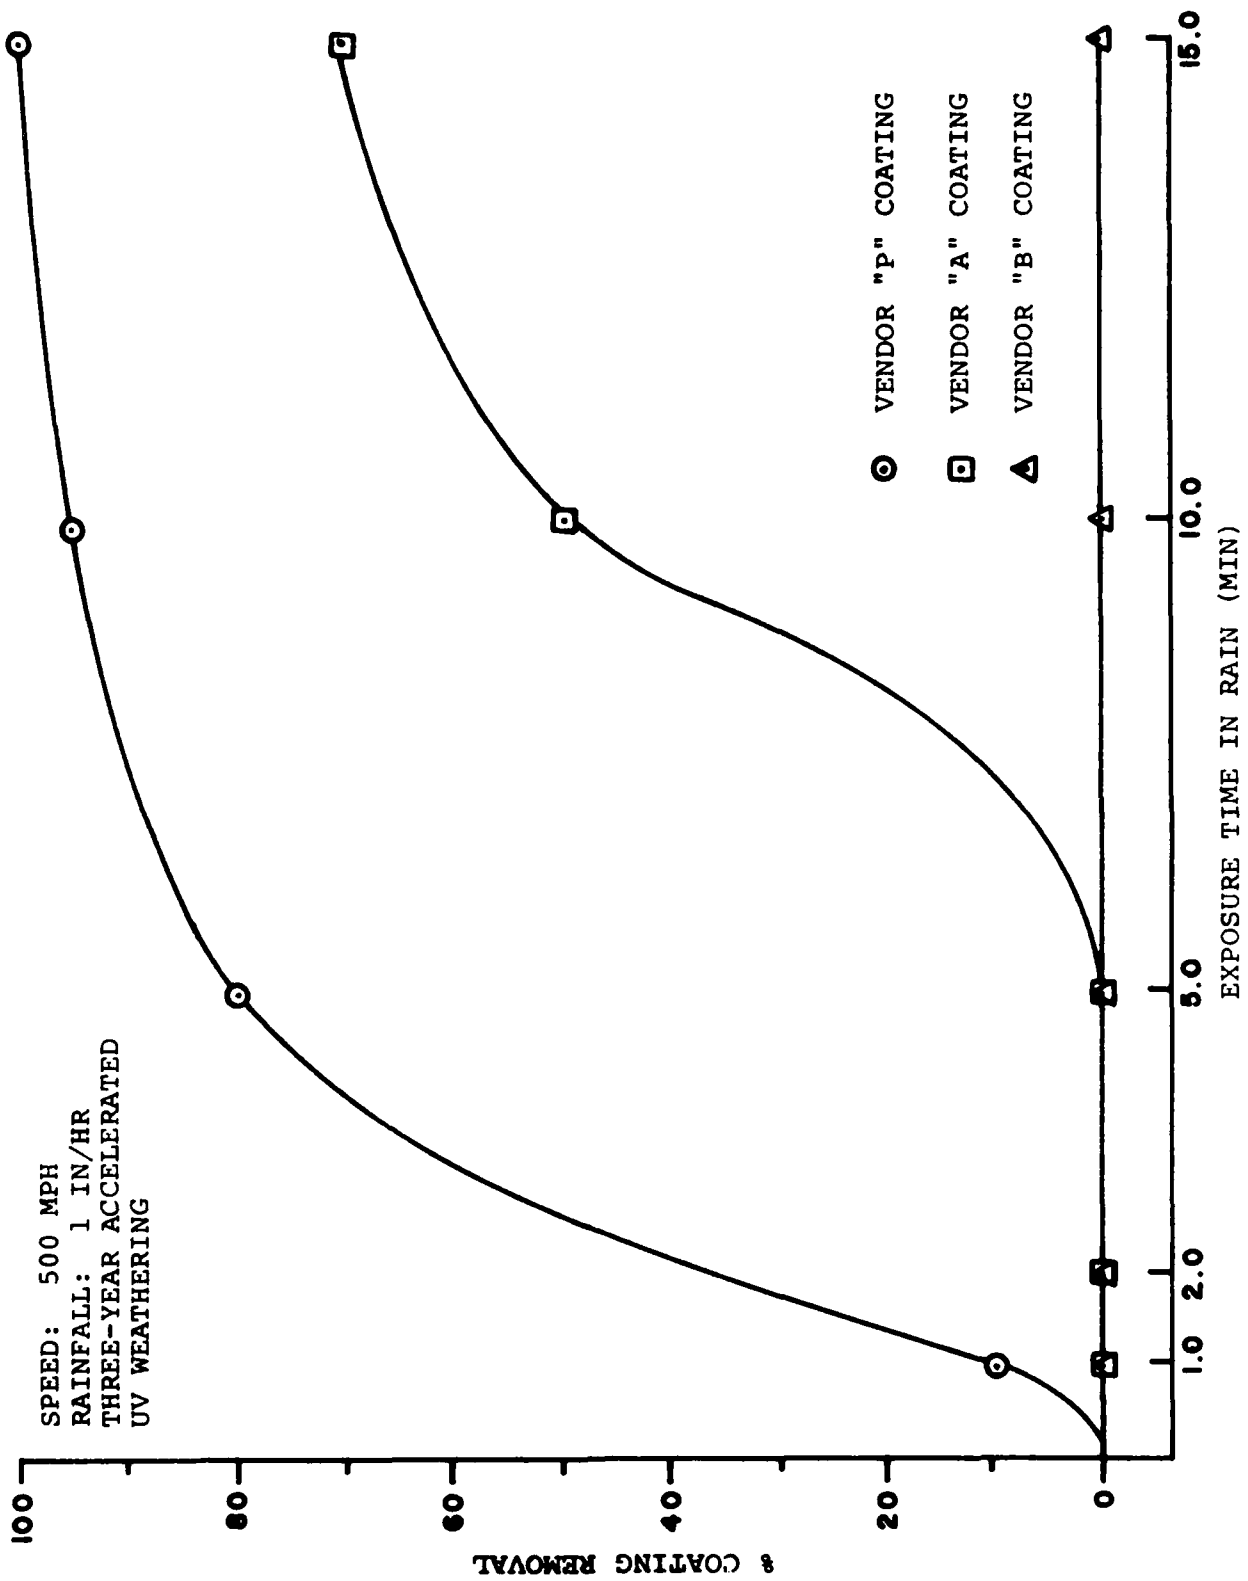
Figure 5. Percent Coating Removal vs. Time in Rain.

The Vendor P specimens exhibited initiation of increased coating removal in the zero to one-minute interval of rainfield exposure. Vendor A specimens continued to exhibit initiation and percent of coating removal at the five to ten-minute interval of rainfield exposure. Vendor B exhibited severe pitting of the coating surface at the 15-minute interval but no observable coating removed. The worst case data is shown in Figure 5. The rain erosion data for specific specimens is shown in Appendix A, Tables A-7 through A-9.

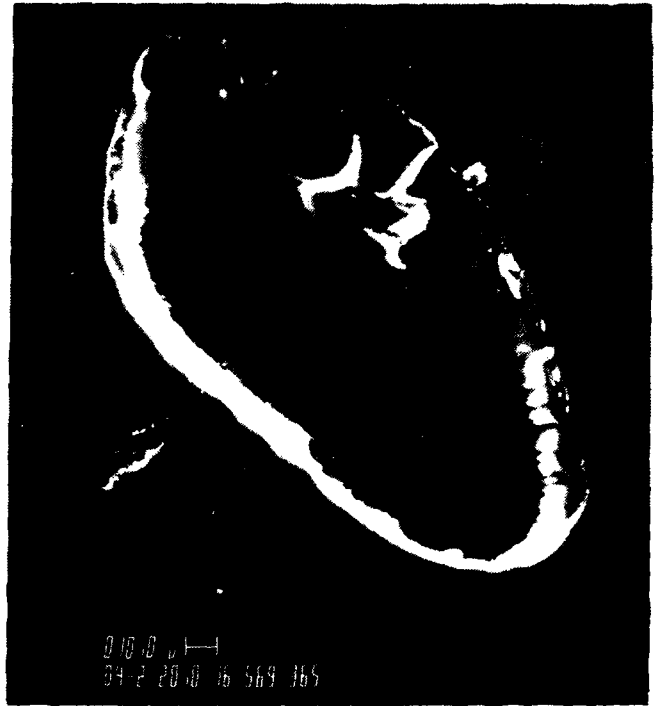
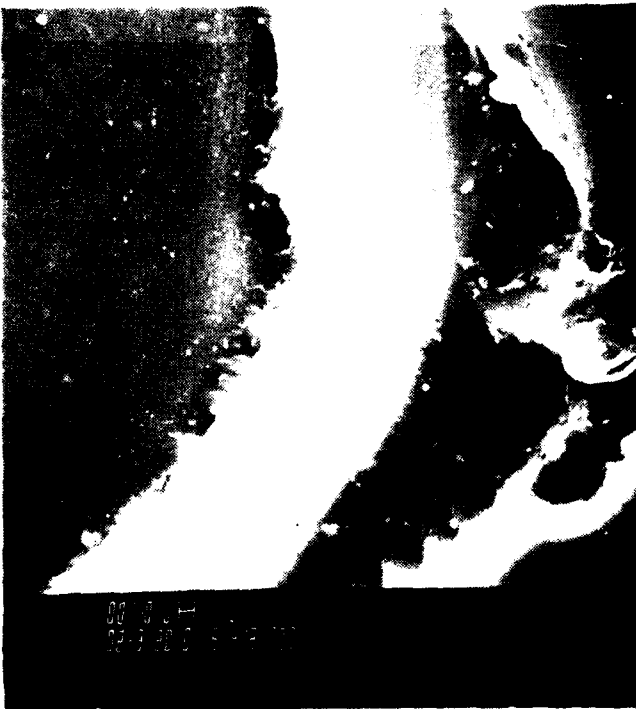
Figure B-9. Vendor B Coated Polycarbonate (3 Yr UV Exposure).

The initiation process was associated with the incubation time as shown by the kinetic curves in Figures 3, 4, and 5. The erosion process at the initiation stage was characterized by local erosion processes which resulted in the formation of isolated craters or pits in the range of 10 to 30 μm in size (Figures B-1A and B-1B for the Vendor P coating, Figures B-4A and B-4B for the Vendor A coating, and Figures B-7A and B-9 for the Vendor B coating). These localized events consisted of material removal from the coating (Figure B-4B) as well as localized coating separation from the polycarbonate substrate (Figure B-9B).
