*Shoreline conditions and bank recession  
along the U.S. shorelines of the St. Marys,  
St. Clair, Detroit and St. Lawrence rivers*

# CRREL Report 82-11

May 1982

Lawrence W. Gatto

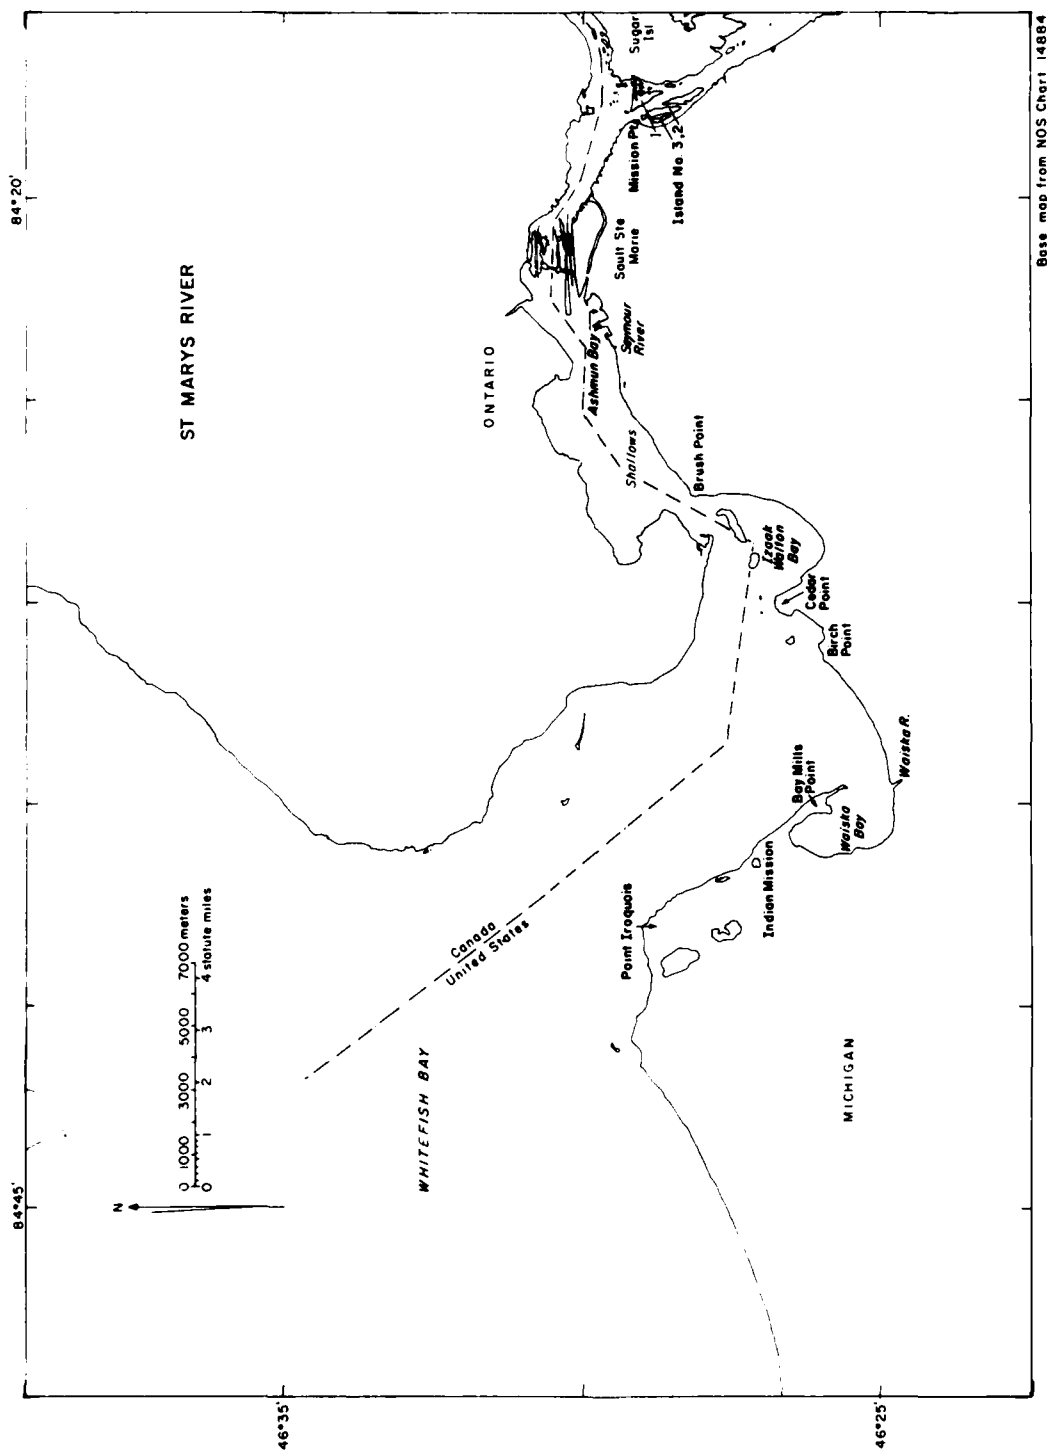
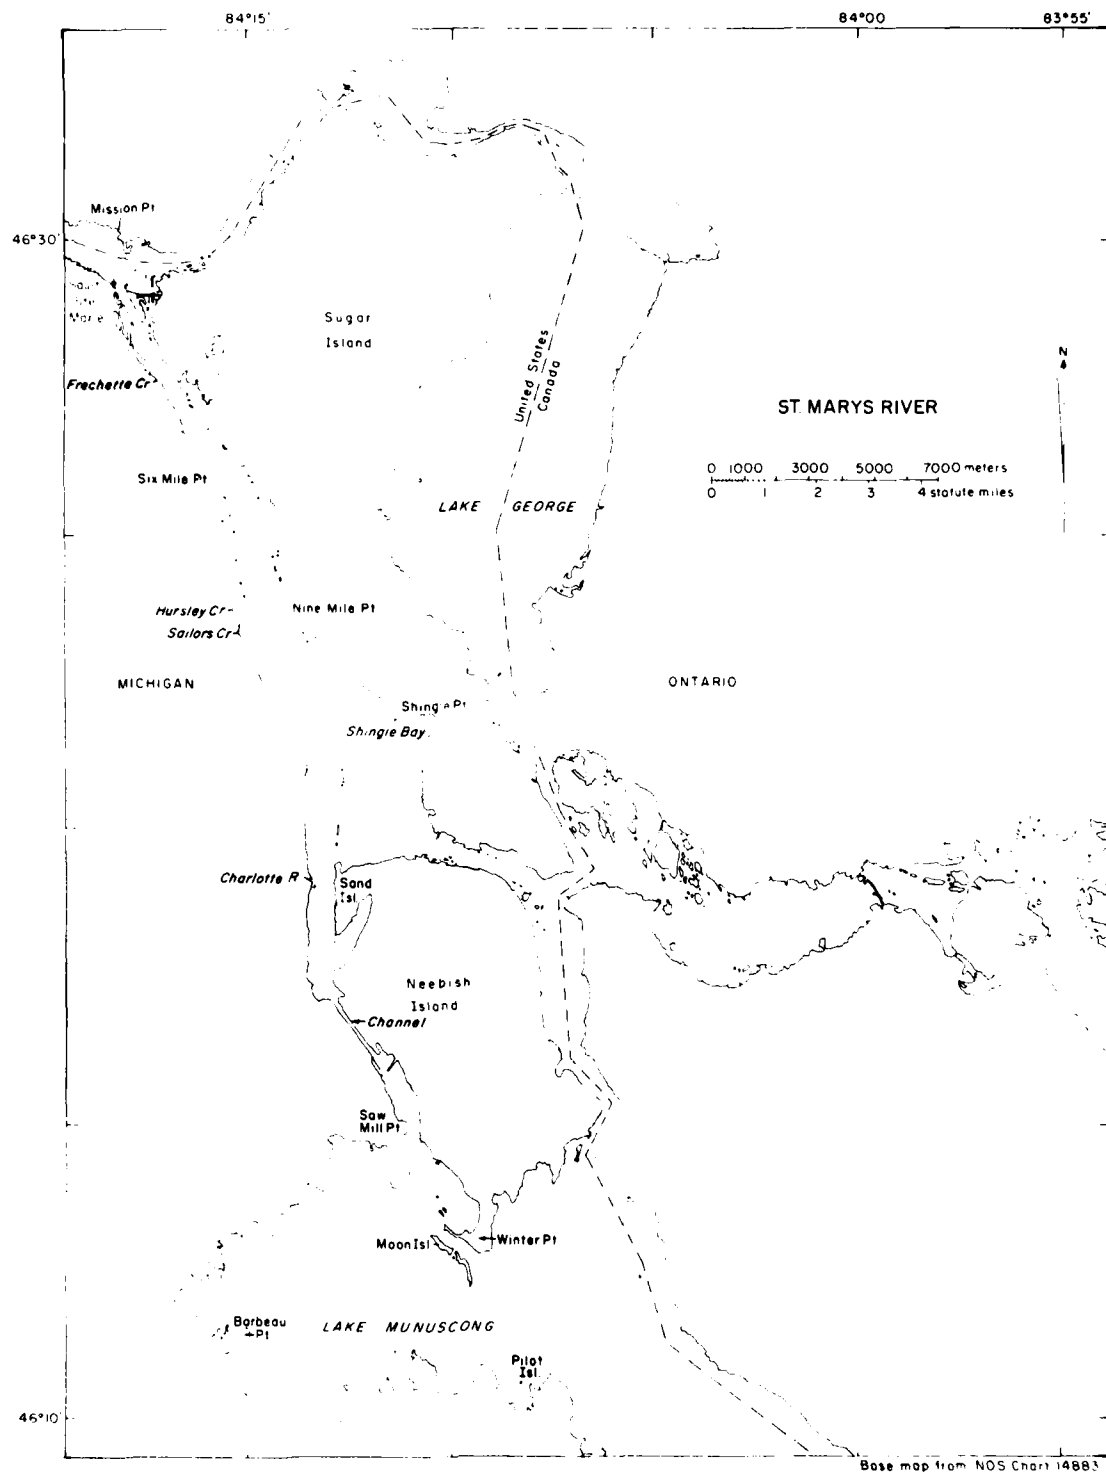
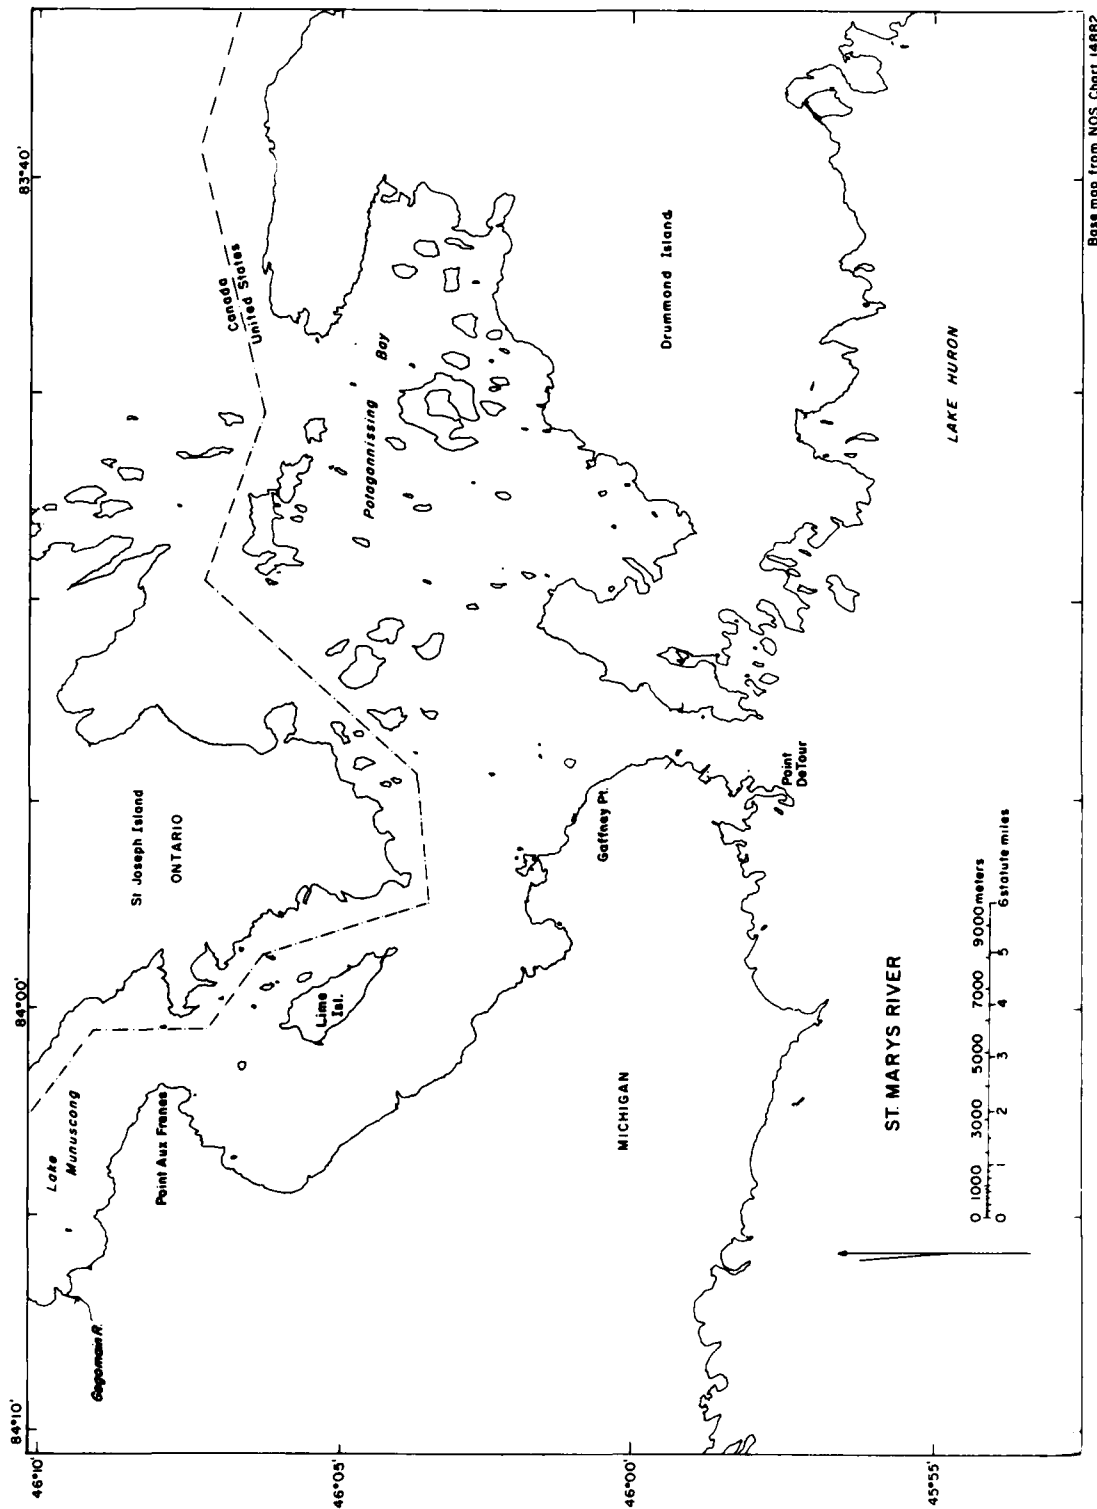
Figure 6. Map of St. Marys River.

The initial boat survey of the St. Marys River (Fig. 6) was made on 25 and 26 May 1977. The shoreline characteristics and conditions observed are shown in Figures A1-A6. Twenty-eight sites, with 66 partially vegetated or bare banks covering a total of 10.7 miles (Table A1, Fig. A1), were delineated during this survey. The banks at 29 of these reaches (5.2 miles) showed evidence of erosion from May 1977 to May 1980. This is 4.3% of the 122 miles of shoreline surveyed. The banks at 37 reaches (5.5 miles) showed no apparent changes.

The types of bank failure along most of the eroding reaches were soil falls and slides (Fig. 7) (Code 1973). Soil falls generally result from extreme undercutting at the toe of a bank, and they usually produce vertical bank faces. Slides are due to shear failures, which result in relatively undeformed masses of soil moving along a single slide plane. These are common, especially where banks are composed of massive lake sediments or fine-grained tills. The slides along the St. Marys River are also due to the loss of support at the bank toe resulting from undercutting and material removal by river water. A few reaches show rotational slumping, and some show evidence of surface erosion (i.e. rills and gullies).

Twenty-three reaches showed minor erosion during this project (Table A1); they varied in distance from the navigation channel from about 80 to 3200 feet, with an average distance of 800 feet. Six reaches were classified as showing major erosion and were from 350 to 850 feet from

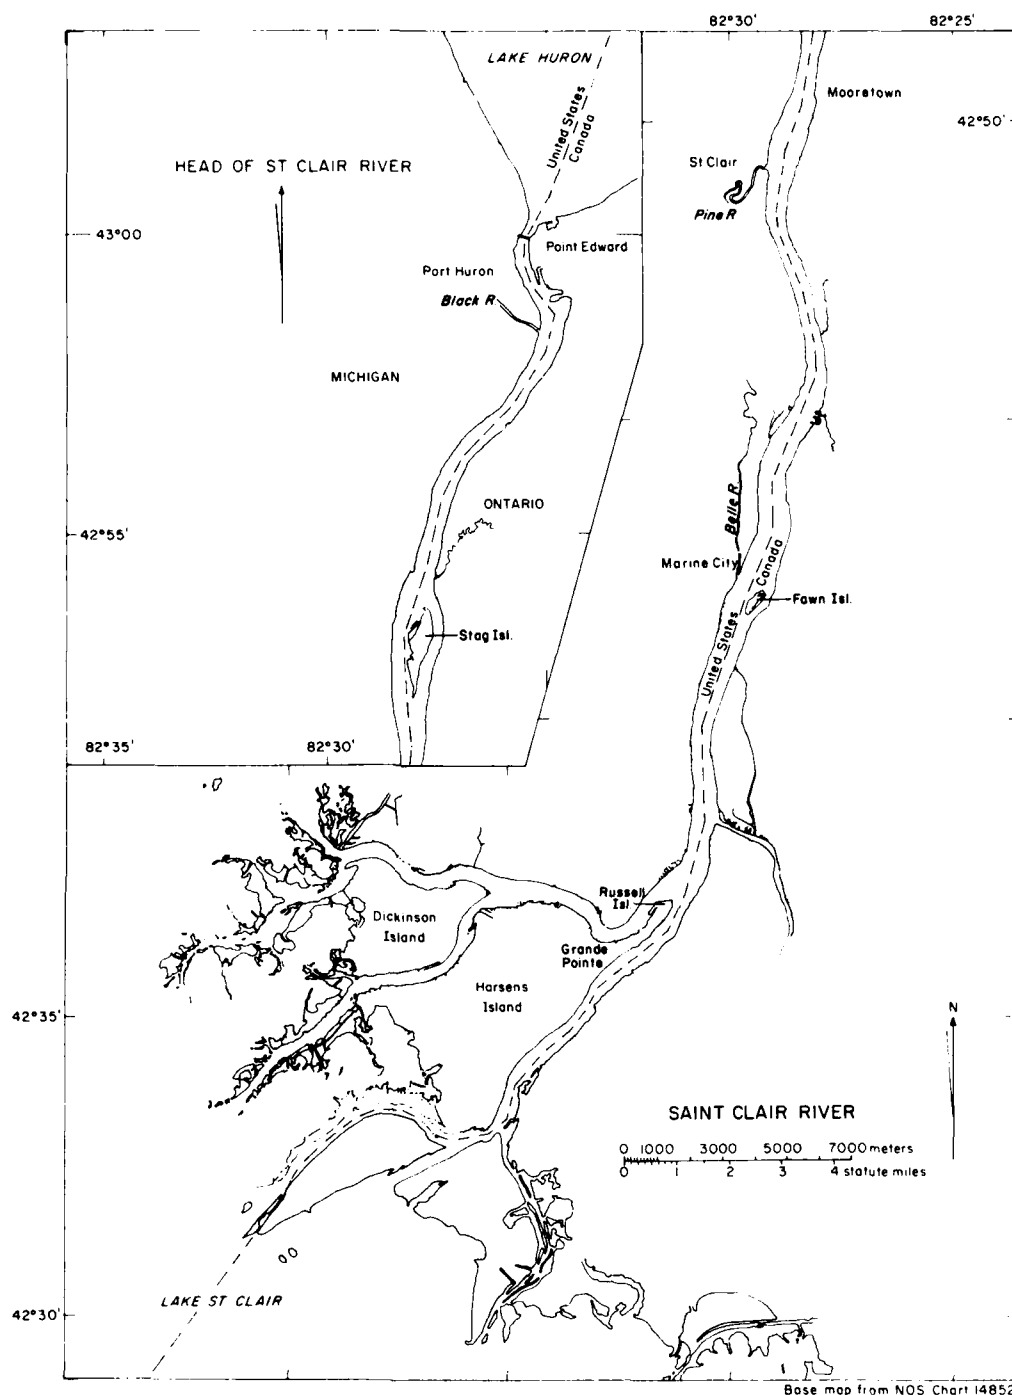
Figure 9. Map of St. Clair River.

The initial boat survey of the St. Clair River (Fig. 9) was done on 23 May 1977. The shoreline conditions and bank characteristics are shown in Figures B1-B3. Partially vegetated or bare banks were delineated along 56 reaches at 25 sites (Fig. B1), covering a total of 3.2 miles. The approximate lengths of the banks at the 24 eroding reaches are given in Table B1. The estimated total length of eroding bankline is 2.1 miles. From May 1977 to May 1980 approximately 5.3% of the banks along the 40 miles of surveyed shoreline were eroding.

The types of bank failure along most of the banks were soil slides and falls along the face of the bank. These were caused by undercutting at the water line, loss of support for overlying sediment, and subsequent collapse. Rotational slumping occurred at reach 11b only (Fig. 10).

The banks along 20 reaches showed minor erosion during this project, and their approximate distance from the navigation channel varied between 150 and 650 feet, with an average distance of 350 feet. The approximate distances from the navigation channel of four banklines that showed major erosion varied from 20 to 350 feet, with an average of 250 feet. This implies that erosion may be more severe nearer the navigation channel, due to the hydraulic effects of ship passage. However, reaches 11a, b, and c, where erosion appeared to be most active, are approximately 200-250 feet from the navigation channel. The offshore slope along these reaches is very steep (Gatto 1982), and I observed that the

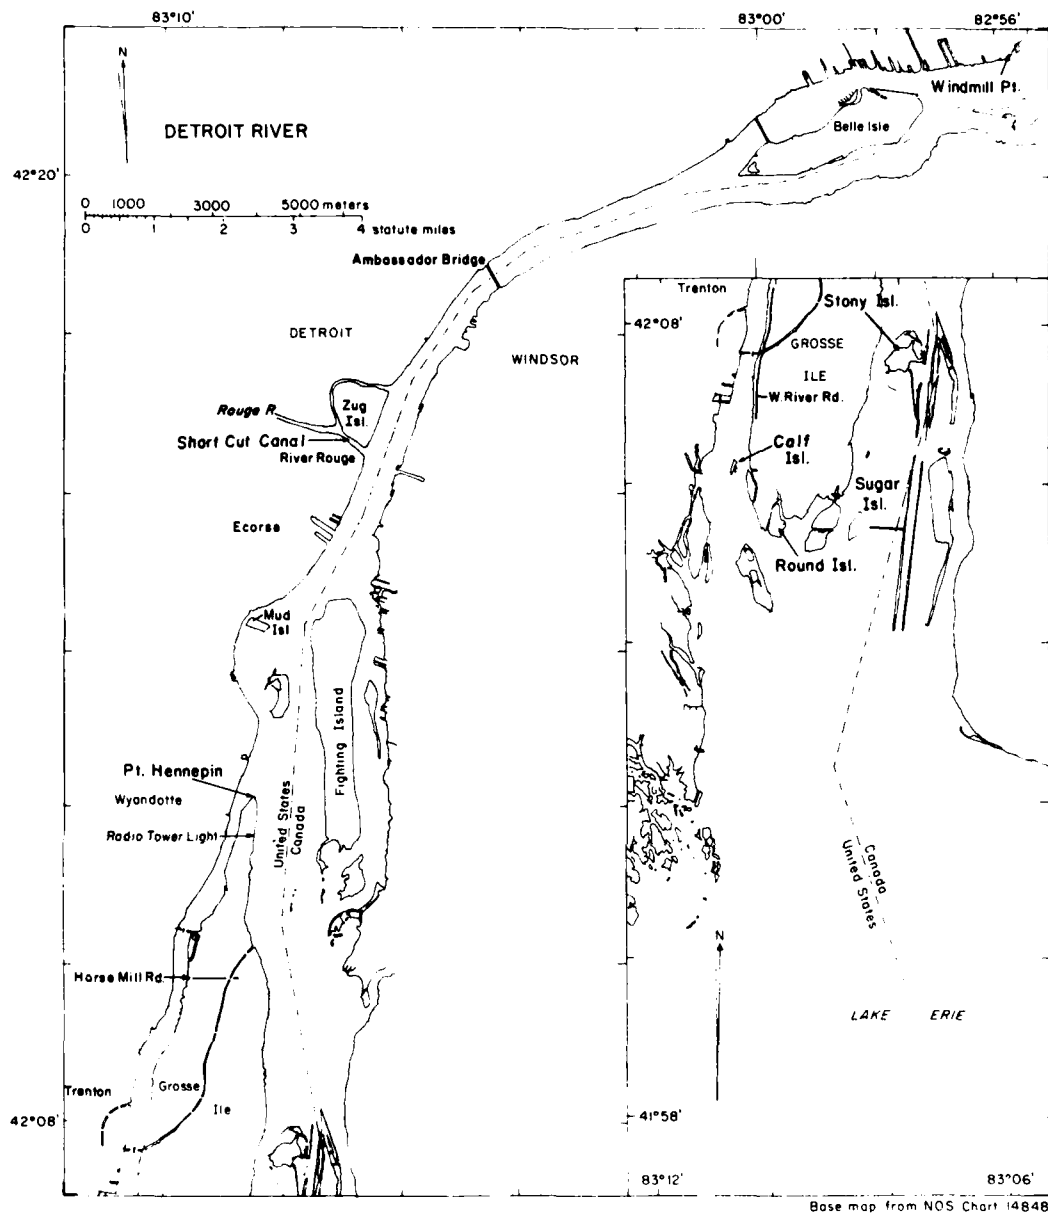
Figure 12. Map of Detroit River.

The initial boat survey of the Detroit River (Fig. 12) was done on 23 and 24 May 1977. The shoreline conditions and bank characteristics observed are shown in Figures C1-C3. I delineated partially vegetated and bare banks along 51 reaches (covering a total of 6.9 miles) at 23 sites (Fig. C1).

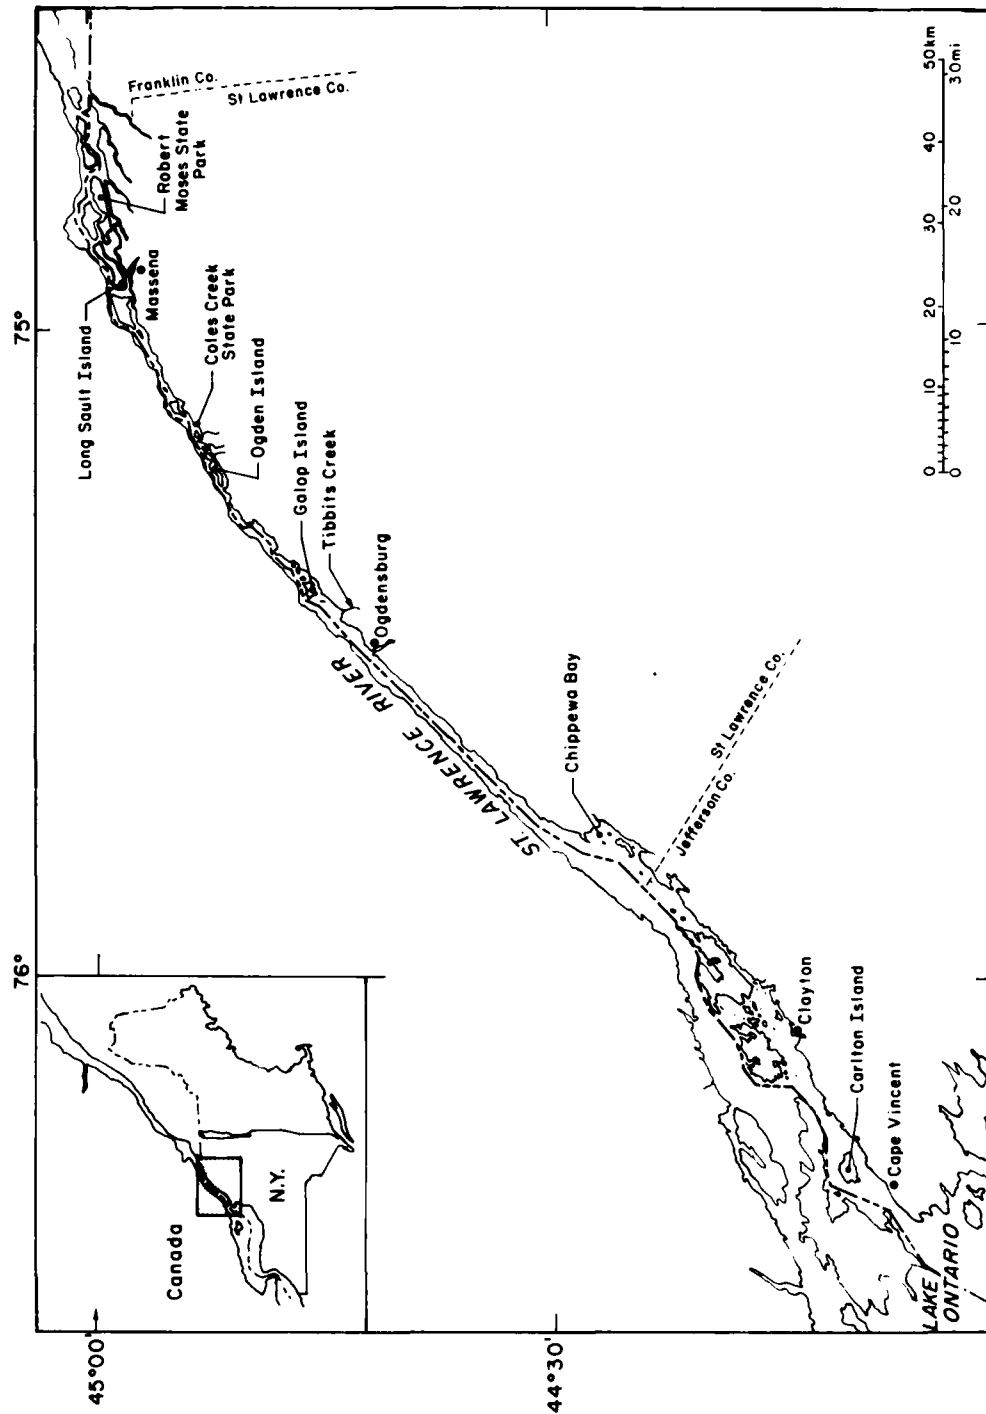
Figure 15. Map of St. Lawrence River.

The initial boat survey of the St. Lawrence River from Lake Ontario to the U.S.-Canadian border near Massena, New York (Fig. 15), was made on 16 and 17 November 1977. I delineated partially vegetated or bare banks at 114 reaches (covering 10.9 miles) at 48 sites (Table D1, Fig. D1). During this project, erosion occurred along 8.6 miles of the riverbank at 59 reaches. This is 6.6% of the 130 miles of surveyed shoreline. Fifty-five reaches, about 2.3 miles of bank, appeared to be stable from 1977 to 1979. Erosion along some of these banks would probably begin if water levels were raised for an extended period.

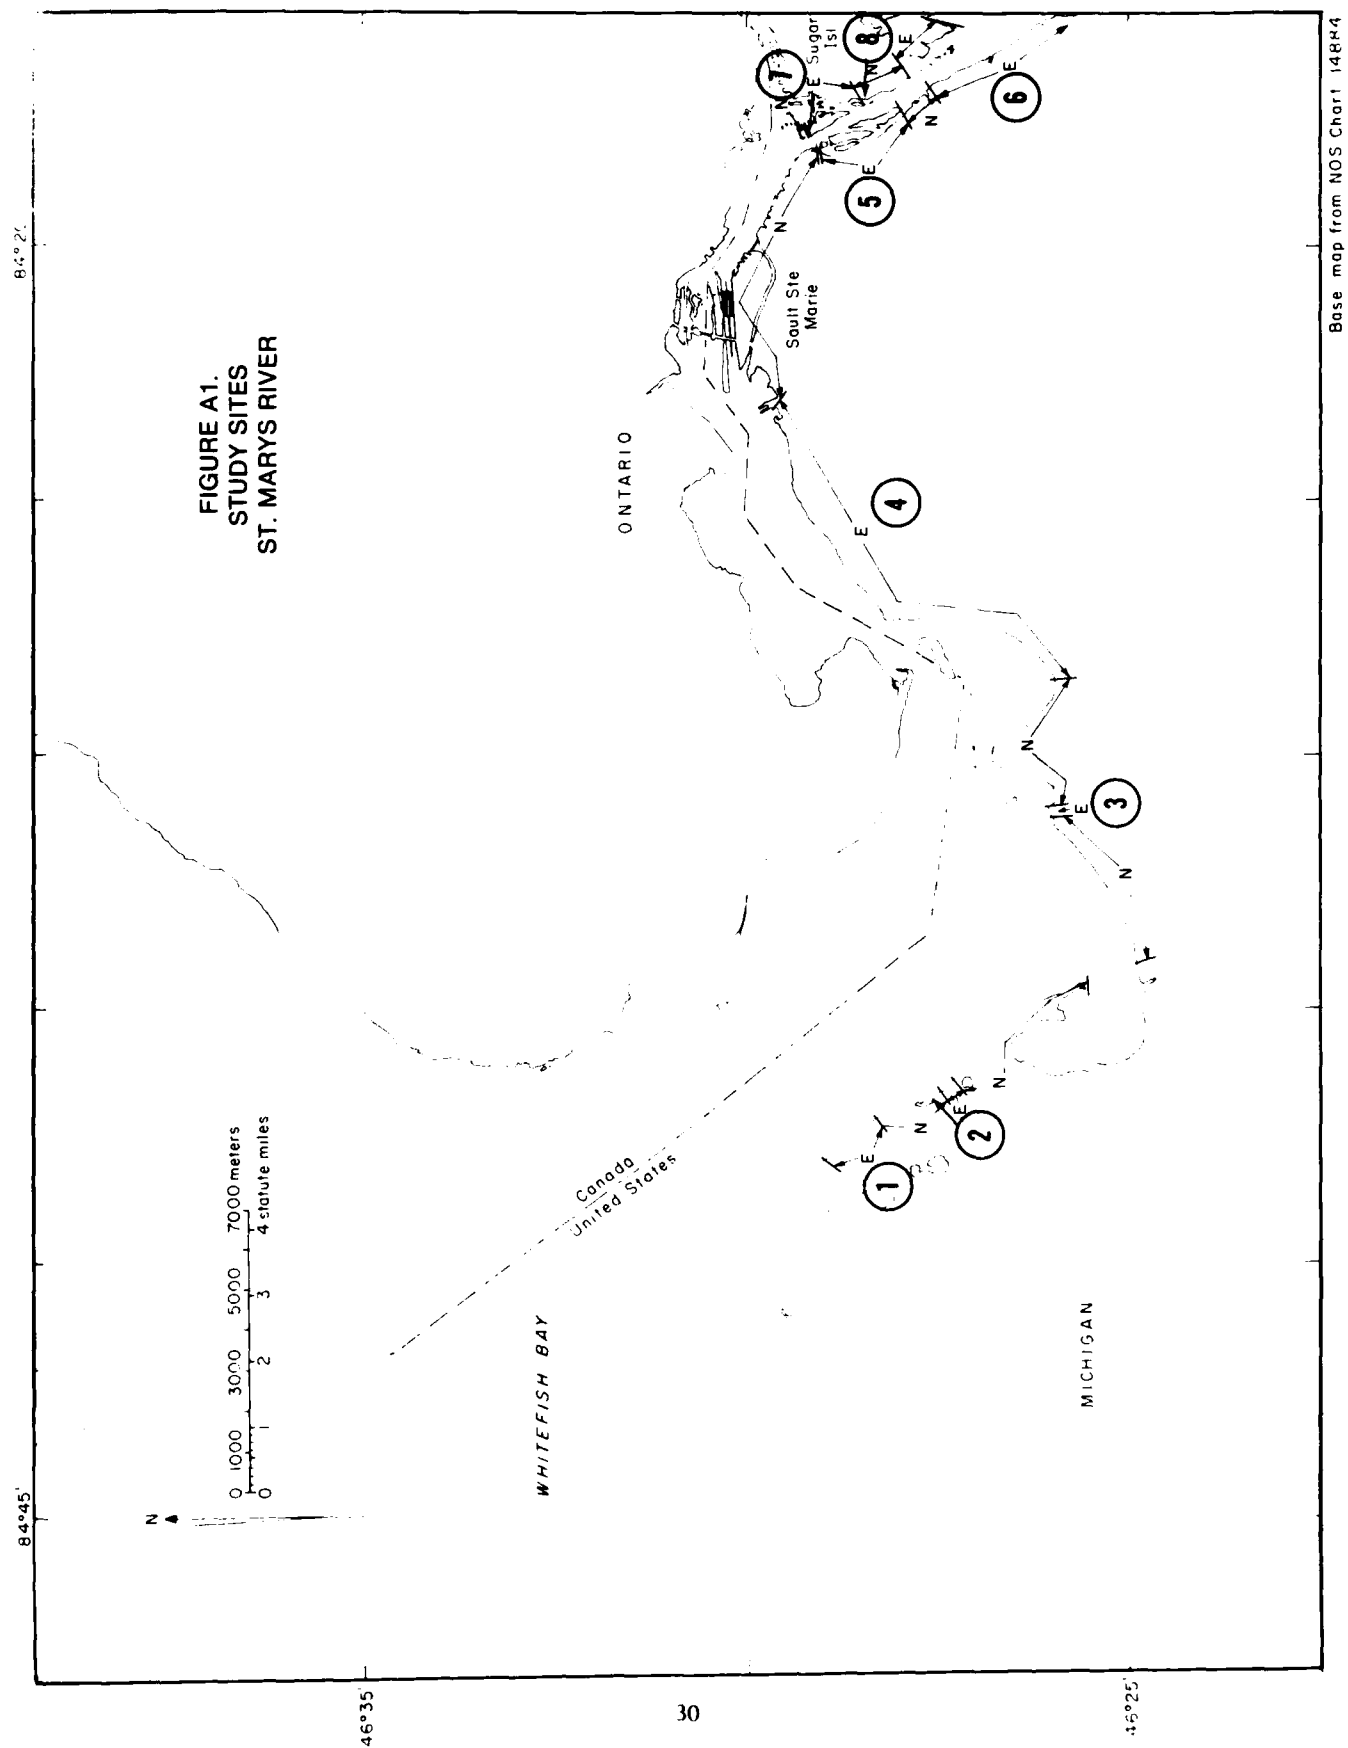
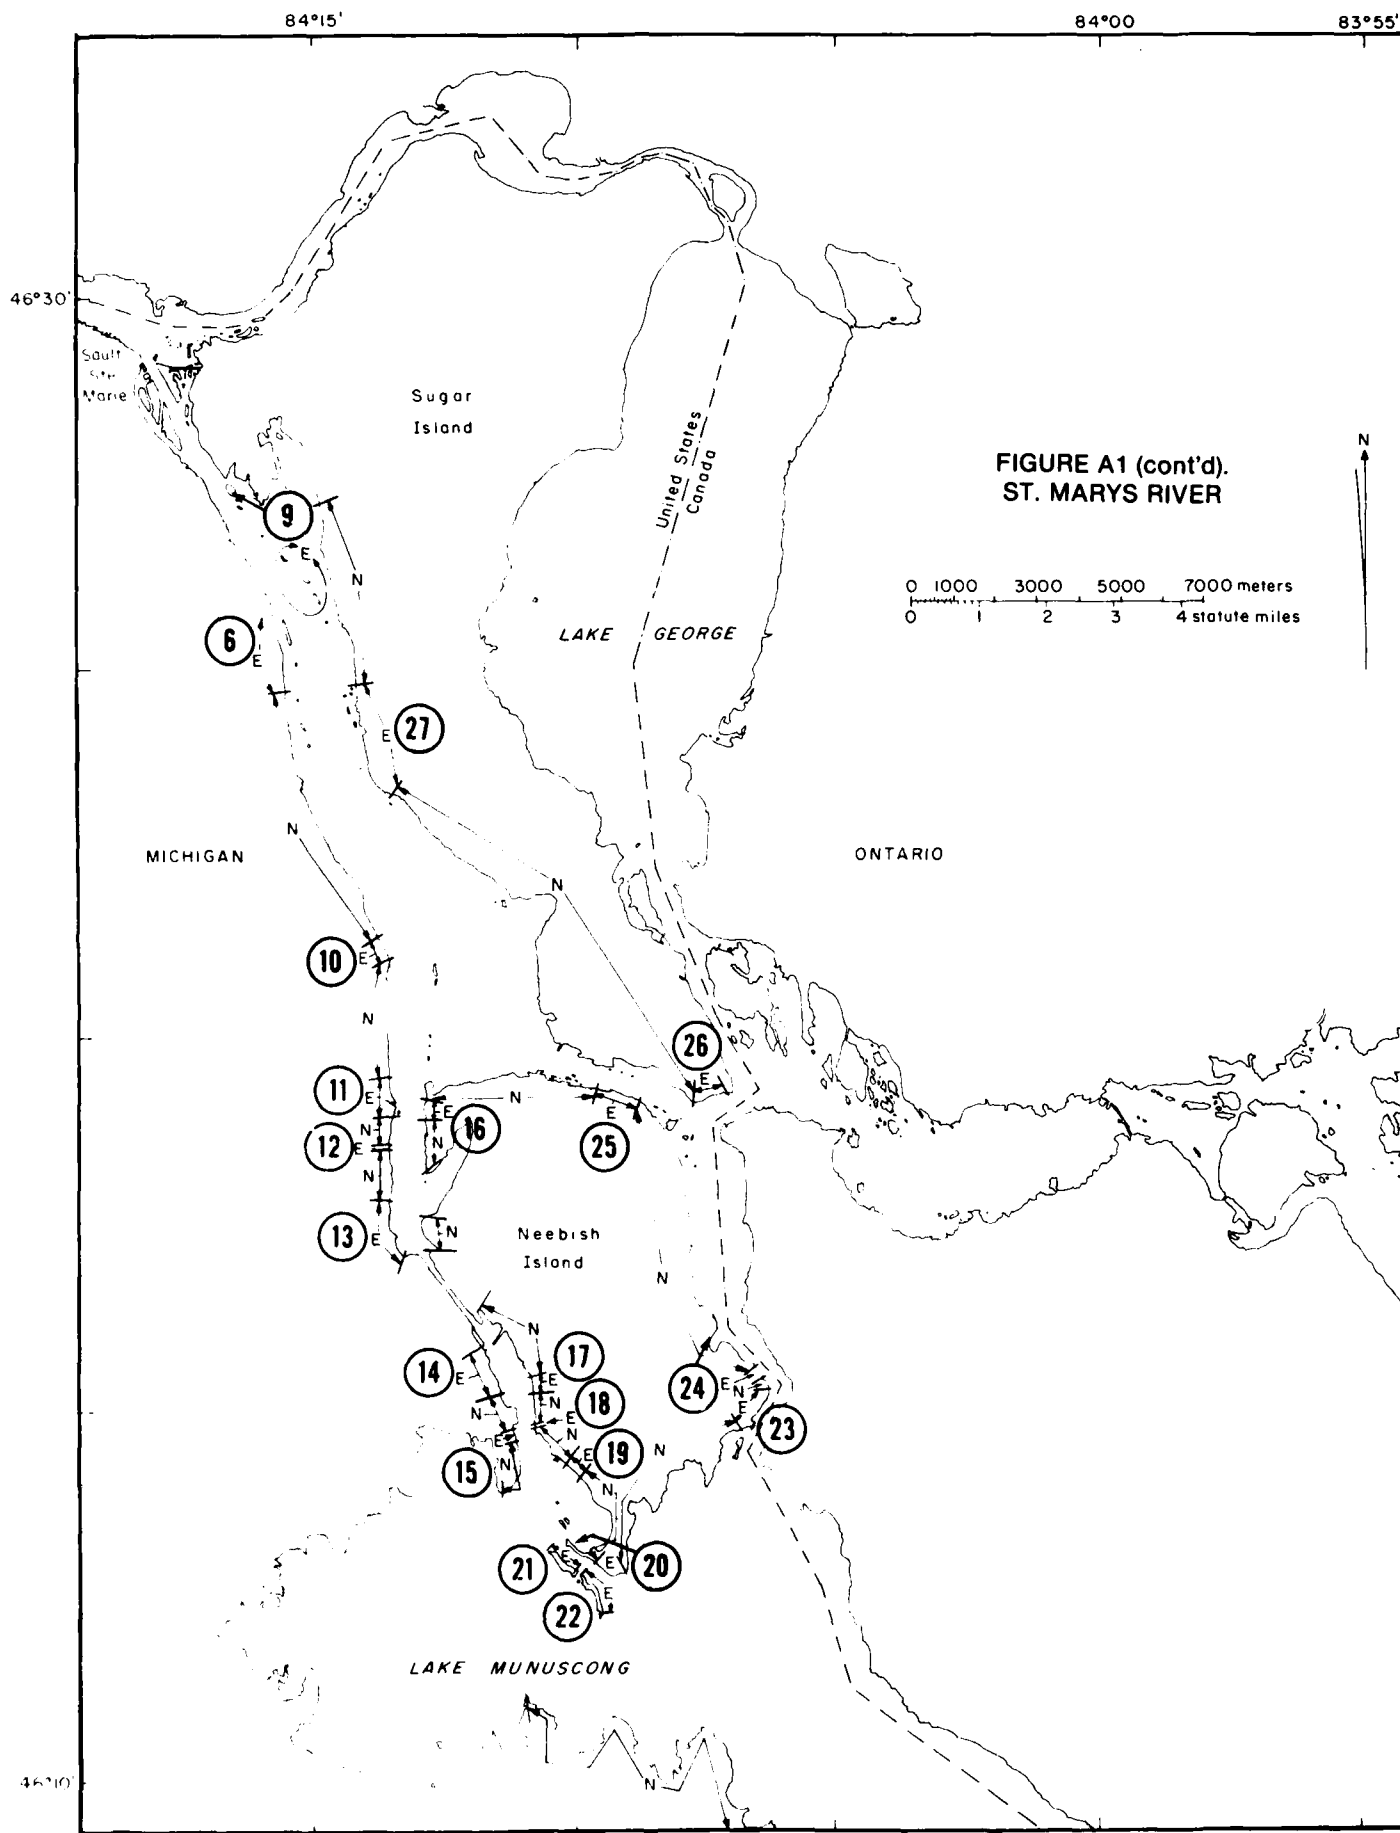
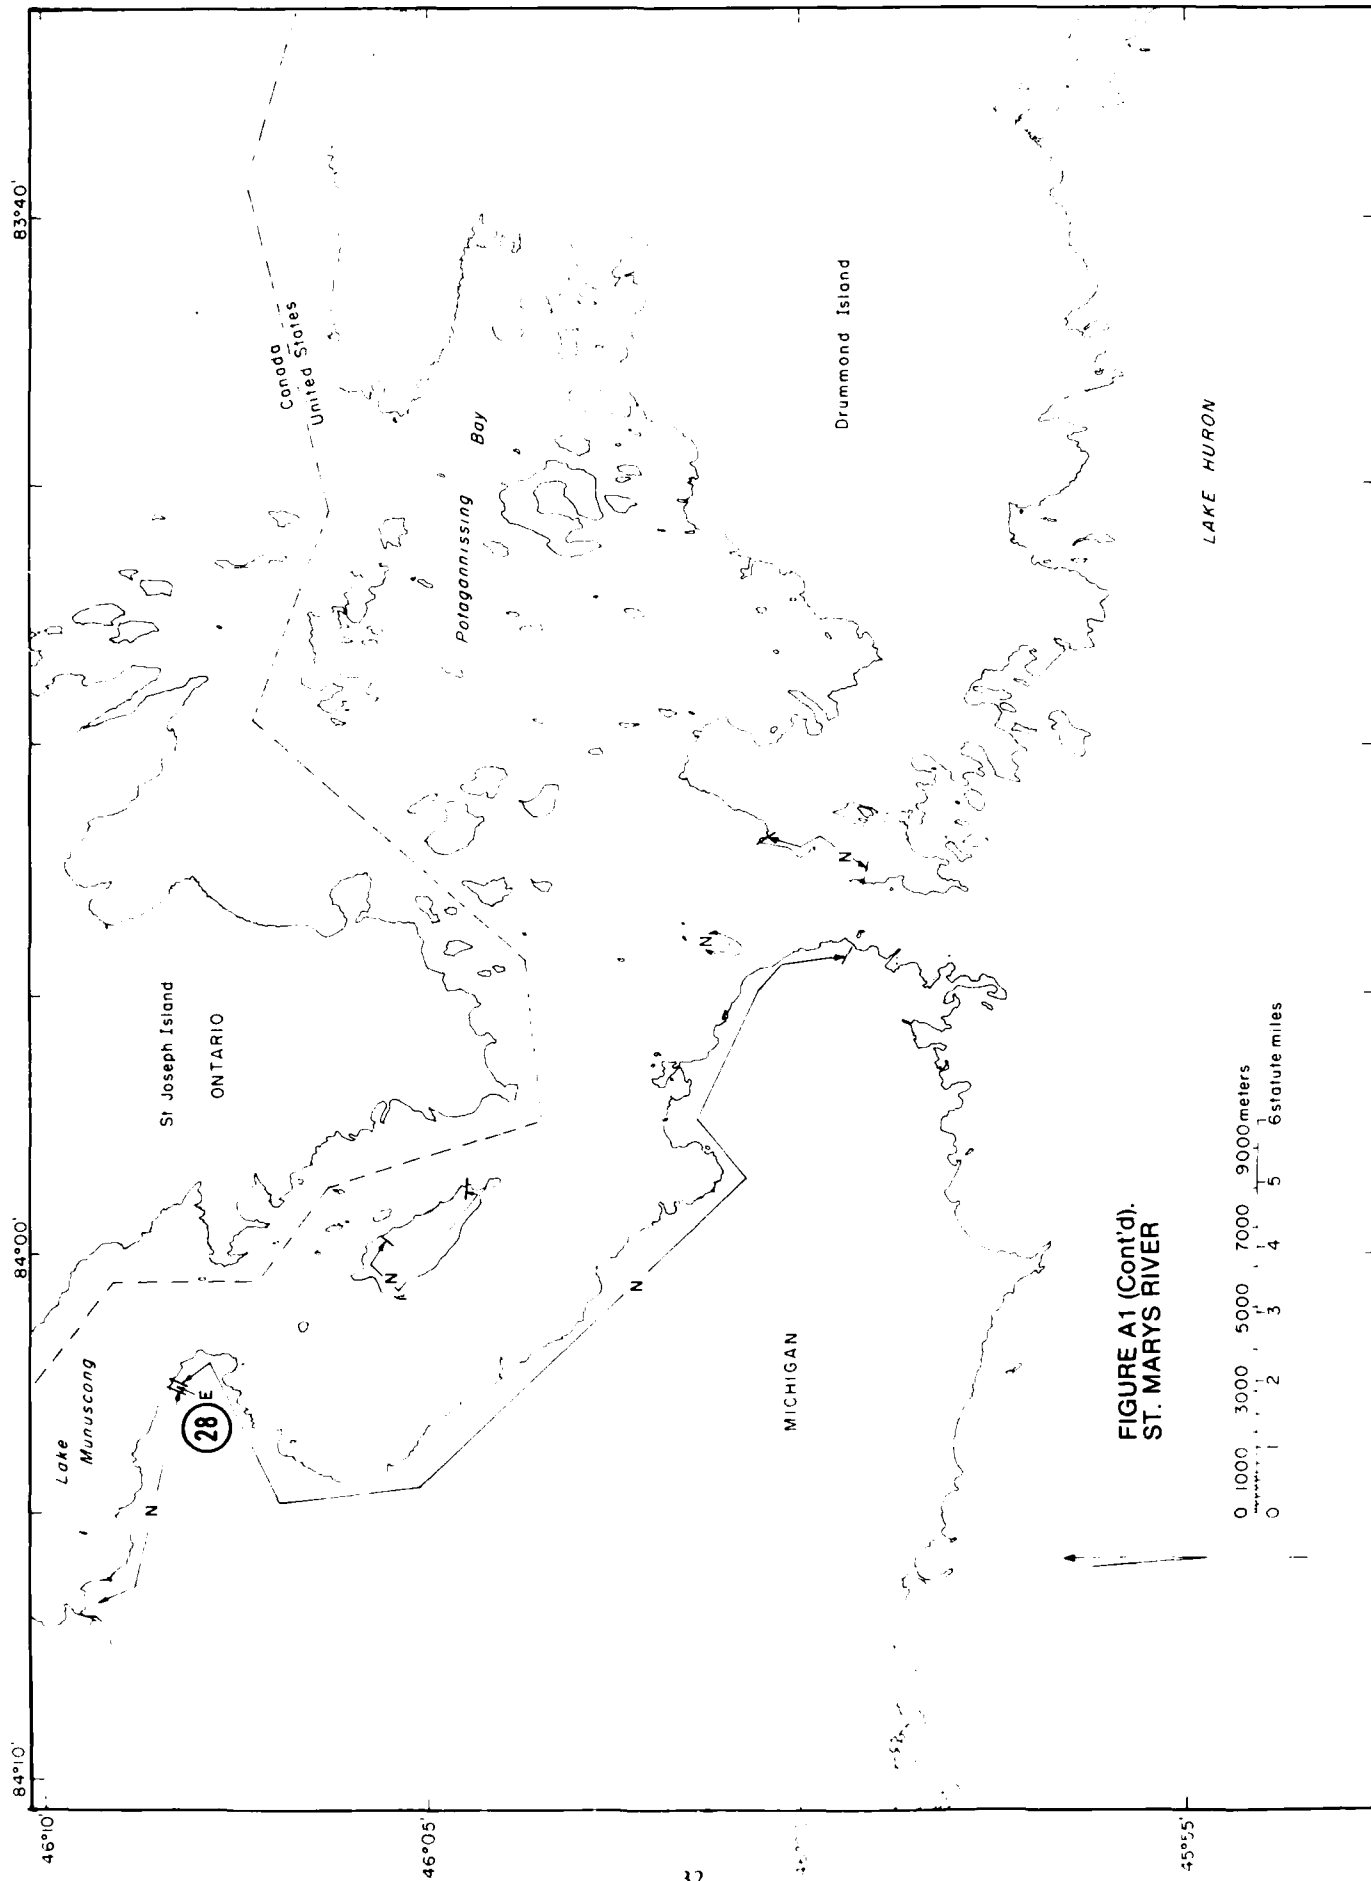
FIGURE A1 (Cont'd).  
ST. MARYS RIVER

The maps show the shoreline conditions and bank characteristics as observed on 25, 26 May 1977

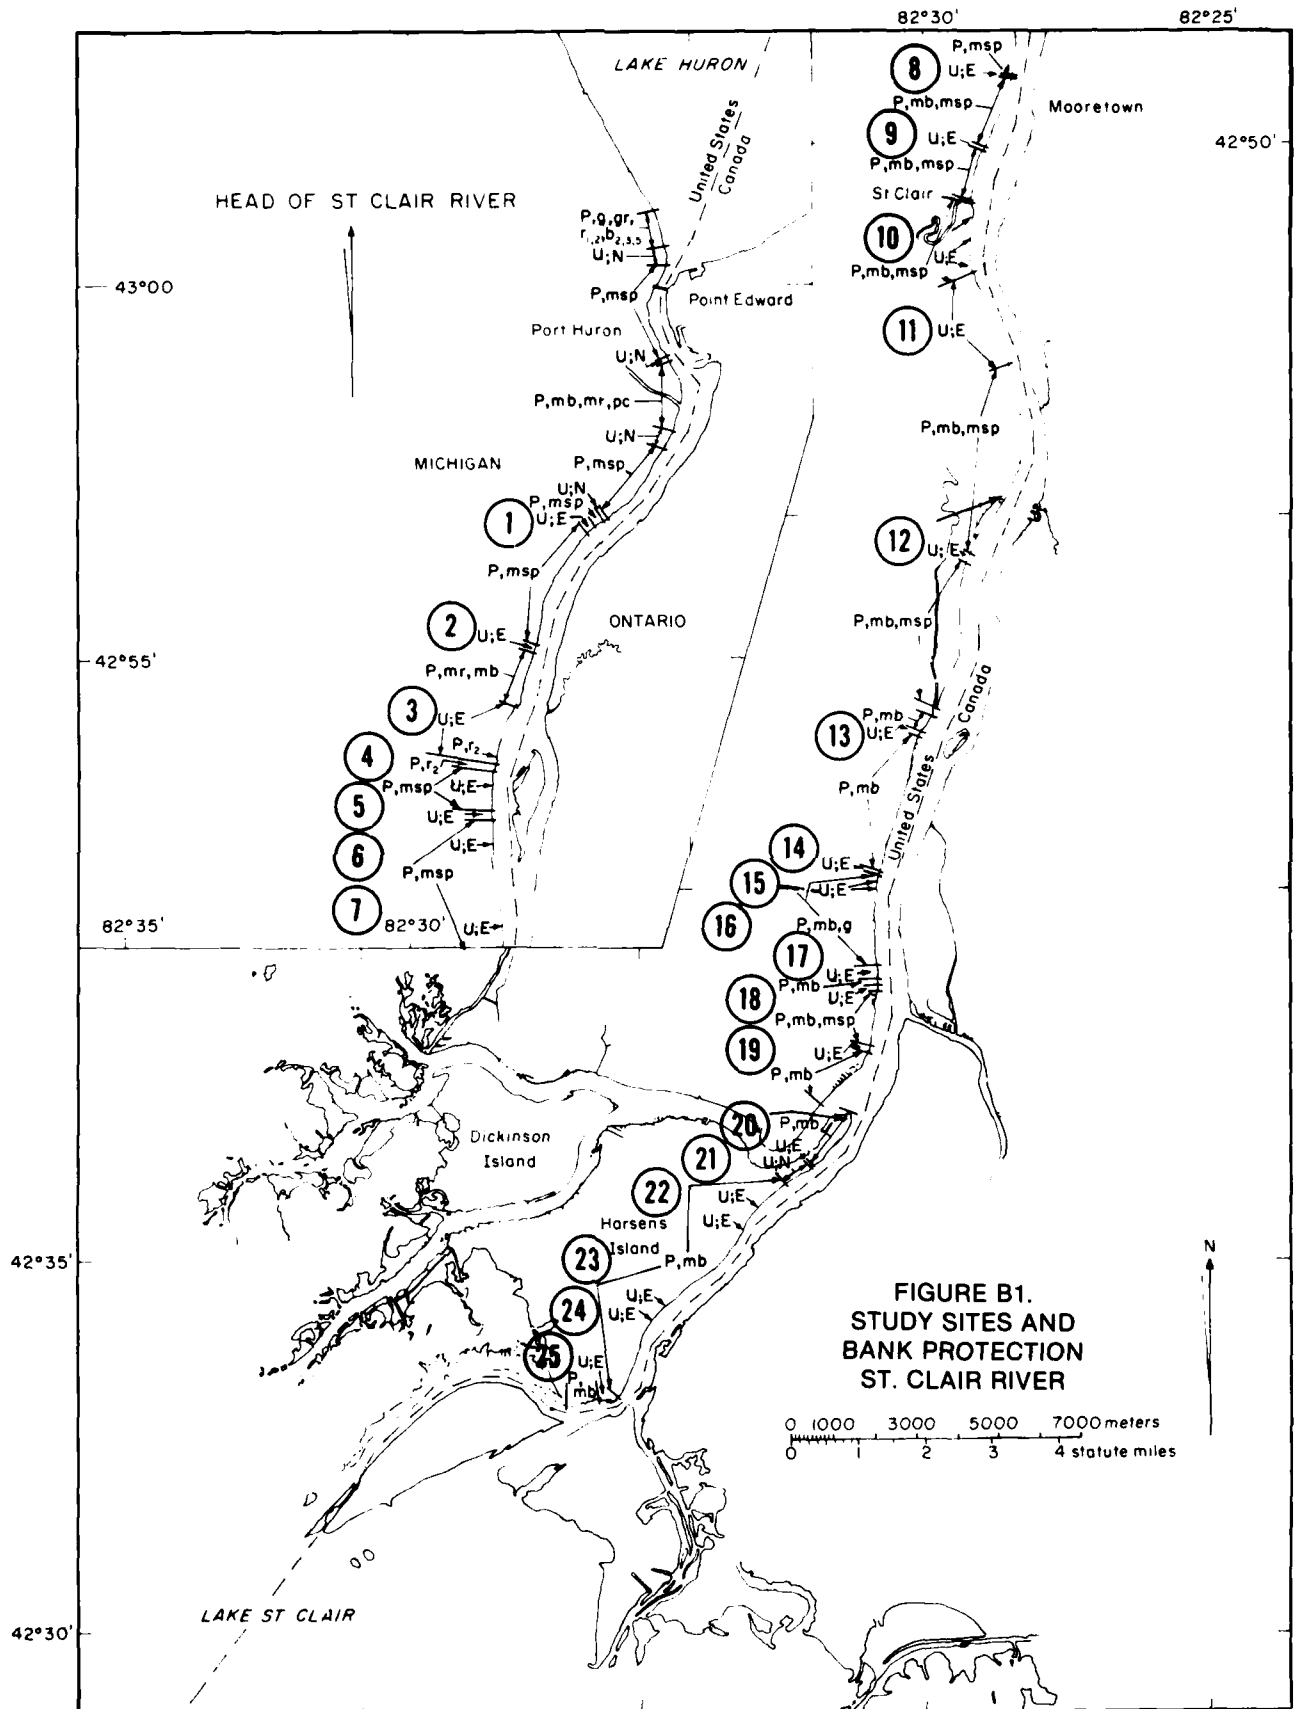
**FIGURE B1.  
STUDY SITES AND  
BANK PROTECTION  
ST. CLAIR RIVER**

**APPENDIX B: ST. CLAIR RIVER.** The maps show the shoreline conditions and bank characteristics as observed on 23 May 1977. Refer to the legend in Appendix A for explanations of map symbols
