NONDESTRUCTIVE EVALUATION OF METAL MATRIX COMPOSITES.(U)

## NONDESTRUCTIVE EVALUATION OF METAL MATRIX COMPOSITES

May 1982

FINAL REPORT

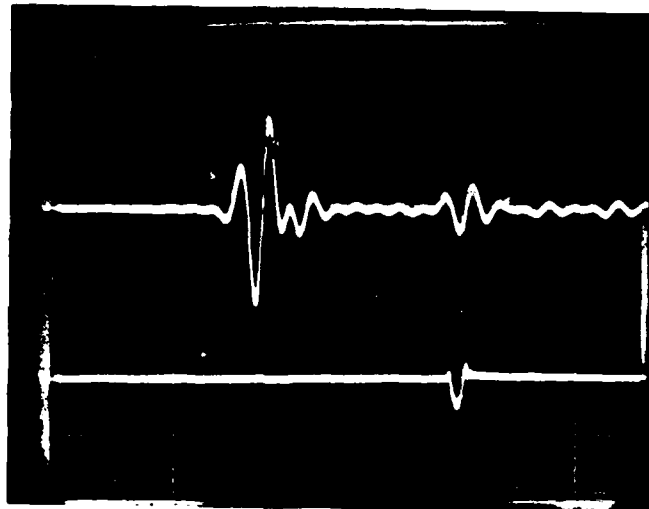
The key to interpreting the two A-scans in Figure 22 is the relative shape and size of the front and back-face reflections. The difference between the A-scan at the "unflawed location (Figure 22a) and at the "flawed" location (Figure 22b) is a decrease in the amplitude of the front-face reflection of the waveform. This is an indication of a minor irregularity at the front-face of the specimen. In this instance an air bubble was attached to the front-face of Specimen 1-1. Similar A-scans were generated where surface irregularities (such as scratches) or excess sealant were present. Figure 23, a pen-lift C-scan of Specimen 1-1, which was generated using a 5 MHz, immersion, compression wave transducer operated in the pulse-echo mode, gives a better overall representation of the material integrity for this particular specimen, but is less sensitive to the presence of defects than the C-scans shown in Figures 20 and 21. This exemplifies the fact that the C-scan only indicates the presence of a defect, and provides limited information about the type or severity of a defect.

Figure 22. Amplitude-time records (A-scans) of ultrasonic pulse at two locations of Specimen 1-1. (a) Unflawed location, (b) flawed location. (0.5 V/div, 0.5  $\mu$ sec/div) 15 MHz transducer in pulse-echo mode.

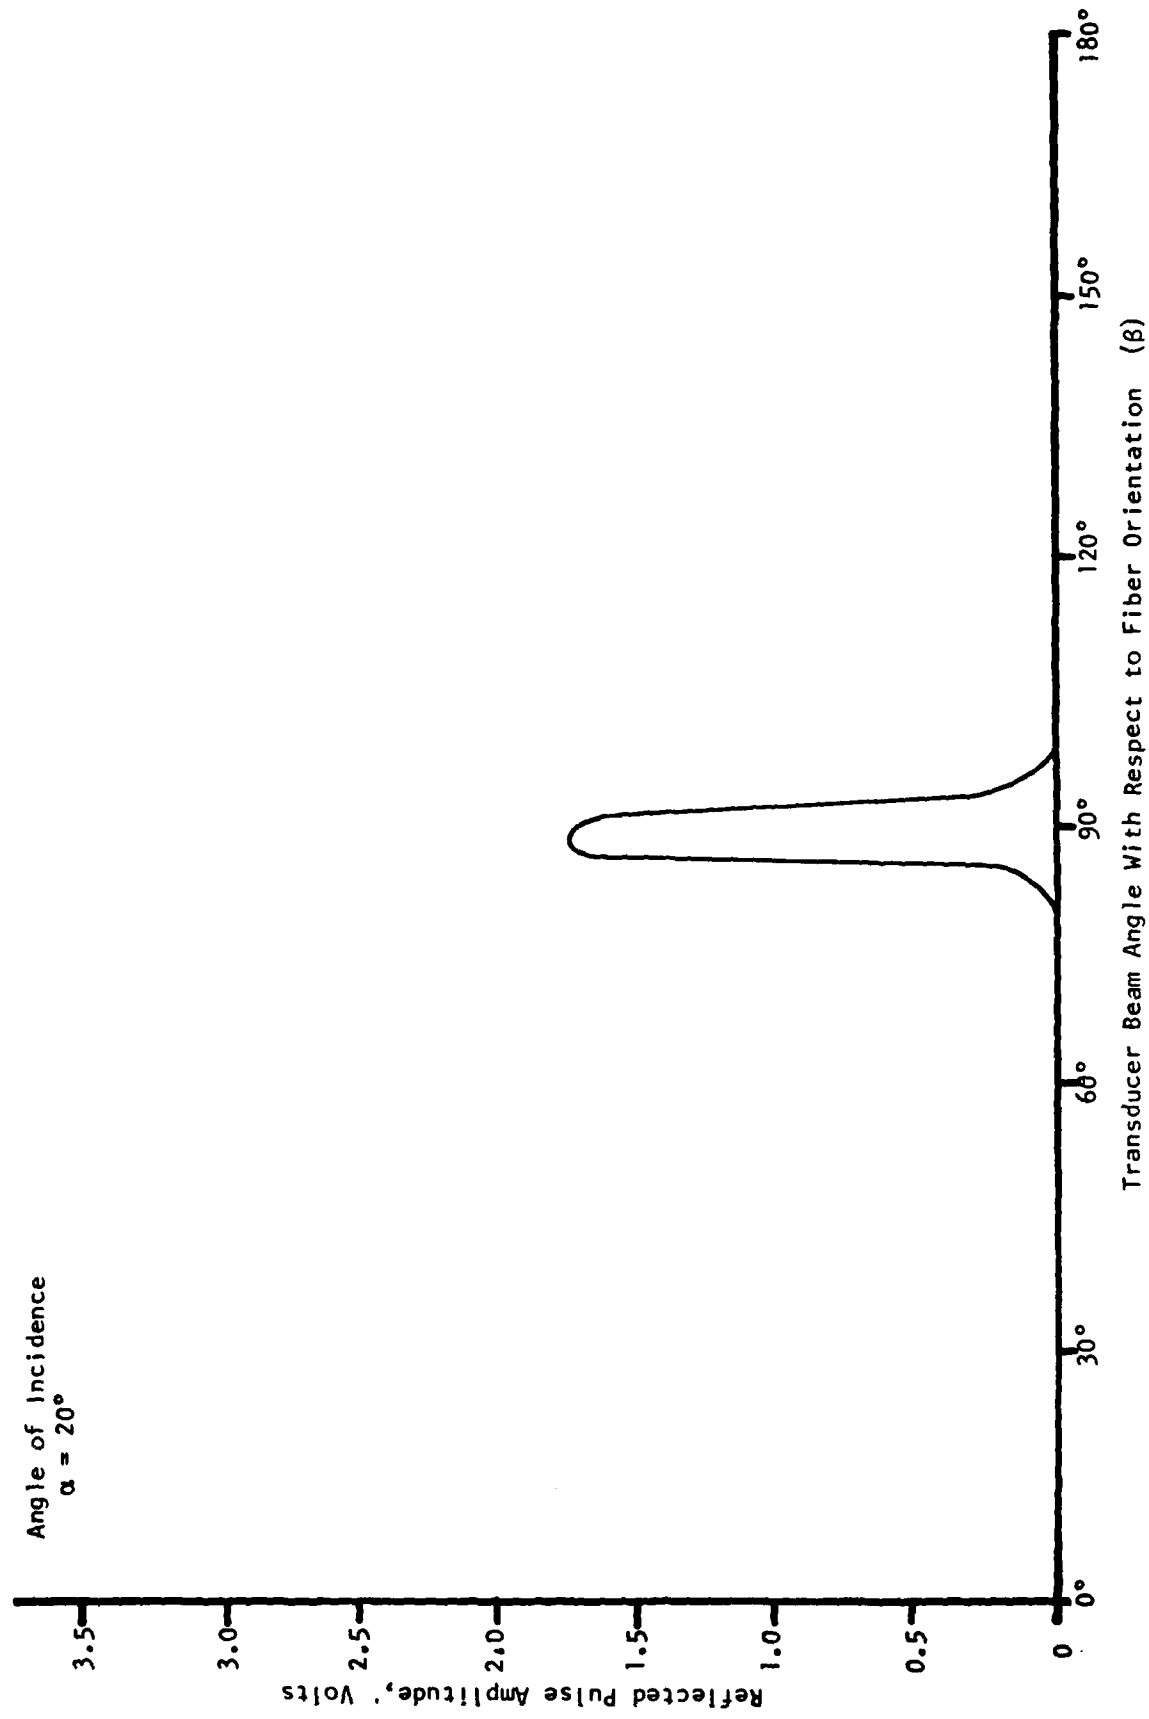
Figure 54 is a backscatter curve of Specimen 5-1. The incident angle ( $\alpha$ ) of the 5 MHz immersion transducer operated in the pulse-echo mode was  $20^\circ$  with respect to a line normal to the front-face surface plane of the specimen.

This curve gives no indication of the presence of fiber fracture beyond the decrease of the amplitude of the reflected pulse. The only activity on the curve occurs when the transducer focal axis sweeps near and through the plane normal to the fiber orientation.

For Specimen 5-1, ultrasonic backscattering does not appear to give any appreciable indication of the presence of fiber fracture.

Figure 54. Ultrasonic backscattering curve of FP/Mg specimen with fiber fracture (Specimen 5-1).

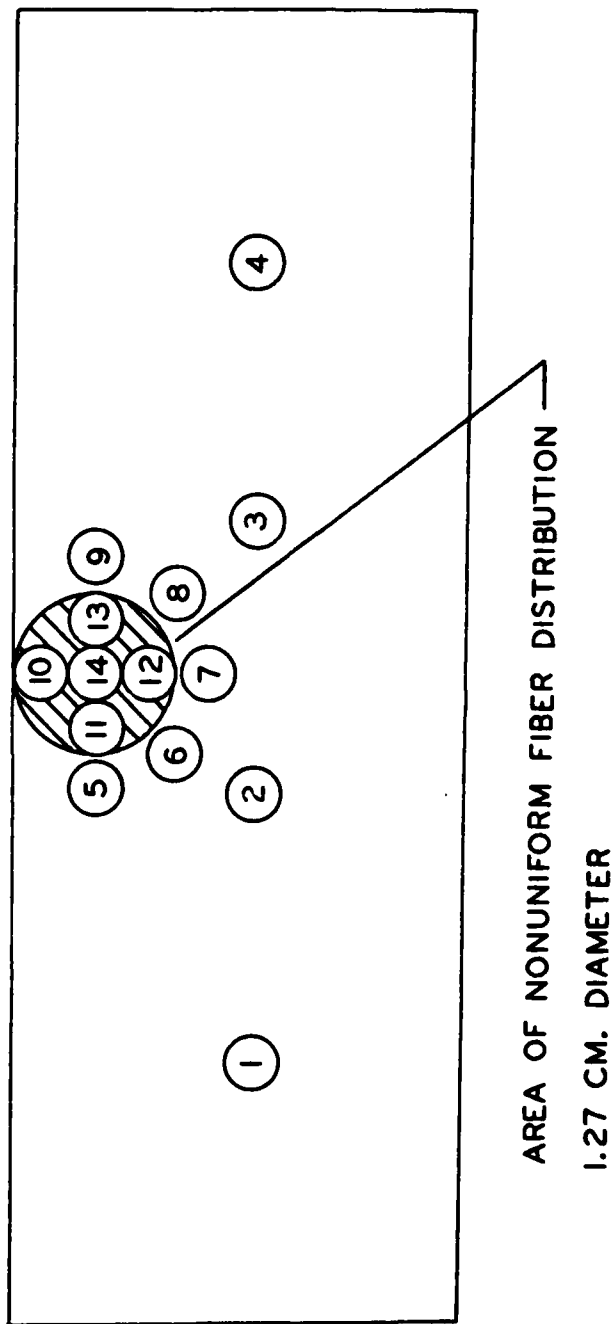
Figure 60 shows the inspection locations on Specimen 6-2 where wave propagation velocity measurements were taken. Table 12 shows the wave propagation velocities for the 14 inspection locations shown in Figure 60, and the average wave propagation velocity of the first nine measurements. The average wave propagation velocity for Specimen 6-2 (for the unflawed locations) is within 6% of the theoretical value of  $6119 \text{ ms}^{-1}$  for Specimen 6-2 and within 1% of the empirical average of  $6466 \text{ ms}^{-1}$  for Specimen 1-1. As a comparison, the average wave propagation velocity for the 20 inspection locations shown in Figure 24 for Specimen 6-2 was  $6466 \text{ ms}^{-1}$  which is identical to the empirical average for Specimen 1-1.

Figure 60. Wave propagation velocity inspection locations for FP/Mg Specimen 6-2 (nonuniform fiber distribution).

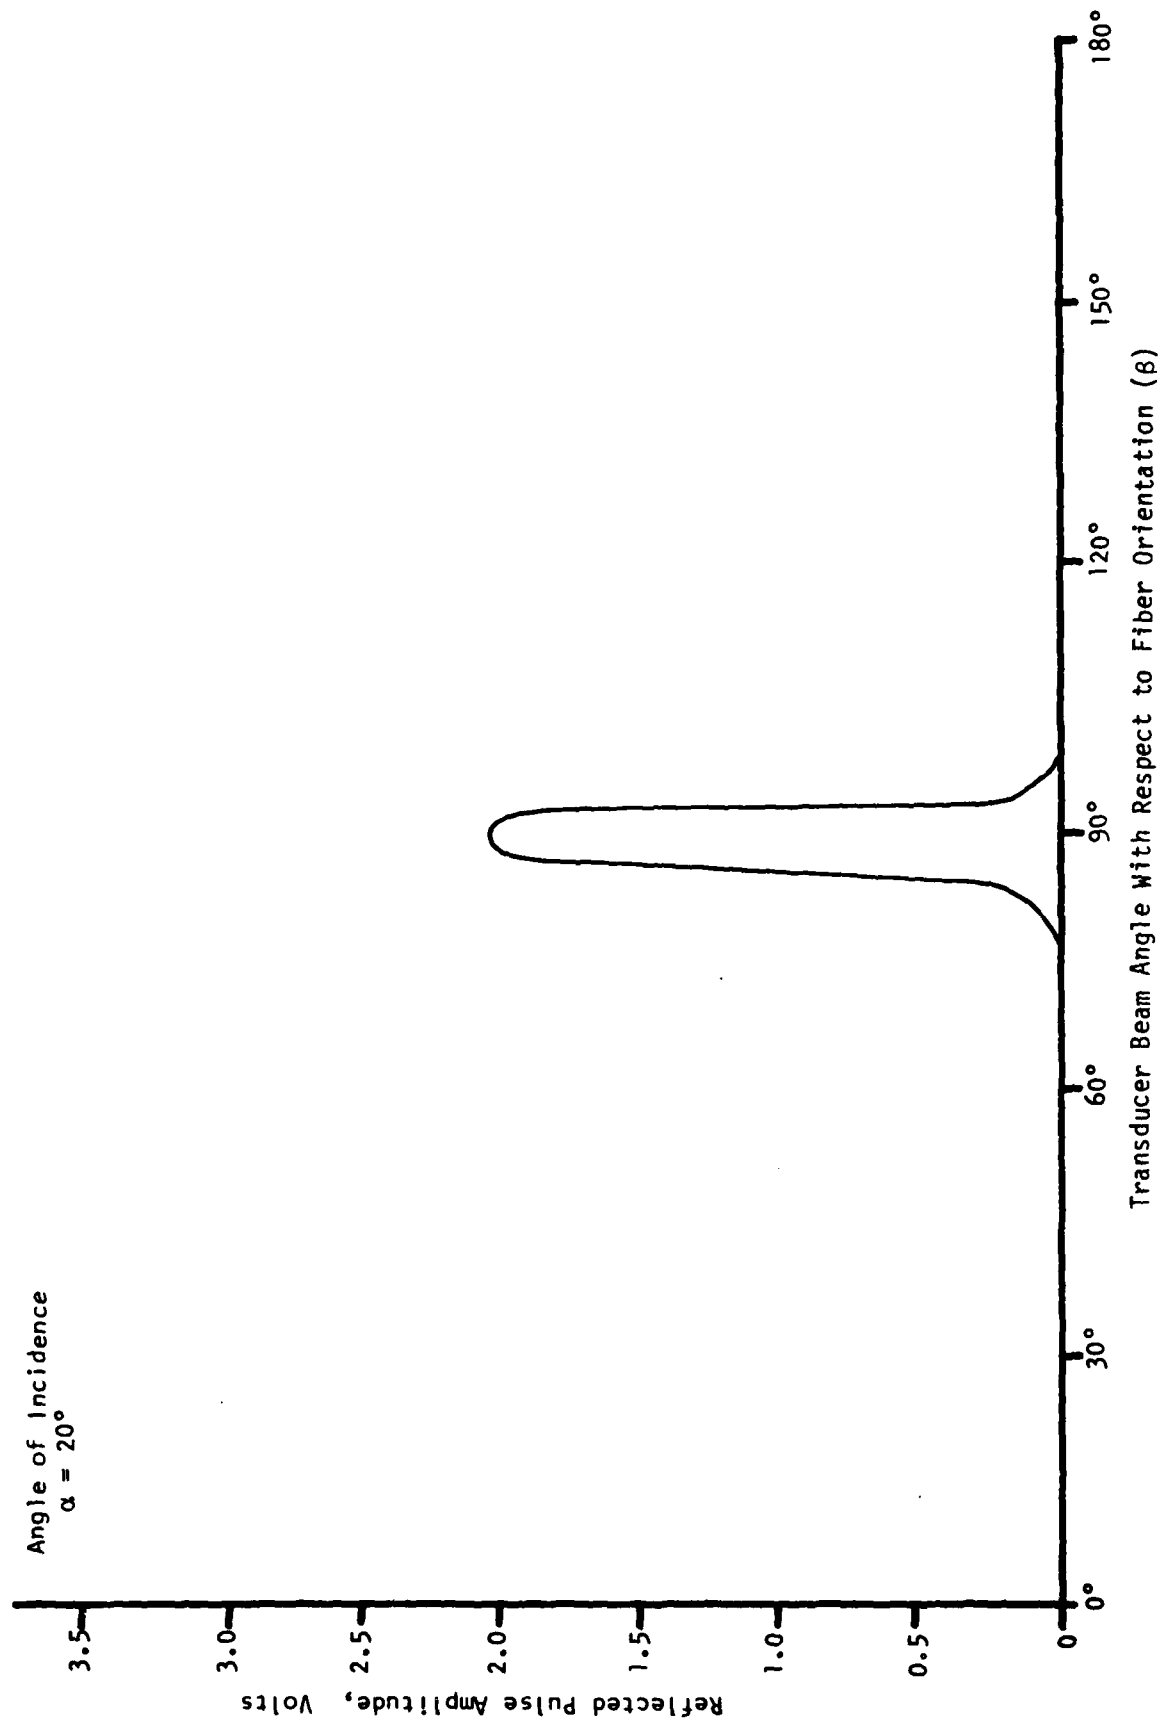
Figure 62 is a backscatter curve of Specimen 6-2. The incident angle ( $\alpha$ ) of the 5 MHz immersion transducer operated in the pulse-echo mode was  $20^\circ$  with respect to a line normal to the front-face surface plane of the specimen.

Figure 62. Ultrasonic backscattering curve of FP/Mg specimen with nonuniform fiber distribution (Specimen 6-2).

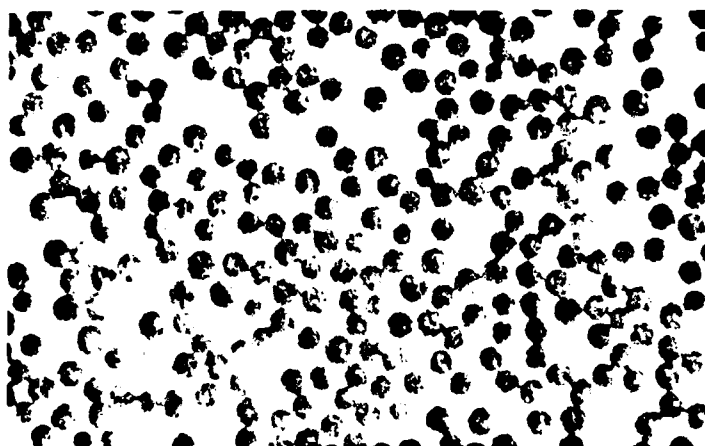
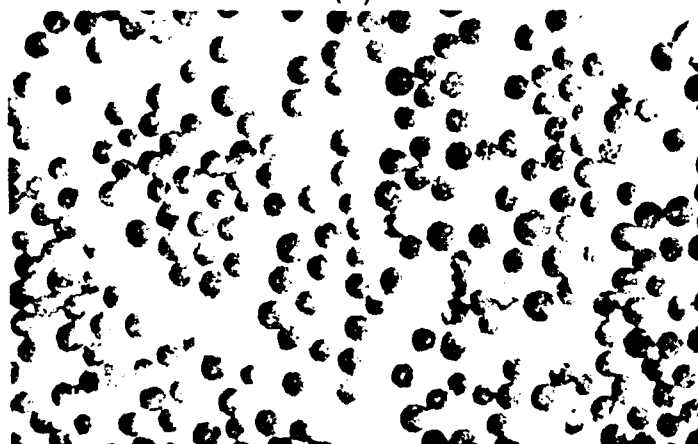
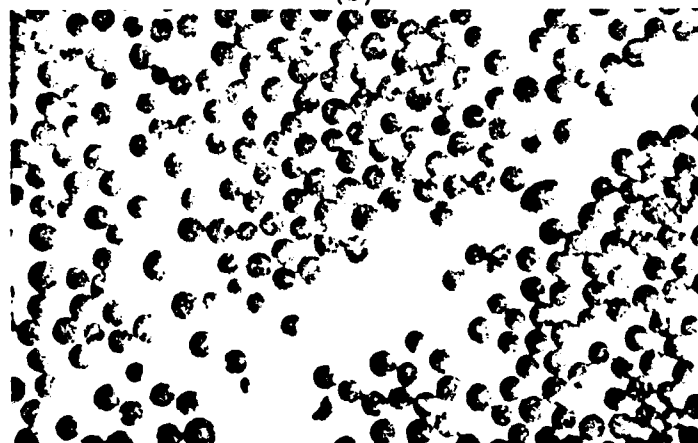
At 200X, the area of nonuniform fiber distribution is apparent in Figure 64b when compared with Figures 64a and 64c. The micrographs shown as Figures 64a and 64c were taken at sections cut through inspection locations 1 and 4 as shown in Figure 60. These two locations have no intentional flaws or defects. Figures 64a and 64c are very similar to the micrographs shown in Figure 28 for Specimen 1-1 (no intentional flaws) as would be expected. The major difference between the micrograph of the area of nonuniform fiber distribution

Figure 64. Micrographs (200X) of FP/Mg Specimen 6-2 (nonuniform fiber distribution) at three section locations: (a) Location 6-2-1, (b) Location 6-2-2, and (c) Location 6-2-3.

(Figure 64b) and the other micrographs (Figures 64a and 64c) is that there is a greater percentage of the matrix visible. This is exactly what was expected since the area of nonuniform fiber distribution was created by removing two fiber plies from the laminate in the circular area indicated in the C-scans (Figures 57 and 58).

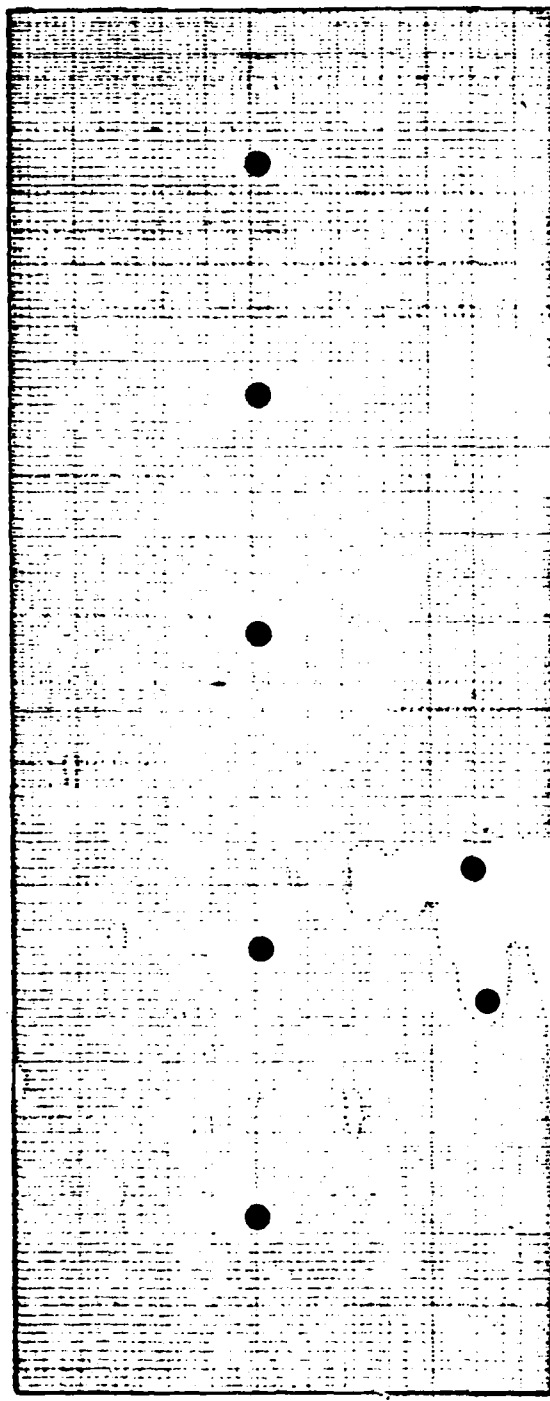
Figures 65 and 66 are pen-lift and analog C-scans, respectively, of Specimen 7-2. Both C-scans were generated using a 5 MHz, immersion, compression wave transducer operated in the pulse-echo mode with the specimen held in the special fixture.

Both C-scans give a clear indication of the presence of a flawed area within Specimen 7-2. The C-scans agree very well with respect to the location and extent of the flawed area. Figure 67 shows an A-scan photograph at an unflawed location (Figure 67a) and within the area of apparent matrix fracture (Figure 67b). Figure 67a is a typical A-scan of a location of unflawed FP/Mg material. There is a well-defined front and back-face reflection which is, once again, very similar to the A-scan (Figure 22a) of Specimen 1-1 with no intentional flaws.

Figure 65. Pen-lift C-scan of FP/Mg Specimen 7-2 (matrix fracture), 5 MHz transducer in pulse-echo mode.

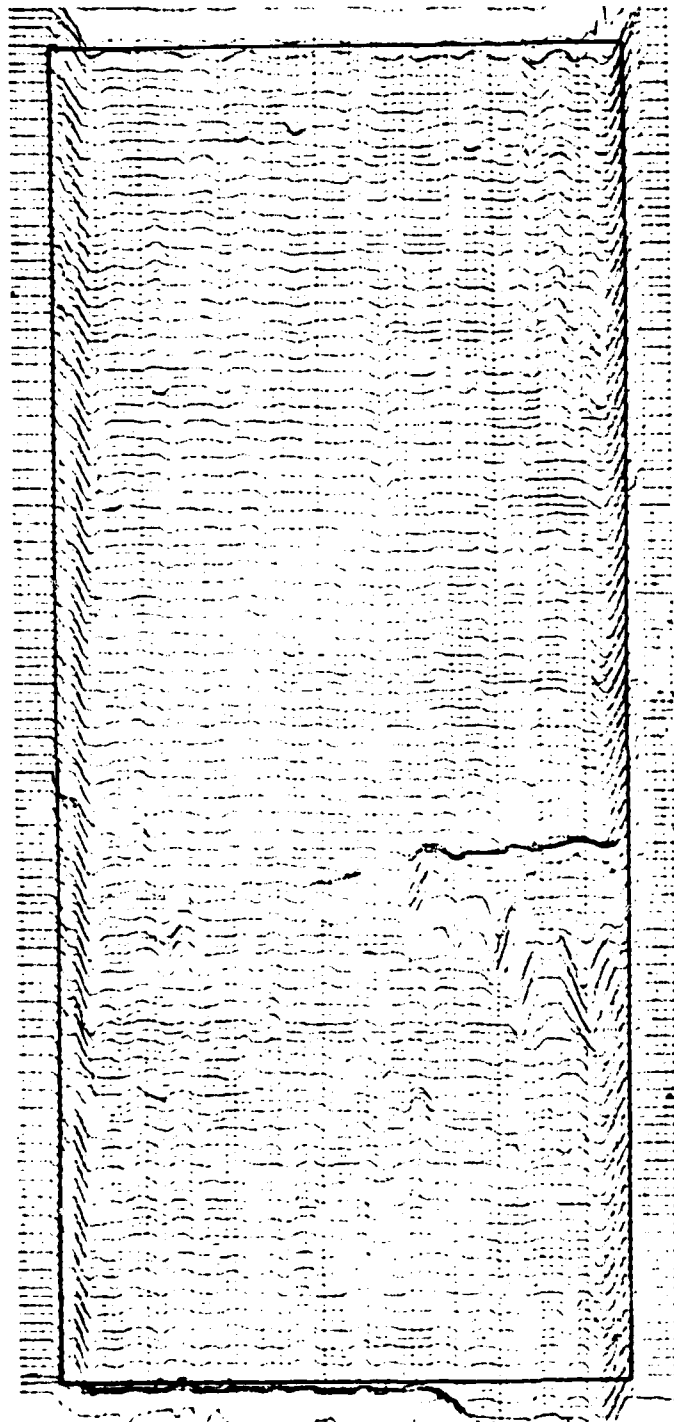
Figure 66. Analog C-scan of FP/Mg Specimen 7-2 (matrix fracture), 5 MHz transducer in pulse-echo mode.

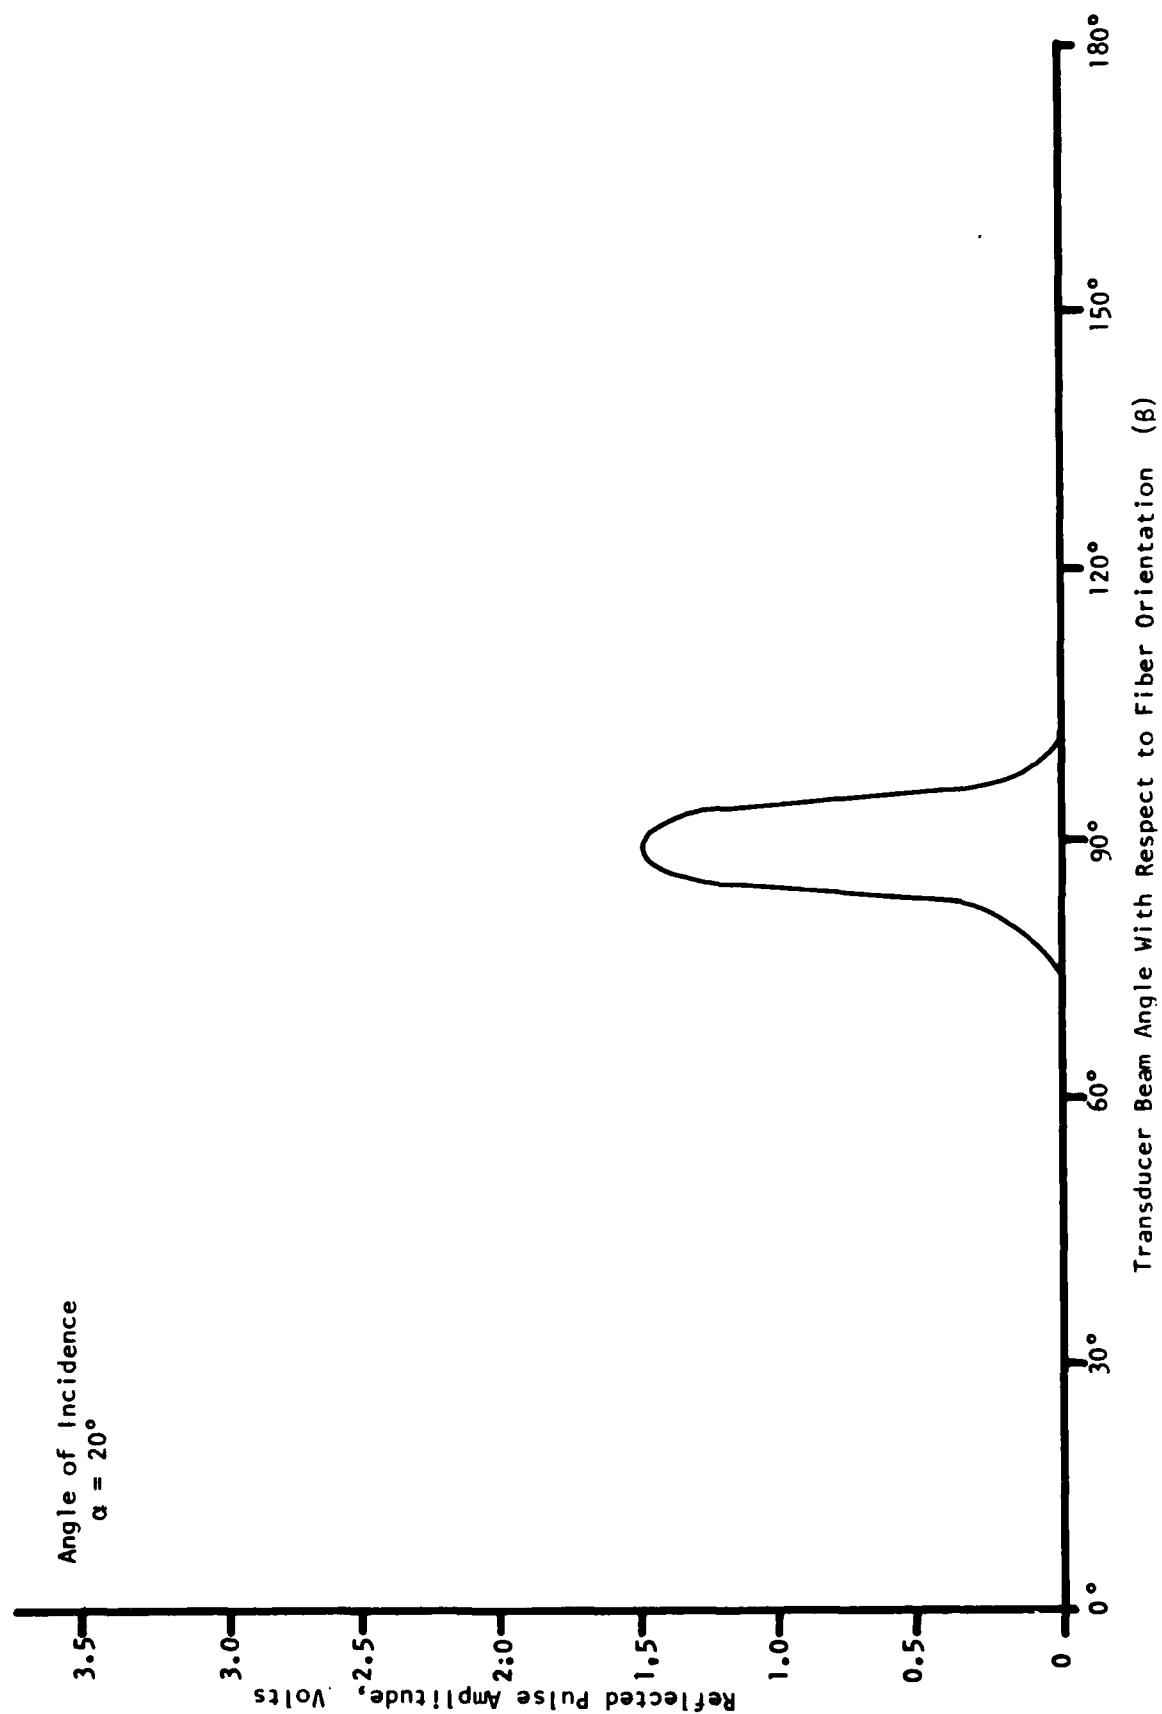
Figure 69. Ultrasonic backscattering curve of FP/Mg specimen with matrix fracture (Specimen 7-2)

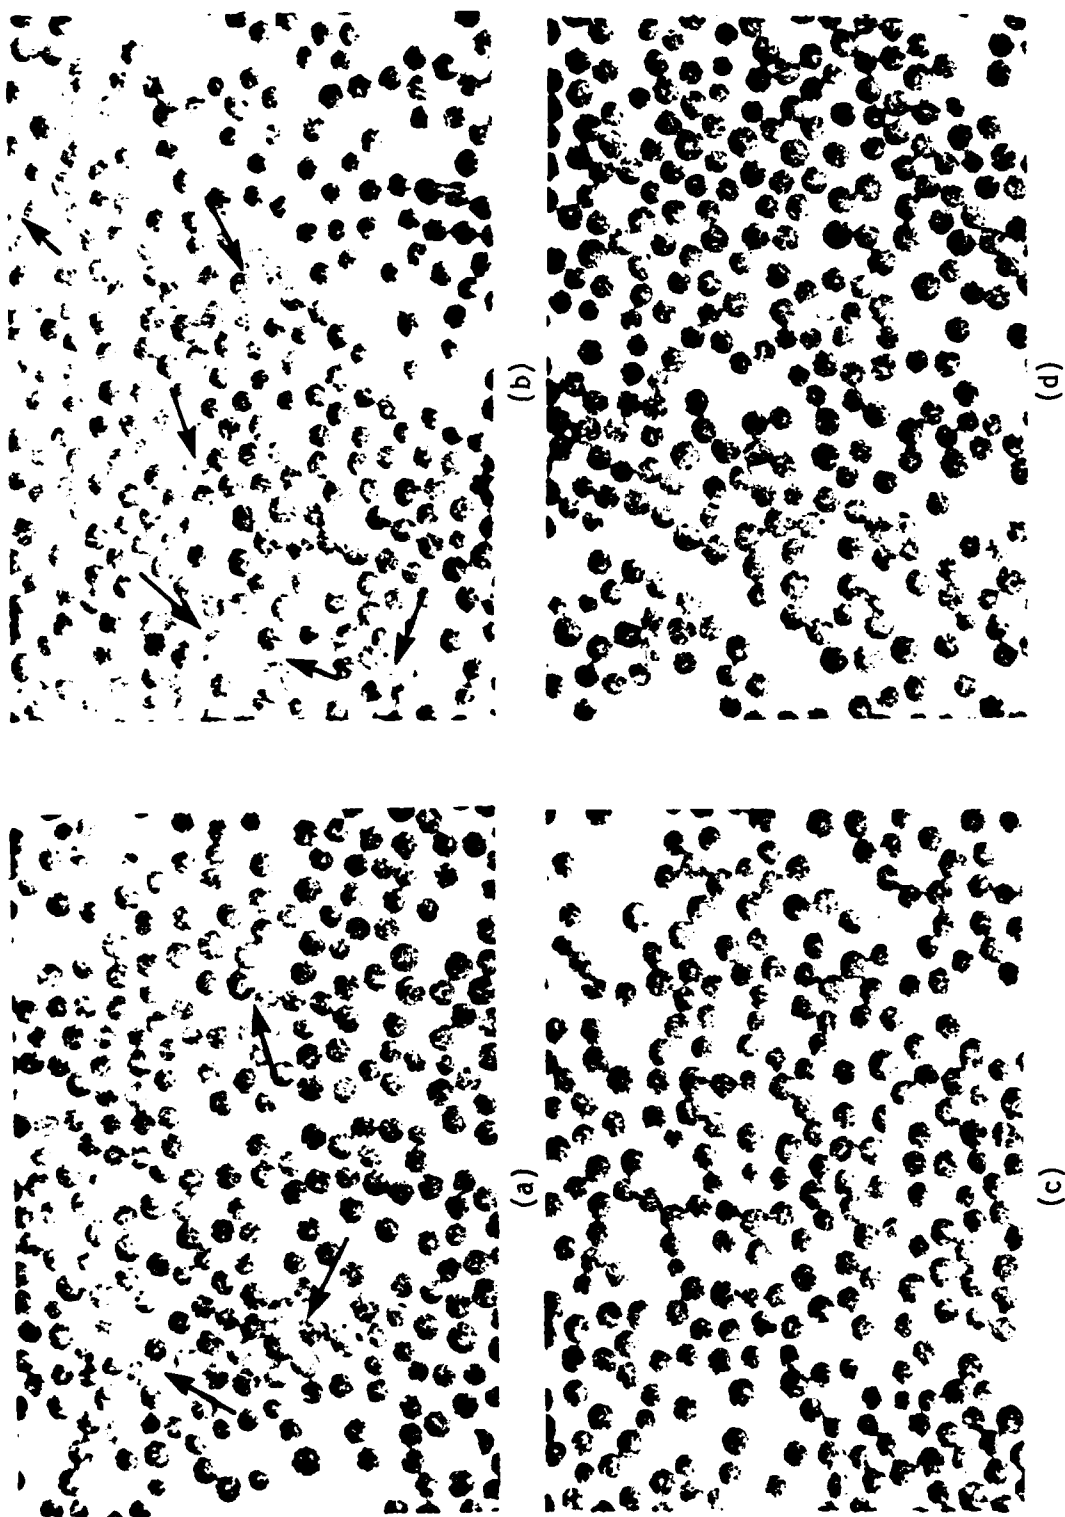
Figures 70 and 71 show four micrographs each of sections cut and polished from Specimen 7-2. The section locations (7-2-1 through 7-2-4) indicated on Figure 70 correspond to inspection locations 7-2-1 through 7-2-4, respectively, on Figure 65.

Figure 71. Micrographs (200X) of FP/Mg Specimen 7-2 (matrix fracture) at four section locations:  
 (a) Location 7-2-1, (b) Location 7-2-2, (c) Location 7-2-3, and (d) Location 7-2-4.
