# **FRACTURE ANALYSIS OF REACTION-BONDED SILICON NITRIDE TURBINE SHROUDS**

**DONALD R. MESSIER, LISELOTTE J. SCHIOLER,  
GEORGE D. QUINN, and JAMES C. NAPIER**

**JUNE 1982**

**ARMY MATERIALS AND MECHANICS RESEARCH CENTER  
Watertown, Massachusetts 02172**

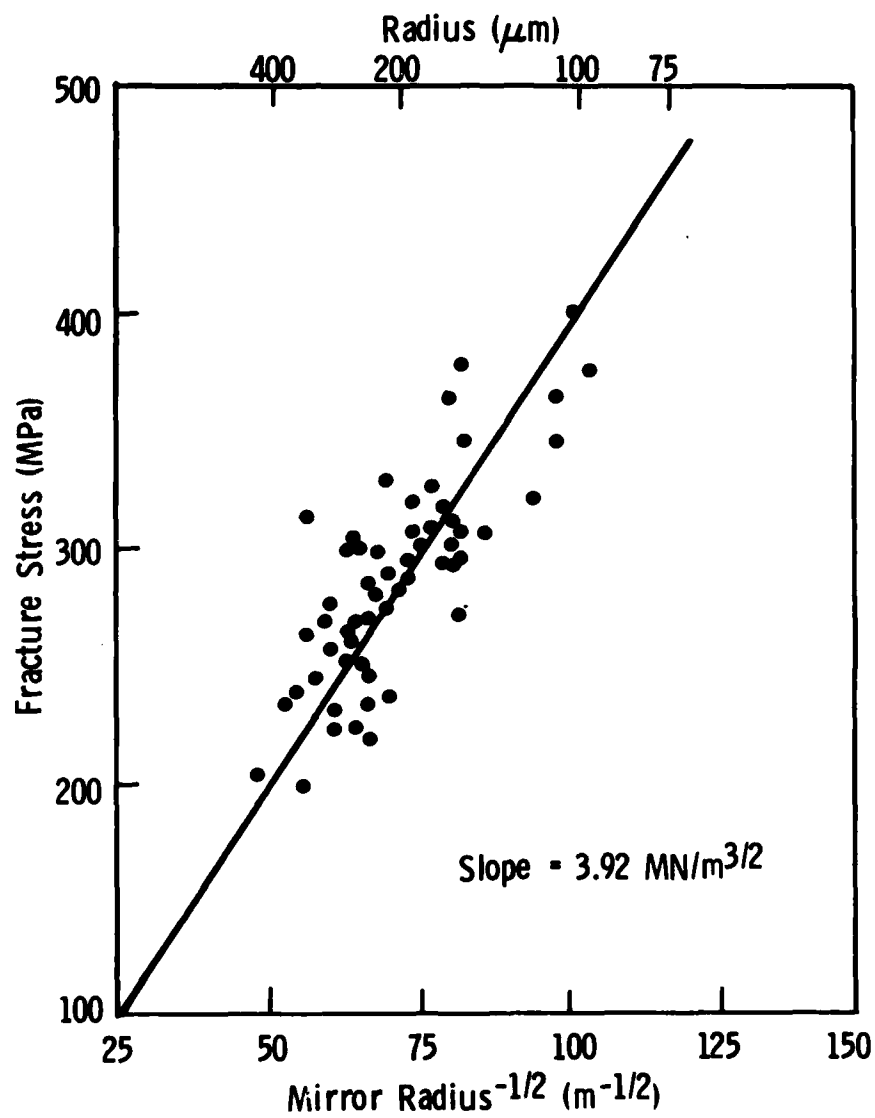
Figure 38 is a plot of fracture stress versus mirror radius. A least squares analysis of the data yielded a value of  $A = 3.92 \text{ MN/m}^{3/2}$ . This value is in reasonable agreement with the value of  $4.2 \text{ MN/m}^{3/2}$  reported by Kirchner et al.<sup>13</sup> for a different grade of RBSN, and also with that of  $3.19 \text{ MN/m}^{3/2}$  reported by Larsen and Walther<sup>14</sup> for the same type of material (NC-350) investigated in this study.

Figure 38. Fracture stress versus fracture mirror radius after Equation 1.  
All data are from bend specimens.
