THE STREAMBANK EROSION CONTROL  
EVALUATION AND DEMONSTRATION ACT OF 1974  
SECTION 32, PUBLIC LAW 93-251

## Appendix H - Evaluation of Existing Projects

Volume 1 of 2

# FINAL REPORT TO CONGRESS

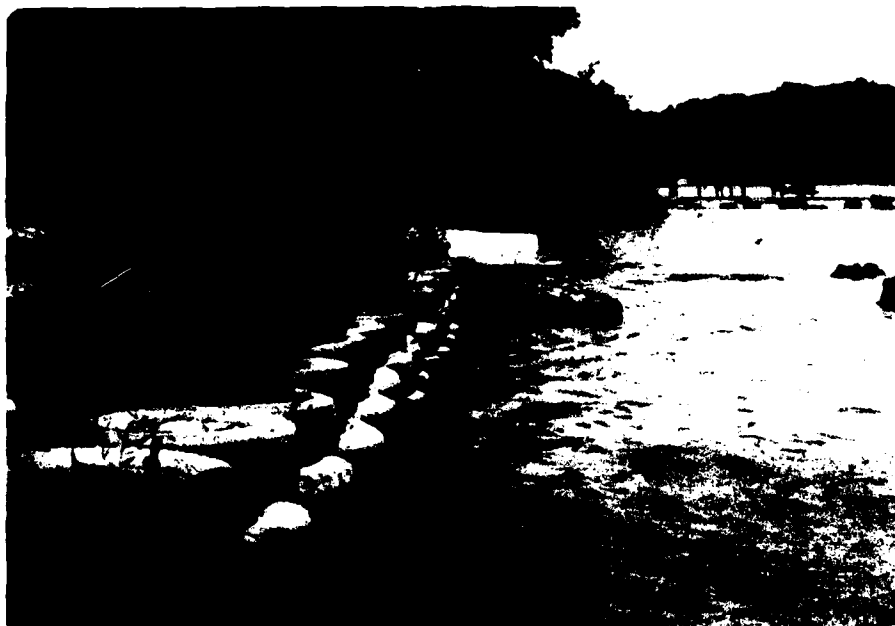
Connecticut River at Thetford, Vermont

Monogahela River (left bank) near California, Pennsylvania

Exhibit 2. Stone-filled tire revetment constructed  
by property owners (successful)

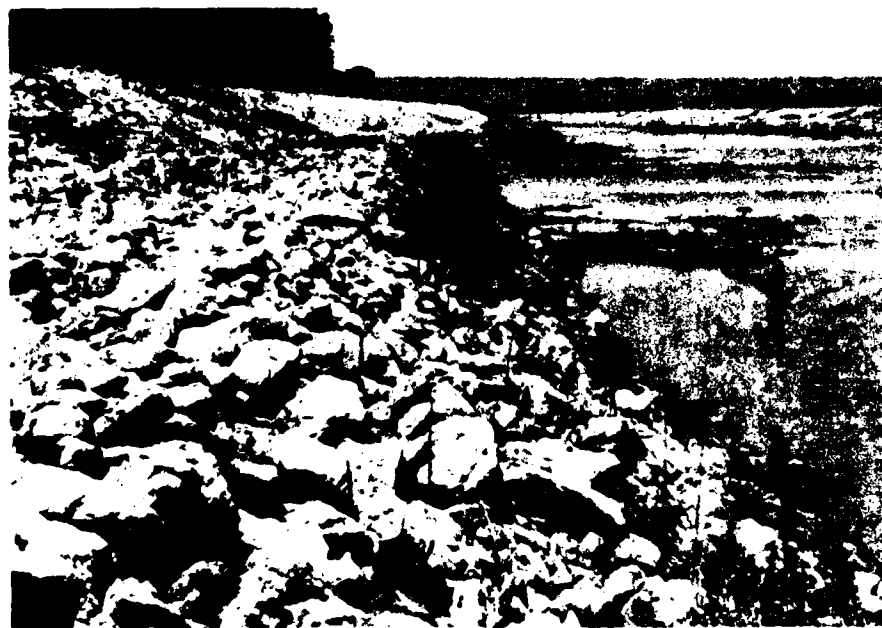
A team consisting of personnel from MRD and MRK conducted the 6th Periodic General Inspection of Milford Dam in May 1981. As part of this inspection, the outlet channel riprap was examined. The team found the rock protection on the channel side slopes was performing satisfactorily, Figure 6, even though the streambed had degraded nearly 6 ft. Progressive armoring was developing over the entire length of the channel bed, and the upstream one-half to two-thirds of the channel bed was armored to the point where no additional degradation was expected. No areas of weakness in the toe protection were noted during this inspection, Figure 7.

Figure 7. Republican River at Milford Dam Outlet Channel, Kans. Typical view of the revetment toes as of July 1981. Note break in slope between the blanket and the slope to the water.

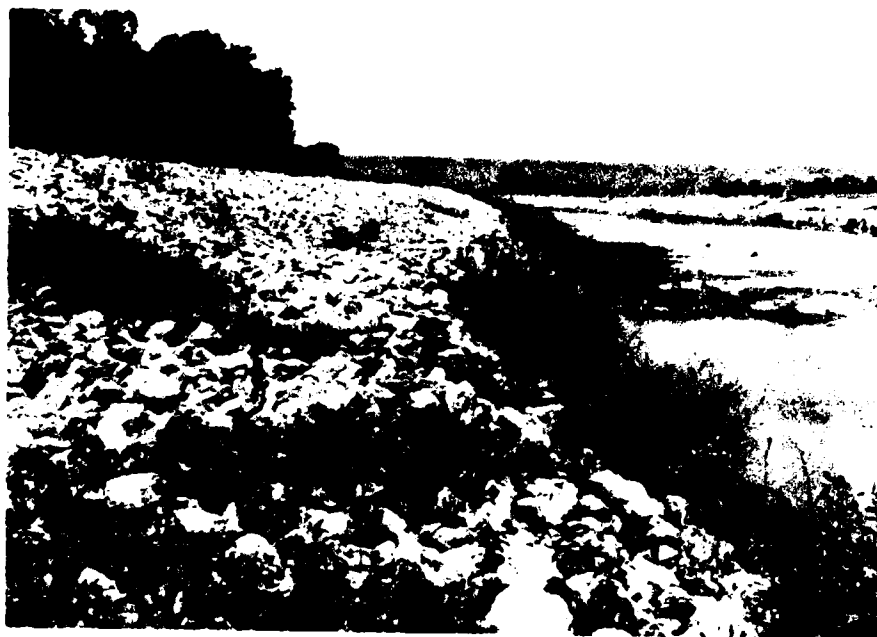
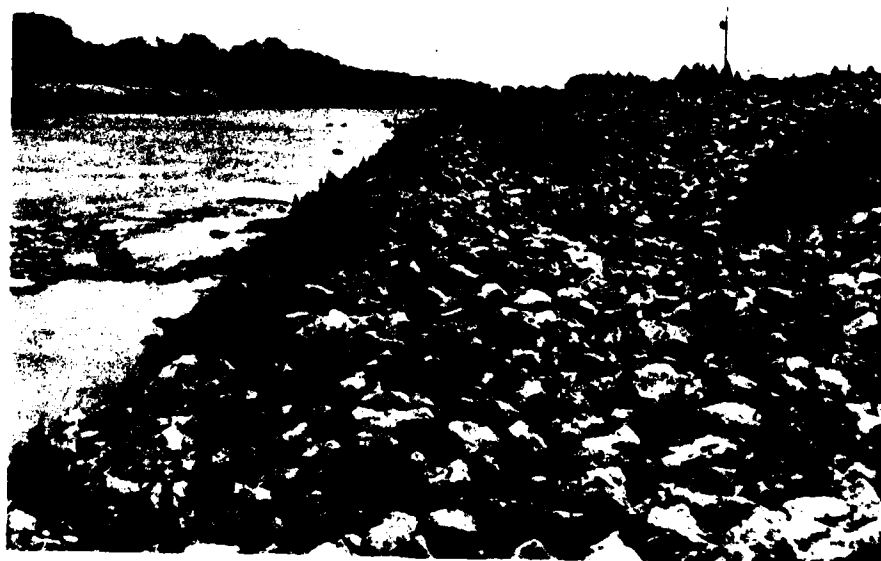
Figure 12 shows upstream and downstream views of the revetment in the outlet channel. The project is performing as designed, Figures 4 and 5. No apparent failures have occurred with the exception of minor areas where stone has been displaced and exposed the bedding material, Figures 8 and 9.

Figure 12. Republican River at Milford Dam Outlet, Kans.  
Upstream and downstream views of the outlet channel revetment.  
(July 1981)

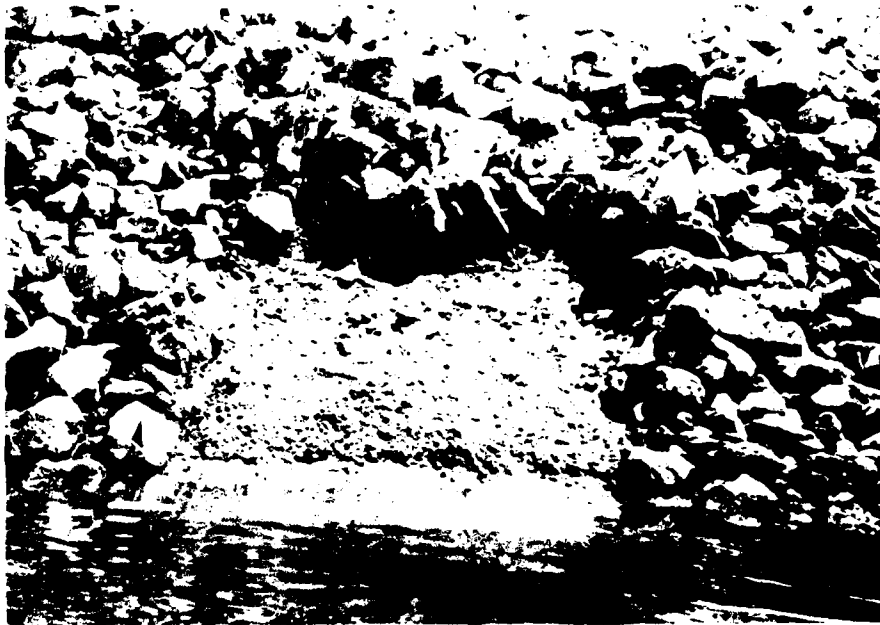
In August 1980, five test areas of stone were excavated and graded, Figures 13 and 14. The results showed the median size of the stone to be 22 pounds against the 25 pound median specified during construction and maximum size of 160 pounds against 150 pound maximum specified. This could indicate some breaking down of stone in the mid-range of the original gradation. The stone coverage in the test sections varied from an average of 1.5 to 2.25 rock diameters. Overall the revetment is performing as designed.

Figure 13. Republican River at Milford Dam Outlet, Kans.  
Test area sampled in August 1980 in Test Section 3.

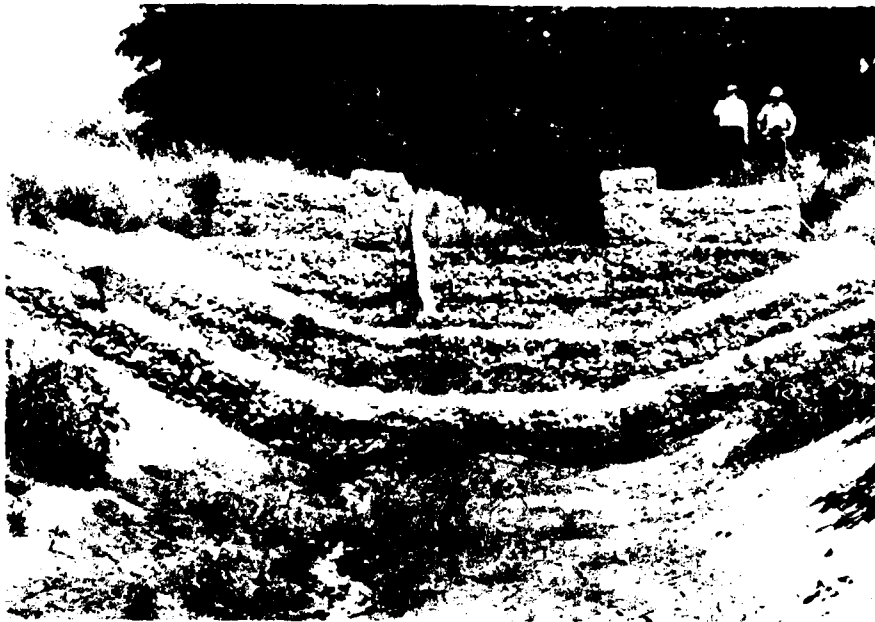
Figure 4. Little Blue River at Independence, Mo. Gabion drop structure to control overbank drainage.

However, as a result of uncontrolled overbank drainage, clay blanket erosion occurred at some locations, Figure 3. These areas have been repaired by the construction of two gabion drop structures, Figure 4, and a number of grouted gutters, Figure 5. Several areas of erosion of the clay blanket on the high flow berm will be repaired by a series of low rock dikes across the berm.

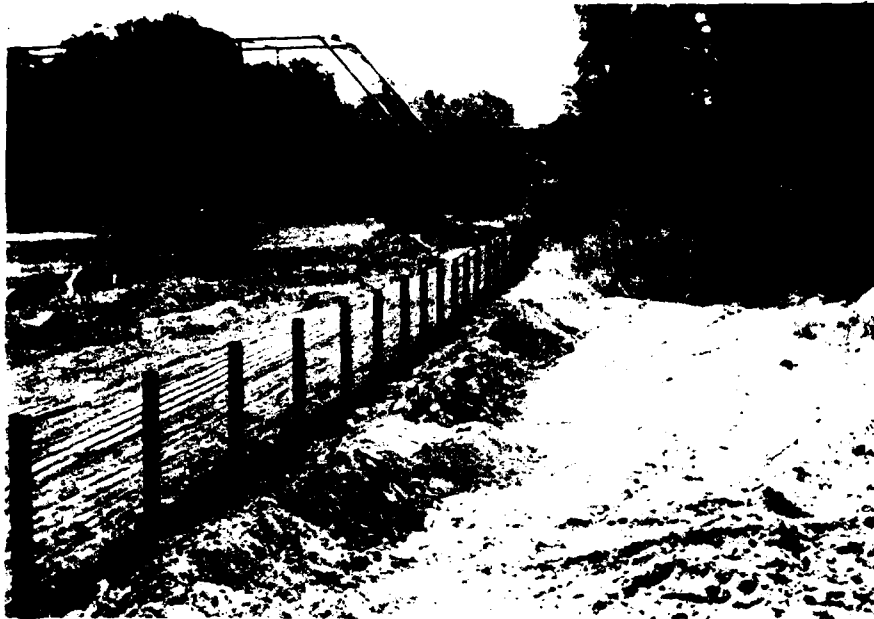
a. Downstream view of wire fence revetment. Schroyer Bridge is in the background.

b. Wire fence revetment viewed toward end of dike 3.

Figure 2. Big Blue River near Marysville, Kans. Two views of the completed project. (July 1977)

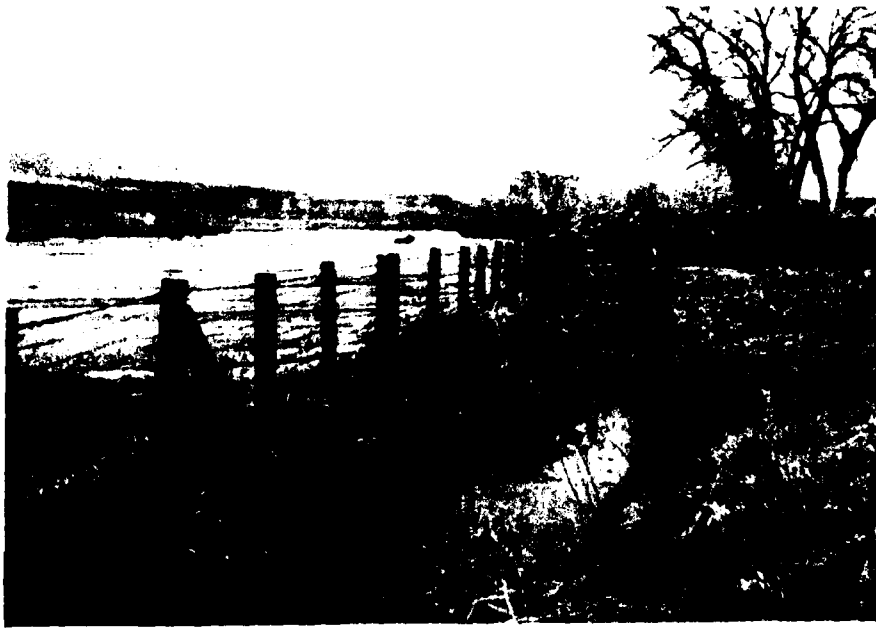
Figure 5. Plum Creek, Douglas County, Colorado.  
Landward side of fence revetment with tieback.

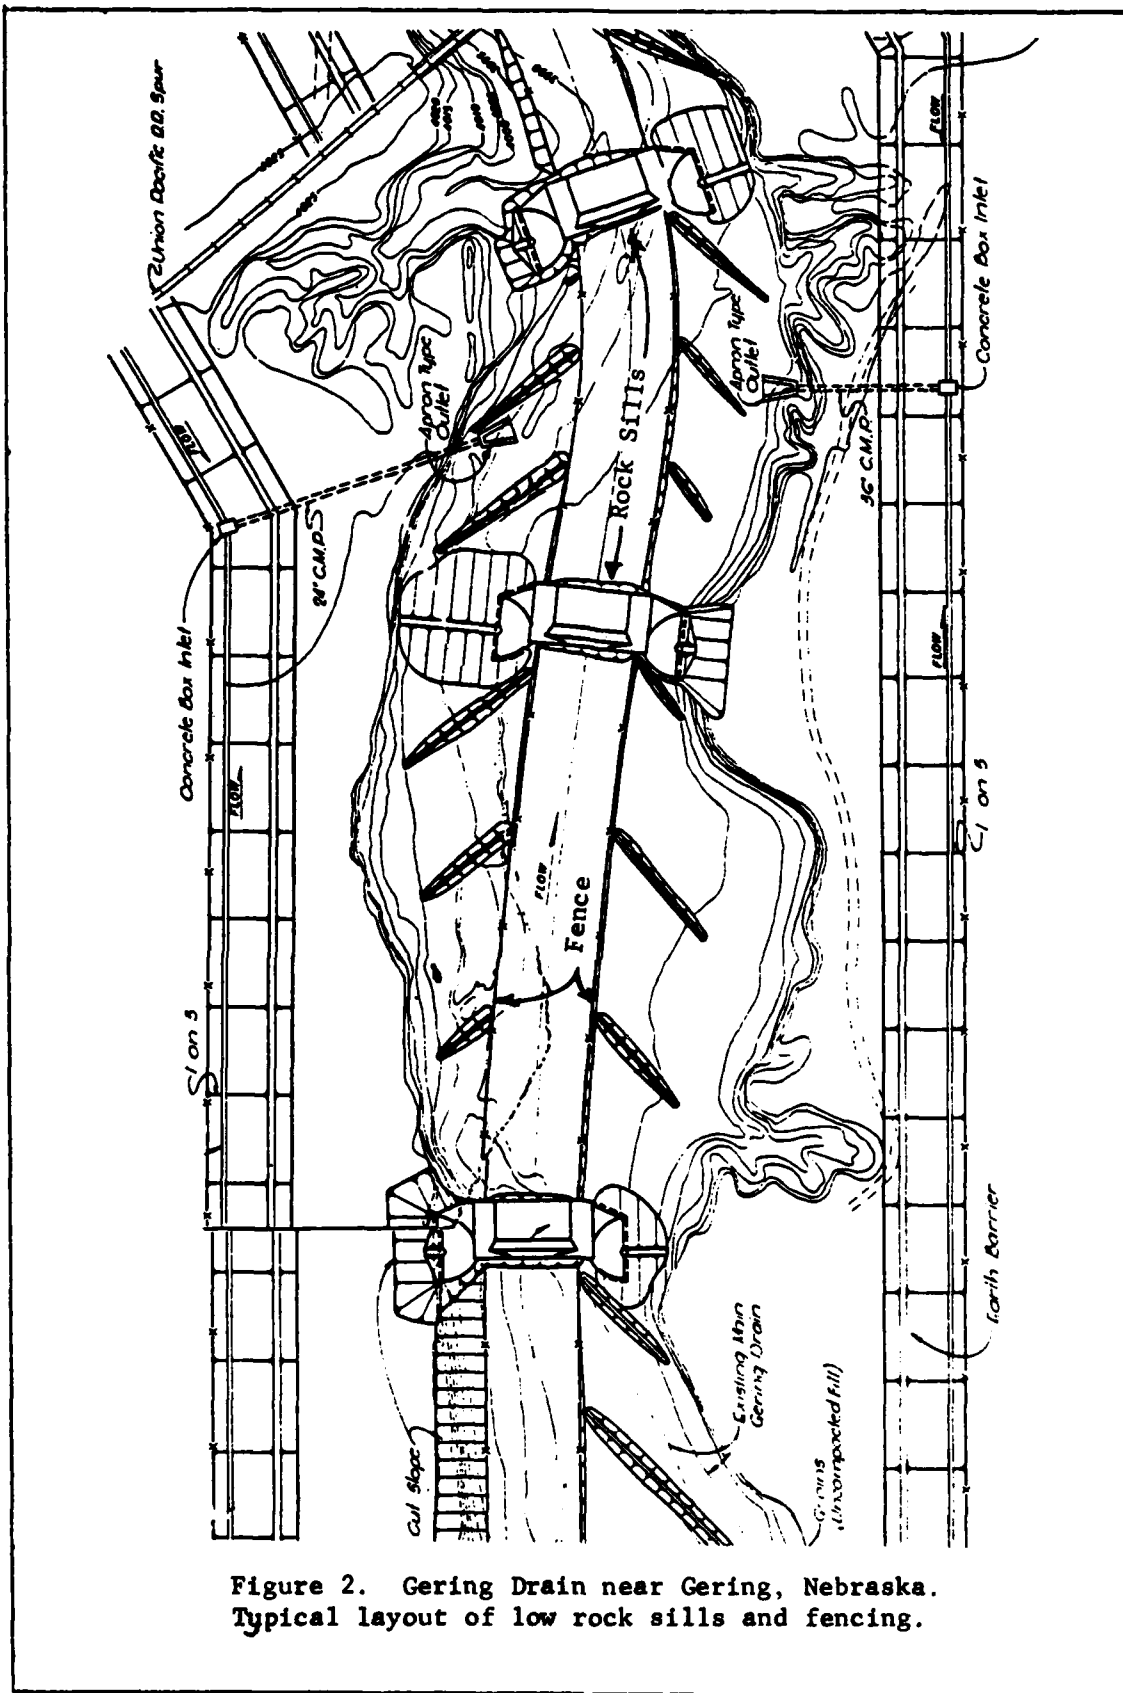
In reaches where the channels are wide and not too steep, a series of low rock sills between two parallel rows of double wire fencing, as shown in Figures 2, 3, and 4, was found to be the most adaptable solution. The rock sills are spaced at approximately 500 feet (depending on the bed slope) and create a head loss of about 2 feet each. The two parallel rows of fencing were placed along the desired channel alignment and filled with rock or hay bales. Earthen groins were spaced at about 100-foot intervals across the berm area to prevent flow from developing behind the fencing, Figure 2. The rock sills are designed to limit the 25-year discharge to a maximum velocity of 6 feet per second. The crest

Figure 2. Gering Drain near Gering, Nebraska.  
Typical layout of low rock sills and fencing.

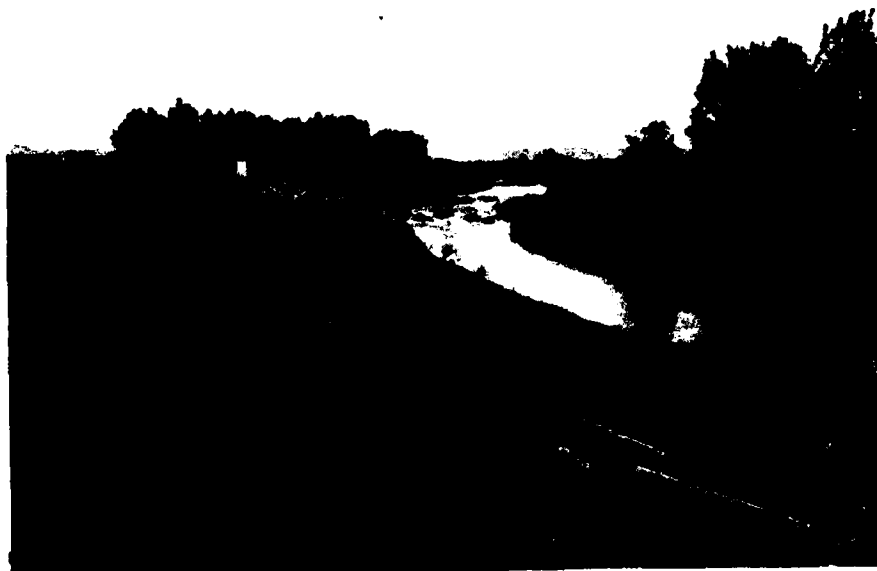
Figure 4. Gering Drain near Gering, Nebraska.  
View of low rock sill and fence line with  
stabilized channel.

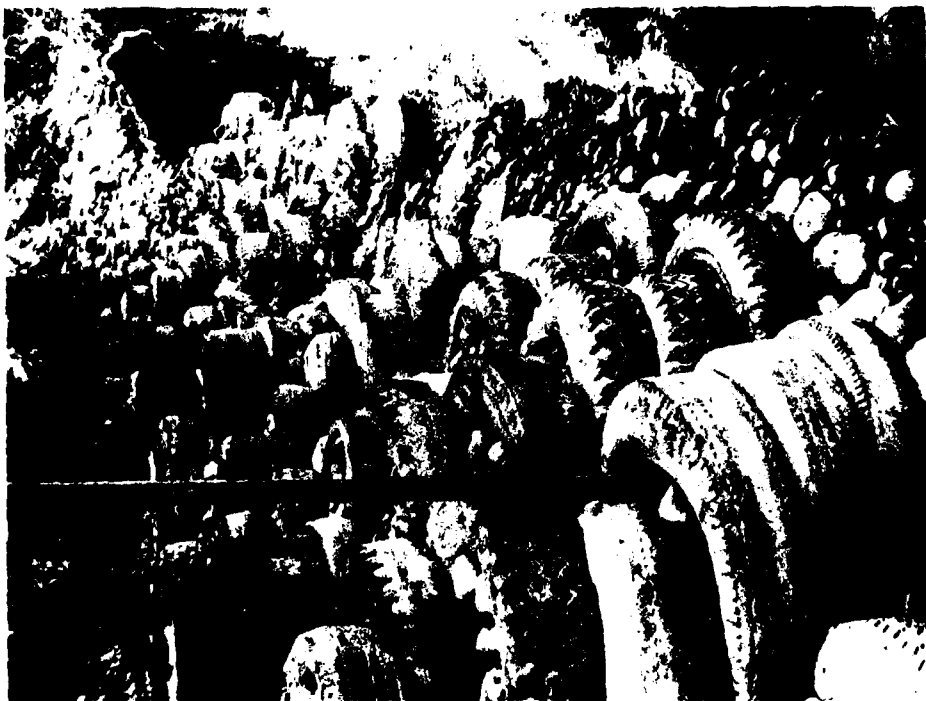
In summer 1972, private landowners constructed a 150-ft-long used-tire revetment on the right bank of the Connecticut River. Height of the protection ranged from three to fourteen layers of tires. Each tire was filled with small stones and tamped. At the time of the 1978 inspection, the revetment was intact, and a good stand of vegetation had become established on the upper bank. Minor structural damage was noted in a few places, including undercutting of tires at the upstream end of the revetment, which has resulted in the sagging of some tires and the spilling of fill material. There has also been some displacement of tires due to impact of ice cakes and heavy overbank drainage. Additional tires have been added to maintain the same top elevation. The New England Division, CE, has recommended that holes be drilled in the sidewalls to prevent flotation, that tires be tied together and anchored to the bank, that tires be stepped back 6 to 12 inches with each row, and that the space between the tires and bank be filled with earth or stone to prevent water or ice flow behind the structure.

Completed revetment shown at low water, Connecticut River at Thetford, Vt. View is upstream

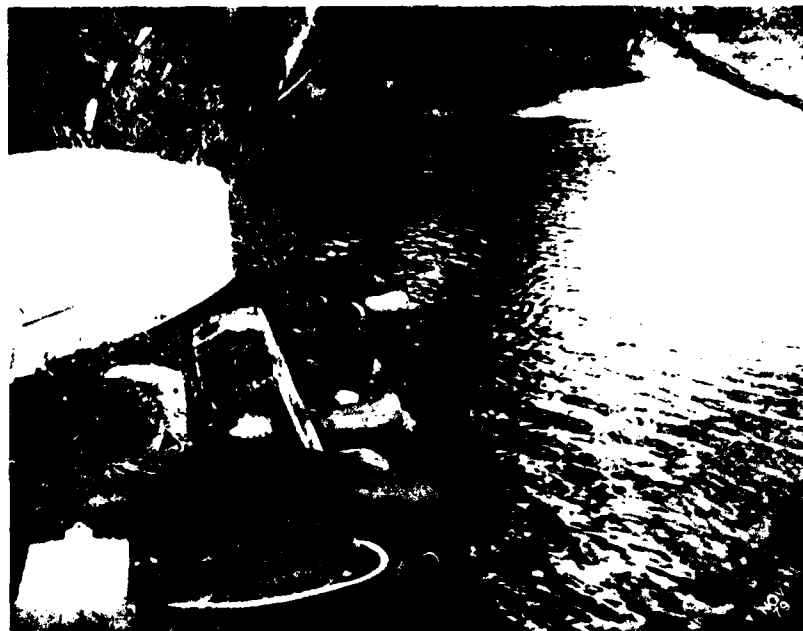
Upstream view of used automobile tire revetment of right bank of  
the Connecticut River at Thetford, VT. 1980
