**THE STREAMBANK EROSION CONTROL  
EVALUATION AND DEMONSTRATION ACT OF 1974  
SECTION 32, PUBLIC LAW 93-251**

**Appendix H - Evaluation of Existing Projects** Volume 2 of 2

Consisting of  
A BRIEF SUMMARY REPORT AND INDIVIDUAL EVALUATION  
REPORTS ON FIFTY EXISTING STREAMBANK EROSION CONTROL  
PROJECTS CONSTRUCTED PRIOR TO OR SEPARATE FROM THE  
SECTION 32 PROGRAM

U.S. ARMY CORPS OF ENGINEERS  
December 1981

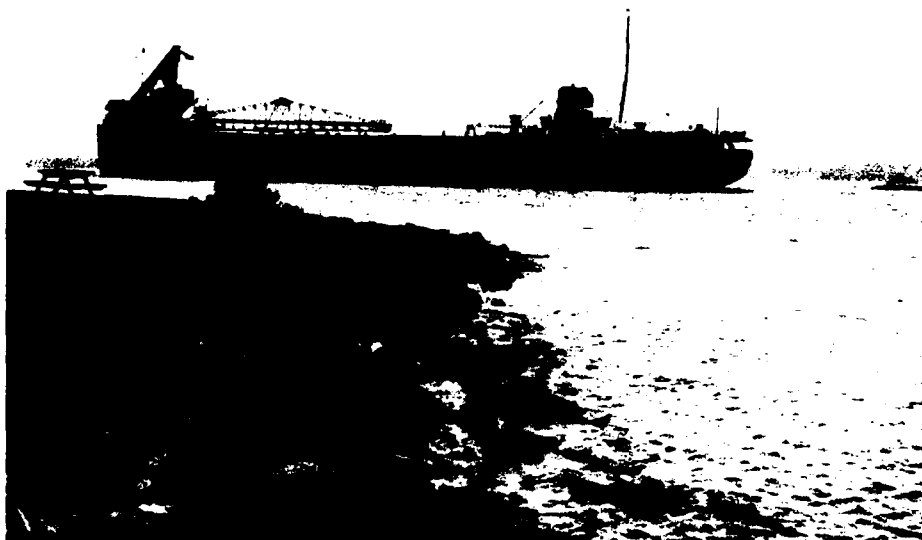
\*The site was observed on relatively windy days and during ship passage. Ship waves appeared to be 1/2 foot or less in height, which can be considered a typical value since the speed of commercial vessels in the channel is regulated by the U.S. Coast Guard. Vessels and other craft violating regulations could cause larger waves which erode the banks. Observed waves did not come within 2 to 3 feet of the bank. The toe of the bank is vegetated. River stage on 26 September 1980 was about 580.4 feet IGLD (1955). The bank immediately downstream of the protected area is eroding.

Examples of typical wave-surge conditions on  
the St. Marys River - 1980

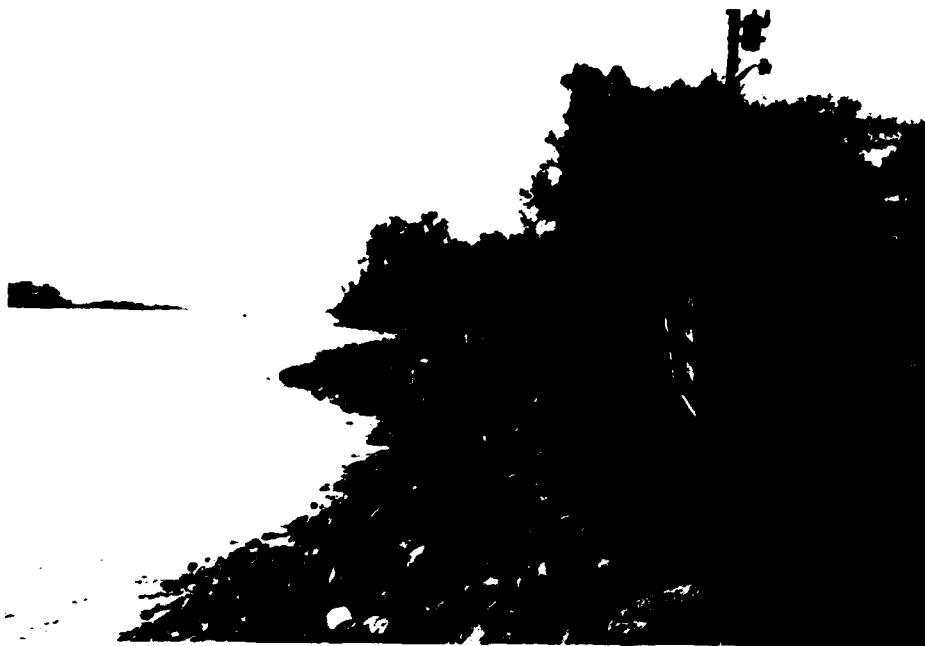
Looking downstream (south) - 1978

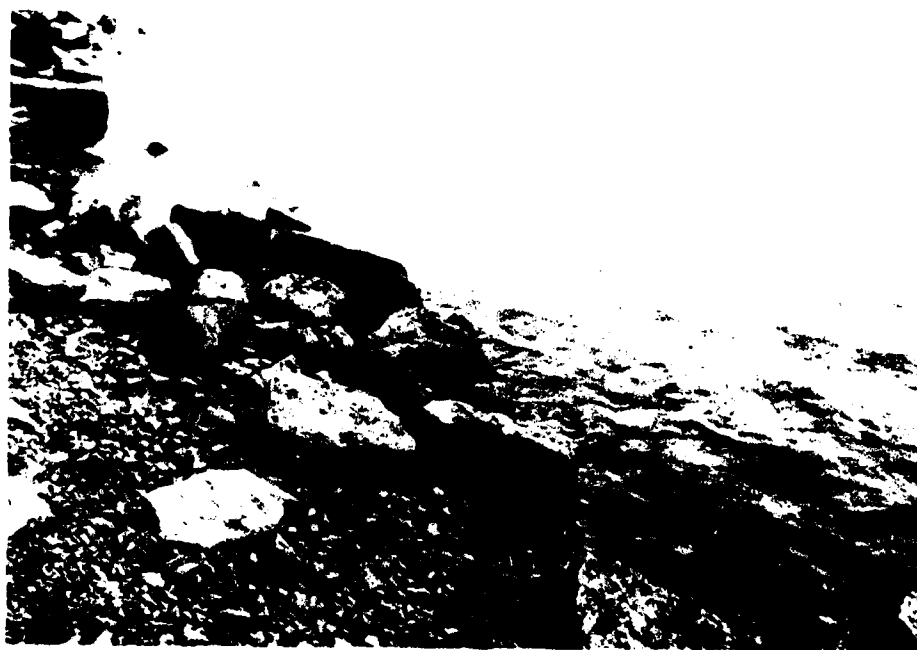
Any settling of the revetment should be complete now. Slope stability is not a problem, since the riprap slope is gentle. Some of the finer gravel included with the riprap may occasionally wash away, but, overall, erosion of the revetment is insignificant.

Closeup view of riprap material - 1980

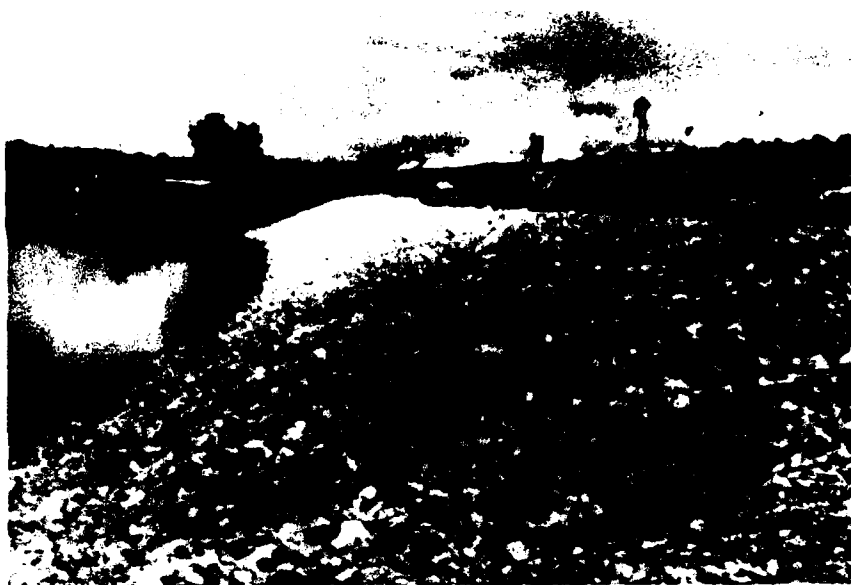
Photo 3

Taken 10 August 1966 looking downstream from creek inlet. Shows bank protection after completion. The 1969 high water overtopped the top of the riprapped bank by almost 10 feet.

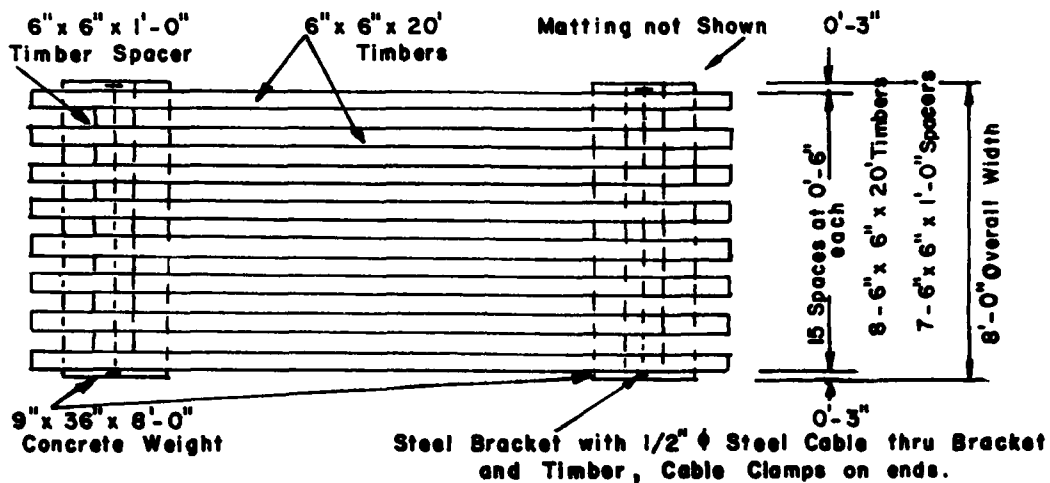
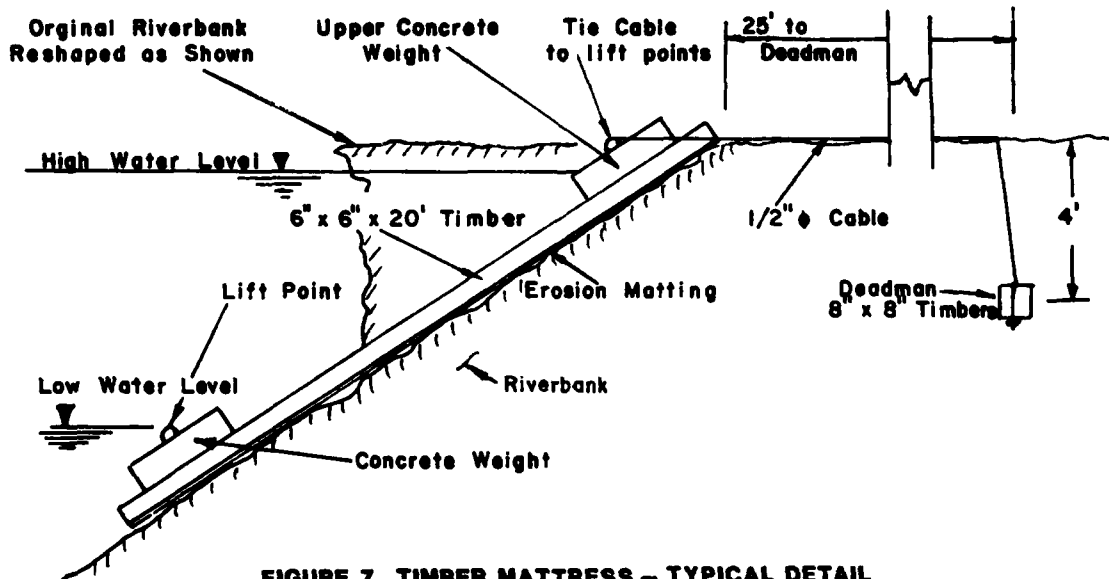
FIGURE 7 TIMBER MATTRESS - TYPICAL DETAIL

3. Details on Construction Type and Technique Typical details of the timber mattress construction are shown in figure 7. Timber mattresses were constructed in units that are "transportable" from an assembly site to the erosion site. The timber mattress unit measures 8' X 20' and was constructed of 6" X 6" X 20' timbers connected to a concrete

weight at both ends. Erosion matting was attached to the timber mattress to assist in protecting the riverbank. The timber mattress units were constructed upside down as shown in figure 7. Forms were prepared for the concrete weights with steel brackets and loops located as shown. Side boards were all that was necessary for form work since the ground was used as the bottom of the form and the concrete poured to a depth of 9". Once the concrete set up, the forms were removed and the timbers added to the concrete weights. The timbers were then tied to the concrete weights with 1/2" diameter cable through the timbers and steel brackets anchored in the concrete. Eighteen timber mattress units were constructed in this manner. The units were then flipped over so that the concrete weights are on top. Erosion matting was attached to the top surface of half of the units and on the bottom of the other half. The riverbank was prepared as shown in figure 7. Steel cables 1/2" in diameter were cut to a length sufficient to go from the deadmen to the timber mattresses; the deadmen were then placed in the riverbank as shown in figure 7. The timber mattress units were trucked, three at a time, from the assembly point to the erosion site, a distance of 14 miles, and installed on the riverbank. Thirty minutes per unit was the time required to offload and install on the riverbank.

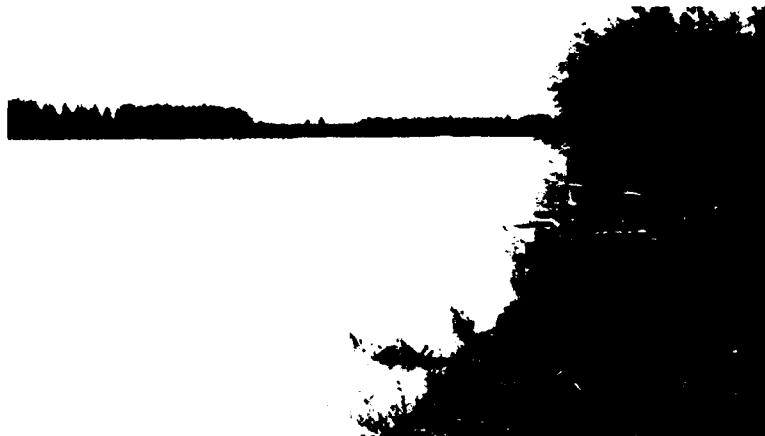
Photo 2 June 1977, mean river discharge was 37,400 cfs,  
view of riverbank prior to construction of tree revetments.

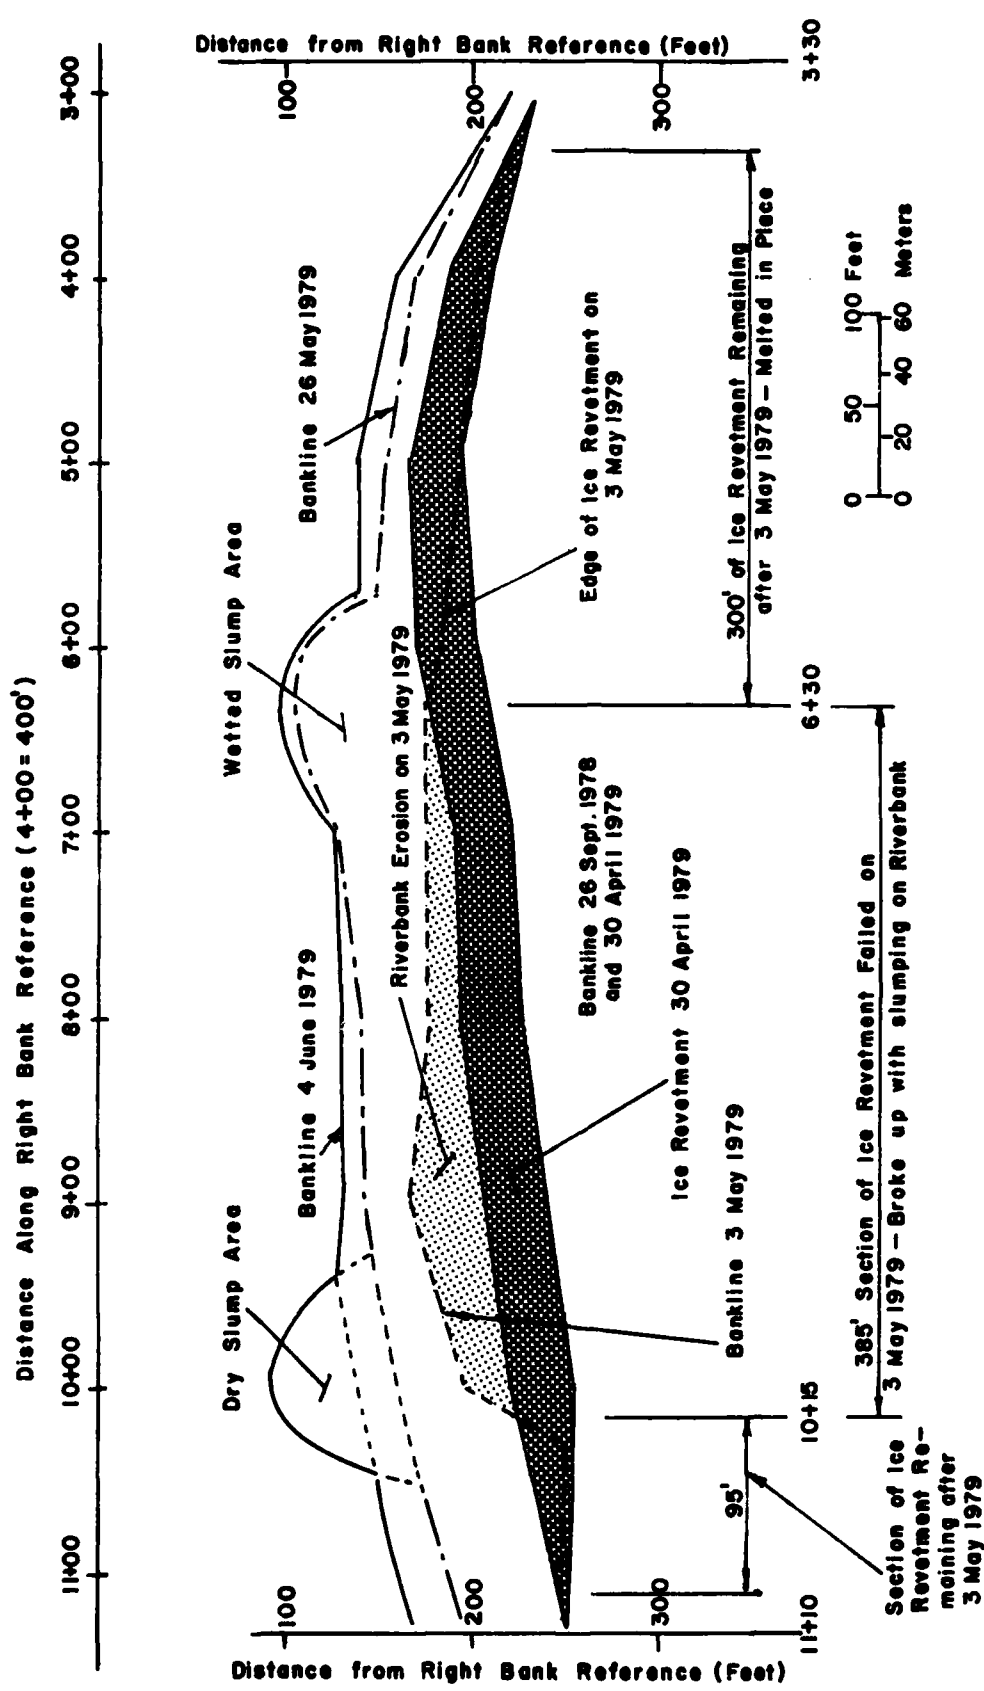
FIGURE 2 BANK-LINE SURVEYS SHOWING ICE REVETMENT FAILURE.

2. How Well Structure Functions for Design Conditions The ice revetment functioned extremely well in protecting the riverbank from ice during breakup. Once the 385 foot section of ice revetment failed the riverbank was unprotected in that area and erosion was rapid. The 300 foot section of the ice revetment that melted in place continued to protect the riverbank until it melted. Photos 2 through 12 show the ice revetment as constructed, breakup, the ice revetment failure, and the subsequent erosion. Figure 2 shows bankline surveys of the site.

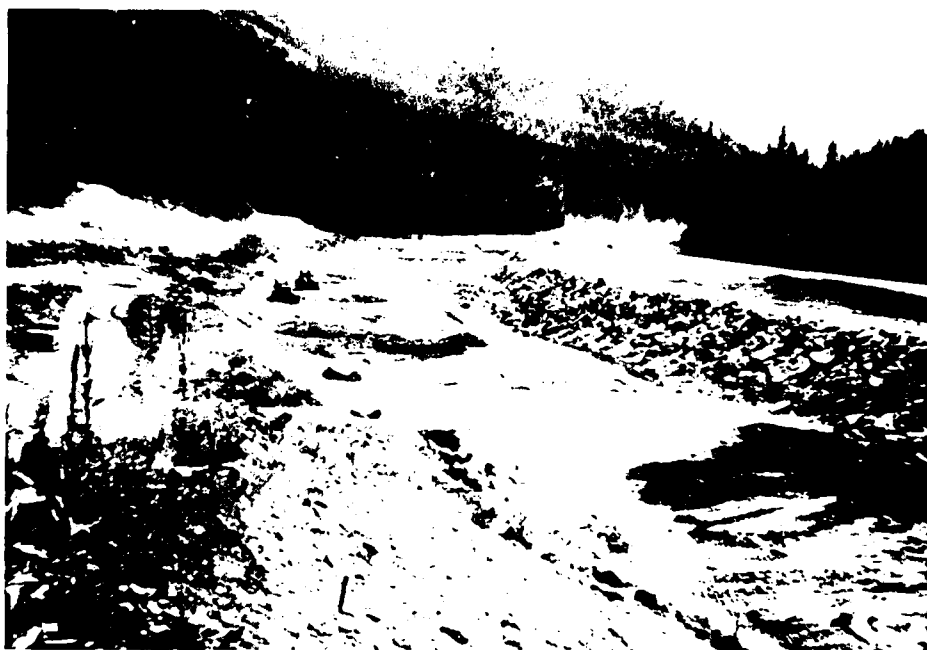
a. Under construction (24 Aug 67)

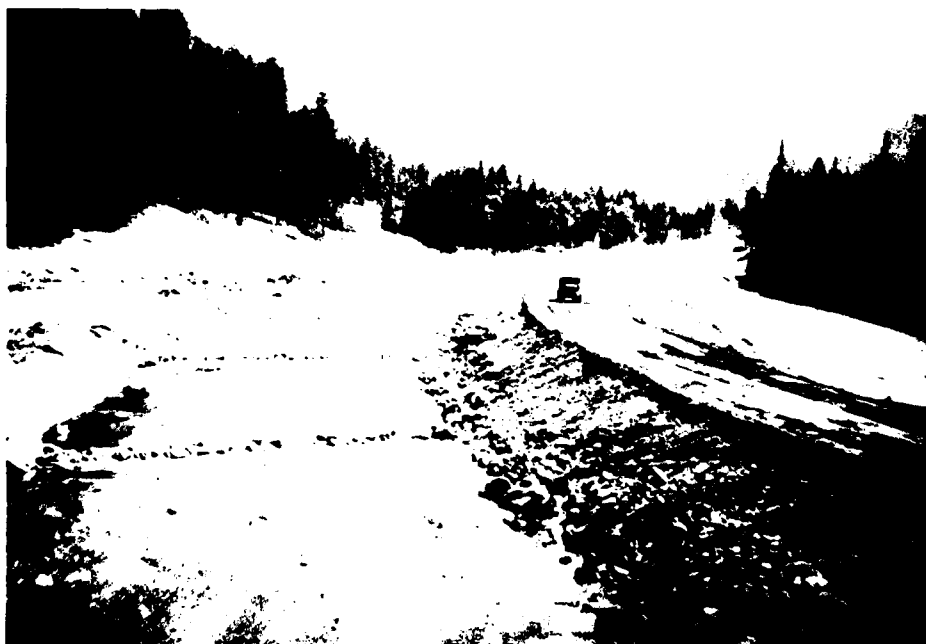
b. Completed channel change (1 Sep 67). Measured discharge when photograph was taken was 11 cfs. Note railroad bed under construction at right

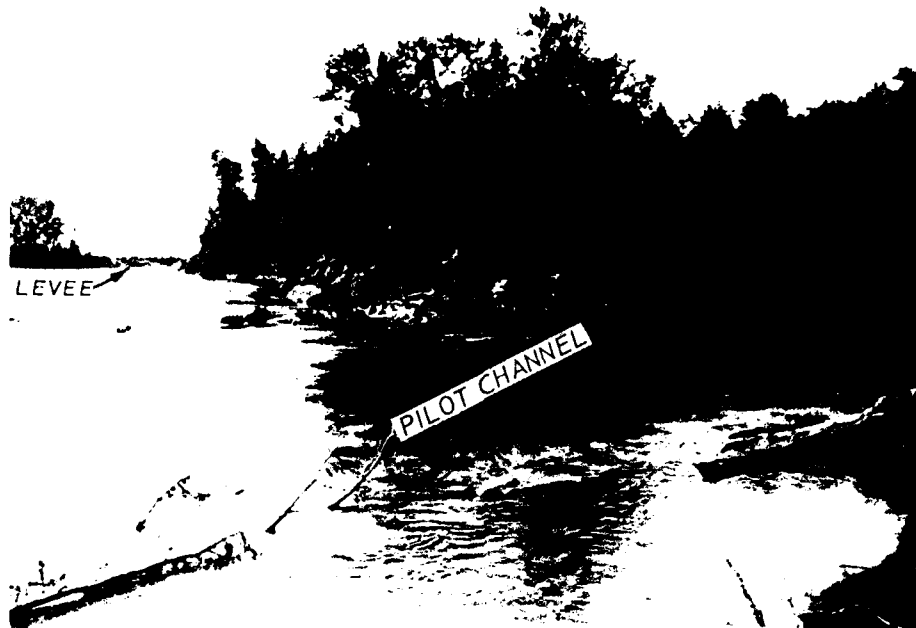
ITEM 39-4

Pilot Channel 1, White River, Levee Unit 8 at Edwardsport, Inc. The upstream end of the pilot channel is to the right; the natural streambed is to the left. Note the levee in the background and deposition in the natural channel. The estimated total discharge is approximately 5,600 cfs, with 95 percent flowing through the pilot channel (20 June 1978).  
View toward downstream direction

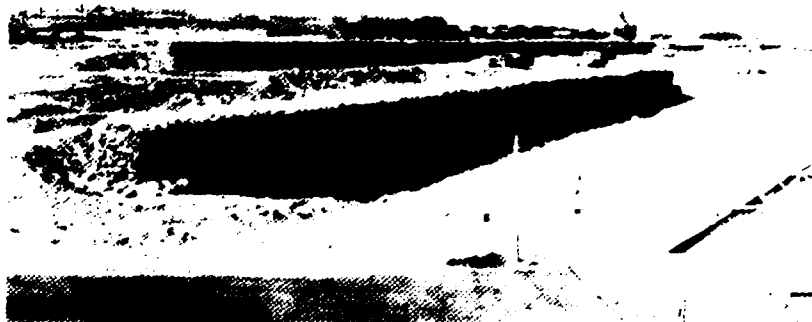
Photo 1 Mid-Floodway Gabion Barrier Looking Downstream  
from Garnet St. Bridge as Constructed

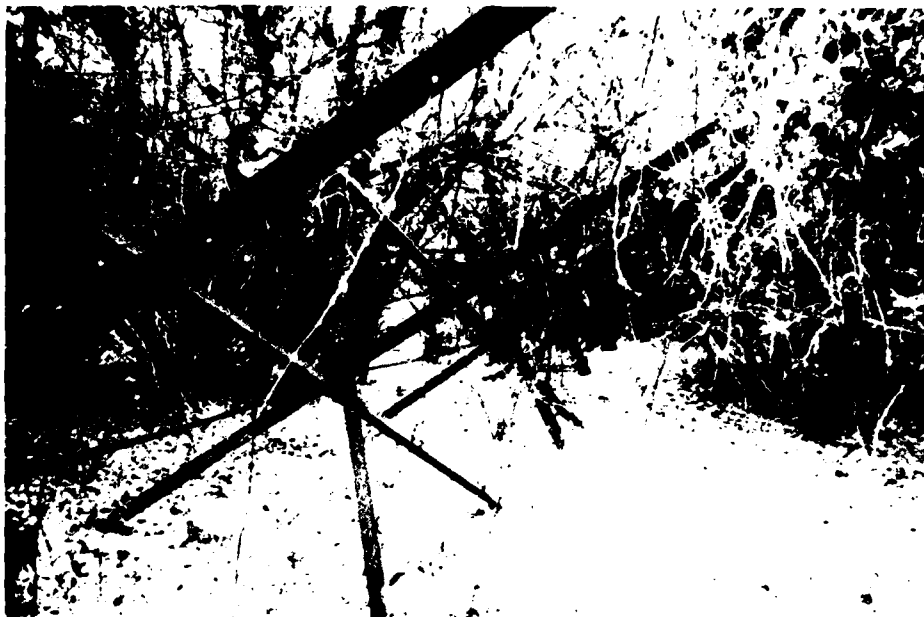
Dense vegetation growths have improved the stability  
of the bank

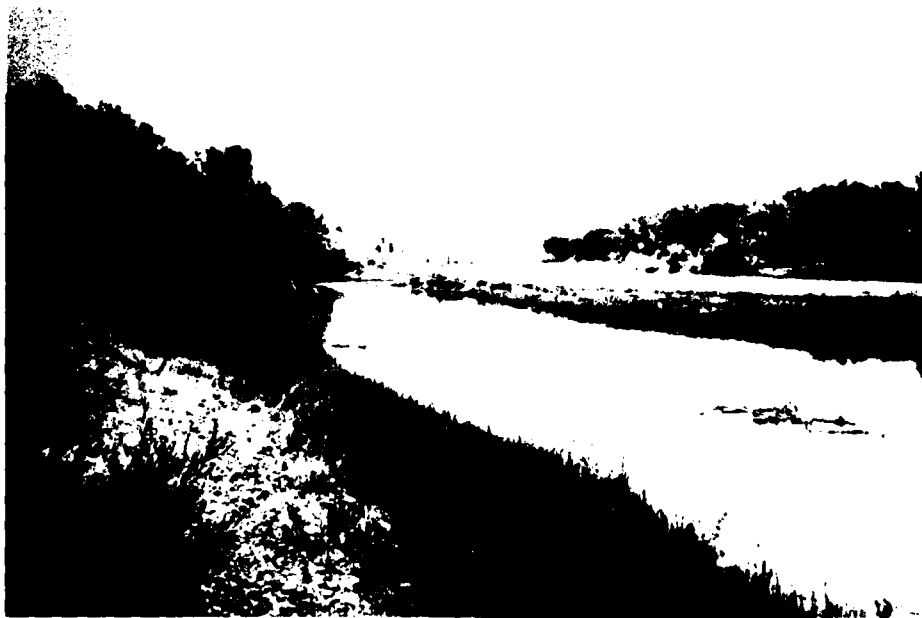
3. Six new jacks were required in 1969 as a repair measure. Beginning in 1972 a gravel bar began to build up in front of the project which has served to direct the flow away from the Kellner Jack Field (Item 46-5). The last inspection, conducted in November 1976, indicated that the project has been effective in preventing further bank erosion and has encouraged sediment deposition and general restoration of the eroded bank.

A gravel bar that began forming in 1972 has directed  
the streamflow away from the project

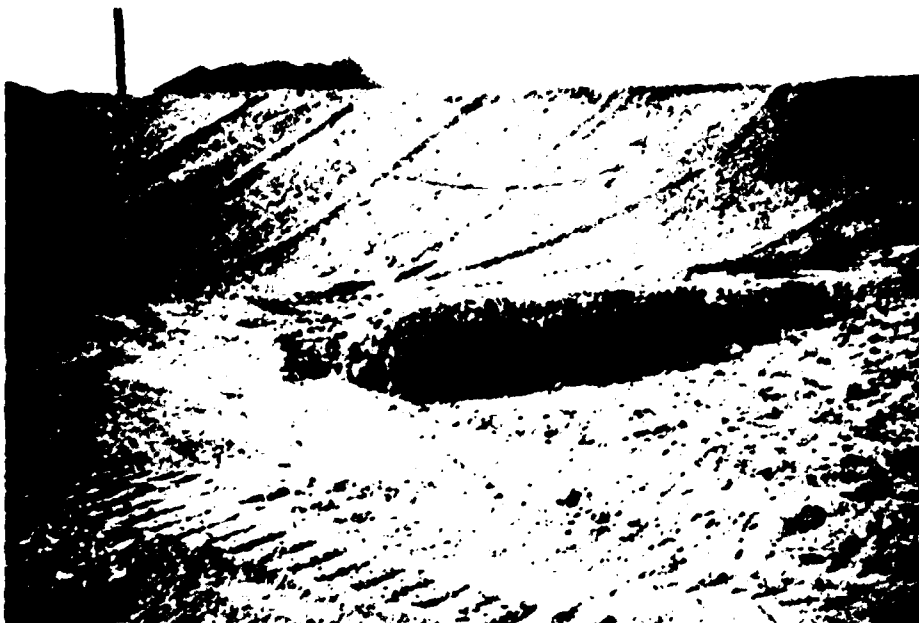
Gabion training dike placed by Vesper Materials Co.  
in December 1972

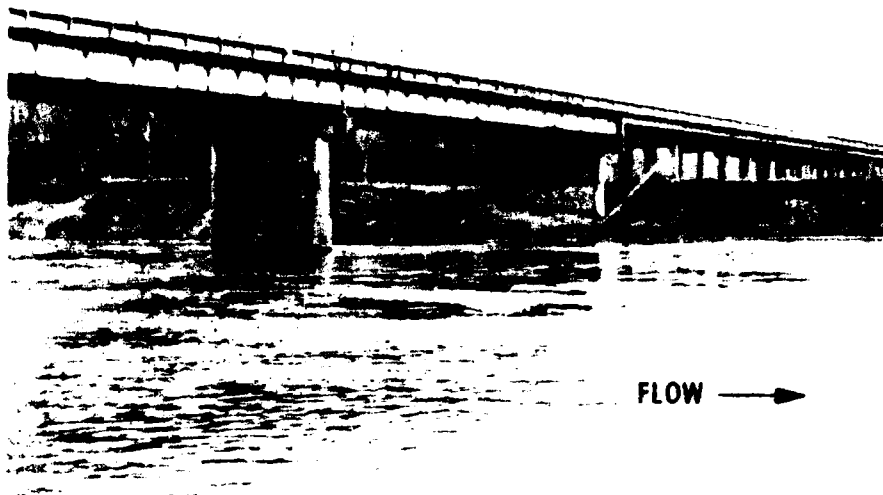
PHOTO 1: LOOKING EASTWARD AT LEFT DESCENDING  
BANK BEFORE CONSTRUCTION OF SECTION 14 PROJECT  
DATE: FEBRUARY 1978 BANK HEIGHT: 15 FEET

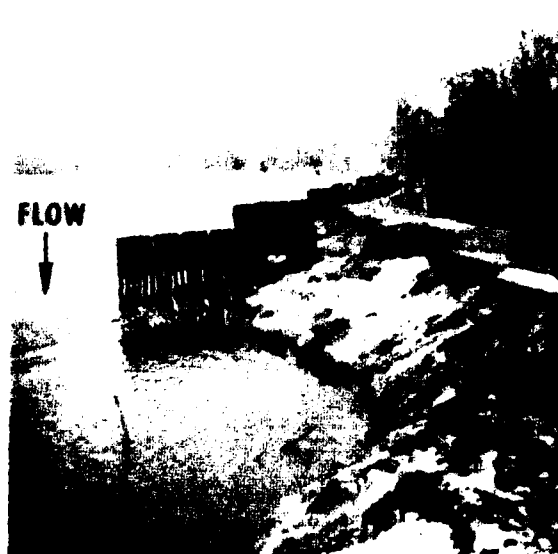
PHOTO 2: LOOKING UPSTREAM AT DIVERTERS  
DATE: MAY 1974 BANK HEIGHT: 20 FEET

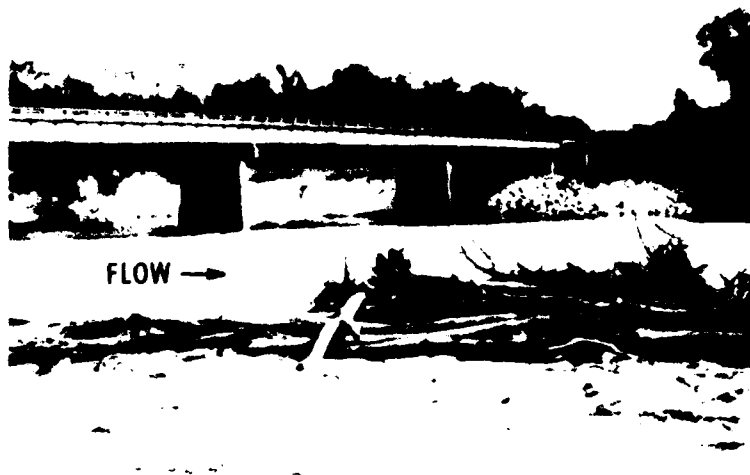
PHOTO 3: VIEW OF RIPRAP BANK PROTECTION 1.5 YEARS  
AFTER COMPLETION  
DATE: NOVEMBER 1979

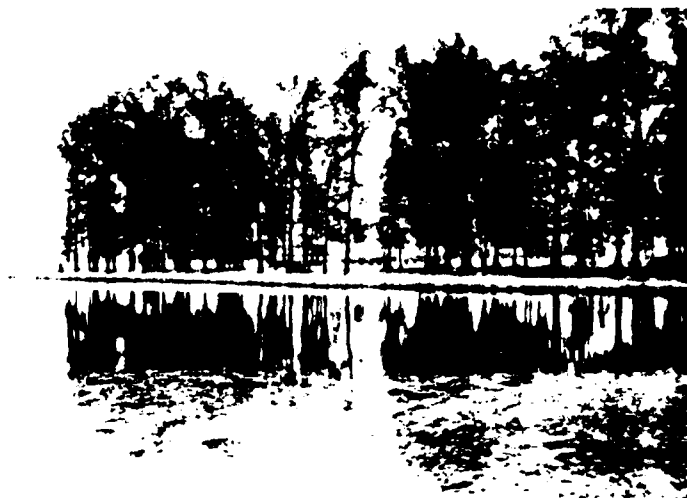
Typical timber sheet-pile walls eight years after construction

Recommendations Replace cap boards and fill scallops with stone.
