# Floating Breakwater Field Experience, West Coast

Eugene P. Richey

MISCELLANEOUS REPORT NO. 82-5

U.S. ARMY, CORPS OF ENGINEERS  
COASTAL ENGINEERING  
RESEARCH CENTER

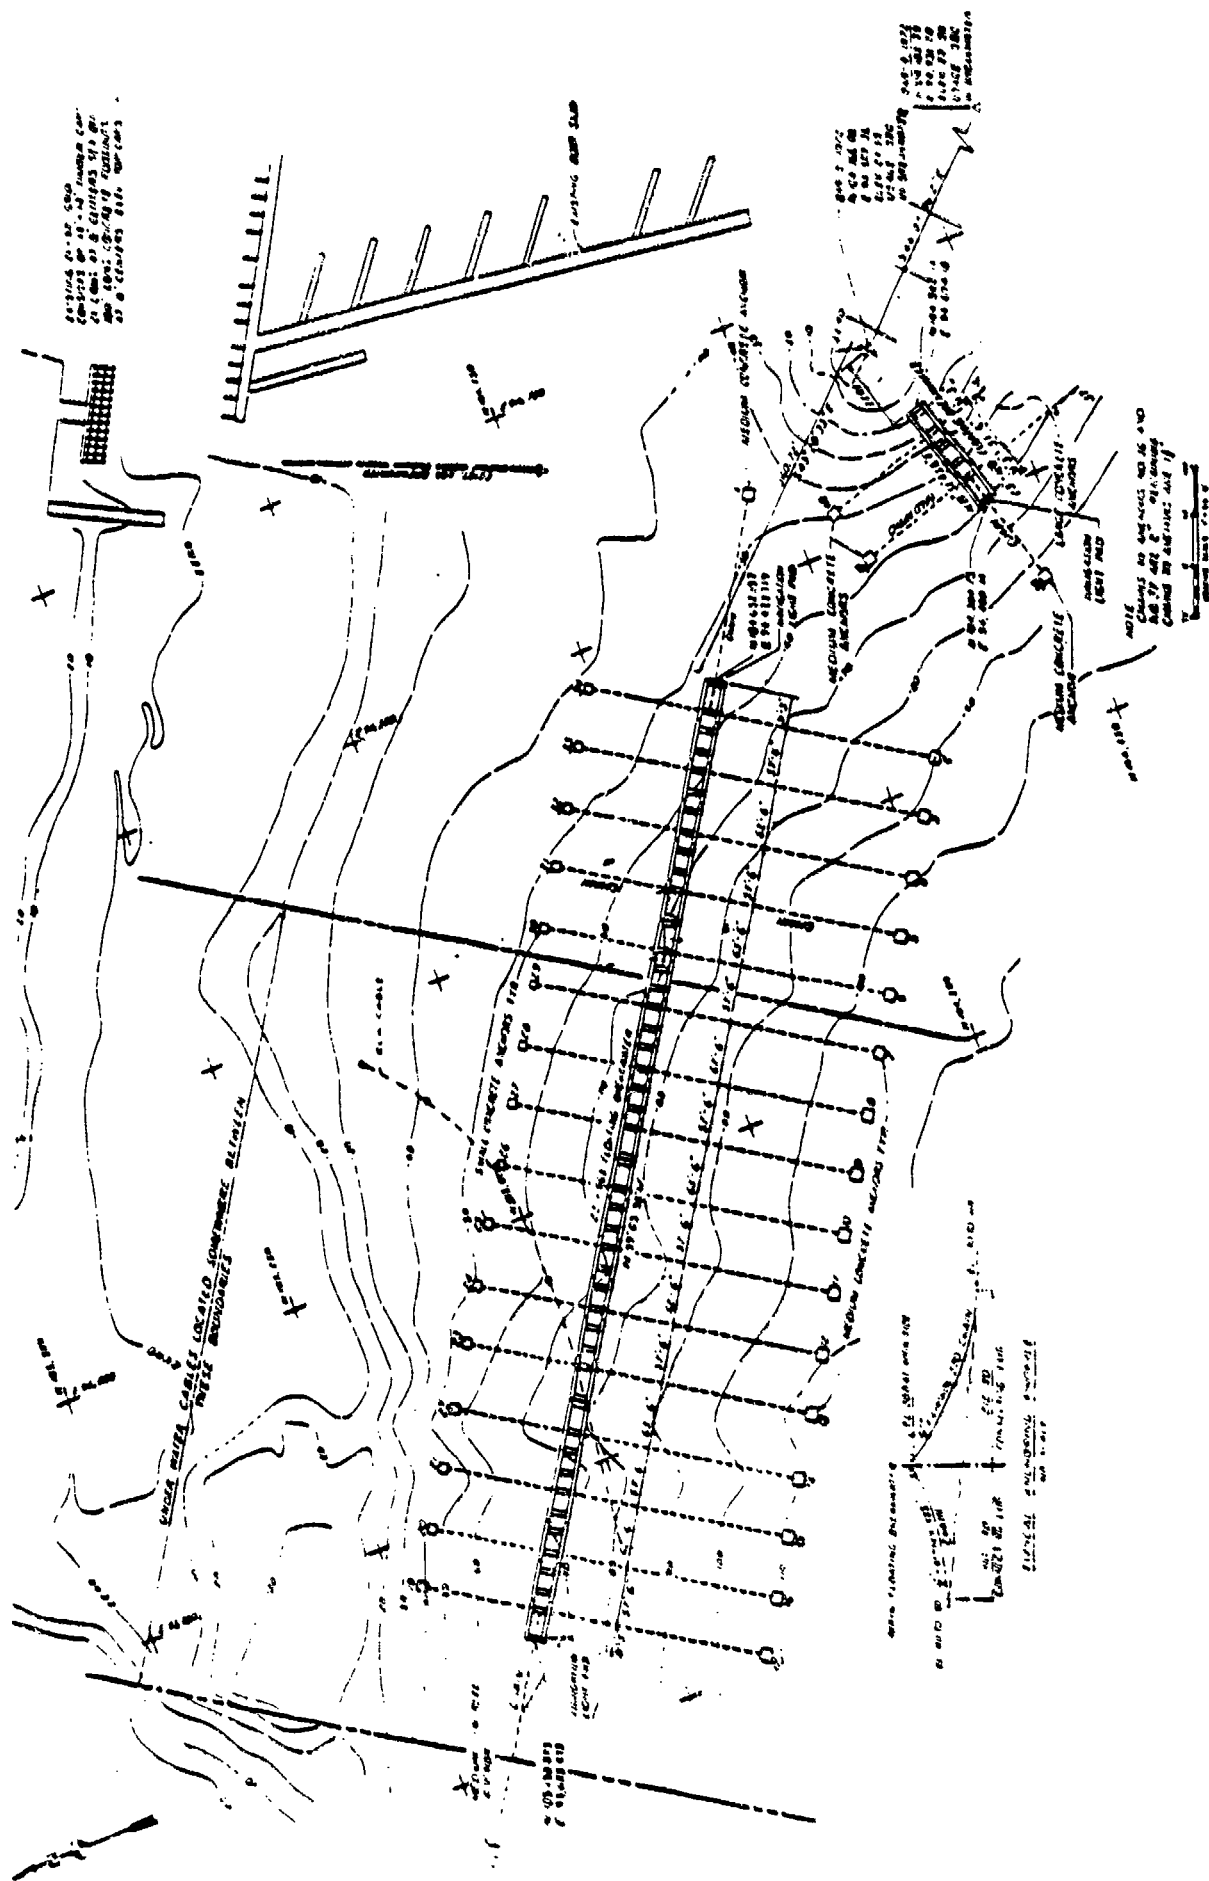
**Figure 4. Layout for Ketchikan floating breakwater.**

The major difficulty experienced was stringing, flushing, greasing, and sealing the posttension cables in the stress-strand ducts. Holes between adjacent modules rarely lined up. The general assembly technique was a difficult procedure to carry out in field conditions. Larger diameter, lower stressed galvanized rods would have been easier to use. The 1-inch cable with threaded studs used to join 240-foot sections was difficult to tighten, since the cable rotated as the nuts were turned. Towing of the 240-foot sections was very difficult except at a very low speed. A skiff was almost as effective as a tug. The accurate placement of the outer row of anchors on a stable site was difficult because of the anchor weights.

bottom slope and bottom conditions; 6- to 8-ton steel anchors would have been much better. Special receptacles for navigation lights should be designed into the breakwater units.

Use epoxy coatings over steel reinforcement to reduce corrosion. Provide positive locking devices at the ends of connecting cables. Obtain sufficient bottom data to allow workable anchorage designs. Some problems with anchor placement were experienced owing to a lack of good topography and knowledge of what materials the anchors would be set on. Consideration should be given to providing a method of regreasing tendons and cables. This design was made with the premise that vessels would not be allowed to tie up to the breakwater. The design must provide heavy wales and recessed bolts to allow for protection of the breakwater from vessels that tie up temporarily. Provide for connections on end units for possible future changes in configuration. These can be temporarily sealed with knockouts. Adequate lighting should be provided for foul weather visibility of the breakwater to supplement U.S. Coast Guard furnished lights. Radar visibility should also be provided. Better quality control should be achieved to eliminate careless slopping of grease on concrete surfaces adjacent to the prestressed cable anchors. Preparation of construction specifications should consider the requirement for a specific assembly method, such as on a sinkable barge, or in the water, or in a dredged area which can be flooded. Materials and procedures used should be compatible with the assembly method. Construction problems were experienced during the process of capping the prestress cable heads in the water. Further consideration might be given to a cofferdam design which would allow this to be accomplished in the dry. Consideration should be given to monitoring anchor chains to determine actual mooring forces to compare with design forces.

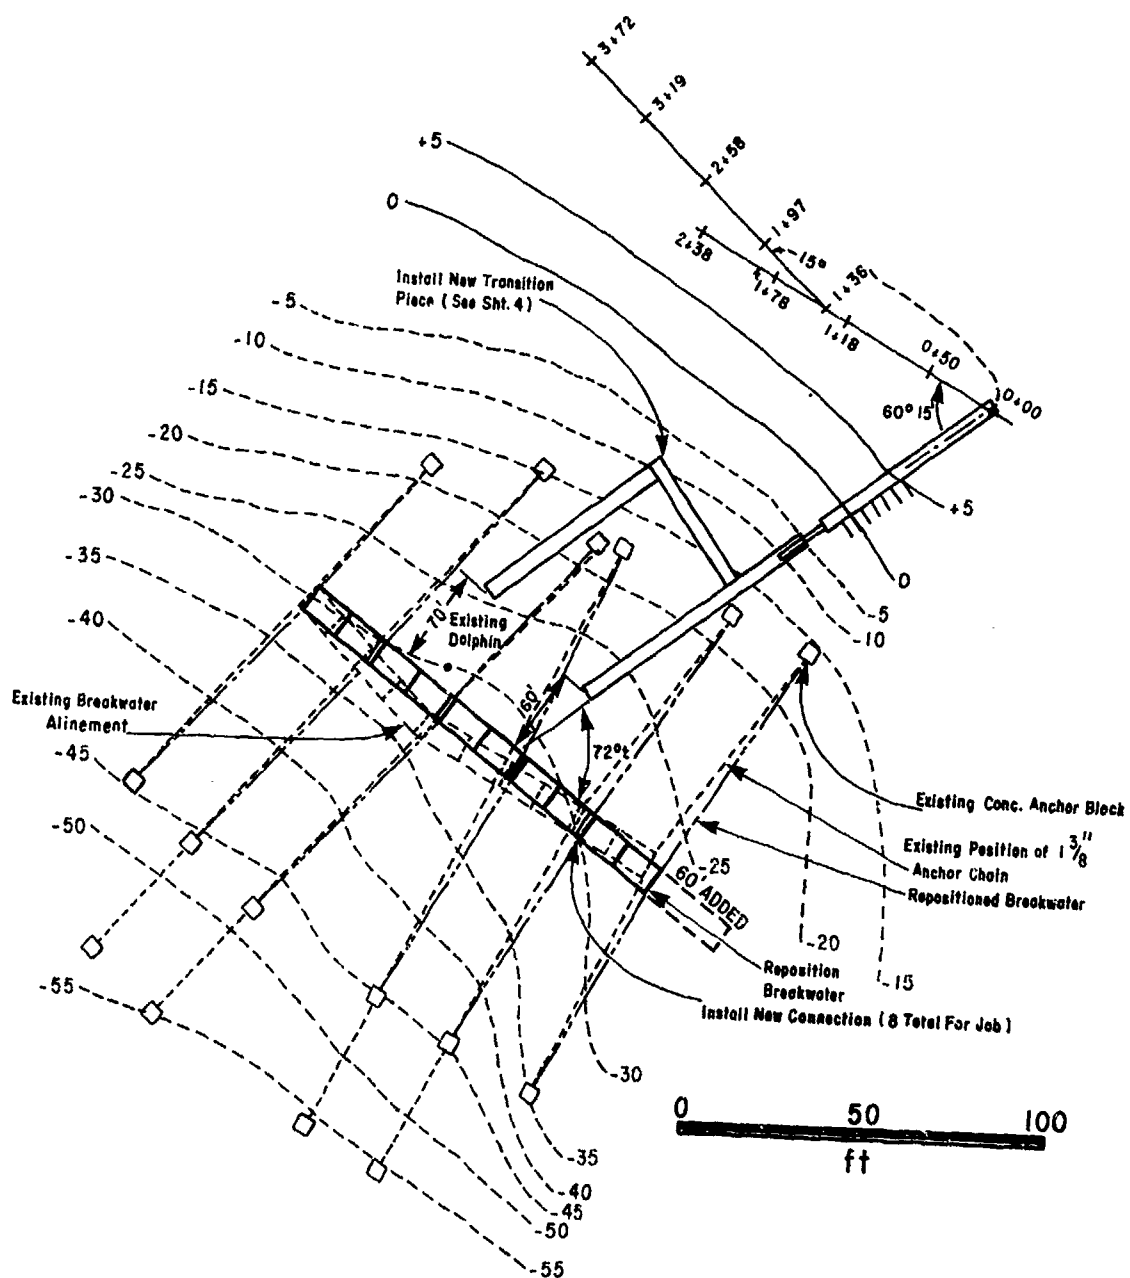
Figure 11. Floating breakwater layout, Tenakee Springs, Alaska.

(3) Performance. The users are satisfied with the protection afforded by the breakwater. Prior to its installation, winter moorage was risky and the boats often had to be moved to more sheltered waters during storms. The outer chain on the base of the V-section in the initial breakwater layout broke during a storm (D. Miller, personal communication). This connection has been eliminated by the new alinement and new connectors have been installed (see Fig. 12,b).

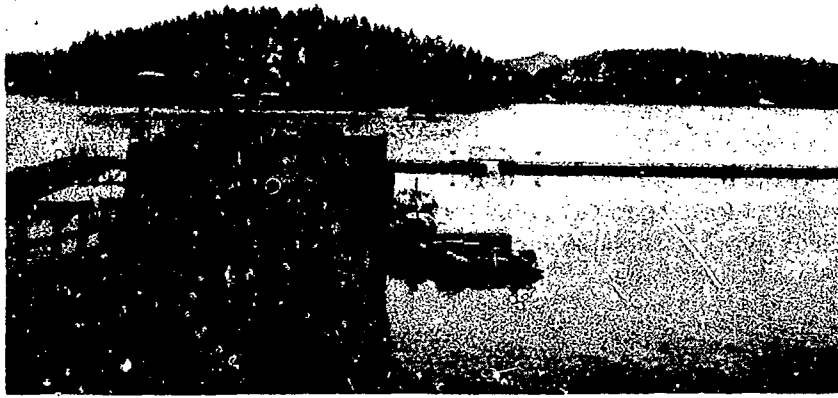
a. Access ramp to floating breakwater.

Some adjustments in the breakwater were necessary after installation. The gangways between the sections had to be redesigned to provide greater freedom of movement to avoid being overstressed. One of the sections did not

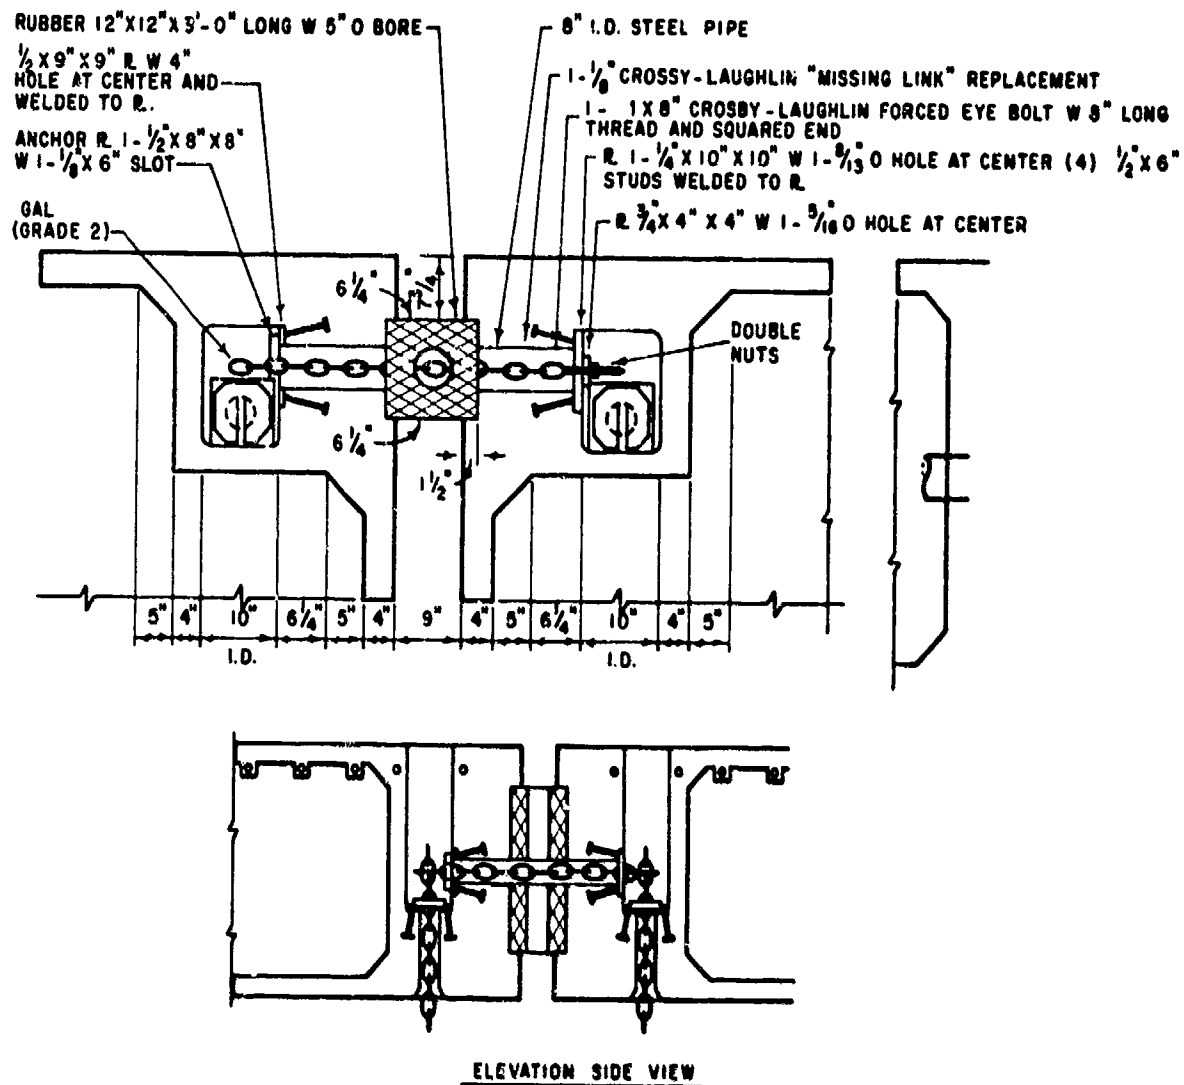
Figure 24. Module connection, Semiahmoo Spit floating breakwater.

The units are truck-hauled to the site where four of the units are post-tensioned together to form 60-foot modules, which are then coupled by a chain-rubber fender connector as illustrated in Figure 24.

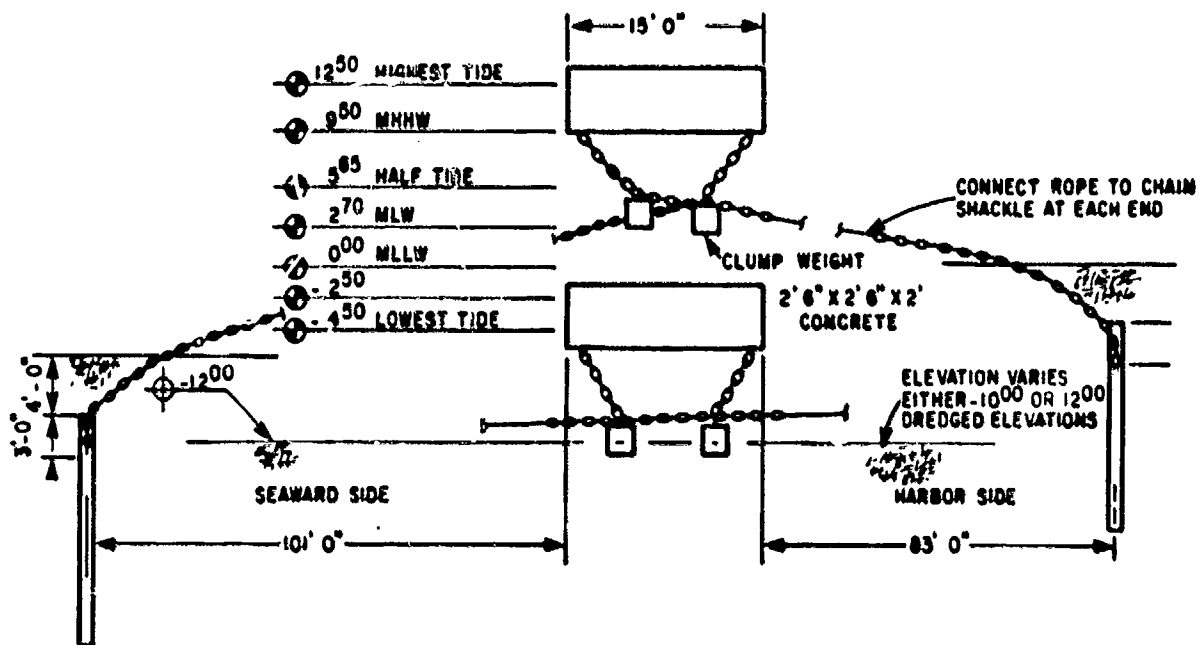
Figure 25. Semiahmoo Spit Marina anchor detail.

The anchor system makes use of clump weights on anchor lines consisting of successive length of nylon rope and chain to stake piles, as shown in Figure 25, with a set of lines at each module connection. Figure 26 illustrates the units and connections. Those responsible for the breakwater design, construction, and operation are as follows:
