MISCELLANEOUS PAPER GL-82-17

EVALUATION OF SOD SAVER BLOCKS AND M. C. GILL PANELS FOR TACTICAL BRIDGE ACCESS/EGRESS APPLICATIONS

Geotechnical Laboratory

October 1982

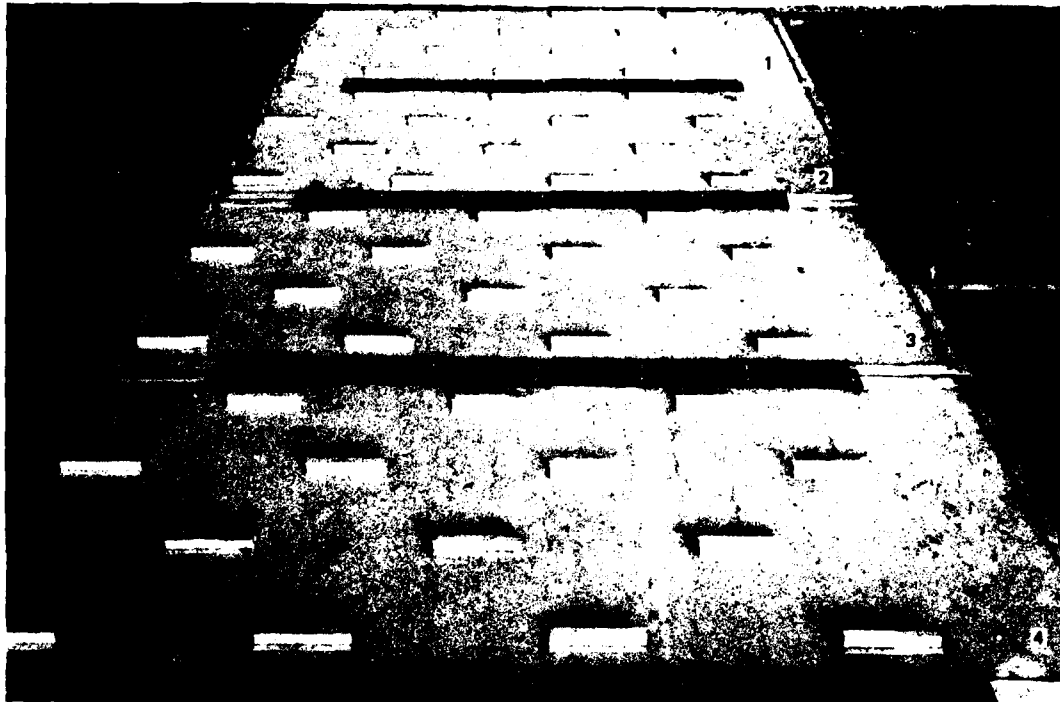
21. A general view of item 2 surfaced with M. C. Gill panels prior to traffic is shown in Photo 23. The average subgrade strength of the top 12 in. was the same as for item 1 (Table 1). The first 39 passes of traffic were common for item 1 and item 2. After two passes with an empty M54, 5-ton truck (20,000 lb) the panels were slightly embedded into the subgrade. The 5-ton truck loaded to 30,000 lb gross weight was used to apply the next eight passes. On the fifth pass (total count) of the 30,000-lb truck, one cleat on panel 4 was broken. After 10 passes were completed, the 5-ton truck was loaded to 40,000-lb gross weight, and traffic continued. After 30 passes of the 40,000-lb truck, the M. C. Gill panels showed no deficiencies except that a total of three cleats had become separated from the panels. After a total of 200 passes of truck traffic were completed, a total of six cleats were broken. All cleats were still in place on panels 1, 2, and 3. A general view of item 2 after 200 passes is shown in Photo 24. Traffic was continued with the 5-ton truck loaded with 40,000 lb until 1,200 passes were completed. A summary of panel failures between 200 and 1,200 passes is as follows:

Photo 23. Close-up of M. C. Gill panels on item 2 before traffic

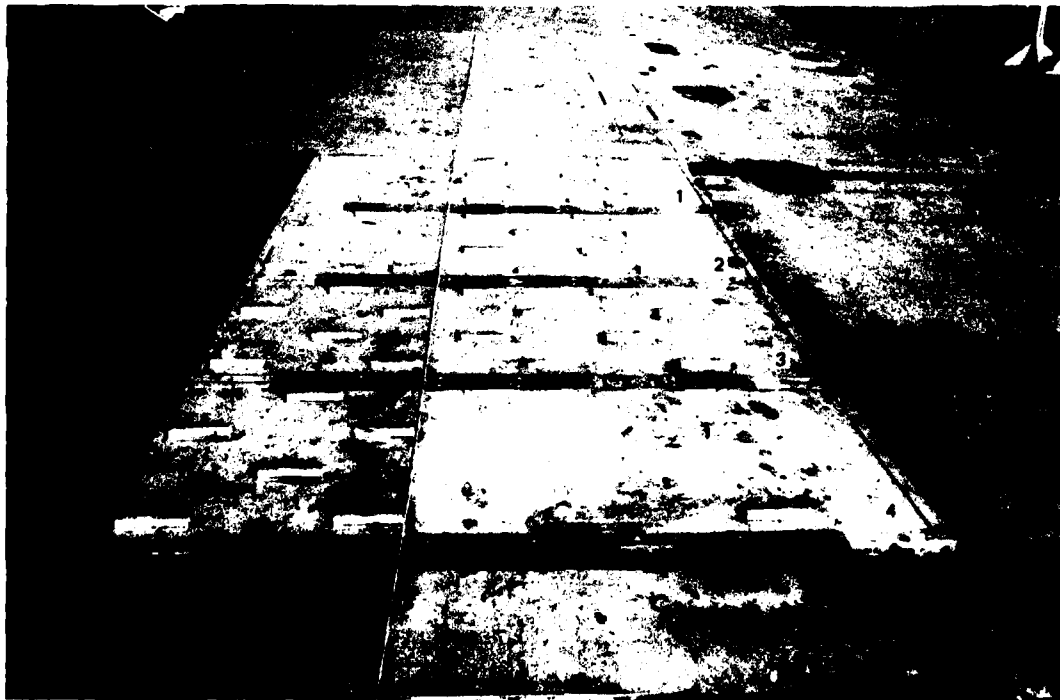
Photo 24. M. C. Gill panels in item 2 after 200 passes with the 5-ton truck

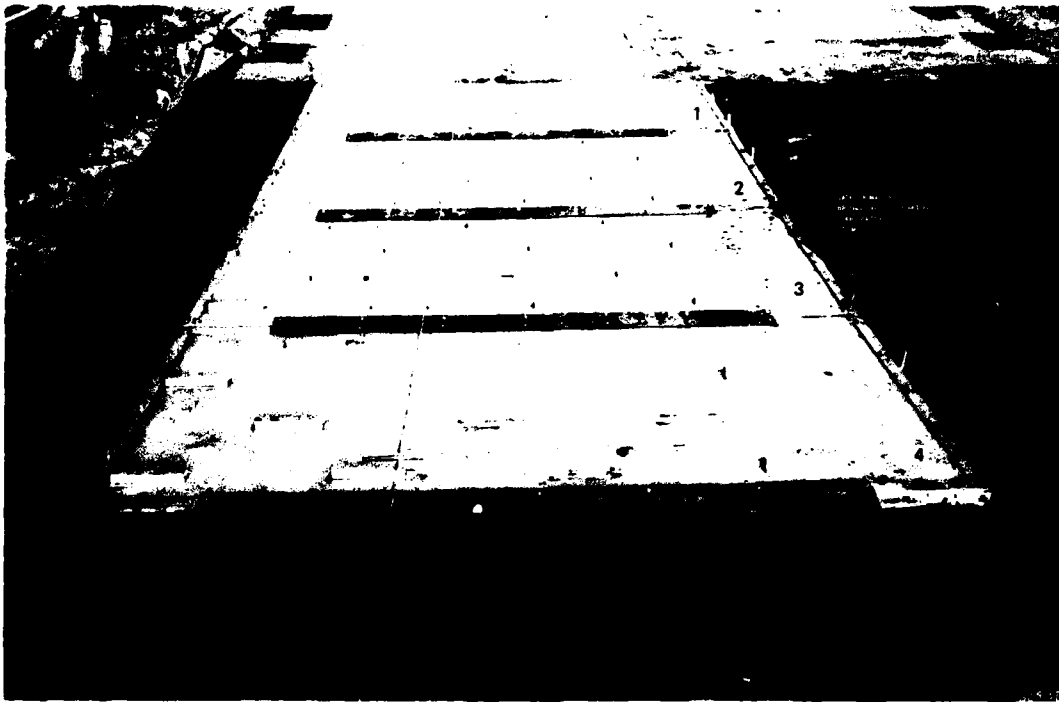
Photo 25. M. C. Gill panels in item 2 after 1148 passes with the 5-ton truck

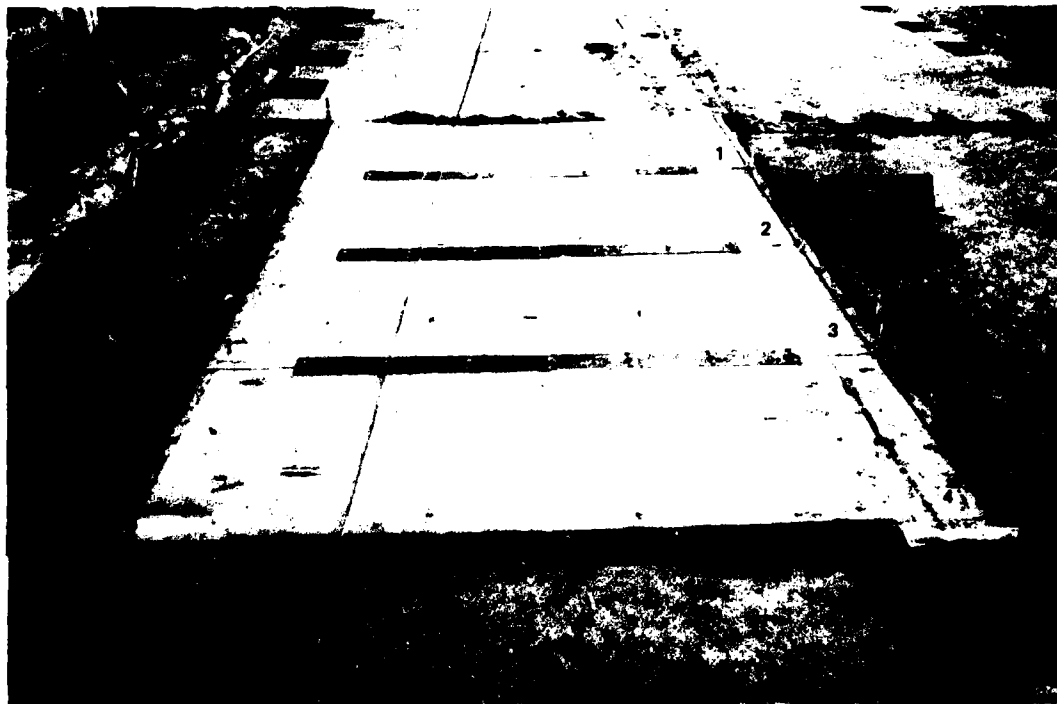
- g. 50 passes. Traffic was continued with the tank until 50 passes were completed with no additional breaks or failures noted. A general view of item 2 after 1200 passes of truck traffic and 50 passes of tank traffic is shown in Photo 29. A 40-in. surface break in panel 1 is shown in Photo 30. A close-up of failures in panel 3 (after 50 passes of tank traffic and 1200 passes of 5-ton truck traffic) is shown in Photo 31. Only one cleat remained in place (panel 3, Photo 31) in the wheel path and there were numerous breaks in this area of the panel as described earlier.

Photo 29. General view of item 2, showing M. C. Gill panel after 50 passes with the M48A1 tank, test 1

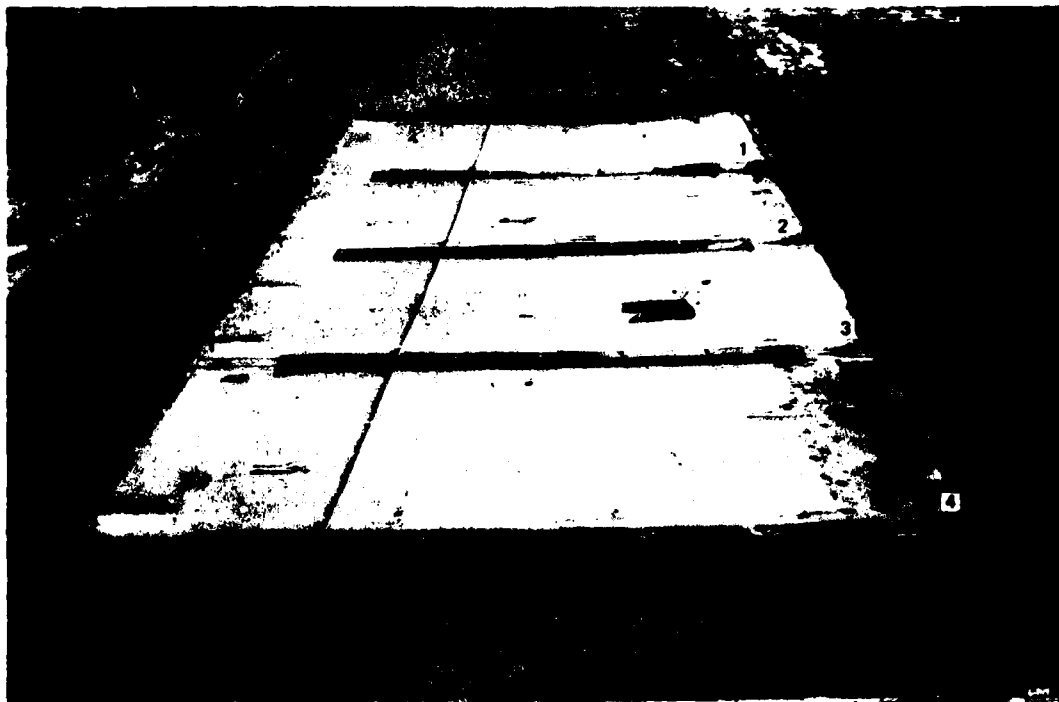
- k. 200 passes. The tank traffic was discontinued after 200 passes to allow more truck traffic to continue. Photos and cross-sectional and profile data were taken. A general view of test item 2 after 200 passes with the M48A1 tank and 1200 passes with the 5-ton truck is shown in Photo 34.

Photo 34. General view of item 2 after 200 passes with M48A1 tank and 1200 passes with the 5-ton truck, test I

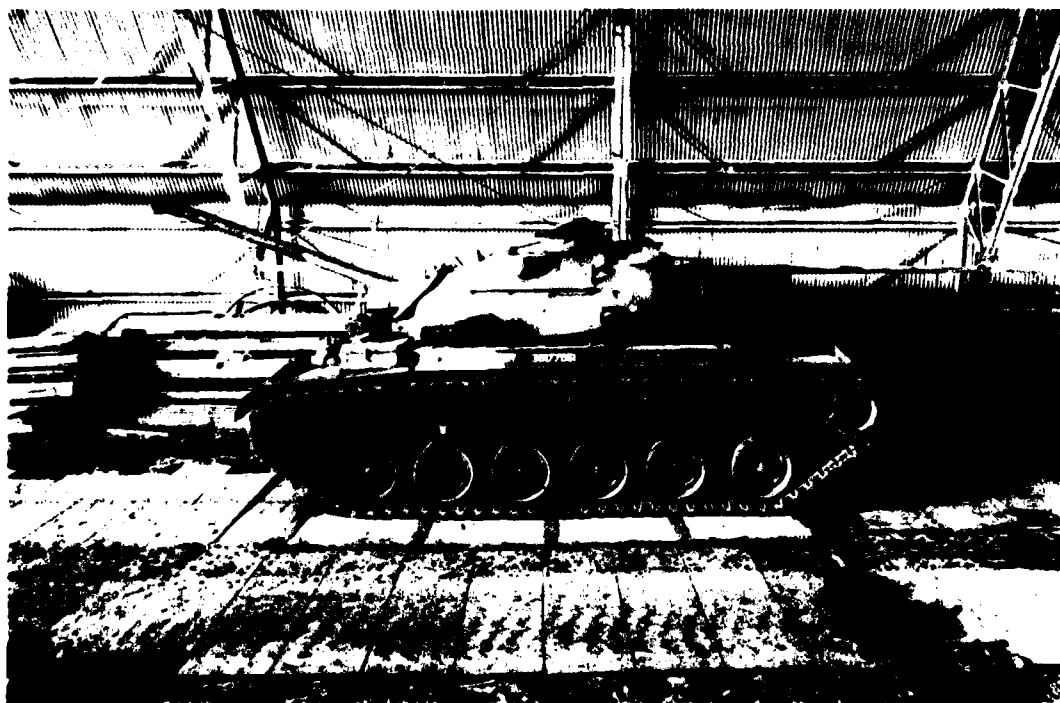
was due to failure of panel 3, which was completely crushed in the center area (Photo 35). The skins on panels 1 and 2 were disbonded, which caused permanent deformation in these panels. Photo 36 shows the M48A1 tank (106,000 lb) on the M. C. Gill panels at failure; failure here is considered only for truck traffic. Note how the tank bridges over the failed panel. Photo 37 shows a general view of the test item. Photo 38 shows a close-up of the rear wheel of the M54 truck on failed panel 3.

Photo 36. M8A1 tank (gross load, 106,000 lb) used
as test vehicle on M. C. Gill panels

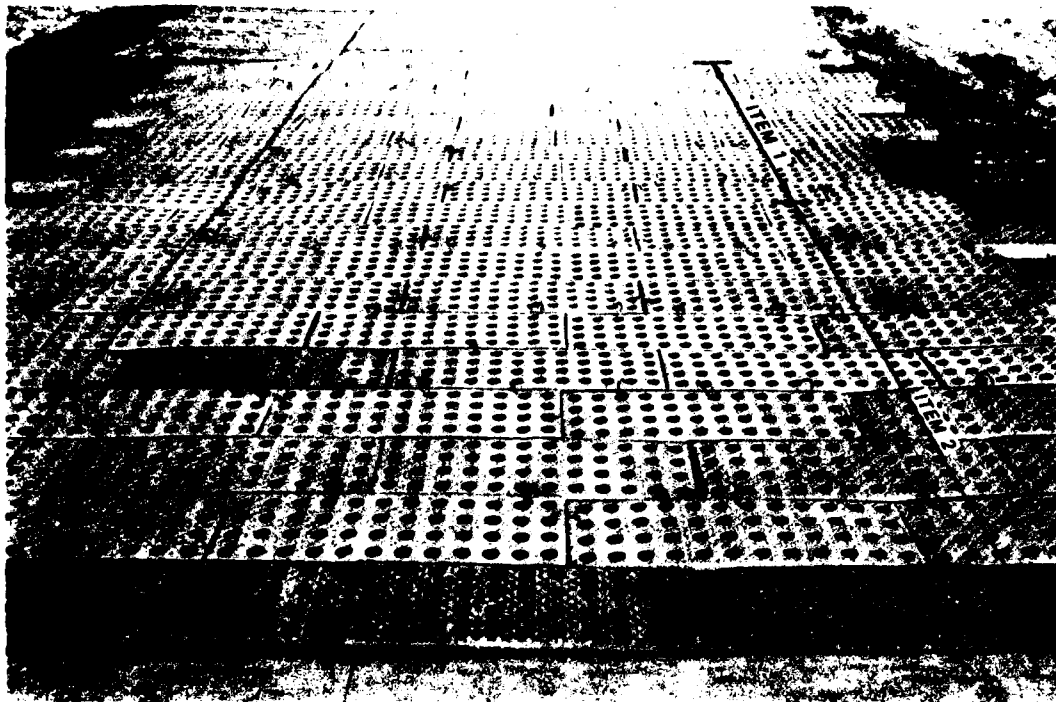
25. During July 1981, traffic tests were conducted on Sod Saver Blocks fastened together with rings fabricated from two different size steel rods (3/16-in. and 1/4-in. diam). Item 1 contained the Sod Saver Blocks fastened together with the 3/16-in.-diam rings and placed over Sod Saver runners (4 ft wide by 10-1/2 ft long) in the wheel paths. Item 2 contained a single layer of the blocks fastened together with 1/4-in.-diam rods. An overall view of the test section prior to traffic is shown in Photo 43.

Photo 43. General view of test section covered with Sod Saver Blocks before traffic, test II
