## STRUCTURAL EVALUATION OF AN ADVANCED COMPOSITE HYDROFOIL FOIL COMPONENT

TEST AND EVALUATION REPORT

DTNDRDC-82/082

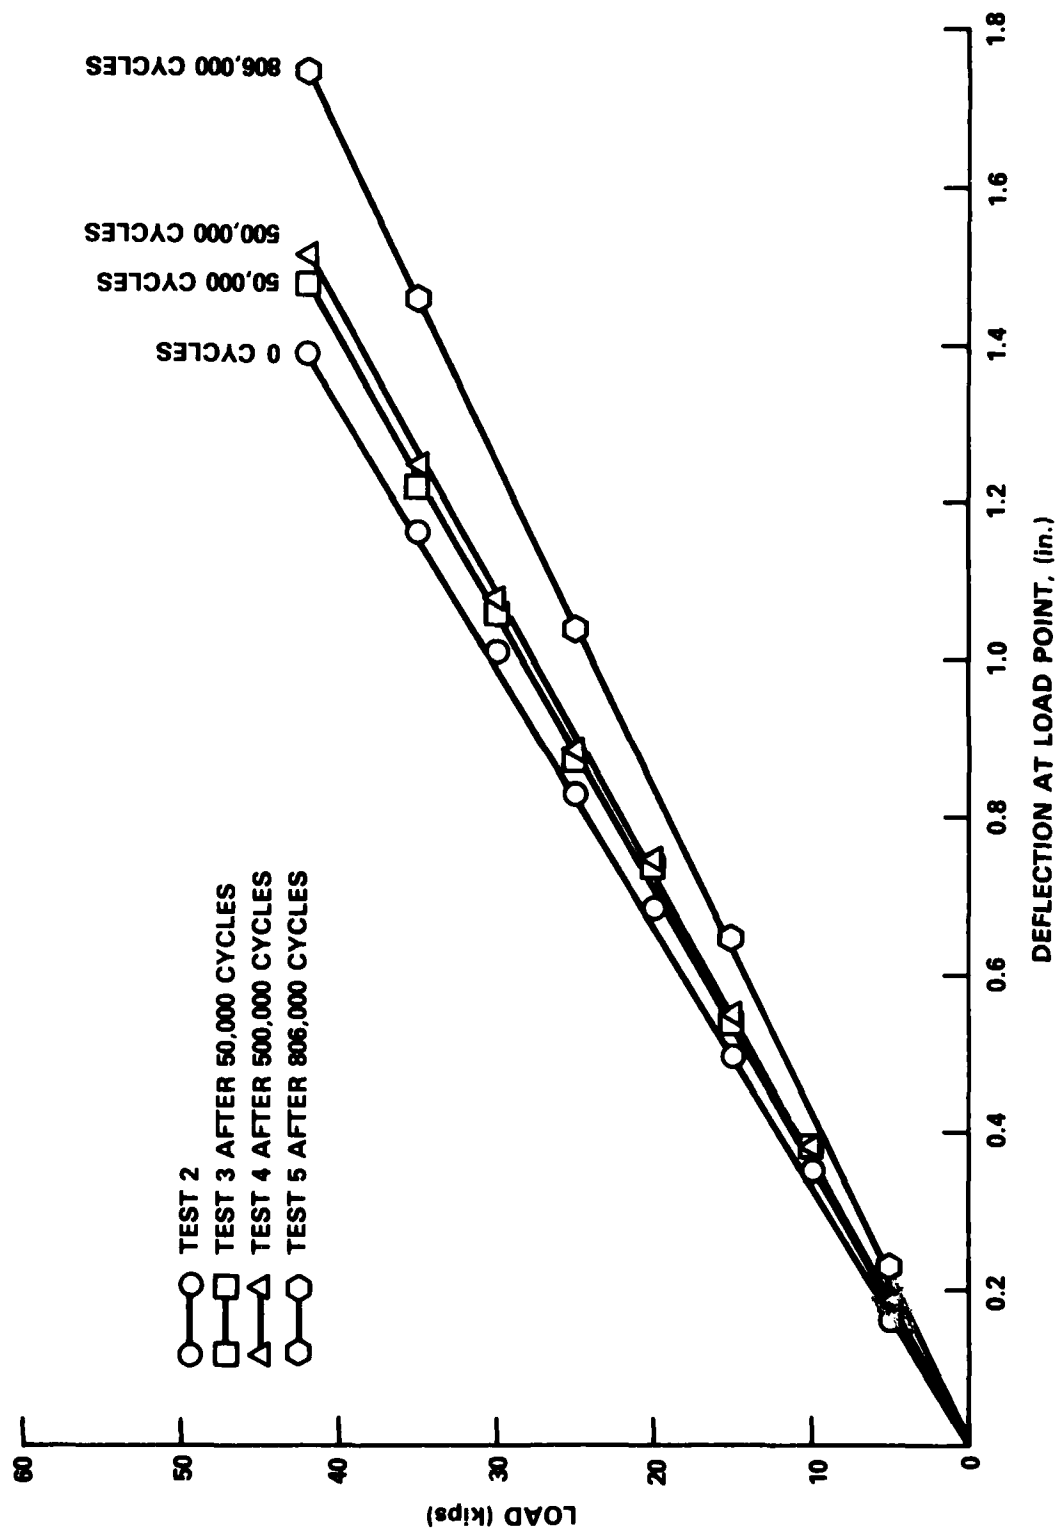
Figure 23 - Changes in Box Beam 2 Deflection Behavior During Cyclic Tests

The cyclic test was halted after 50,000 and 500,000 cycles for visual inspection and for static tests to measure deflection and strains; see Tables 7 and 8 for results. Also see Figure 23 for plots of deflection versus load. Since there was no gross indication of damage, it was decided to hold the first ultrasonic inspection at 1,000,000. However, after 806,000 cycles, delaminations similar to the initial delamination of Box Beam 1 were discovered during a routine visual inspection. Although the exact time of failure is not positively known, there is good reason to suspect that it occurred after 712,000 cycles. An electrical storm caused a power loss; at which point the test mechanic heard a loud noise which "sounded just like the noise heard when Box Beam 1 failed." He made a quick visual inspection for apparent damage; and since he did not see anything, he did not report it. A manual UT inspection after 806,000 cycles revealed a damage pattern similar to that of Box Beam 1 following its initial failure; however, an inspection of very small flaws found during the original inspection indicated no growth. This factor is another indication that the failure may have been caused by a single overload when the power

shut down. A static test in which deflections were measured was conducted; the results are given in Table 7. The cyclic test was resumed, and the box beam failed catastrophically after 920,000 cycles. Figure 24 shows the failed box beam.

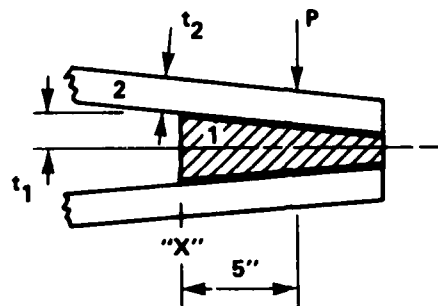
# PREDICTED LOAD TO CAUSE DELAMINATION IN BOX BEAM

McDonnell Douglas Astronautics Corporation prepared the following calculations for predicting the load required to delaminate the box beam skins. This analysis gives one possible explanation for the observed delaminations.

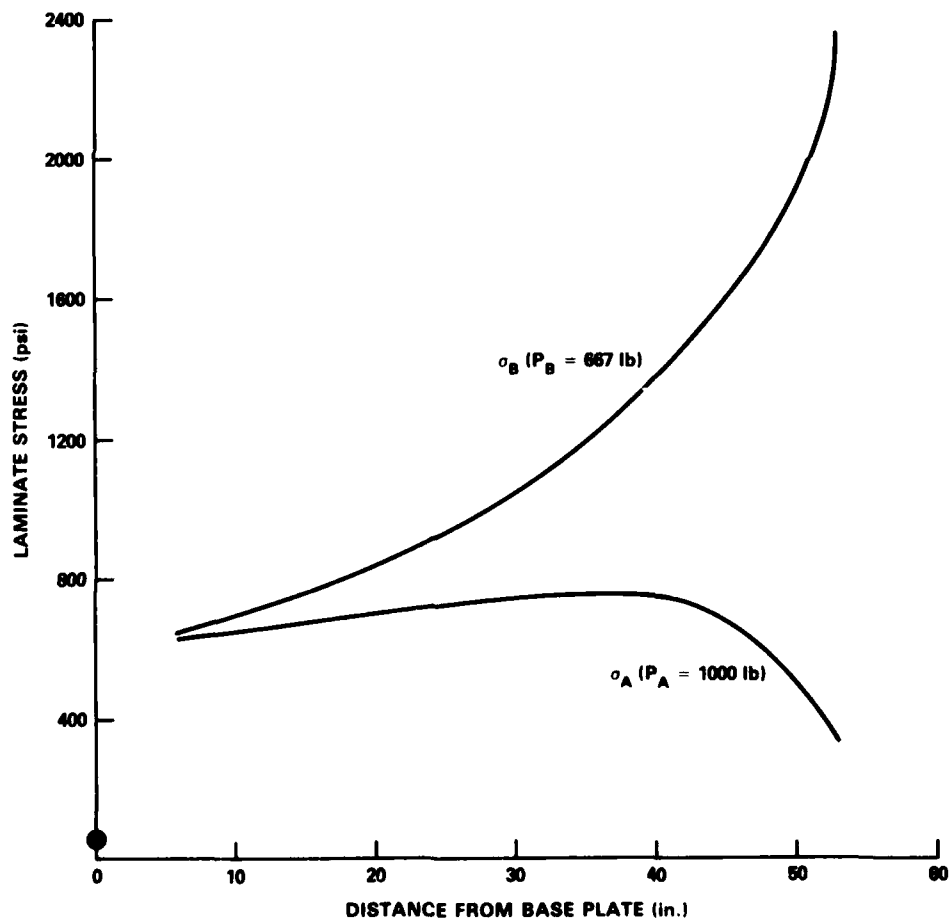
Figure C.1 - Comparison of Box Beam Stresses for Change in Load Application

Using basic beam bending equations and cross-sectional properties, an attempt was made to calculate the effect of modifying the load application (load and location). It was thought to be possible to obtain less shear stress in the load region while maintaining the same bending stress by extending the point of load application and varying the load. Table C.1 and Figure C.1 demonstrate the current situation (A) and the proposed one (B). It is seen that varying the load application causes an undesirable disturbance in the bending stress and, therefore, was discarded.
