DESIGN, FABRICATION, AND STRUCTURAL EVALUATION OF AN ADVANCED COMPOSITE HYDROFOIL CONTROL FLAP

by
William P. Couch

STRUCTURES DEPARTMENT
TEST AND EVALUATION REPORT

November 1982

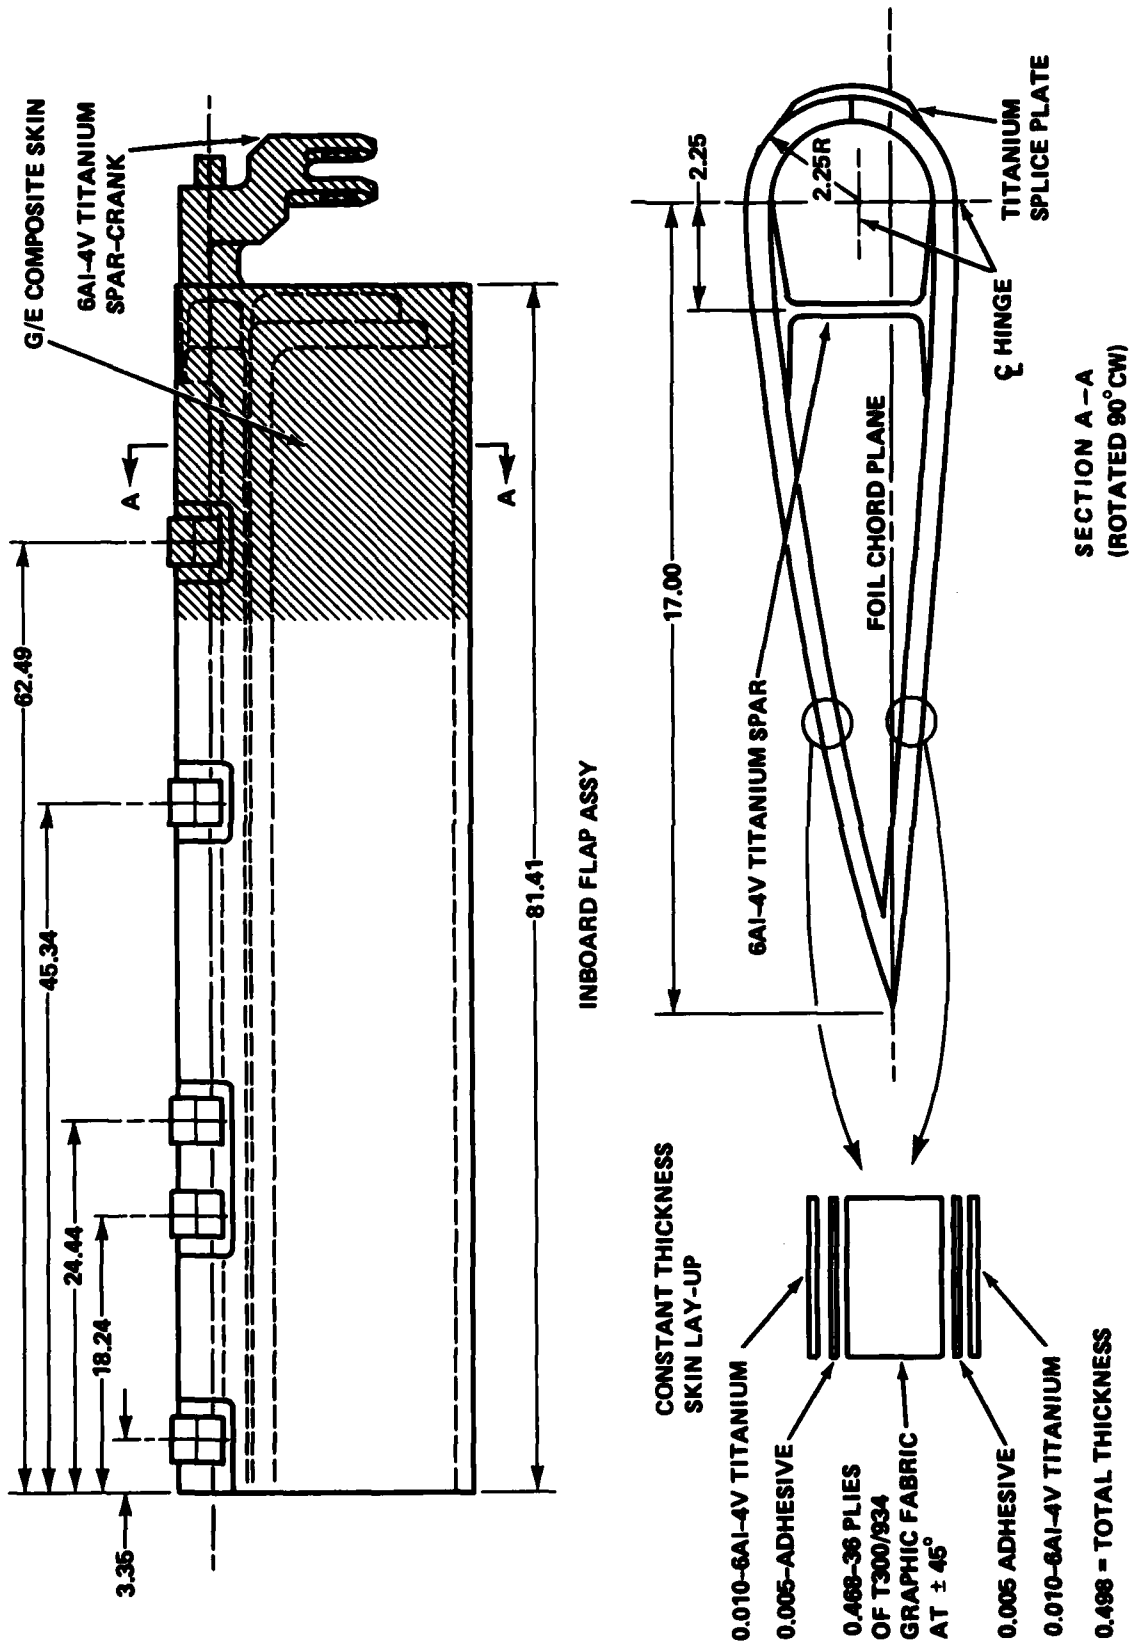
Figure 3 - Details of Preliminary Design

In order to verify the design and fabrication processes and to evaluate joints, a full-scale portion of the flap was built and tested. This feasibility component incorporates the first 20 inches of the flap, end joint, and crank fitting; see the shaded area in Figure 3. The feasibility component sustained a static proof test to the maximum operating load, or 40 percent of design ultimate. The component failed after approximately 12,000 cycles (safe life = 16×10^6 cycles) due to a debond along the leading edge, which changed the load path and resulted in a catastrophic failure of the titanium end fitting. In order to simulate actual service experience in the

planned laboratory test, operational data taken from the existing PCH-1 flap system have been examined and a fatigue load spectrum developed*, see Table 3. The loading spectrum was derived from a projected typical 15-year lifetime for the craft which was normalized for all ship headings in various sea states and maneuvers. A more detailed NASTRAN analysis was performed, and the component was repaired and strengthened in the leading edge joint and end fitting areas. A second fatigue test resulted in catastrophic failure of the titanium end fitting after 145,000 cycles.

The results of the component test and fastener evaluation led to a redesign of the crank-spar assembly and removal of all blind fasteners for the final design; see Figure 4 for details of the final design. The composite covers remained the same as shown in Figure 3. The spar was changed from an I-beam to a flat bar, and threaded inserts were incorporated in the lower cover to accommodate the use of torqued through-bolts. Special machined nut plates were installed in place of the blind fasteners. All welds except the primary electron beam welds were removed from the crank-spar assembly. The diameter of the crank stub shaft was increased, as well as the radius at its base. Also, all surfaces of the crank-spar assembly were shot peened prior to final flap assembly.

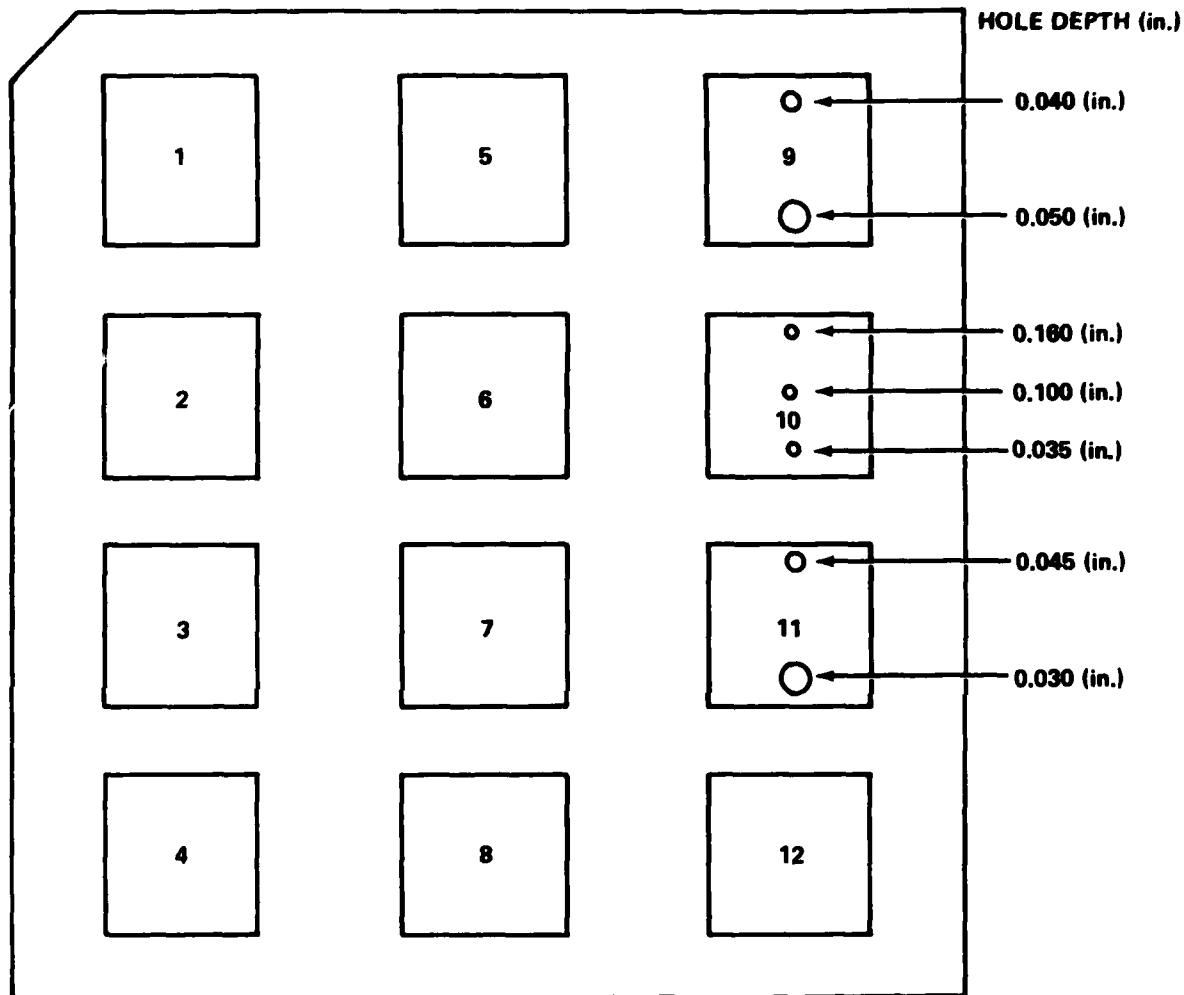
A test panel, containing twelve areas in which artificial flaws were induced, was fabricated to determine the capability of existing NDE methods to find and characterize defects that are typical to composite structures. The test panel was prepared by autoclaving 36 plies of Thornel - 300 graphite fiber fabric preimpregnated with Fiberite 934 epoxy resin. Titanium cover sheets (cladding) 0.010-in. thick were postbonded on each side with EA9628 adhesive which was cured for 90 min at 50 psi. The defects were induced in the bondline between one of the titanium sheets and the graphite epoxy laminate, and in some cases, by drilling holes in the graphite laminate. The location and description of these planned flaws are shown in Figure A.1. Although care was taken to be sure the identification of the flaws was correct, the radiographic analysis with an image enhancement system indicated that at least one of the flaws was different than planned. In order to confirm this discrepancy, the titanium cover sheet was chemically removed and the actual flaws were noted. A photograph of the actual flaws is shown in Figure A.2.

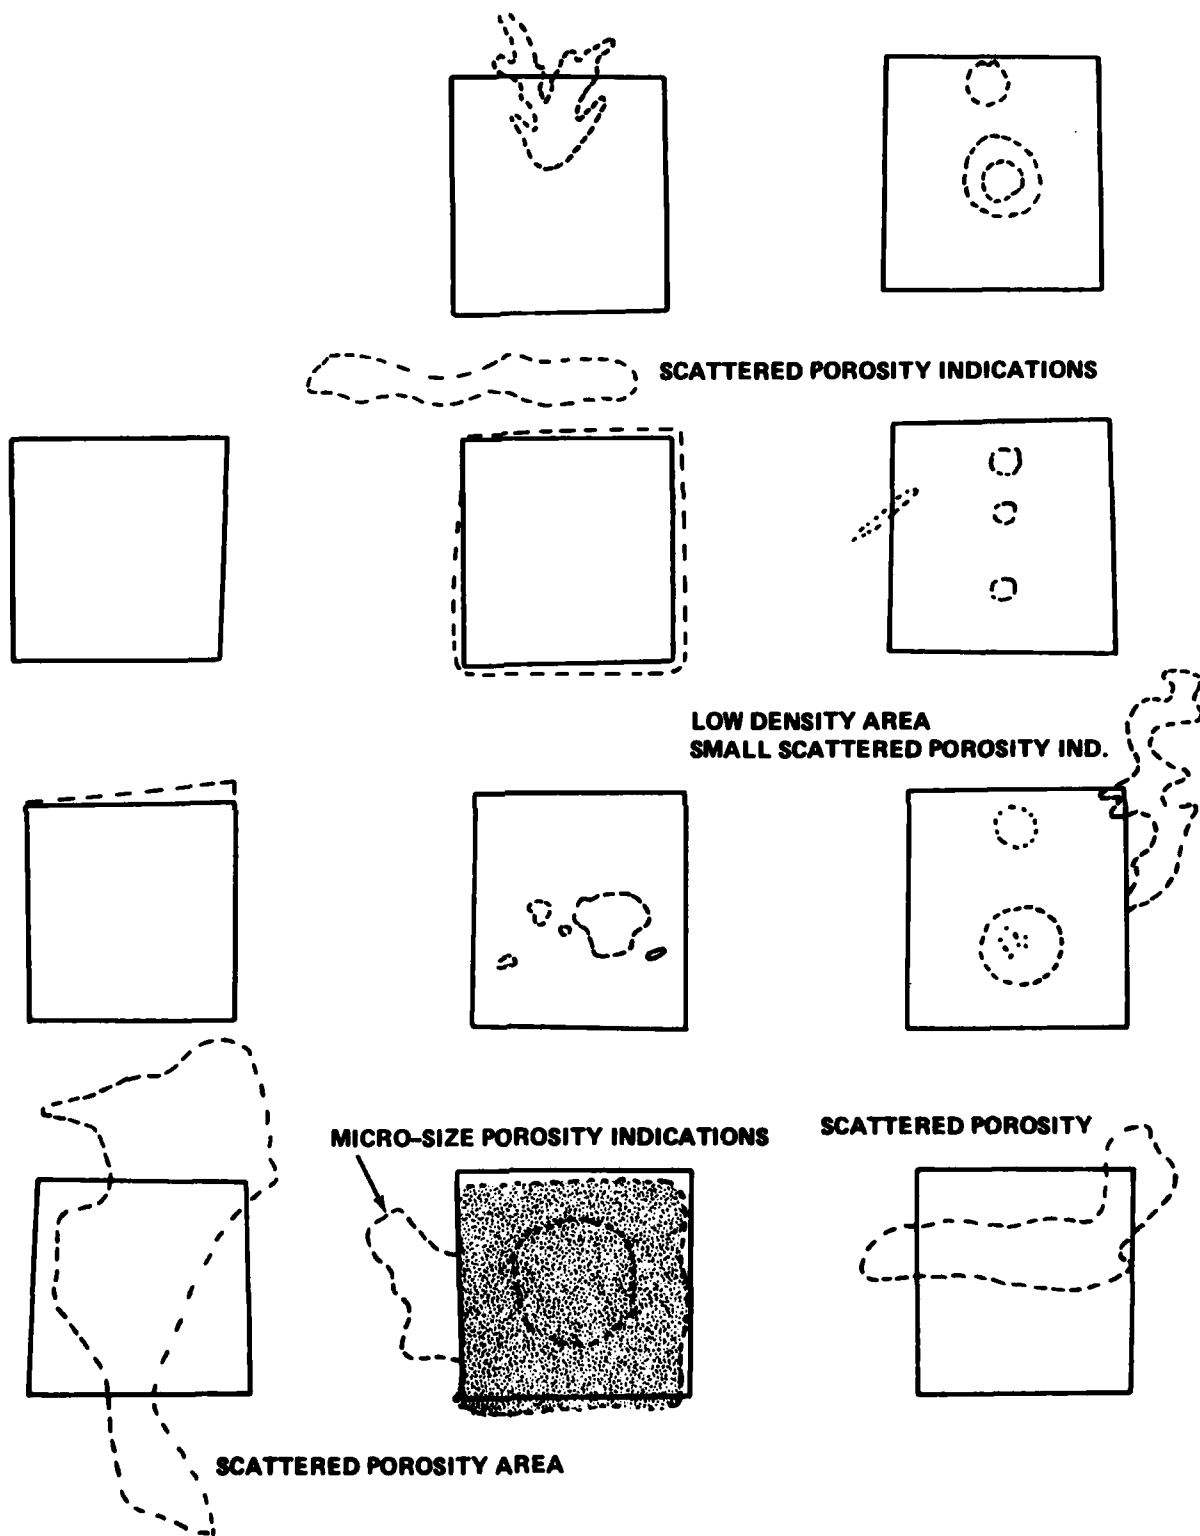
Figure A.4 - Results of X-Ray with Image Enhancement Analysis

the laminate (water tank or water jet) and because the small transducer required to concentrate the ultrasonic energy leads to a large amount of time for inspection (unless multiple transducers are used). If flaws in the post cured laminate are detected with this method, the radiographic analysis with an image enhancement system and a calibrated density profiler can be used to give an accurate three-dimensional characterization of the flaws. The pulse-echo ultrasonics should be used when both sides of the laminate can be inspected and when the more sophisticated through-transmission ultrasonics is not available, or when the component is too large to make through-transmission feasible.
