STRUCTURES REPORT 389

BRITTLE FRACTURE OF CRASH HELMETS

S. R. SARRAILHE AND G. PAUL

FEBRUARY, 1982

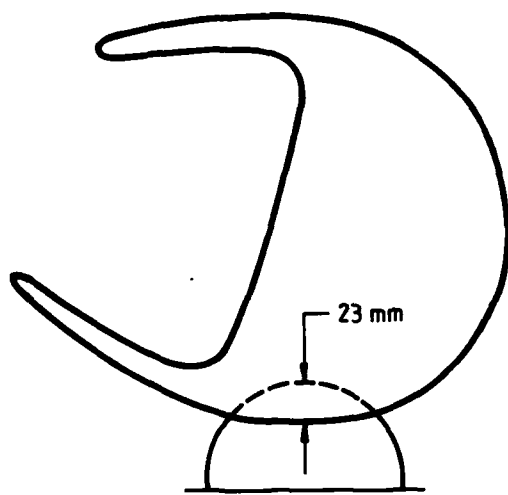
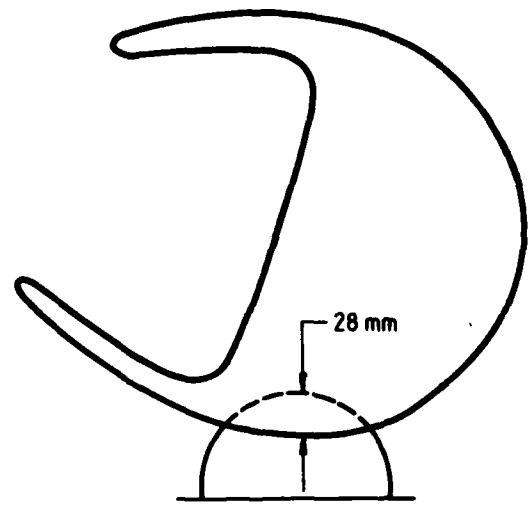
All the helmets withstood the conventional tests (i.e. AS1698 and Snell 1975 spherical anvil impacts) without failure. The surfaces of the fibreglass shells were cracked at the impact site but the polycarbonate shells did not show any damage. The deceleration of the head form was measured in some tests and was about 130 g in all of these. High speed films of selected impacts showed that the polycarbonate and fibreglass shells deflected by about the same amount as shown in Figure 3.

Polycarbonate helmet

Fibreglass helmet

FIG. 3 PROFILE OF HELMET AT LOWEST POSITION DURING IMPACT ONTO
HEMISPHERICAL ANVIL (from high speed film)

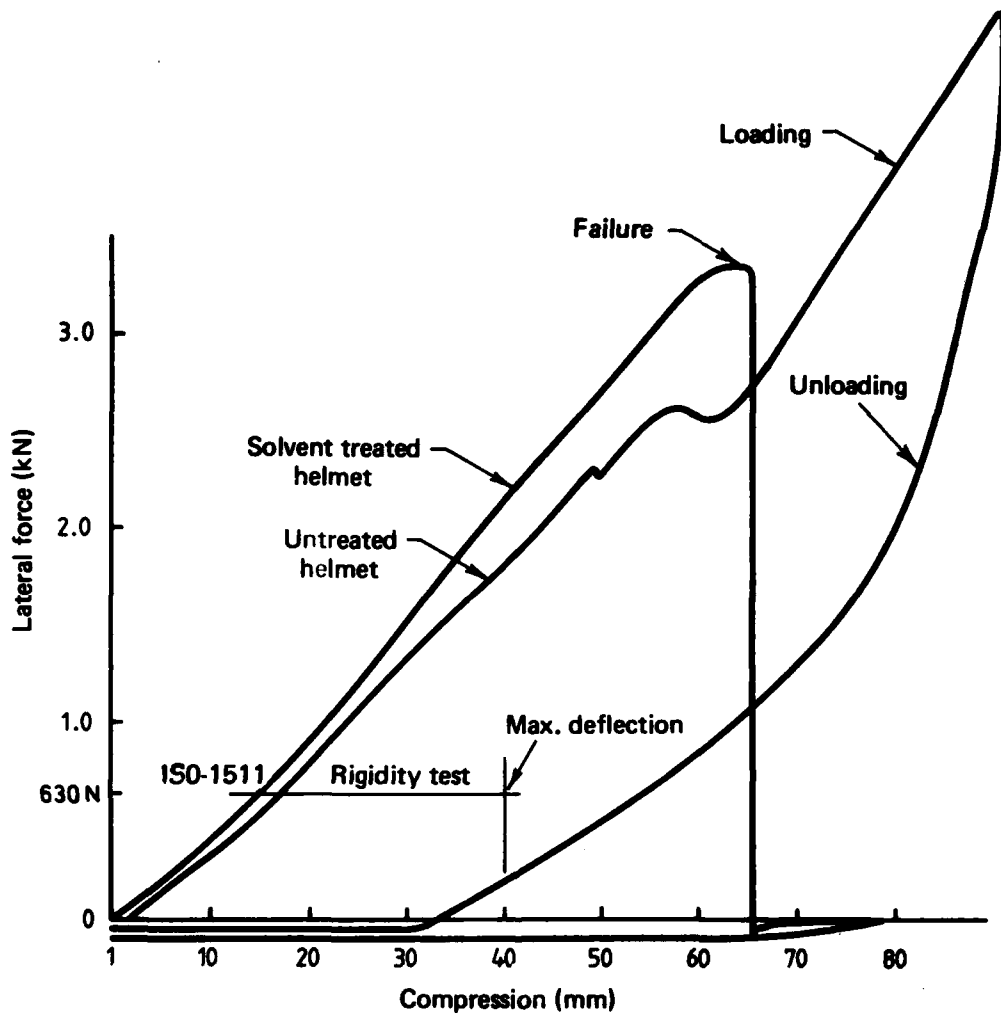
An unused Eldorado helmet and a Shoeni fibreglass helmet which had been in an accident but which only had surface scratches, were compressed across their width in a testing machine. Compression and force were noted and it was found that until the opposite sides touched, the stiffness of the two helmets was approximately the same. Views of the helmets under load are shown in Figure 8. Two Eldorado helmets were also compressed in a different machine between a flat platen and a ram shaped like the striker. Both helmets had received high speed blows previously. One helmet, which had not been treated with solvent, deflected 100 mm without fracture before the test was terminated, the other, treated with the test solvent fractured when the deflection reached 65 mm. Force/deflection curves were plotted automatically and are shown on Figure 9. The previous tests would have left stresses in the helmet so it would have been attacked abnormally by the solvent. However, the test shows that even in this condition the helmet could deflect considerably before failure. The failure was similar to that which occurred in the dynamic tests so it would seem that one of the principal causes of the brittle fracture was the large deflection.

Note: Rigidity test of ISO standard 1511 states the deflection must not exceed 40 mm at a load of 630 N.

FIG. 9 COMPRESSION TEST (side to side)
Compression rate 5 mm/sec

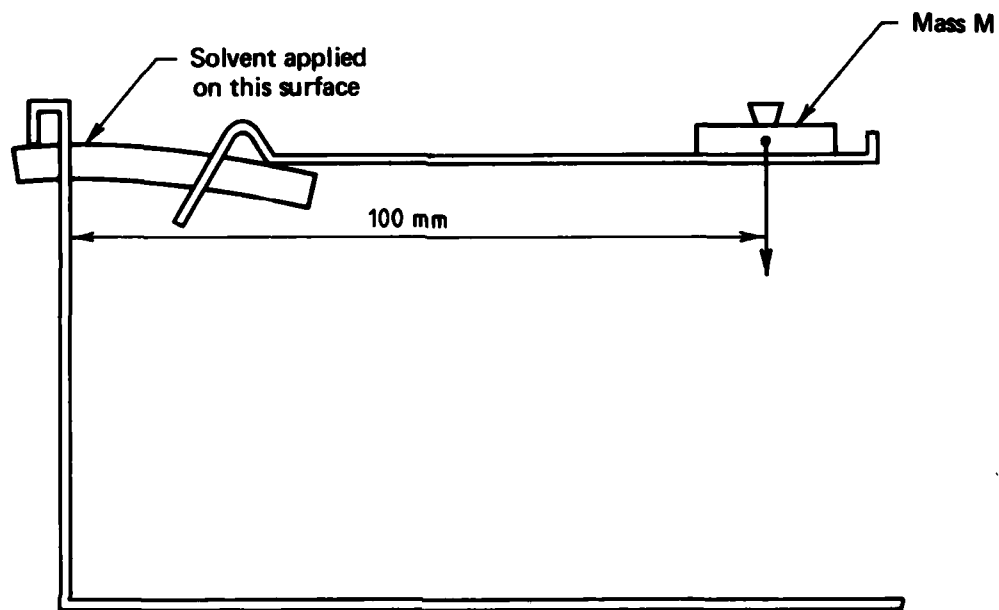
To stress them they were placed in a bending rig as shown in Figure 10. They were then moistened with a solvent, either ASTM standard fuel "C" or "super" grade petrol.

FIG. 10 BENDING RIG
(Stress \approx 4.7 MPa per 100 gm for typical specimen)

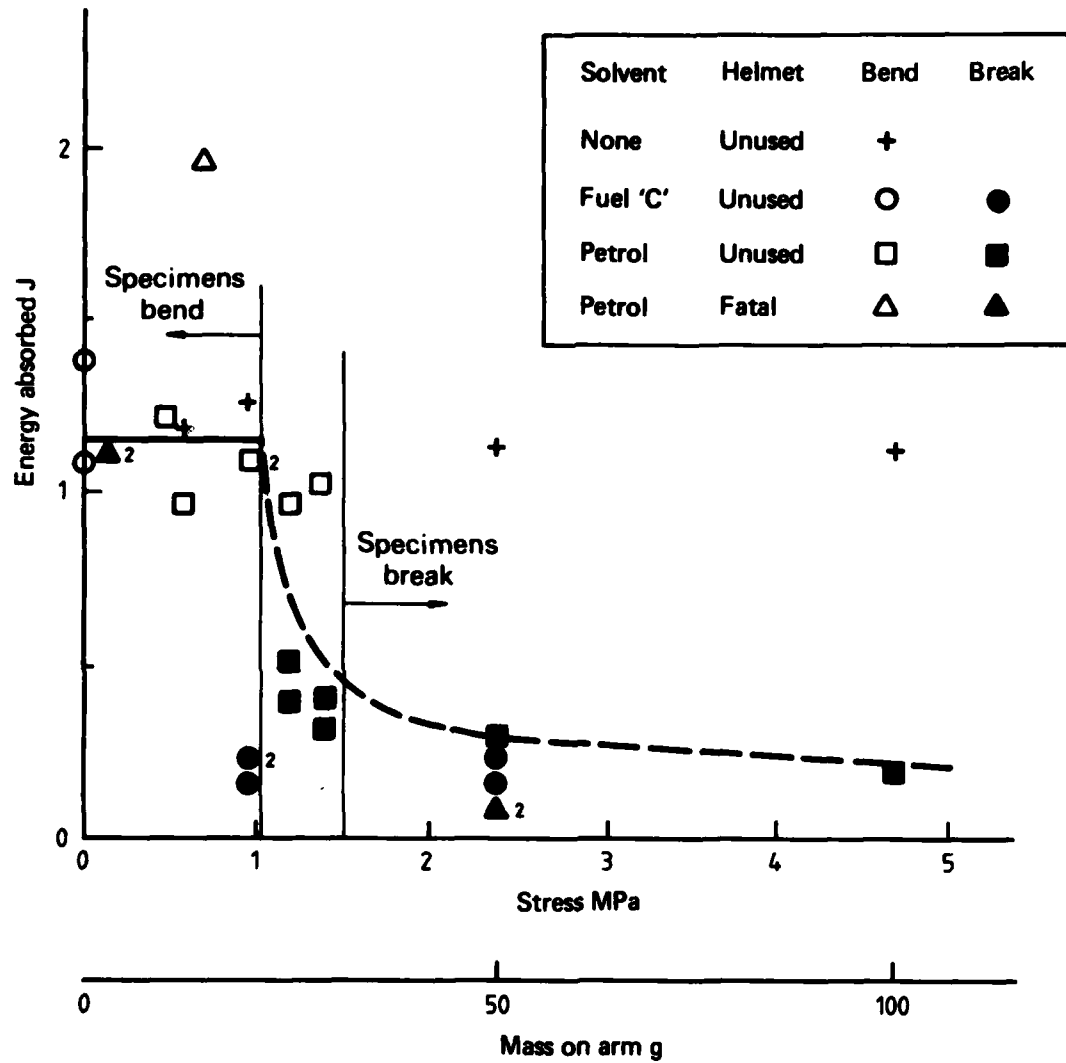
Most of the specimens which had been exposed to solvent while under stress snapped cleanly in the Izod test and the energy absorbed varied inversely with the stress acting during the solvent attack as shown in Figure 11. When the stress was less than 1 MPa during solvent attack the energy absorbed was usually 0.9 to 1.3 J and the specimens bent but when the stress was greater than 1.5 MPa the energy absorbed was usually less than 0.3 J and the specimens broke. Stresses above 2.4 MPa produced visible cracks and when the stress was greater than 10 MPa the specimen fractured under the static load, (during the 10–30 minute period allowed between moistening the specimen and transferring it to the Izod machine). An untreated specimen could support a 1 kg mass (with considerable deflection) corresponding to a stress of approxi-

FIG. 11 EFFECT OF STRESS DURING SOLVENT ATTACK ON IZOD ENERGY

mately 50 MPa. Consistent brittle failure with low energy absorption occurred with a stressing mass of 30 gm, giving 1.4 MPa, i.e., only 3% of the stress that the material could support.
