**BROOKVILLE LAKE  
GREATER MIAMI RIVER BASIN  
INDIANA**

**EMBANKMENT CRITERIA AND  
PERFORMANCE REPORT**

**PREPARED BY  
U.S. ARMY ENGINEER DISTRICT, LOUISVILLE  
CORPS OF ENGINEERS**

**SEPTEMBER 1982**

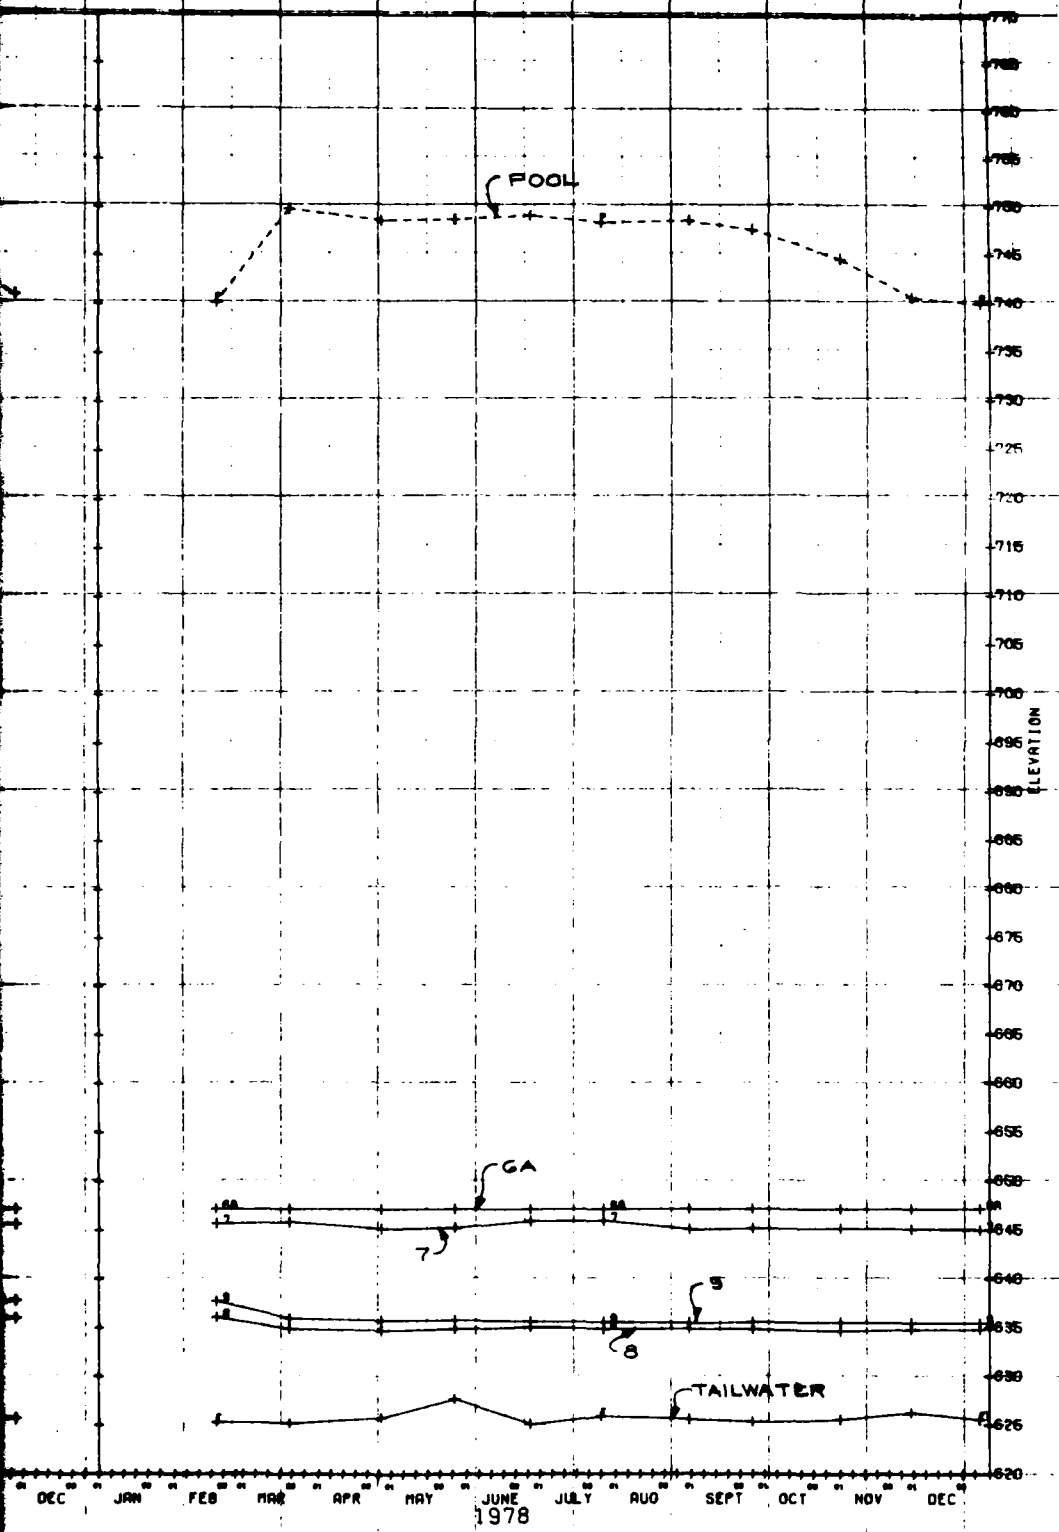
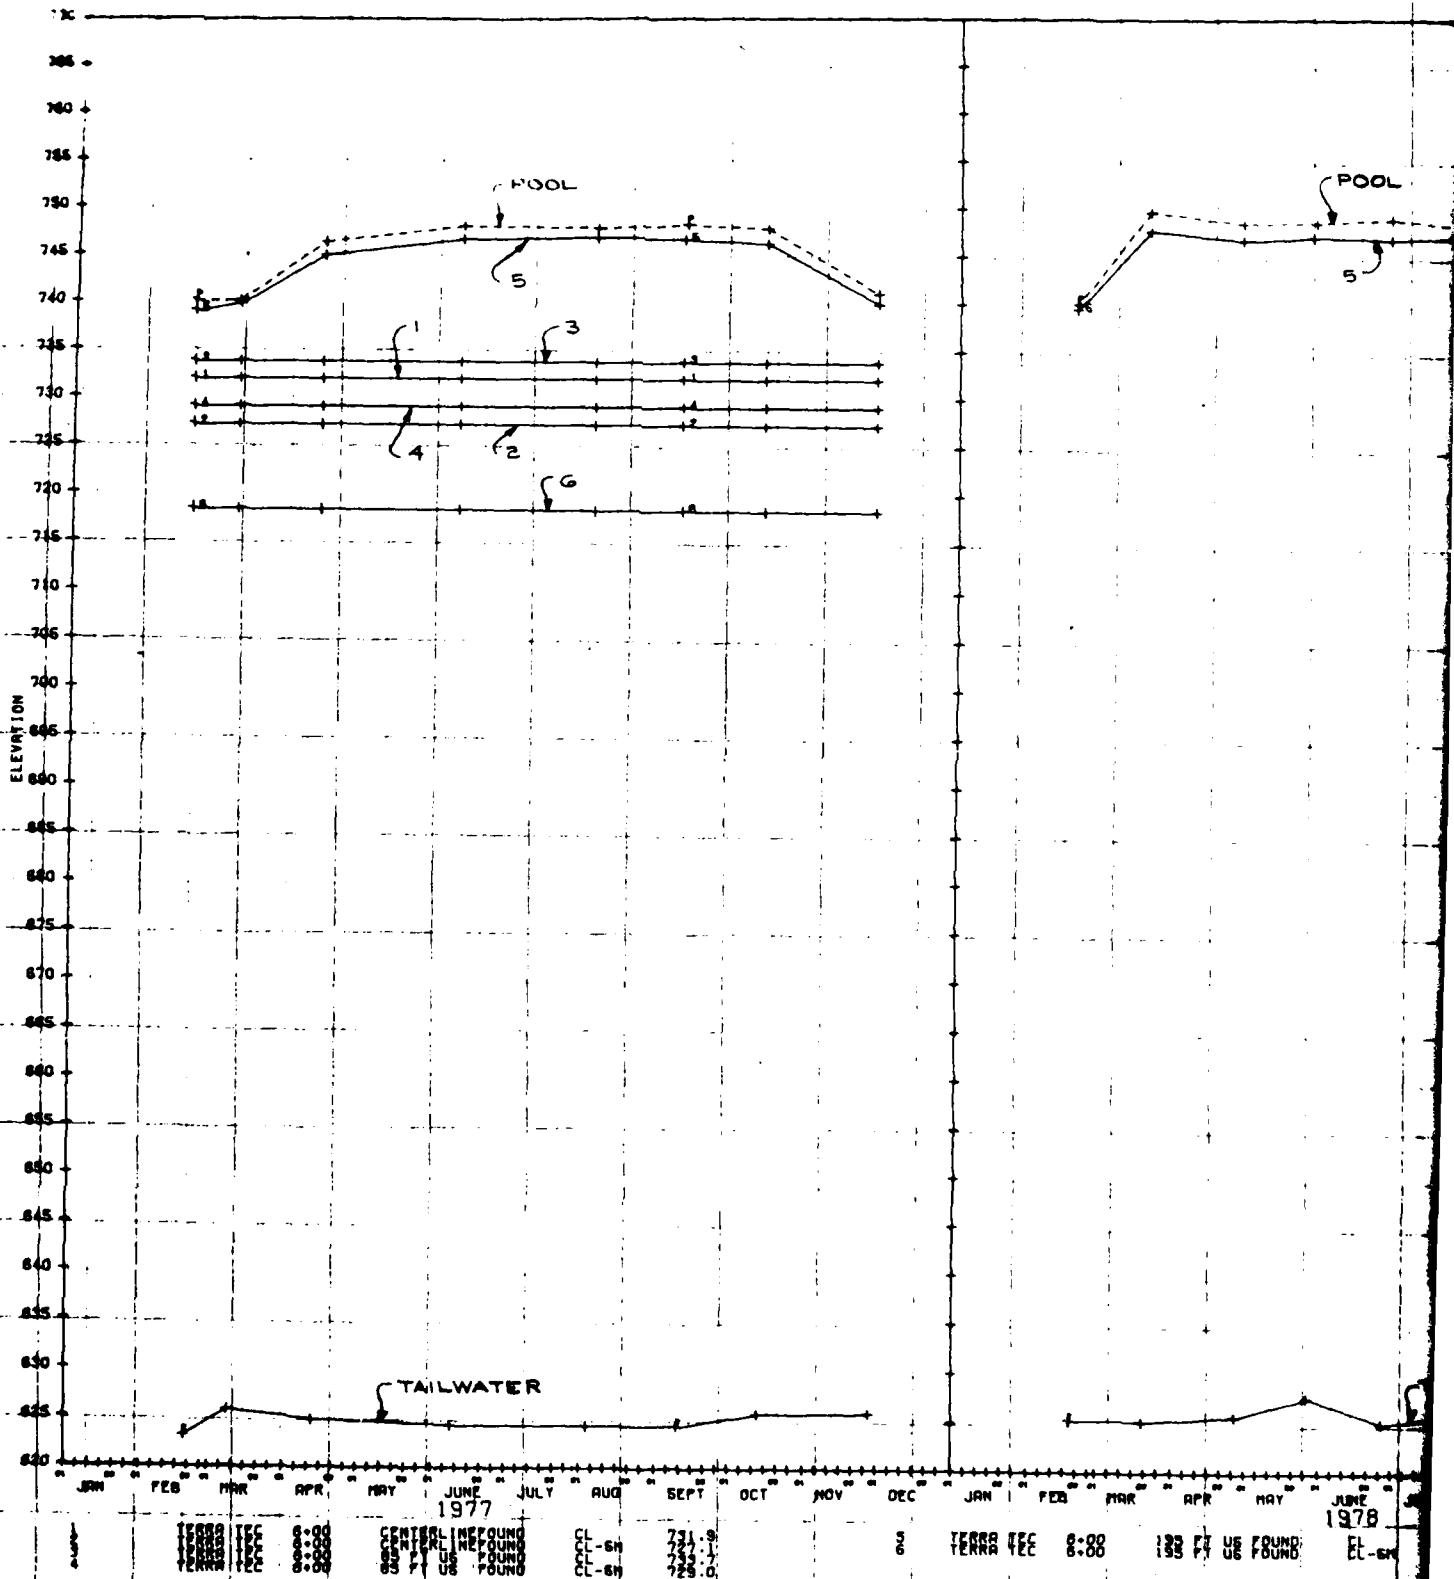
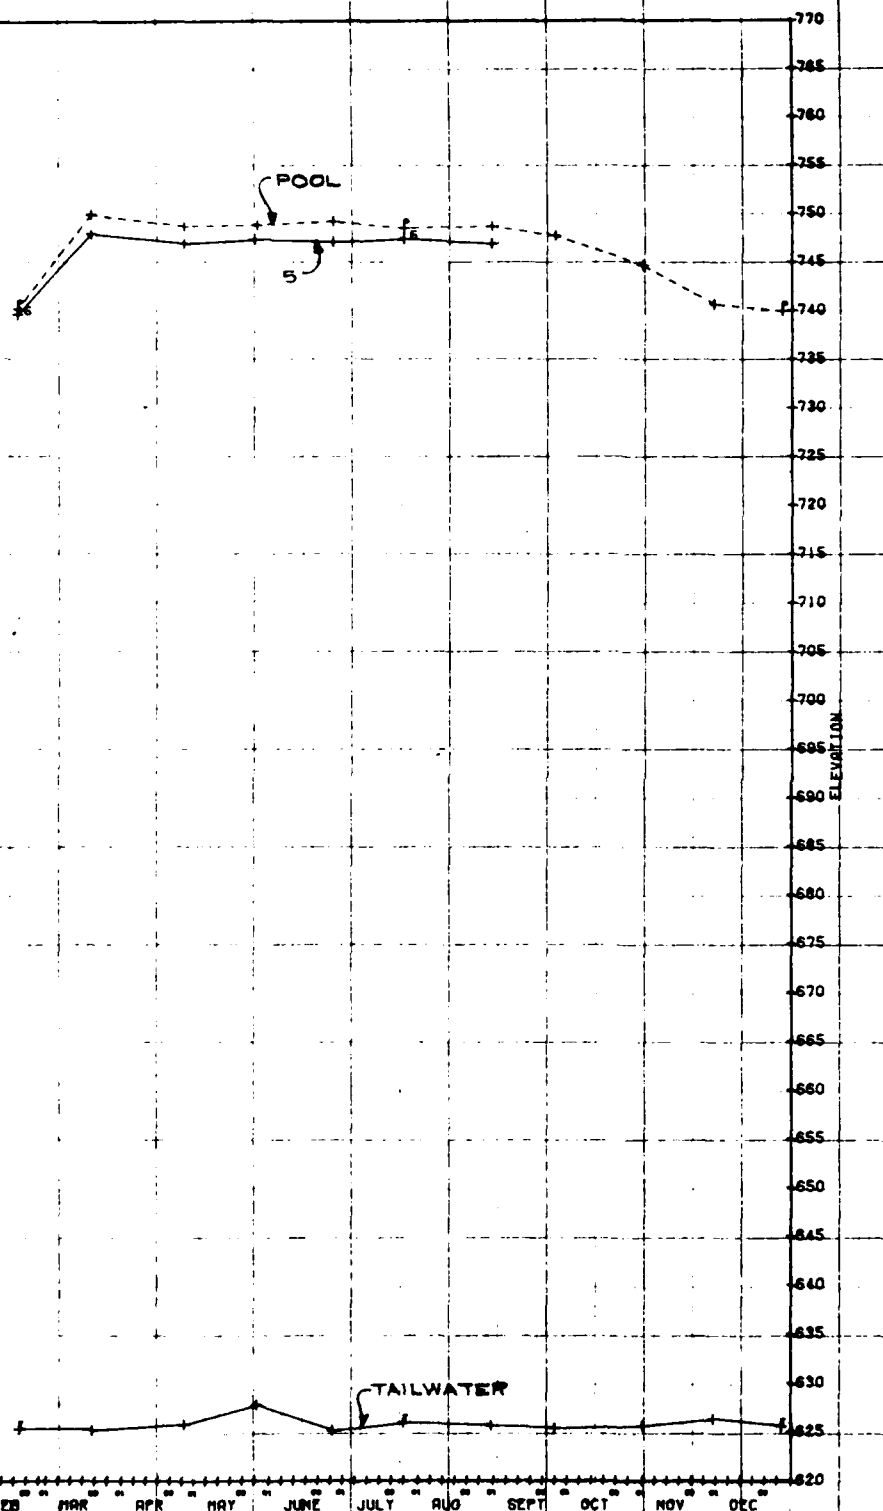
# BROOKVILLE U.S. FOUND PIEZ. STA 6+00

(a) Station 6+00--The replacement piezometers are the only operative piezometers at this station. These piezometers were recently set and have not stabilized yet.
