F-4C/D LIFE EXTENSION PROGRAM

Robert L. Schneider
Structures Test Branch
Structures and Dynamics Division

October 1982

Final Report for Period October 1974 - May 1981

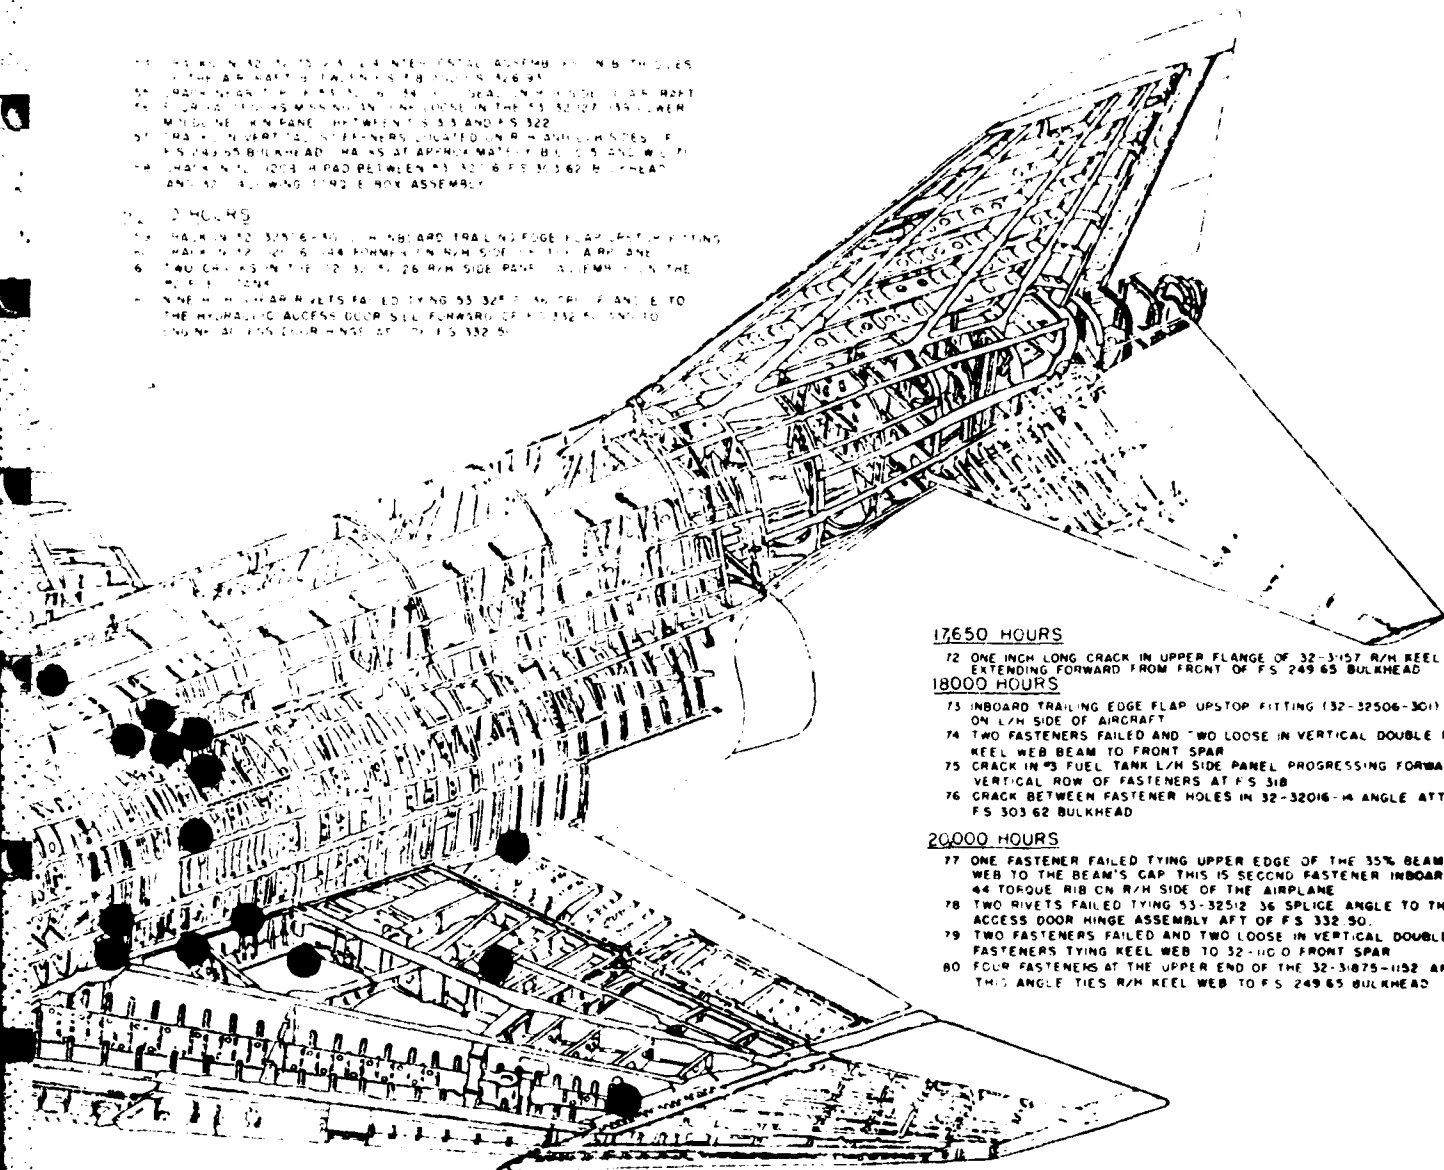
17,650 HOURS

- 72 ONE INCH LONG CRACK IN UPPER FLANGE OF 32-3157 R/H KEEL WEB TRUSS EXTENDING FORWARD FROM FRONT OF FS 249 65 BULKHEAD
