SEABEE PRETEST RESULTS OF THE JOINT LOGISTICS-OVER-THE-SHORE (LOTS) TEST AND EVALUATION PROGRAM(U) ORI INC SILVER SPRING MD H KNIGHT ET AL.

07 DEC 77 ORI-TR-1267 MDA903-75-C-0016

Subj: ORI Technical Report No. 1267: SEABEE Pretest Results  
of the Joint Logistics-Over-the-Shore (LOTS) Test  
and Evaluation Program

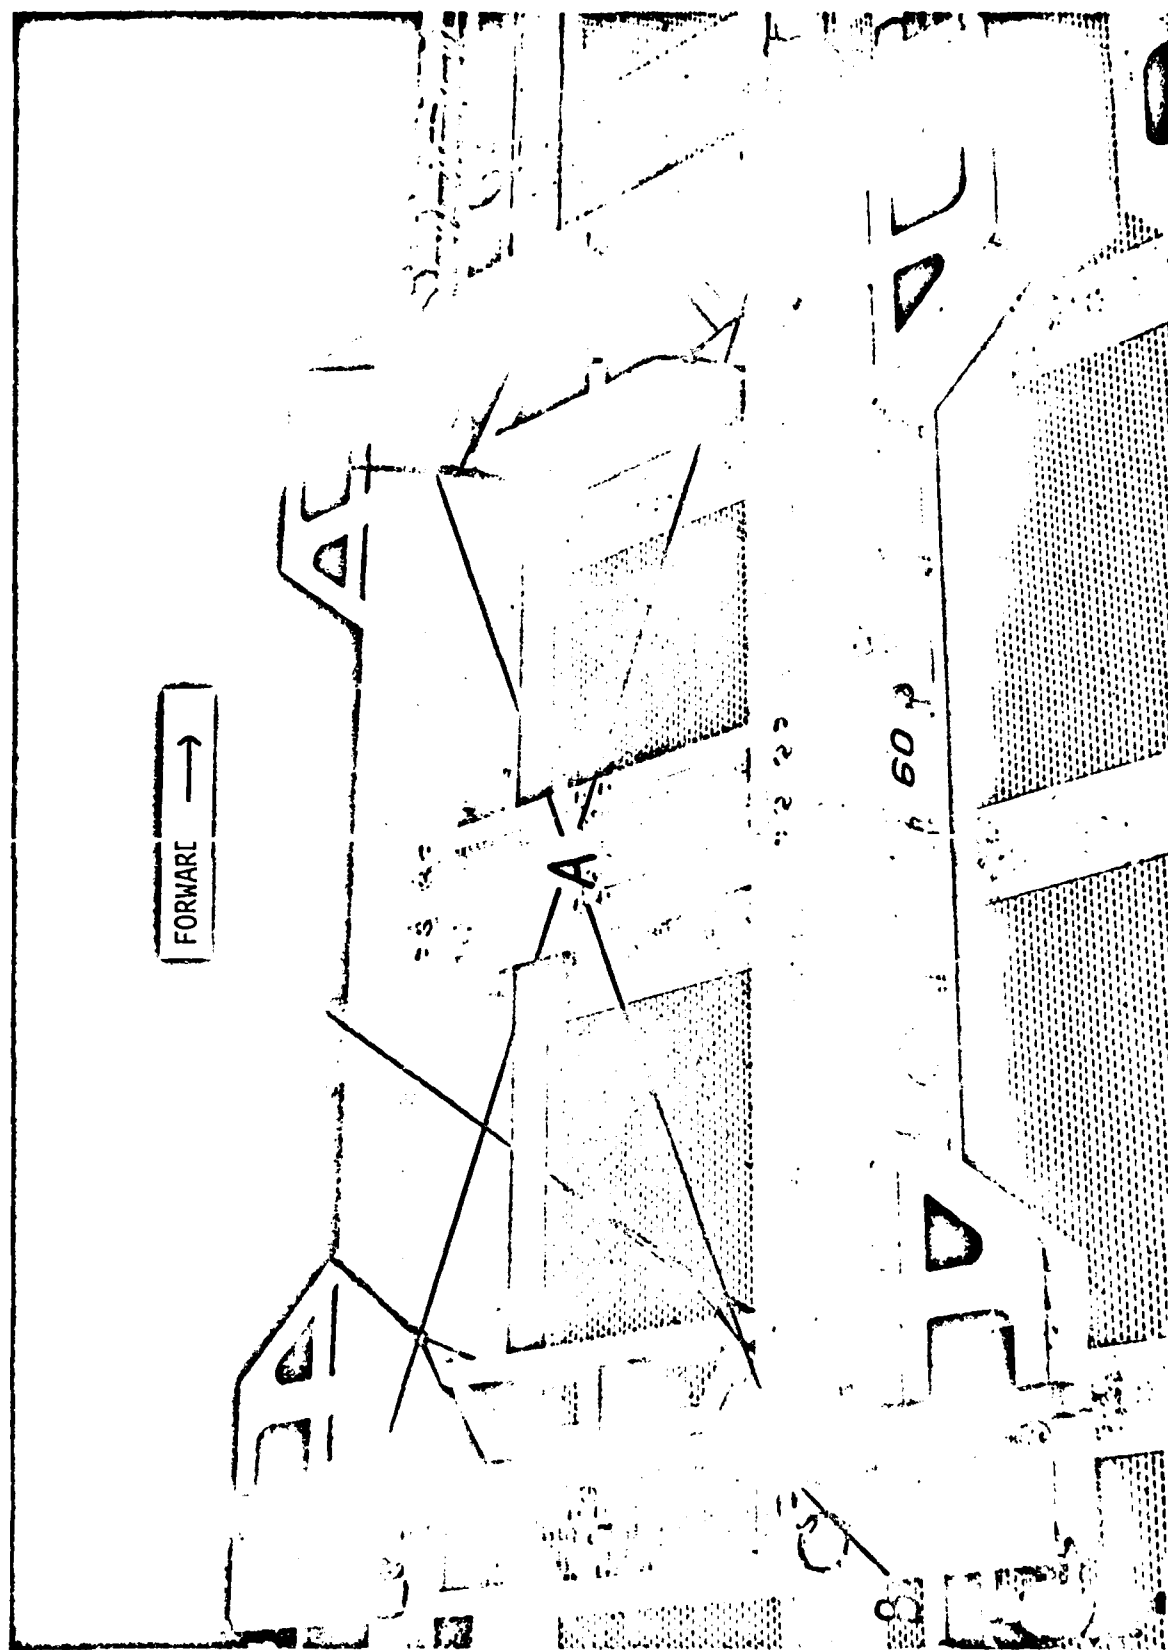
FIGURE 4. LACV-30 MODIFIED CONTAINER ADAPTER FRAME

The adapter frame modified for this lift (see Figure 4), allowed too little clearance for the alignment with the craft's landing pads. The four elevated platforms (or sockets) indicated by the letter "A" in the figure, had three sides approximately the same size as the LACV-30 landing pads. The fourth or rear side, indicated by the letter "B" in the figure, was removable and about 6 in. longer than the forward side. These platforms provided clearance from D-rings and container fittings on the adapter frame and support for the docked LACV-30's polyurethane landing pads which extend about 1 ft below the craft's hull. The major purpose was to neutralize the effects of lateral forces from the roll or pitch of the ship during sea transit. However, the difficulties involved in the precise positioning of the pads on the platforms were aggravated by the rubber skirts of the LACV-30 which totally obscured both the landing pads and the sockets.

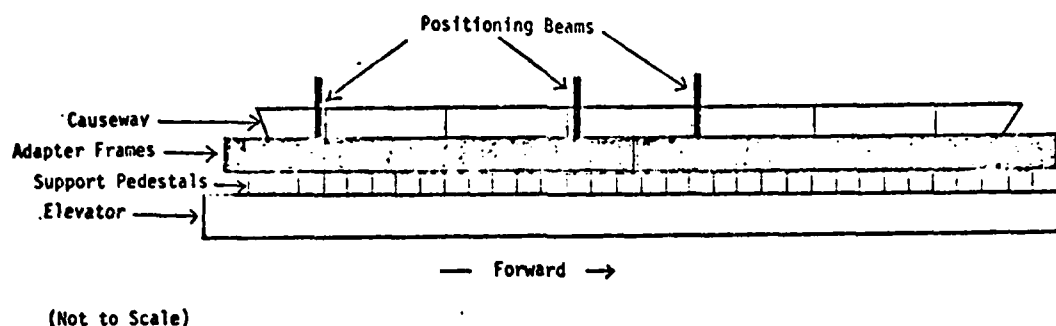
FIGURE A.6. CAUSEWAY ON THE ELEVATOR

For the causeway, additional modifications were required on two of the adapter frames that had previously been used for the TCDF. Three vertical positioning beams were bolted to the outboard sides of the adapters as illustrated in Figure A.6.

Note should be taken that these adapter frames were on the starboard side and were repositioned after the TCDF lift. The forward frame has its forward end 24 in. aft of the elevator's front edge. The aft adapter was placed against the forward one.

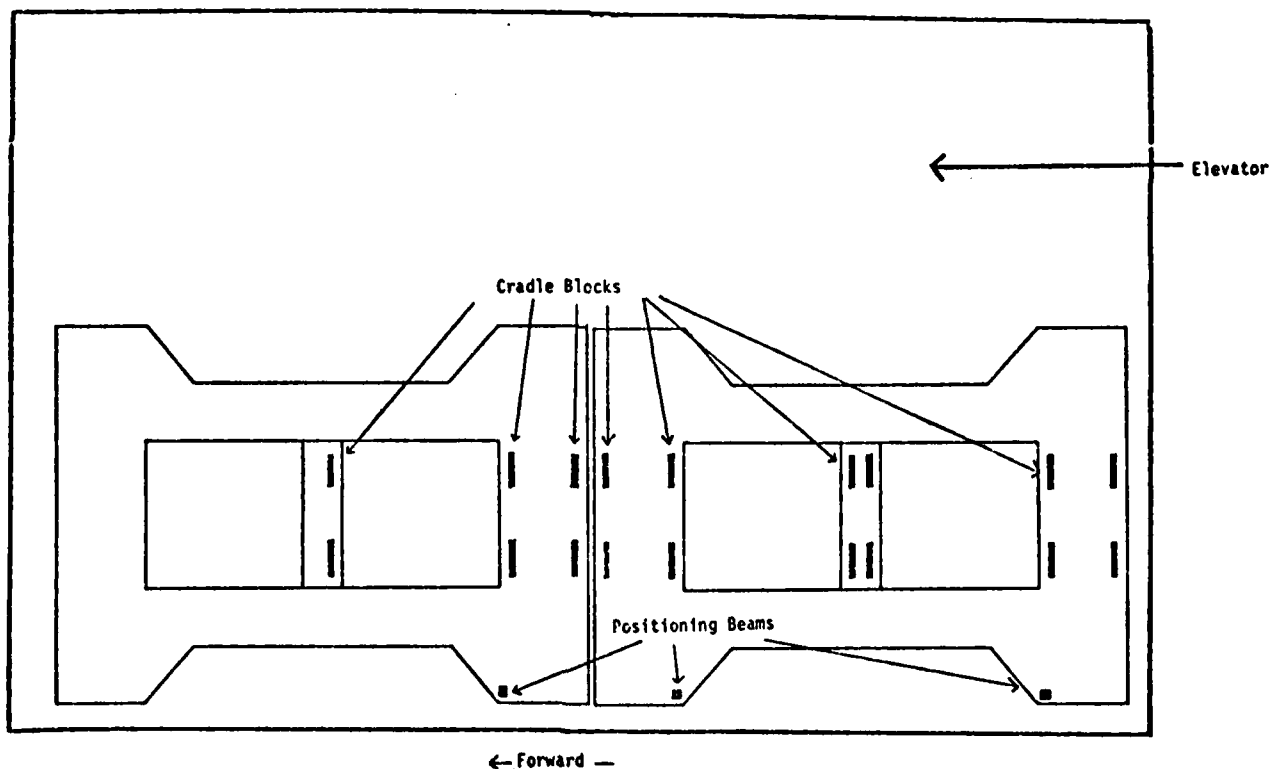
FIGURE A.7. TOP VIEW OF THE LCU (1646-CLASS)  
MODIFIED ADAPTER FRAMES

As planned, additional modifications were installed on the frames designated for the 1646 class LCU subsequent to the TCDF lift. The forward adapter on the port side of the elevator was fitted with six 3-ft cradling blocks (8-in. I beams faced with 6 in. by 12 in. timber) and one vertical positioning beam (similar to those in Figure A.6). The aft adapter was fitted with twice that number. The installation of these additional modifications was completed during the causeway lift and are as noted in Figure A.7.
