### *Detection of cavities under concrete pavement*

# CRREL Report 83-18

July 1983

Austin Kovacs and Rexford M. Morey

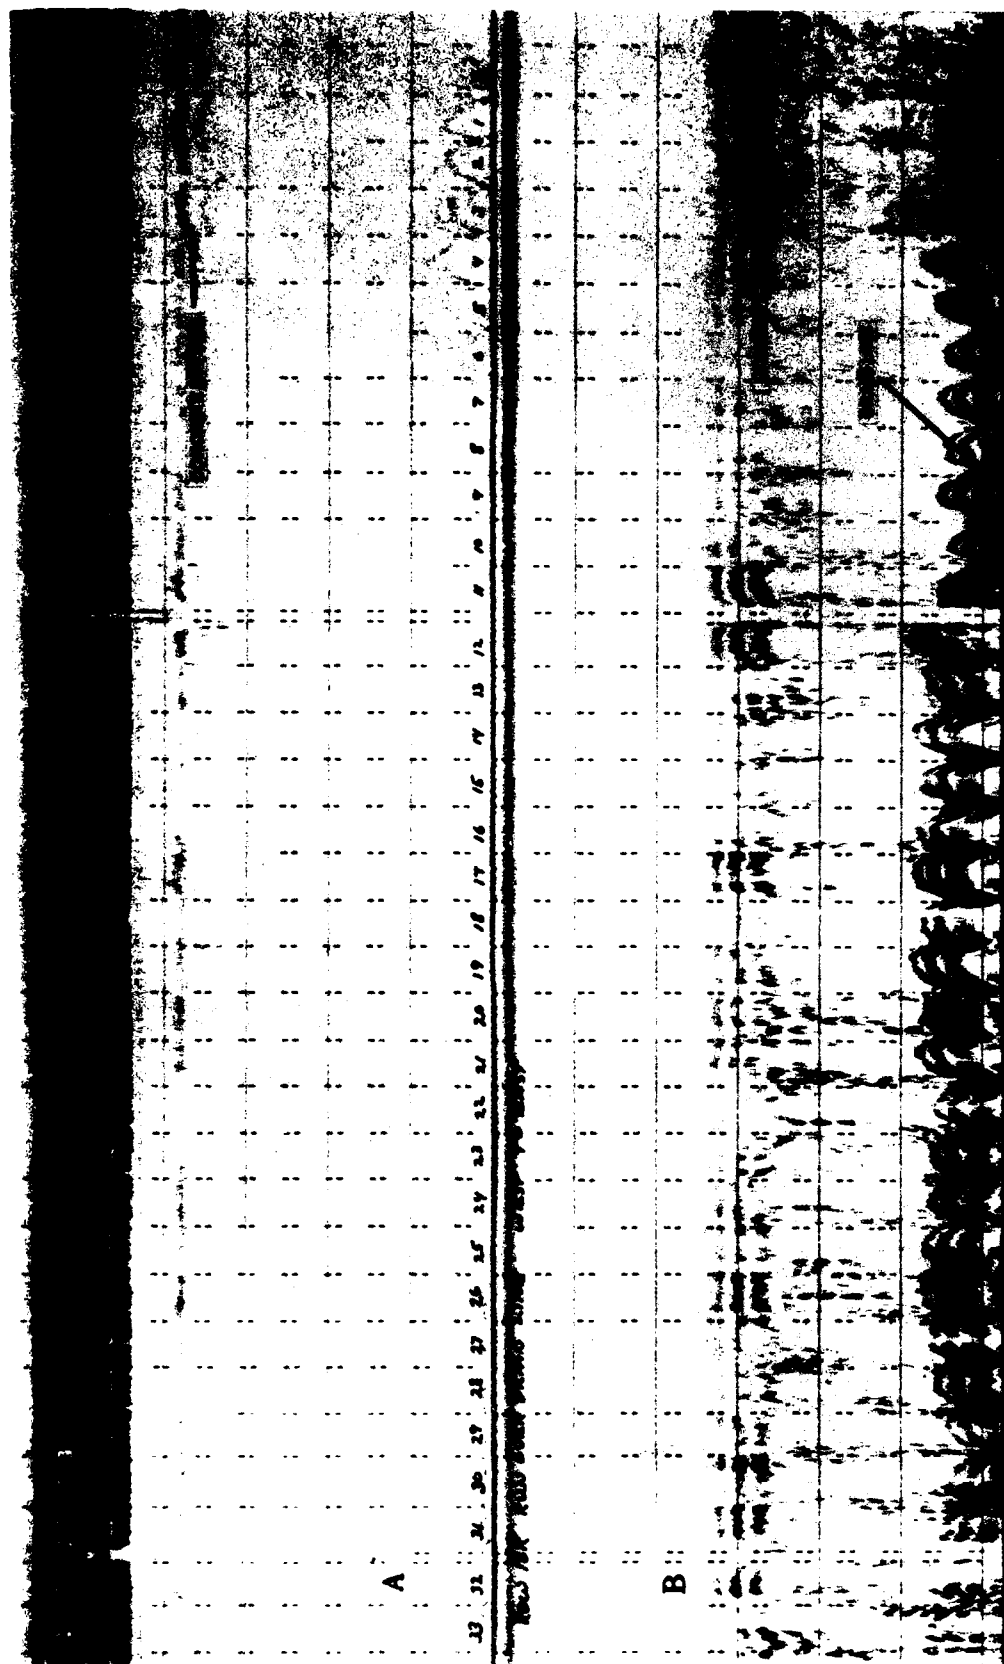
Figure 20. Portion of radar profile along row 18K from slab 33 to slab 1 over a 30-in. drain line. The scale lines are 5 ns apart.

The high-frequency variation, or short-period undulation, in the pipe return under slabs 29-40 is the result of changing subsurface conditions that affect  $V$  and  $\epsilon'$ . The same effect is shown in Figure 20. Here the antennas were towed over the drain line under row 18K. The system gain was set too low for a good pipe reflection to appear in the upper trace. Nevertheless, the pipe reflection in this trace is visible, especially on the right. Note that at each key joint the pipe appears to bend downward. This effect is caused by an increase in the real effective dielectric constant of the subgrade under the joints, which in turn decreases the propagation velocity of the EM wavelet. The burial depth of the pipe has not changed, but the travel time of the EM wavelet to and from the pipe has increased. The variation in EM wavelet velocity, or flight time, was caused by a variation in the moisture content of the subgrade. At the joints, rainwater freely entered and drained downward into the subgrade. This raised the moisture content of the sand, which in turn increased  $\epsilon'$

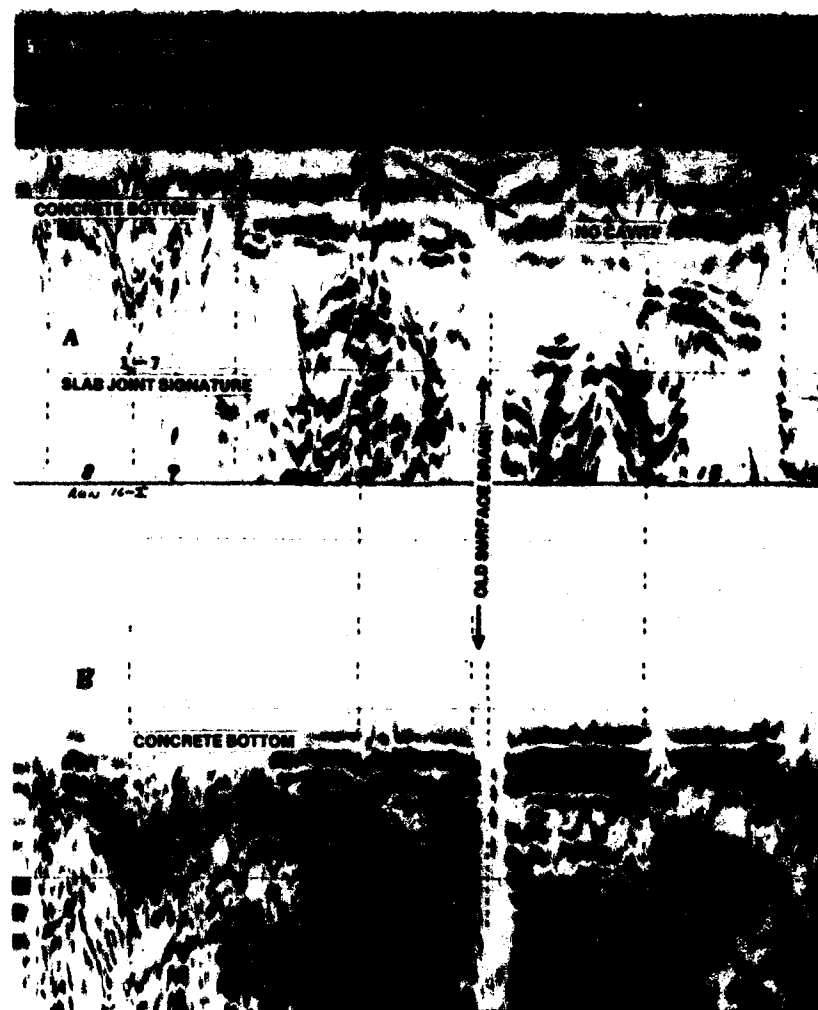
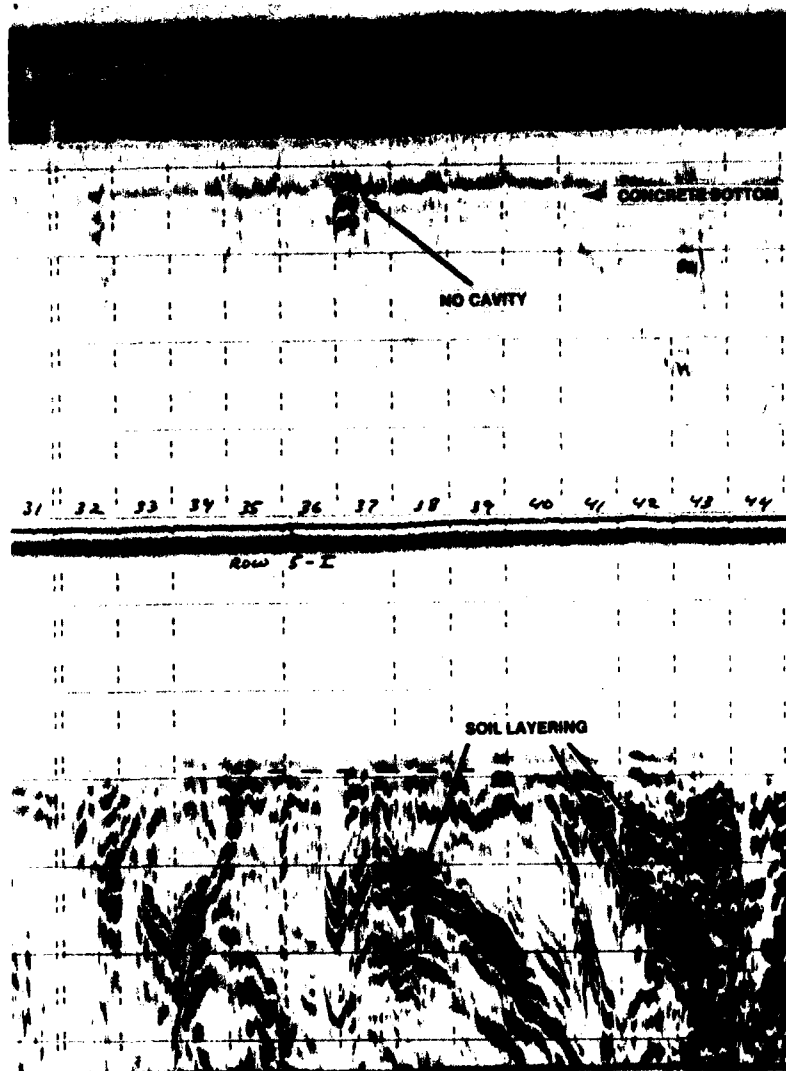
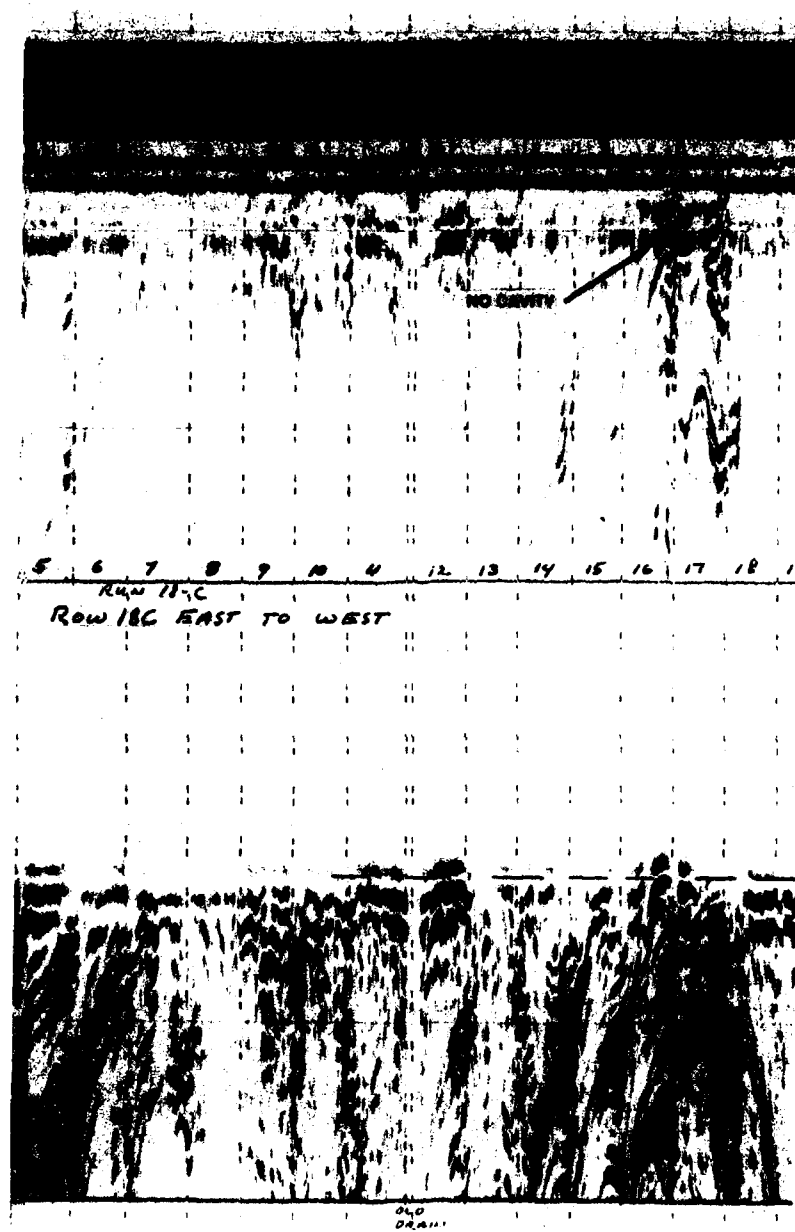
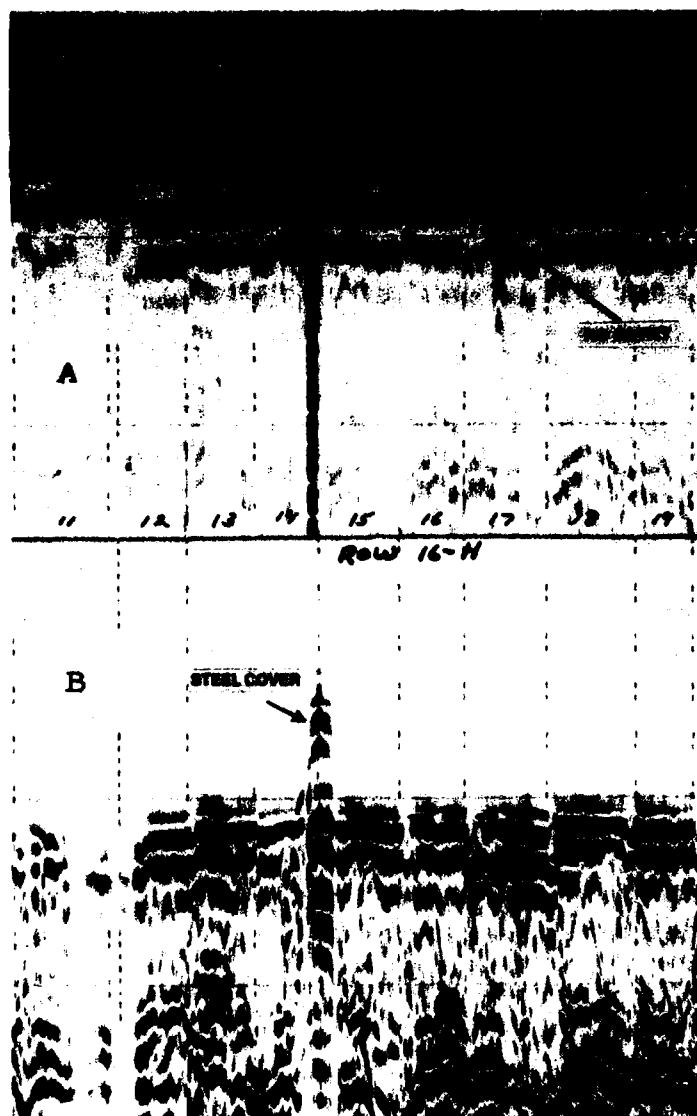
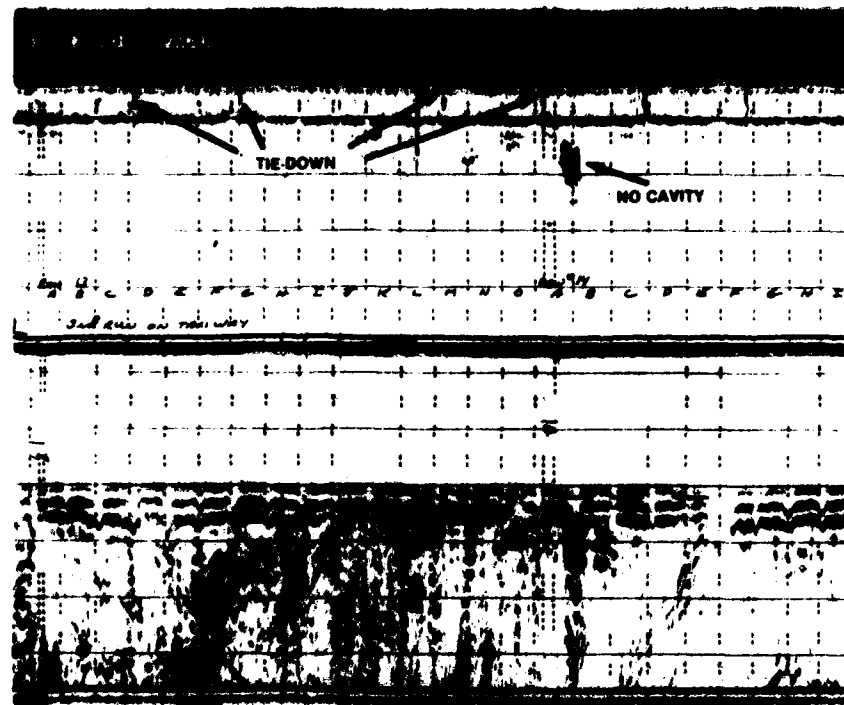
Figure 34 shows other examples of features that appeared in the single-transceiver antenna graphic record that can be or have been misinterpreted as cavities. In each case the anomalous feature in trace A does not produce the hump in the receive-only antenna graphic record that signifies a cavity. Drill hole measurement and inspection was used to verify that these features were not cavities.

The signatures of slab joints are highlighted in Figure 34a and b. The arrows in Figure 34b point to metal targets in the concrete. The center one was a buried reinforcing bar; the outer two were steel

Figure 34. Radar profile records showing slab joint features, metal targets and other subsurface reflection signatures that can be misinterpreted as cavities under concrete pavement.
