TECHNICAL REPORT SL-83-6

# AN EVALUATION OF THE SEPARATED BAY CONCEPT FOR A MUNITION ASSEMBLY COMPLEX; AN EXPERIMENTAL INVESTIGATION OF THE DEPARTMENT OF ENERGY BUILDING 12-64 COMPLEX

Structures Laboratory

September 1983

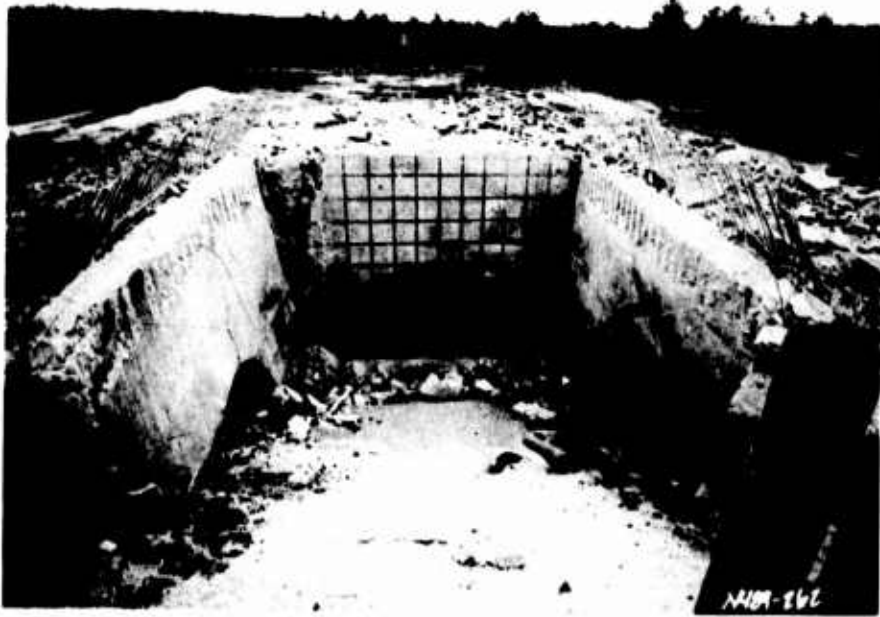
An overall view of the donor bay immediately after the test is shown in Figure 4.2. The roof disengaged and completely separated from the bay leaving only a few No. 5 bars which had pulled out of the roof slab. The roof slab broke into two major fragments which impacted to the east and west of the donor bay. The north wall completely separated from the floor and the east and west walls and fell back onto the bay floor. The east wall was displaced and rotated away from the center of the bay, and the corrugated entrance pipe was destroyed. The south and west walls suffered much less severe damage. Post-test donor bay relative displacements were measured between the east and west walls and are listed in Table 4.3.

**Figure 4.2. Posttest view of donor bay.**

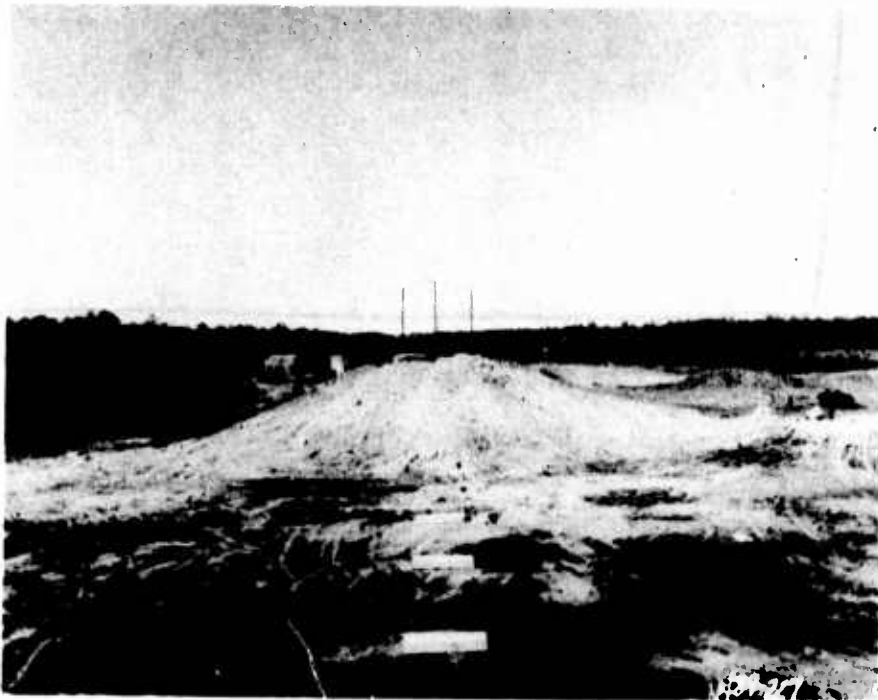
The roof slab broke into two major fragments, approximately 9 by 31 ft in plan, which impacted 104 ft to the east and 102 ft to the west of the bay (Figure 4.3). Analysis of high-speed photography from camera station 1 revealed that the major roof fragment on the west side of the bay achieved a terminal velocity of 52 fps. The two major roof slab fragments are shown in Figures 4.4 and 4.5. The concrete covering the rebar splices at the east and west edges was spalled away from the bars. These secondary fragments were primarily distributed on the east and west backfill slopes, as shown in Figure 4.6.

**Figure 4.3. Posttest view of Phase I test site.**

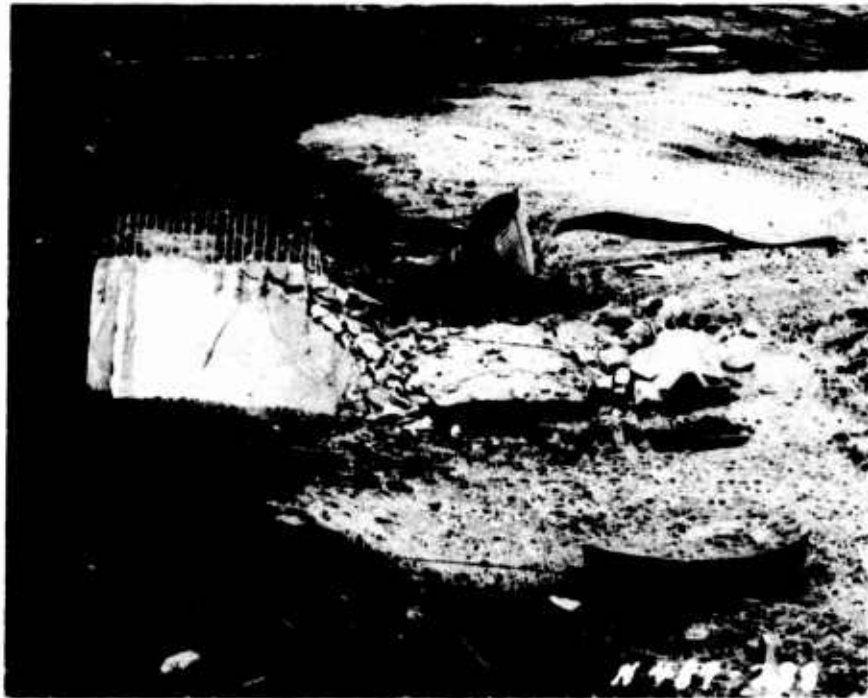
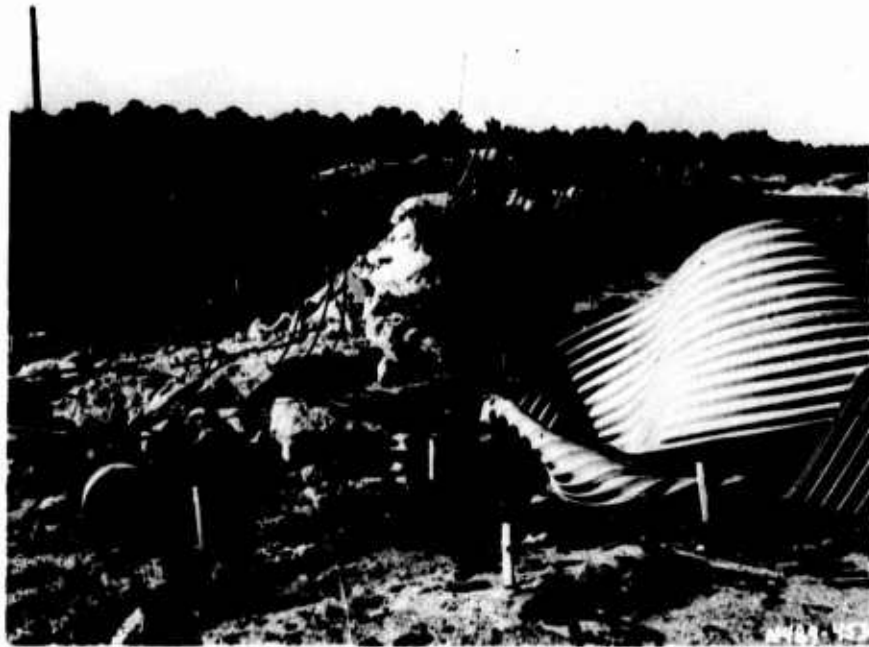
Figure 4.4. Major roof-slab fragment on east side of structure.

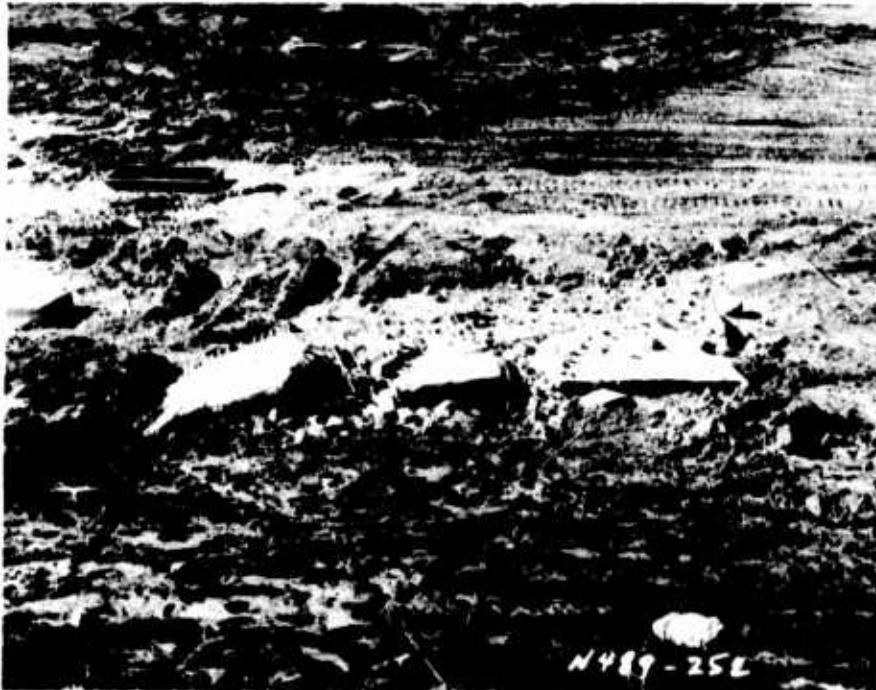
Figure 4.5. Major roof-slab fragment on west side of structure.

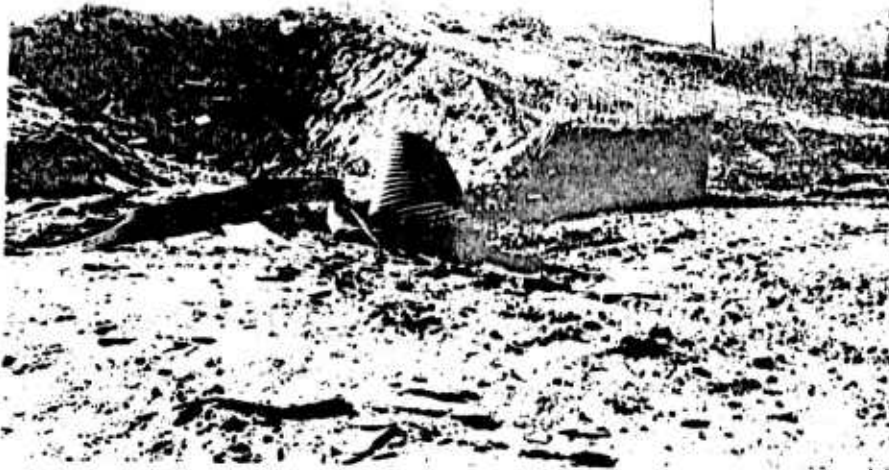
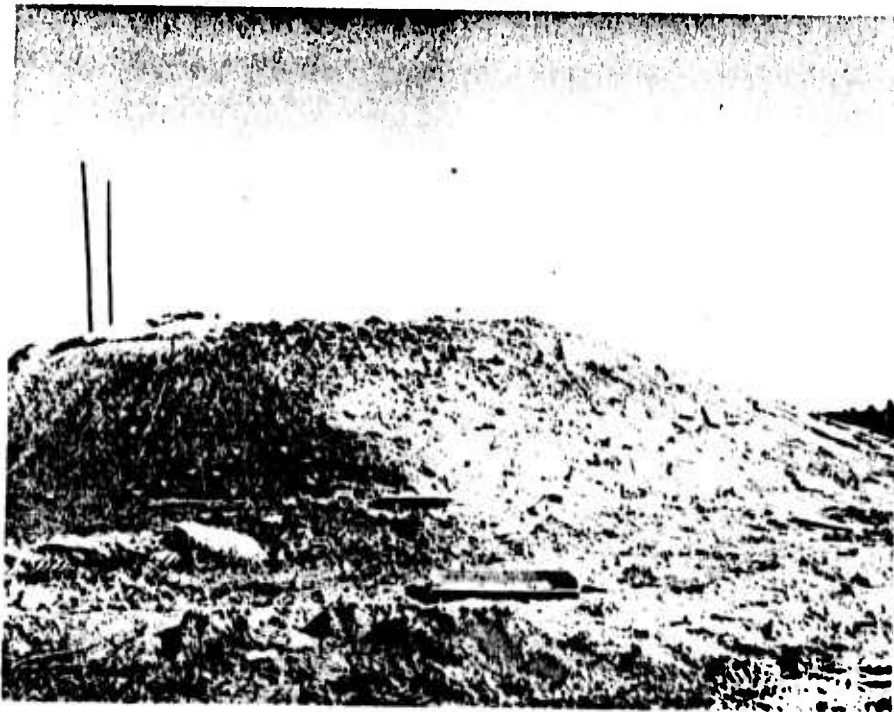
Figure 4.6. Posttest view of backfill slopes on Phase I structure.

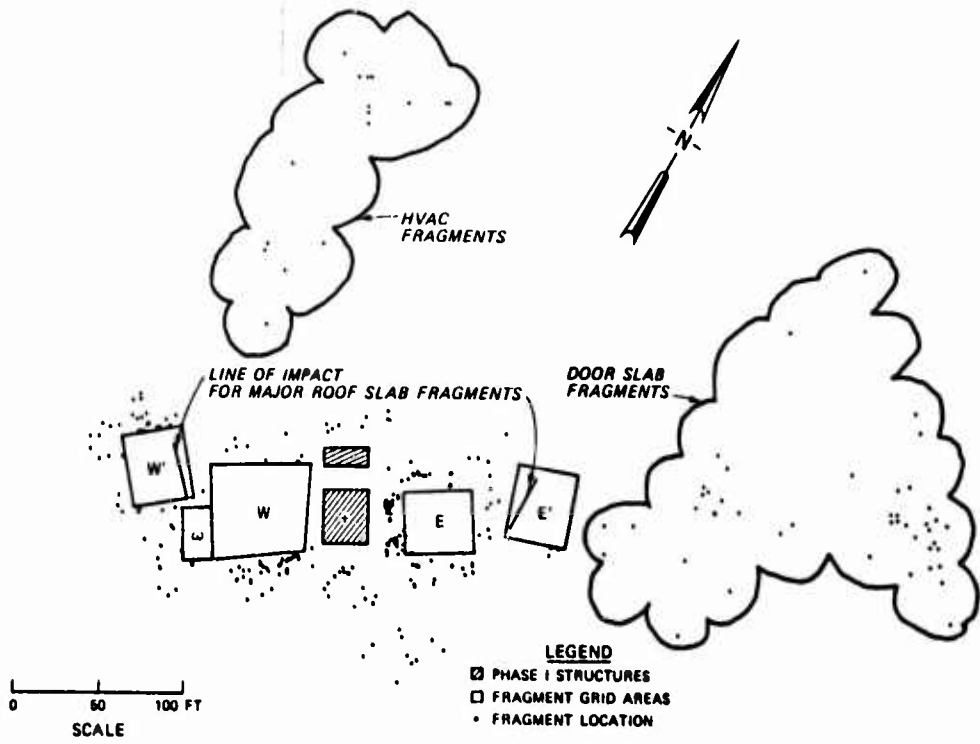
Individual fragment locations and fragment grid areas are shown relative to the Phase I structures in Figure 4.7. The figure shows the locations of all fragments which impacted outside of the five grids (E, E', W, w, and W'). The fragment content within these areas was too dense to produce a legible map. Grids E, W, and w represent the east and west backfill slopes. Grids E' and W' were impact areas for the two major roof slab fragments.

Figure 4.7. Individual fragments and grid areas relative to Phase I structures.

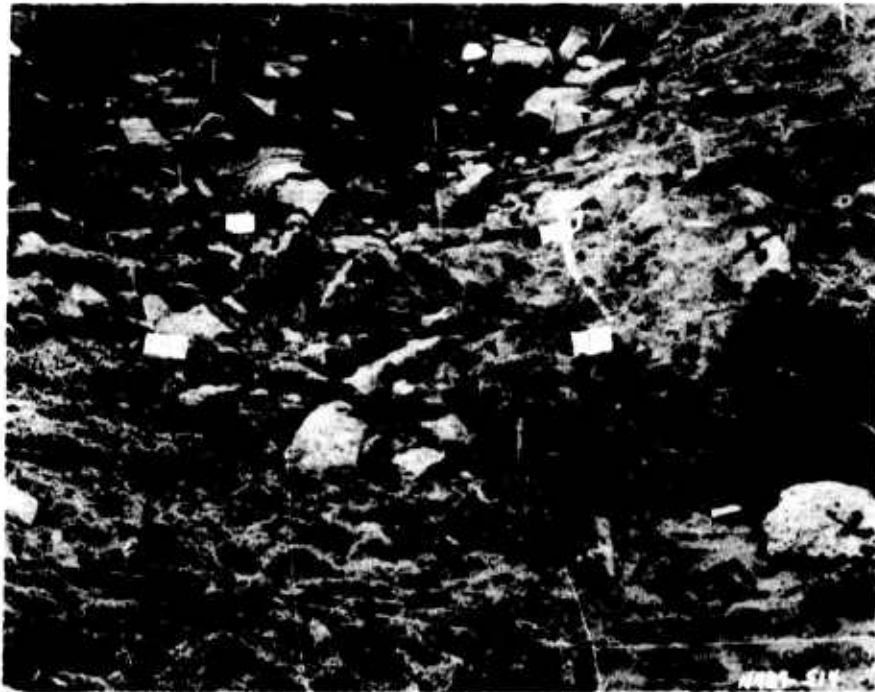
Each of these grids was subdivided into 6-ft-square areas as shown in Figure 4.8. Grids E and W are shown in Figures 4.9 and 4.10 after the grids were subdivided and the styrofoam was removed. The fragments which fell outside of the five grids were grouped according to the four quadrants shown in Figure 4.8. Tables 4.4-4.8 show the fragment distribution by weight in the fragment grid areas E, E', W, W', and w. Table 4.9 shows the fragment distribution by weight of the quadrants not included in grids. Table 4.10 itemizes all fragments weighing over 100 lb. All weights were calculated using a unit weight of 150 pcf.

Figure 4.9. East slope with E grid.

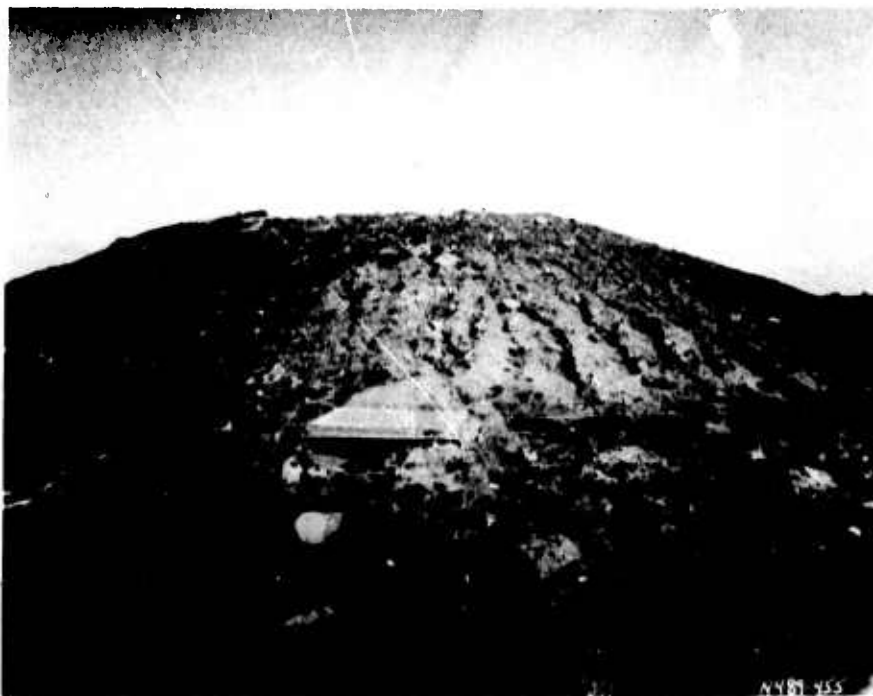
Figure 4.10. West slope with W grid.

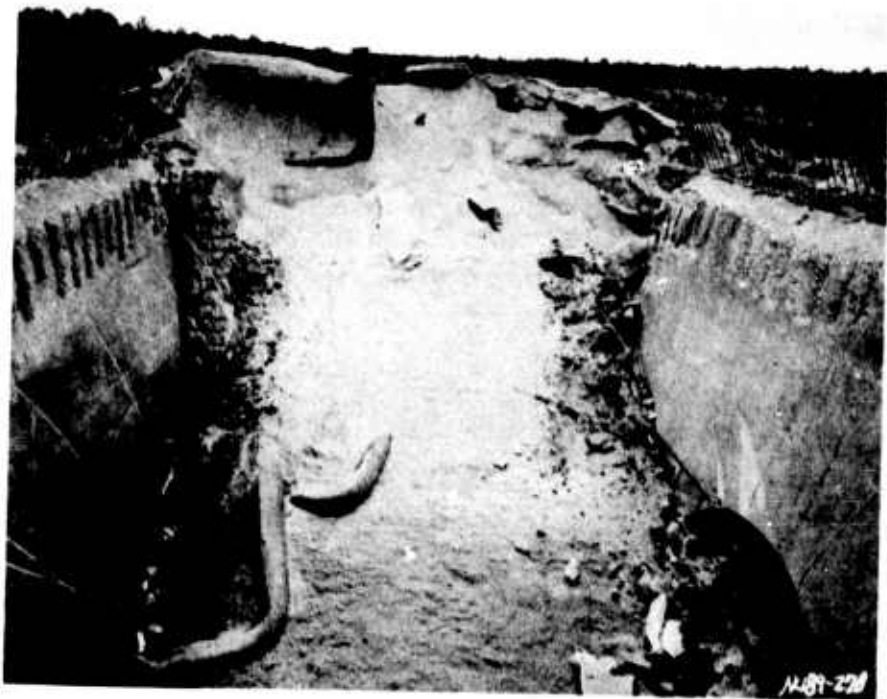
a. Before excavation.

Figure 4.11a shows the north wall shortly after the test event. The wall was excavated to remove the sand backfill which fell back into the bay. Figure 4.11b shows the exterior face of the north wall. The collapse of the wall left all No. 8 dowel bars joining the floor to the wall intact. The wall broke away from the floor slab as shown in Figure 4.11c. The portion of the wall left standing on either side of the center of the wall was 36 in. high and was broken flush with the top of the floor dowels. The wall's inside face vertical No. 8 rebar merely pulled away from the dowels without apparent deformation. Of the outside face vertical No. 4 rebar, 9 bars pulled out and 11 were broken. The center of the wall adjacent to the charge location was crushed and spalled. The distance from the top of the wall to the spalled and crushed area was 14 ft 10 in.

Figure 4.11. Posttest view of north donor bay wall  
(Sheet 1 of 3).

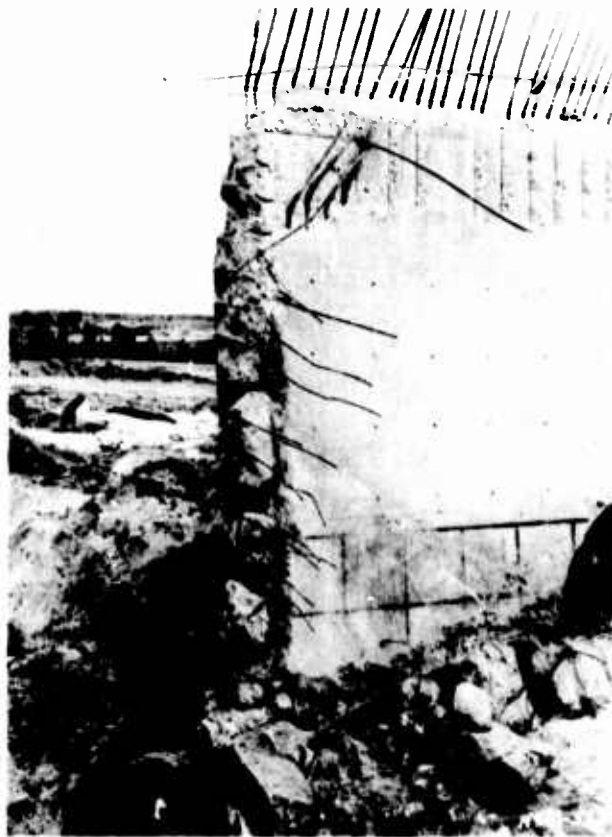
e. Northwest corner.

On the northwest edge, the wall opened up at the corner but it broke away approximately 2 ft from the edge leaving a section of the wall attached to the west wall (Figure 4.11e). At the separation point, all of the inside face steel rebars spalled their concrete cover and pulled away. All of the No. 4 rebars in the outer face horizontal direction failed in tension. Four No. 4

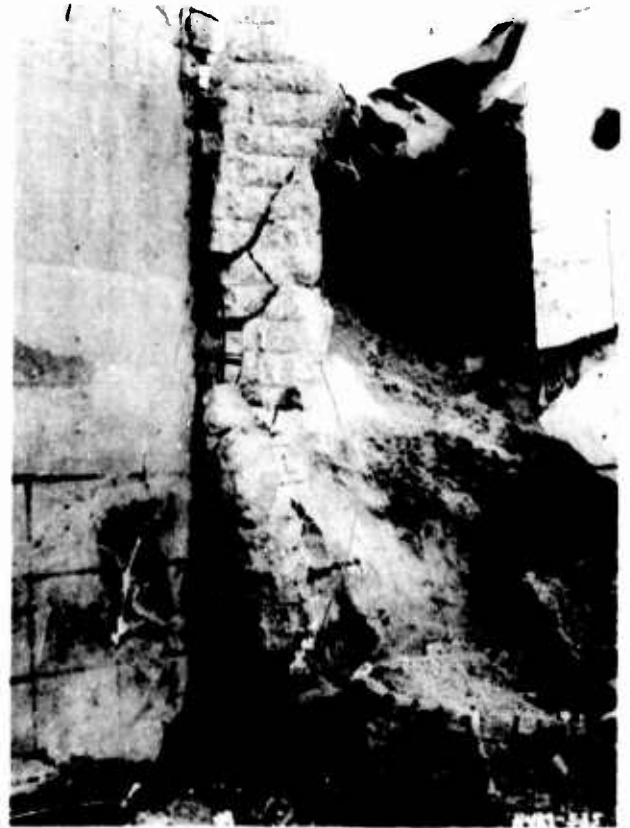
f. Northeast corner.

The northeast edge of the north wall separated from the east wall at the corner as shown in Figure 4.11f. One No. 4 vertical rebar from the outside face mat was left embedded at the east wall. The outside face No. 4 horizontal rebar pulled out at the corner with minimal damage while all of the inside face No. 4 horizontal bars were broken. The corner reinforcement details included No. 5 horizontal steel from the east wall bent 90 deg around the corners into the north wall (see Figure 2.13). On the outside face, 3 No. 5 bars were broken and 13 pulled out of the north wall. On the inside face 4 No. 5's were broken and 10 pulled out.

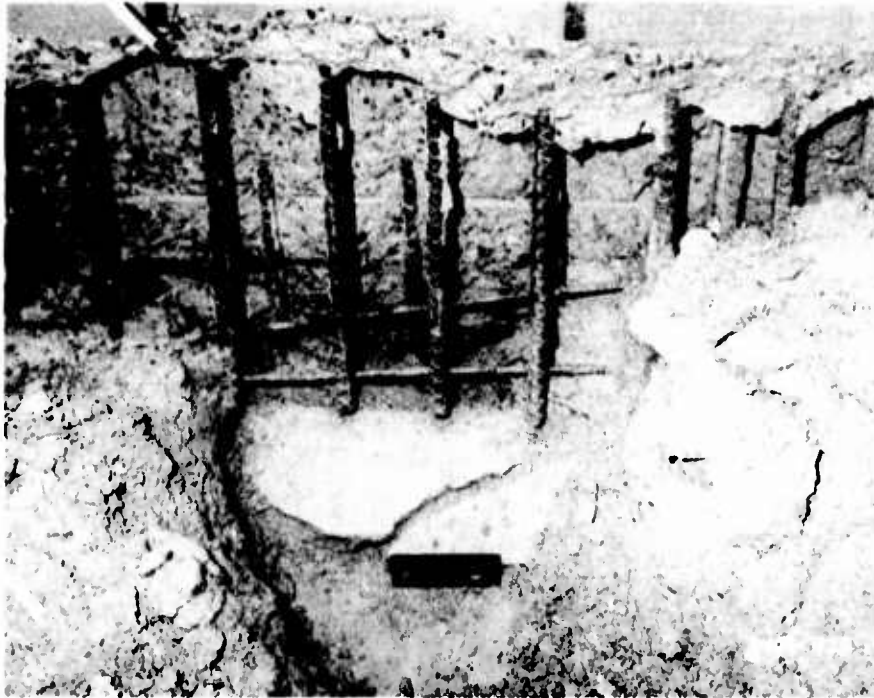
b. Reinforcement separation at base of wall.

Figure 4.12. Posttest view of east donor bay wall.

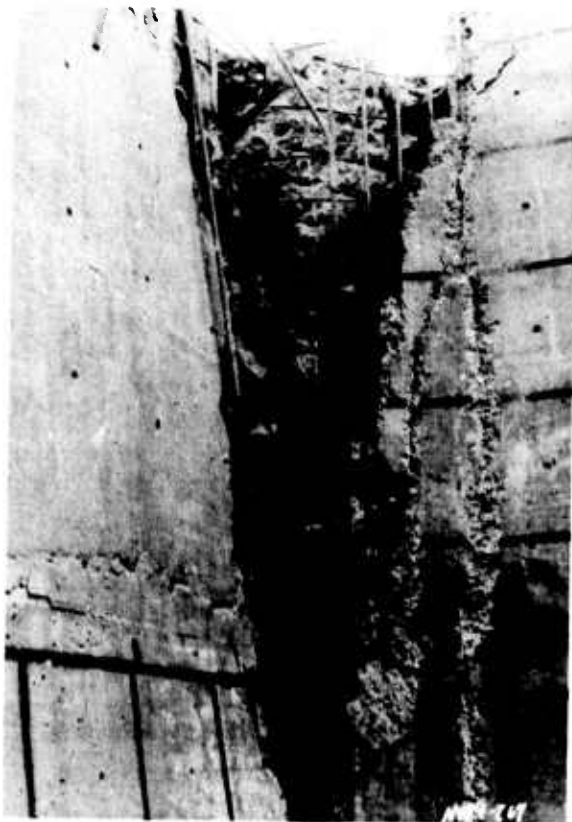
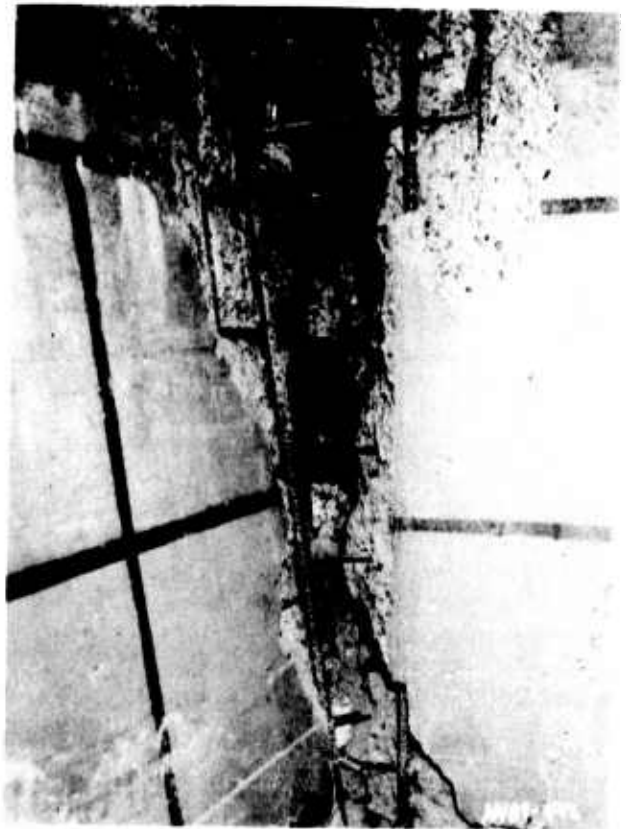
Figure 4.14. Posttest damage to donor bay south wall (Sheet 1 of 3).

c. Upper interior view of southeast corner.

d. Lower interior view of southeast corner.

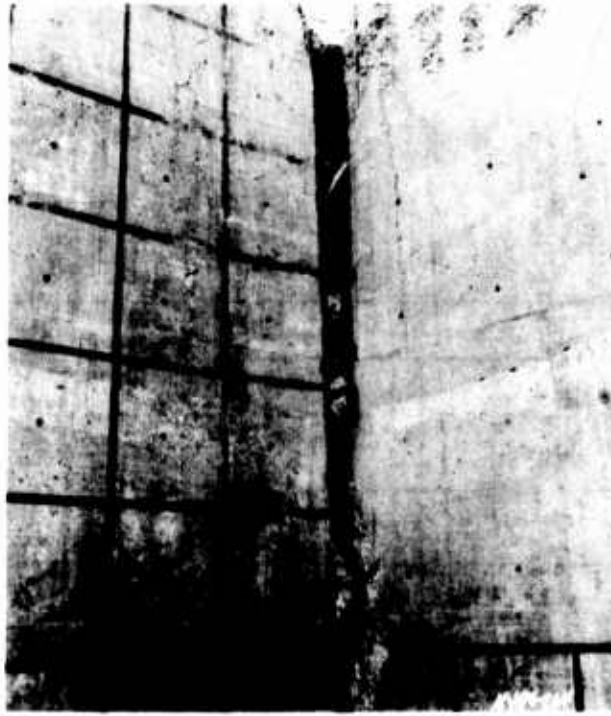
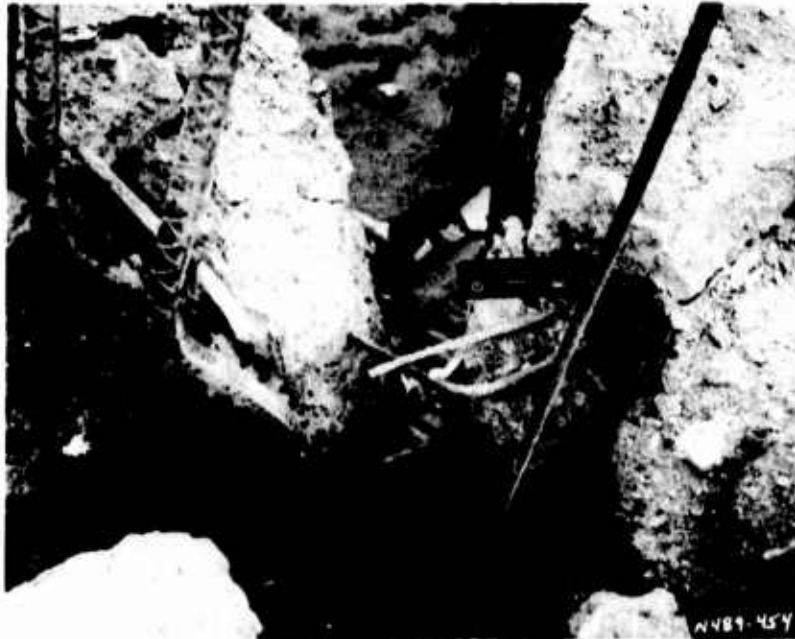
e. Interior view of southwest corner.

f. Exterior view of southwest corner.

Figure 4.14. (Sheet 3 of 3).

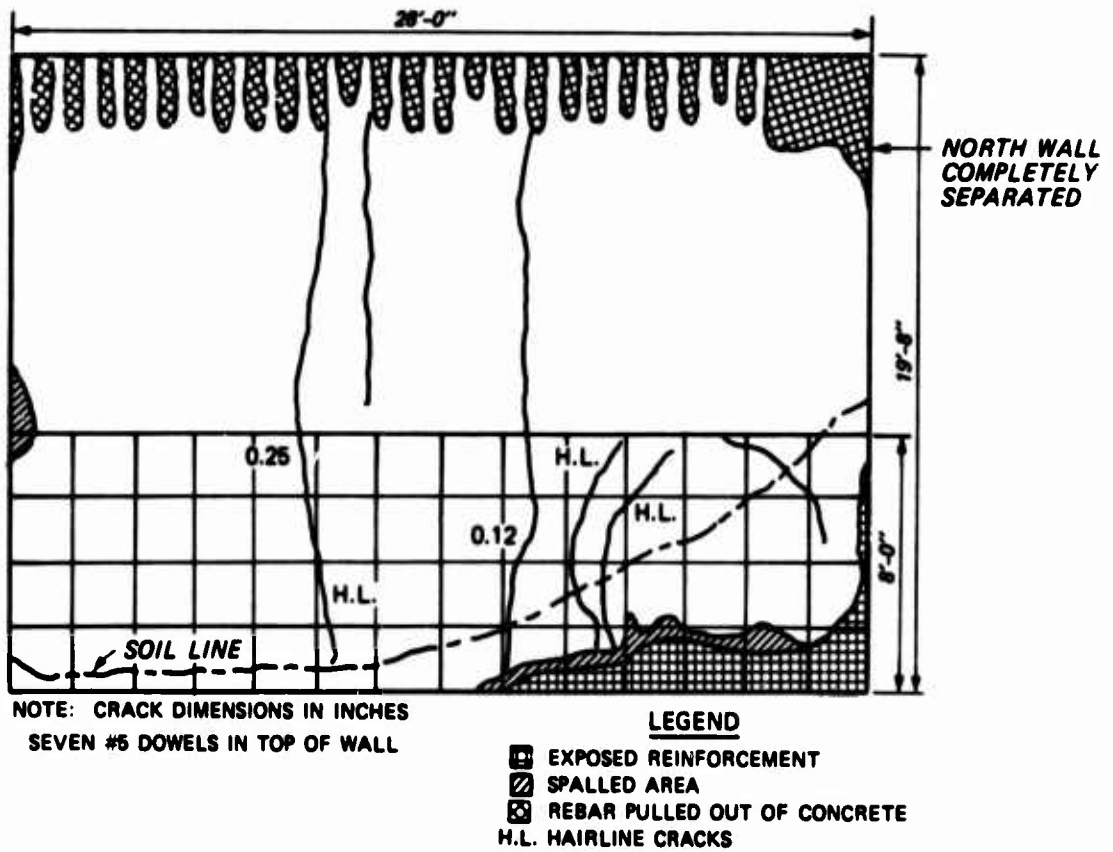
Figure 4.17. Posttest damage to west donor bay wall.

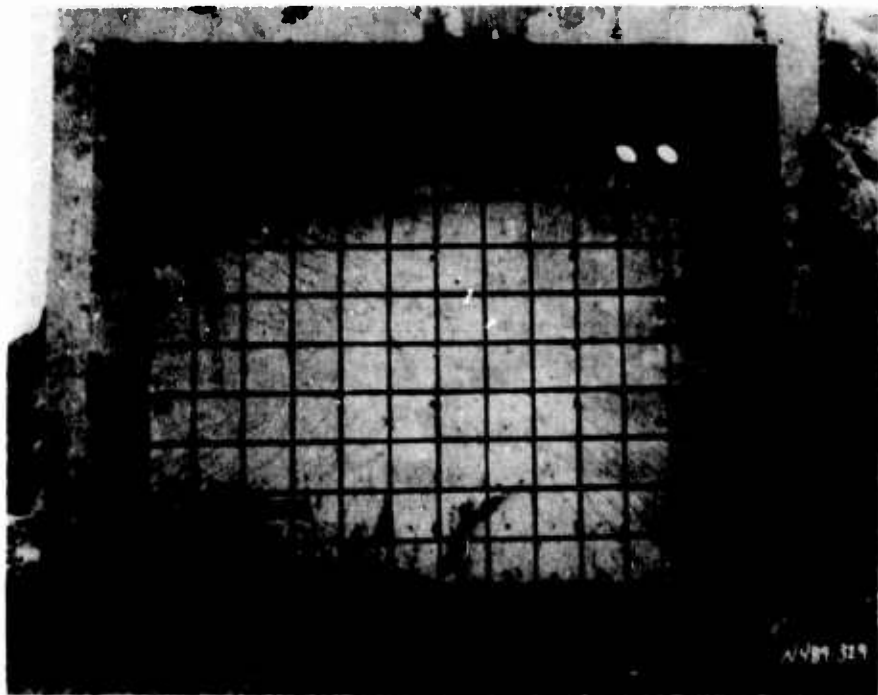
Figure 4.20. Acceptor bay after excavation.

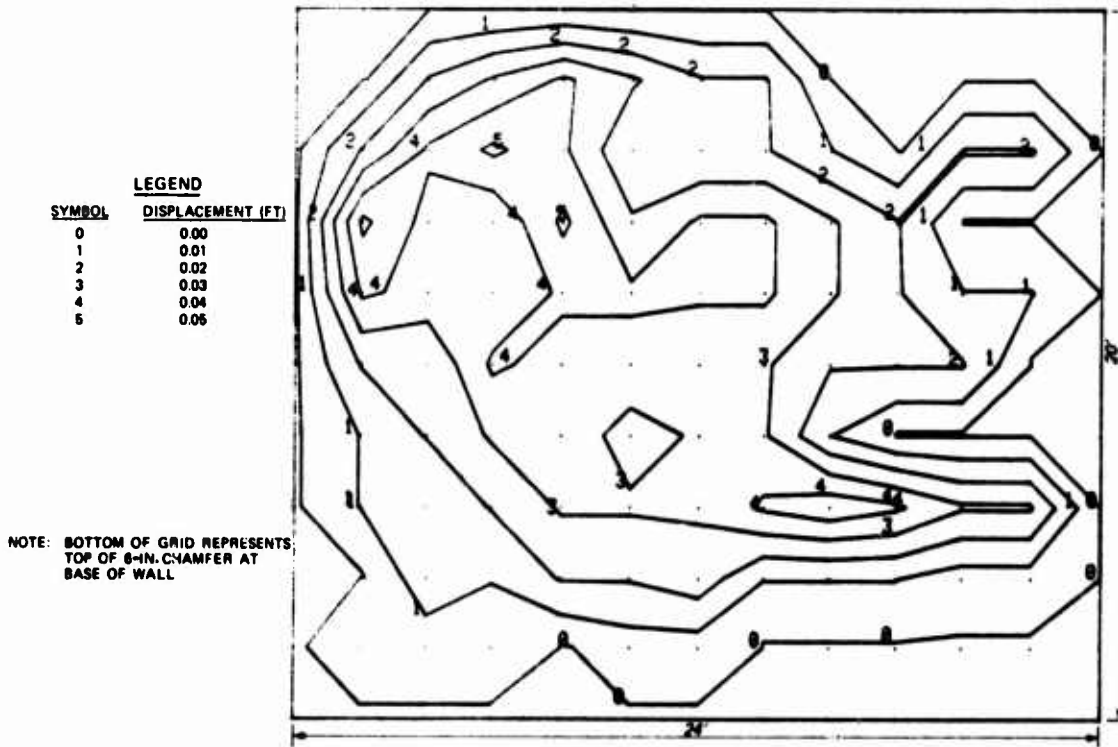
Figure 4.21. Acceptor bay wall posttest displacement contours.

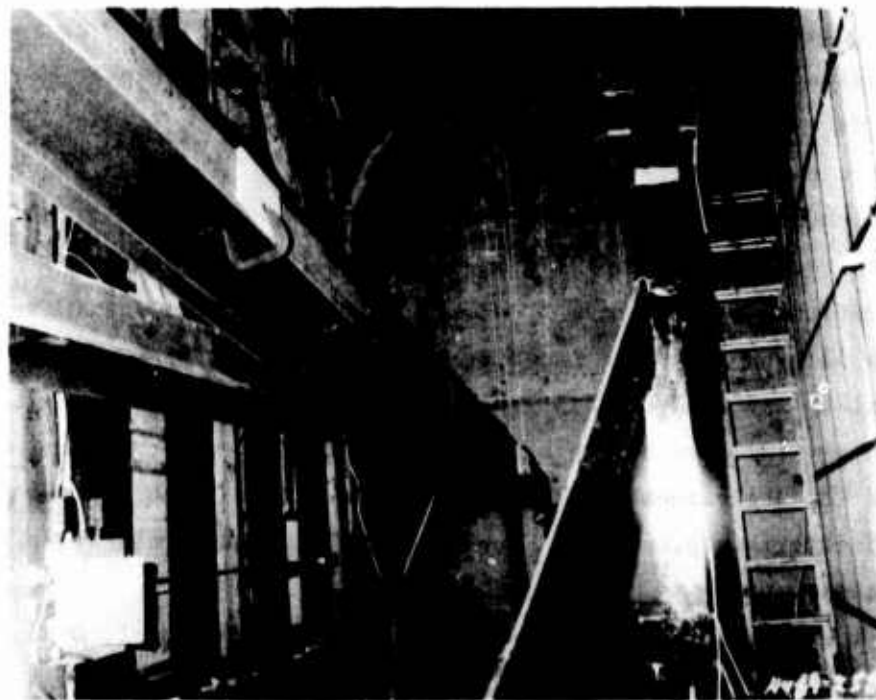
Figure 4.22. Posttest view of acceptor bay north wall.

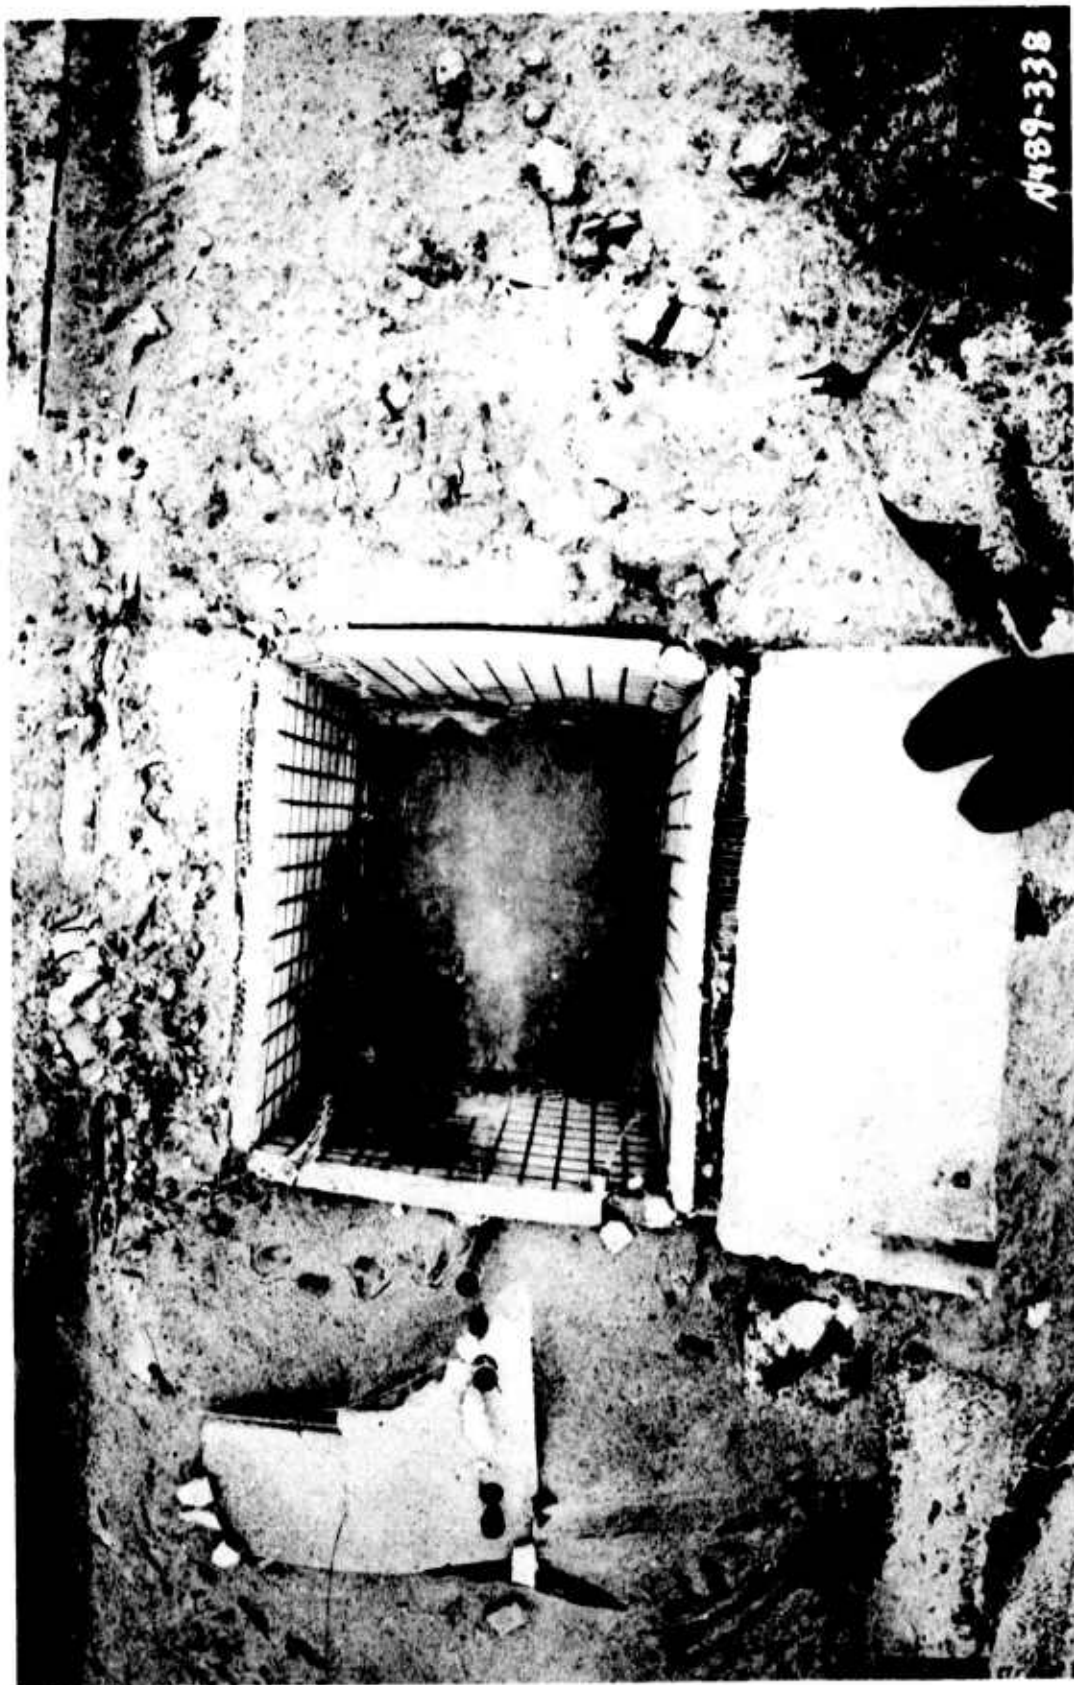
Figure 5.1 shows an overall posttest view of the donor bay. The roof disengaged during the test, with the east half separating and becoming a missile while the west half remained attached to the bay. In general, the north and south walls were the most heavily damaged, with extensive cracking and rotation near the corners in addition to spalling at the base of each wall. The east and west walls exhibited relatively minor vertical cracking but were also spalled near the base. Posttest wall displacements are listed in Table 5.5.

The roof slab broke into two major pieces in accordance with its design philosophy. Three planes of failure developed in the roof, all along a north-south axis. These failure planes included the center line of the roof where there was no reinforcement and at the intersection of the roof with the east and west walls. The east half of the roof completely separated from the bay while the west half remained attached to the bay and was folded over to the west side, Figure 5.1.

Figure 5.1. Posttest top view of donor bay.

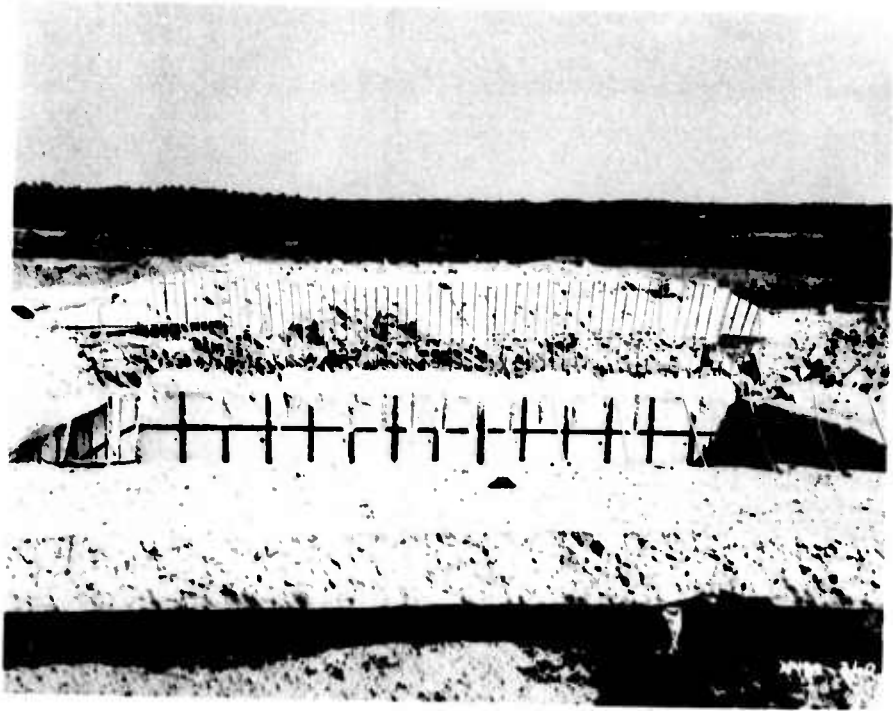
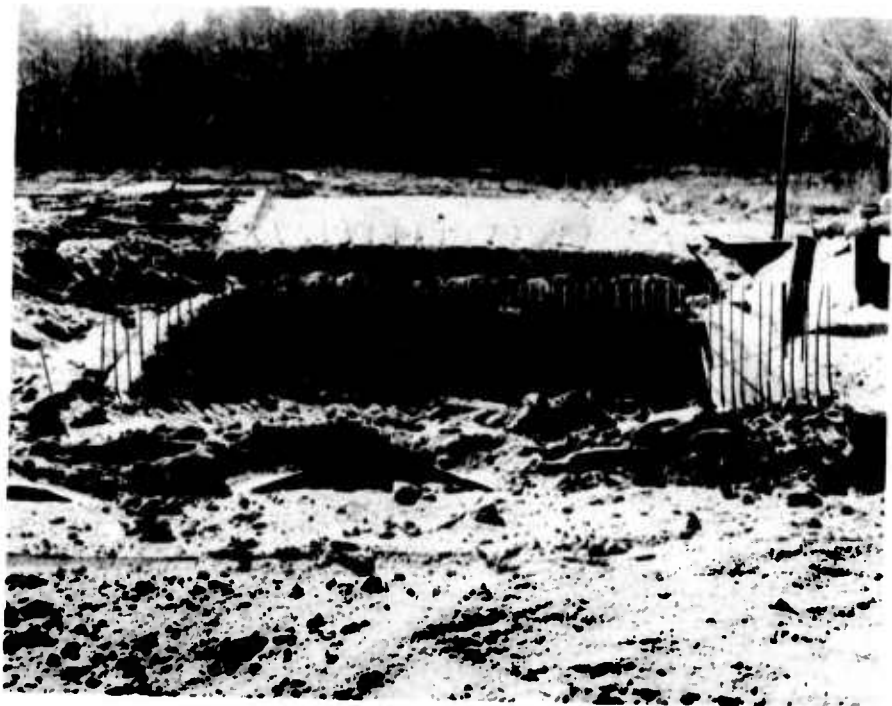
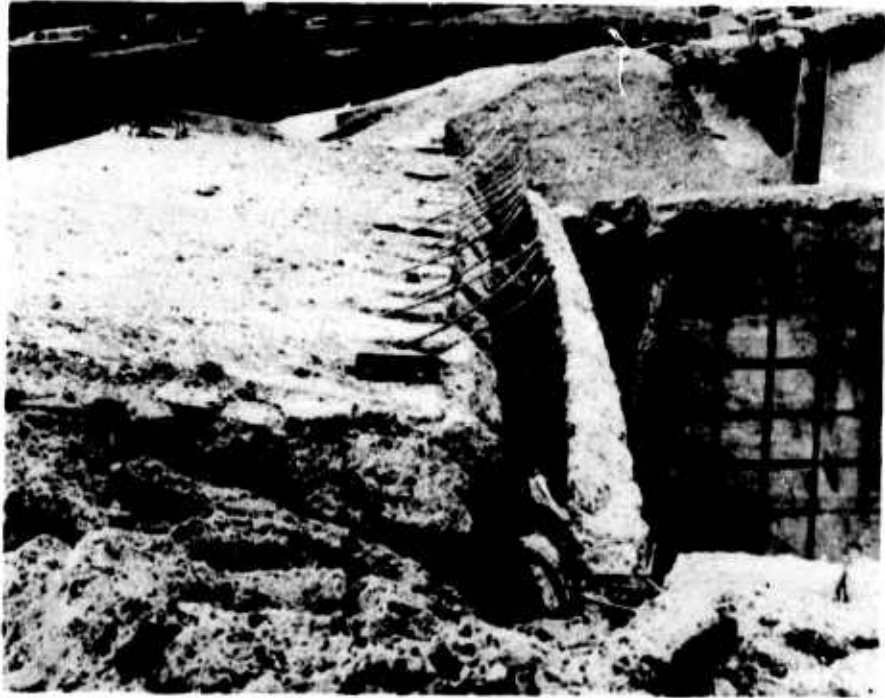
Details of the failure surfaces at the tops of the east and west walls are shown in Figure 5.2. The failure planes along the tops of the east and west walls were inclined at 45-deg angles.

Figure 5.2. Damage to donor bay roof (Sheet 1 of 2).

c. Detail of west half of roof slab.

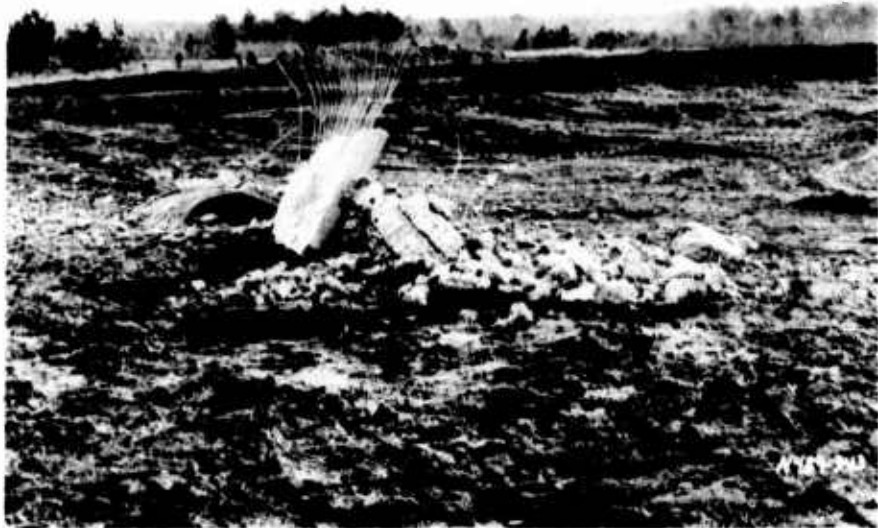
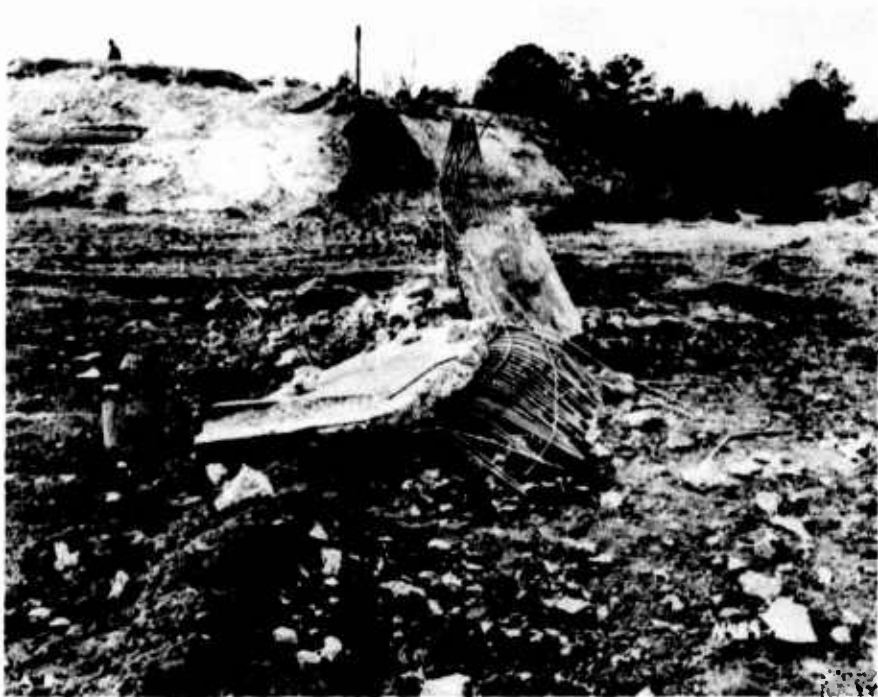
As the east half of the roof slab separated from the bay, the concrete covering the bar splices between the No. 5 bars in the roof and the No. 5 dowels from the walls was spalled and fragmented. The major fragment was 15.5 by 3.54 ft in plan and weighed approximately 6550 lb. It was projected 114 ft from the bay and achieved an impact velocity of 53 fps. The force of impact fractured and twisted the slab into the shape observed in the posttest photographs (Figure 5.3). The small fragments impacted to the east of the donor bay over the simulated acceptor roof slab and the backfill slope. These areas were marked with 6-ft grids and photographed to produce Figure 5.4. No significant fragments impacted on fragment collection boxes. Fragments visible in Figure 5.4b rolled onto the box rather than impacting upon it.

Figure 5.3. Major donor bay roof fragment.

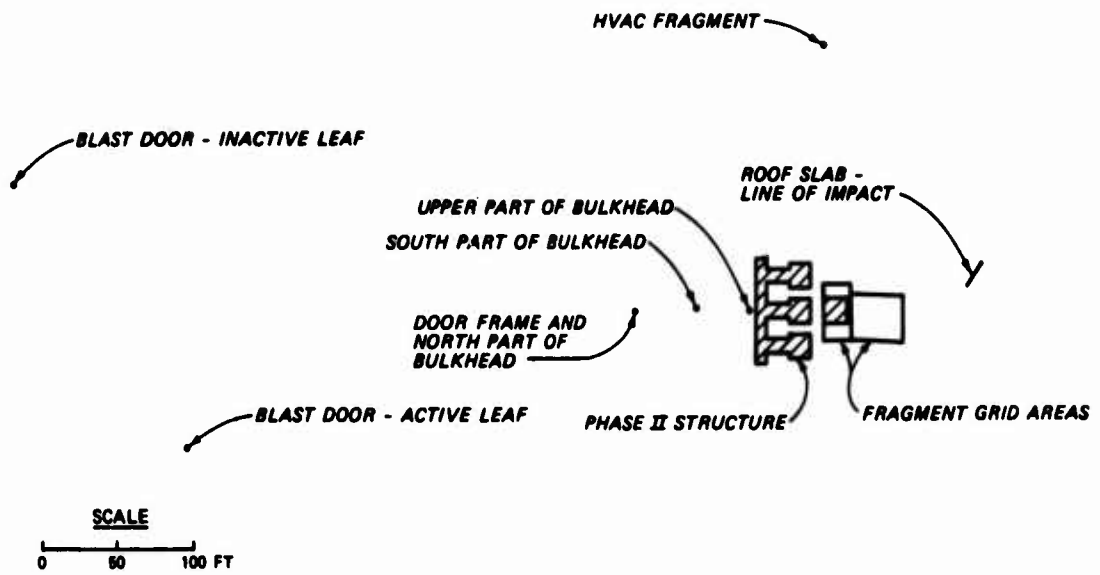
A map of all major fragments and fragment grid areas is presented in Figure 5.5. In addition to the roof fragments, approximately 40 percent of the HVAC penthouse slab broke into fragments which impacted approximately 168 ft north of the bay. Fragments associated with the air lock and blast doors will be discussed in Section 5.5.2.

Figure 5.5. Location of significant fragments from Phase II test.

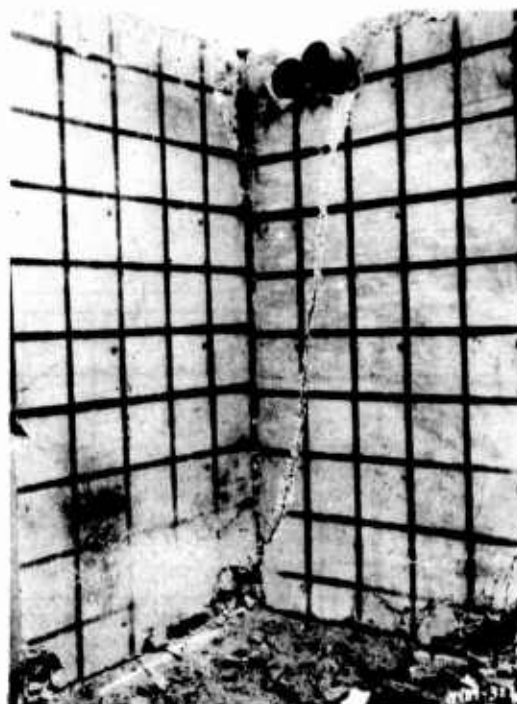
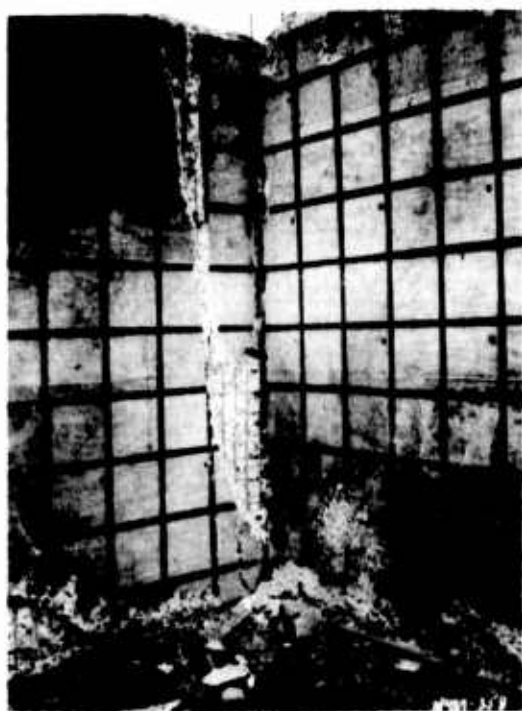
The posttest condition of the north wall is shown in Figure 5.6. The damage was mapped and the map is presented in Figure 5.7. The area adjacent to the explosive charge was badly cracked and spalled leaving a significant portion of the innerface reinforcing steel mat exposed. One vertical crack near the center extended to the top of the wall.

Figure 5.6. Posttest view of north donor bay wall  
(Sheet 1 of 2).

c. Northwest corner.

d. Northeast corner.

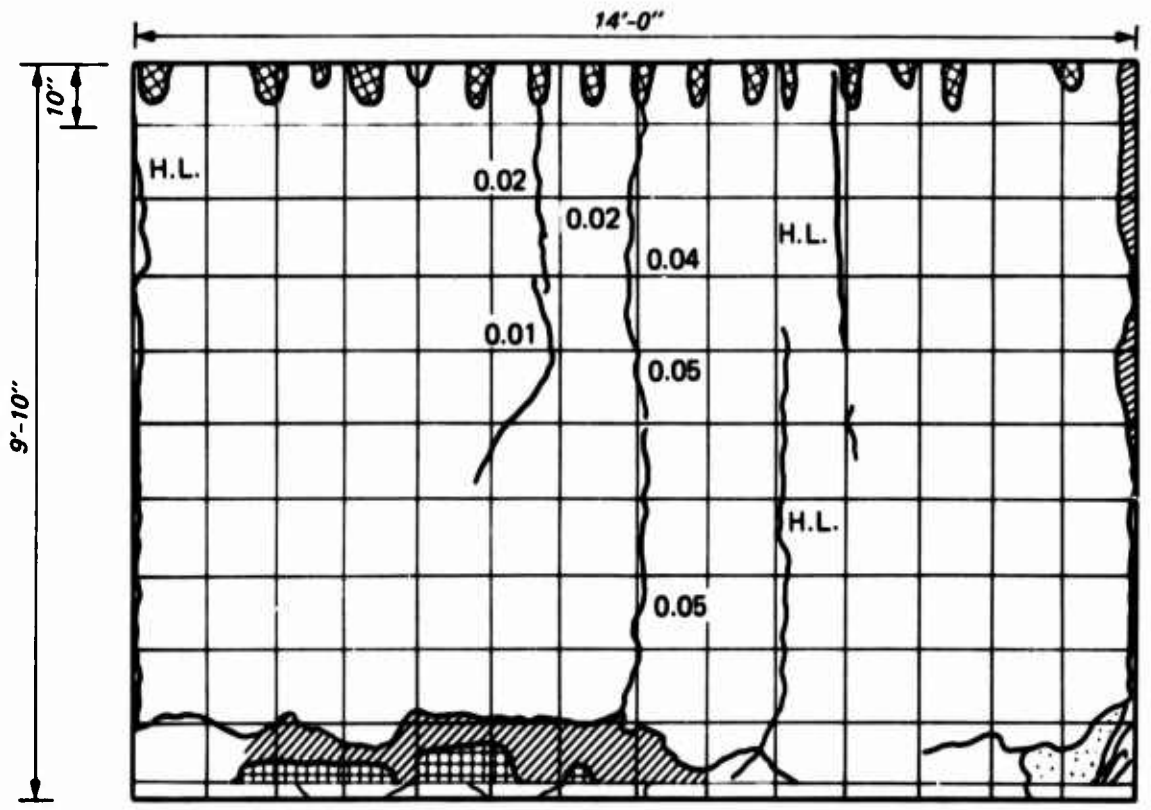
The east wall suffered relatively minor damage during the test. Figure 5.8 shows a posttest view of the wall, and damage is detailed in Figure 5.9. The roof completely separated from the wall and 15 of the No. 3 inside face dowels pulled out of the wall. All of the outside face No. 5 roof dowels remained embedded in the wall but were rotated approximately 64 deg. The corners separated where they joined the north and south walls, but corner damage to the east wall itself was confined to minor spalling. Spalling occurred at the base of the wall, particularly at the north end, leaving some of the reinforcing steel exposed. Several vertical cracks were noted near the center of the wall.
