TECHNICAL REPORT SL-83-6

# AN EVALUATION OF THE SEPARATED BAY CONCEPT FOR A MUNITION ASSEMBLY COMPLEX; AN EXPERIMENTAL INVESTIGATION OF THE DEPARTMENT OF ENERGY BUILDING 12-64 COMPLEX

Structures Laboratory

September 1983

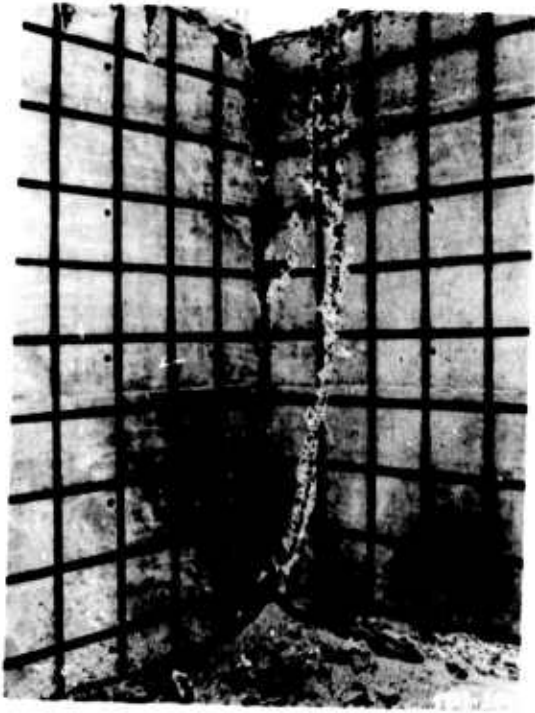
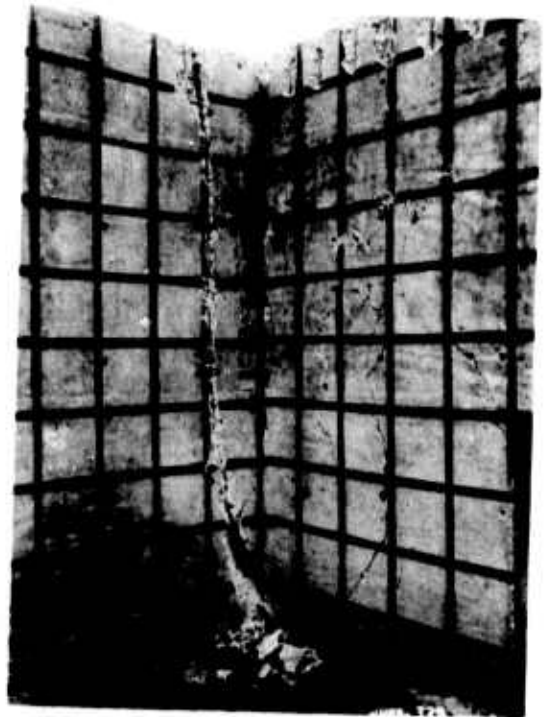
Damage to the south wall was very similar to that of the north wall except there was no local spalling at the center since the charge was detonated near the north wall. The wall is shown in Figure 5.10, and posttest damage is shown in Figure 5.11. Although the corners were seriously damaged, the damage to the remainder of the wall was limited to spalling at the base of the wall and two small vertical cracks which terminated 4 ft from the floor.

c. Southeast corner.

d. Southwest corner.

Figure 5.10. (Sheet 2 of 2).

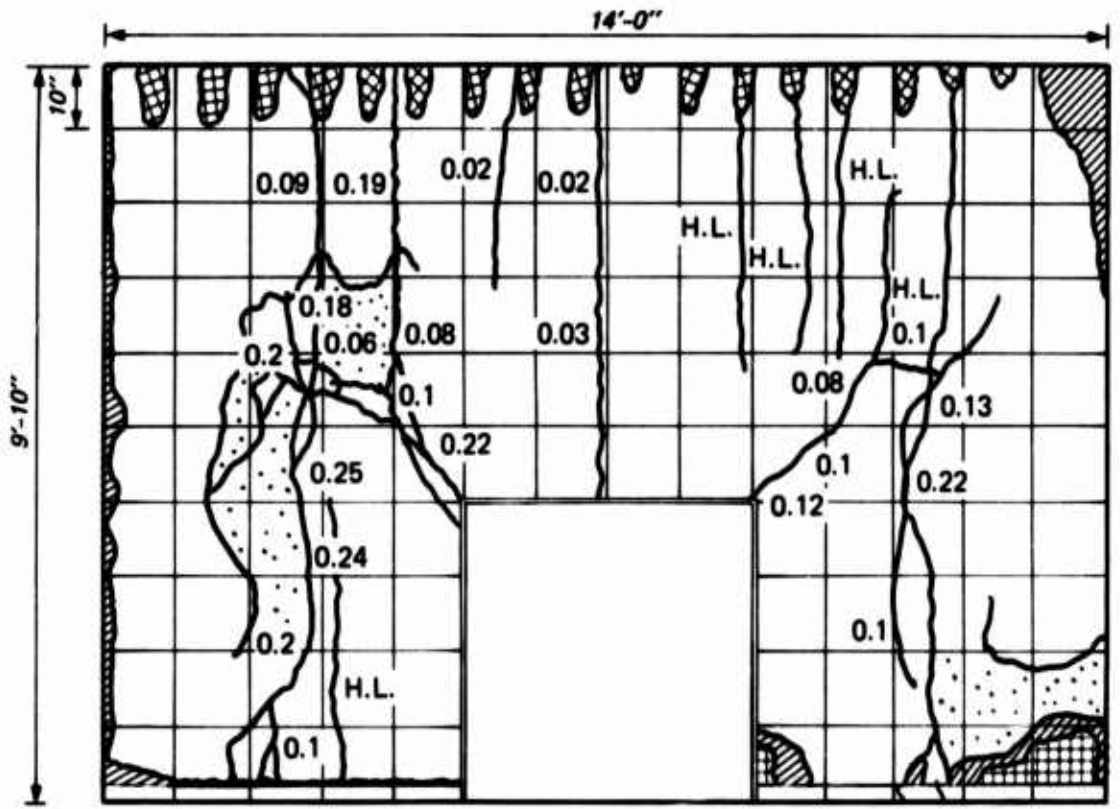
The condition of the west wall after the test is shown in Figure 5.12. Damage to the wall is displayed in Figure 5.13. The disengagement of the roof pulled the inside face No. 3 dowels out of the wall. But unlike the other side of the roof, the west half of the roof remained connected to the No. 5 outside face roof dowels and merely flipped open without tearing loose from the bay. The corners of the walls incurred only minor spalling. Significant spalling occurred at the north end of the wall near the base. The rebar was exposed at the corner of the air-lock opening and adjacent to the north wall. Numerous cracks occurred near the intersection of the bay wall and the air-lock walls.

Figure 5.13. Posttest damage to west donor bay wall.

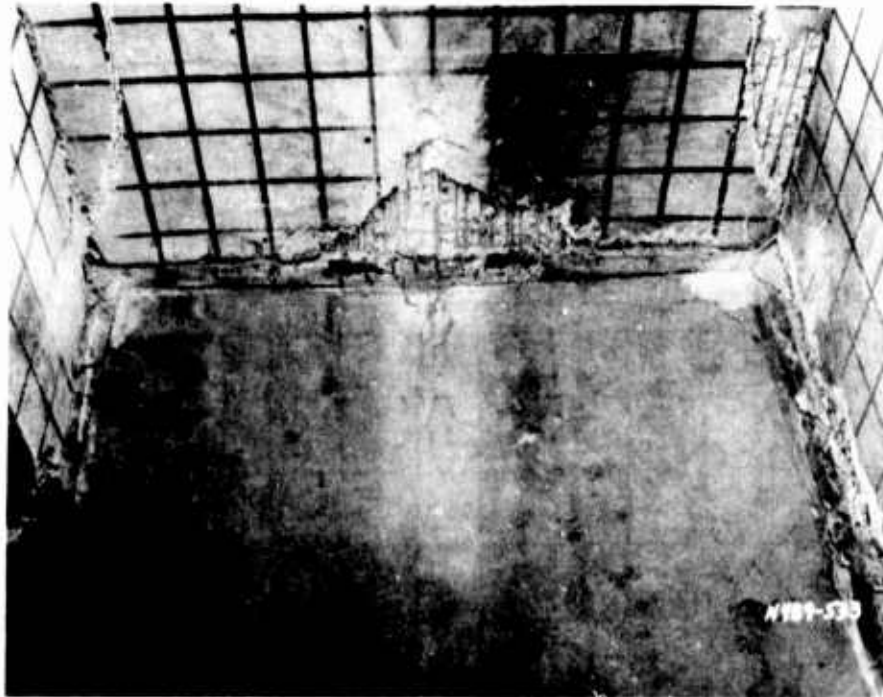
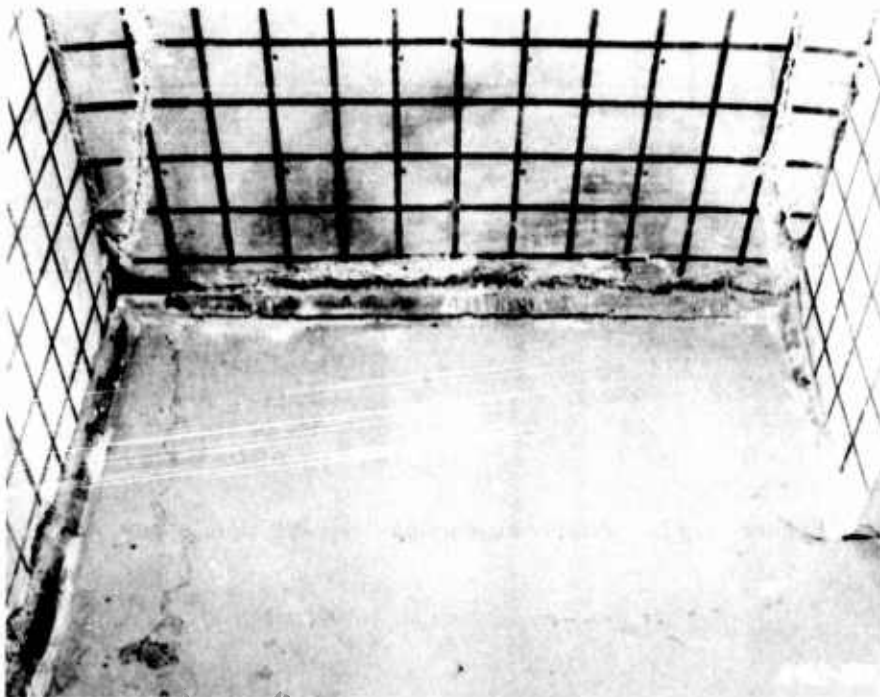
Damage to the floor slab included hairline cracks near the location of the explosive charge and cracks adjacent to the east and west walls. Spalling was limited to an area near the northwest corner of the slab. A pictorial view of the slab is shown in Figure 5.14 and the damage is mapped in Figure 5.15.

Figure 5.14. Posttest view of donor bay floor after removal of debris.

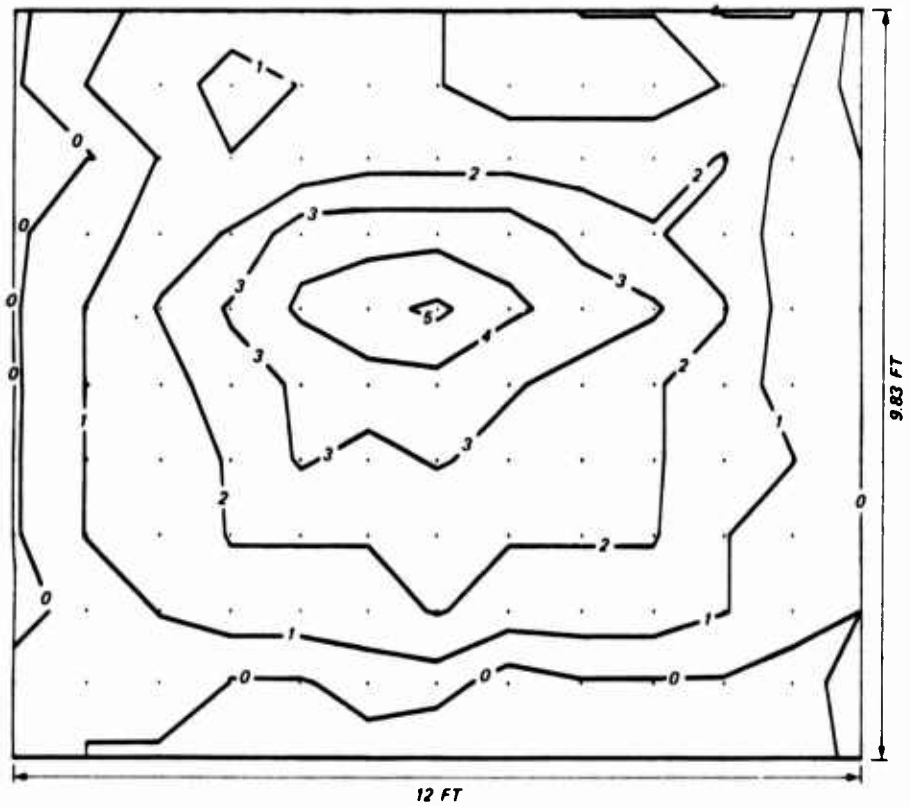
The permanent displacements in the south wall are listed in Table 5.6. These deflections were measured at the locations of the grid intersections shown in Figures 5.17-5.18. Figure 5.19 is a deflection contour map of the

Figure 5.19. Deflection contour map of acceptor bay south wall.

The crack pattern and posttest deflections show that the acceptor bay wall responded in a flexural mode. This is consistent with the load distribution measured on the face of the wall. There was no indication of a punching shear failure.

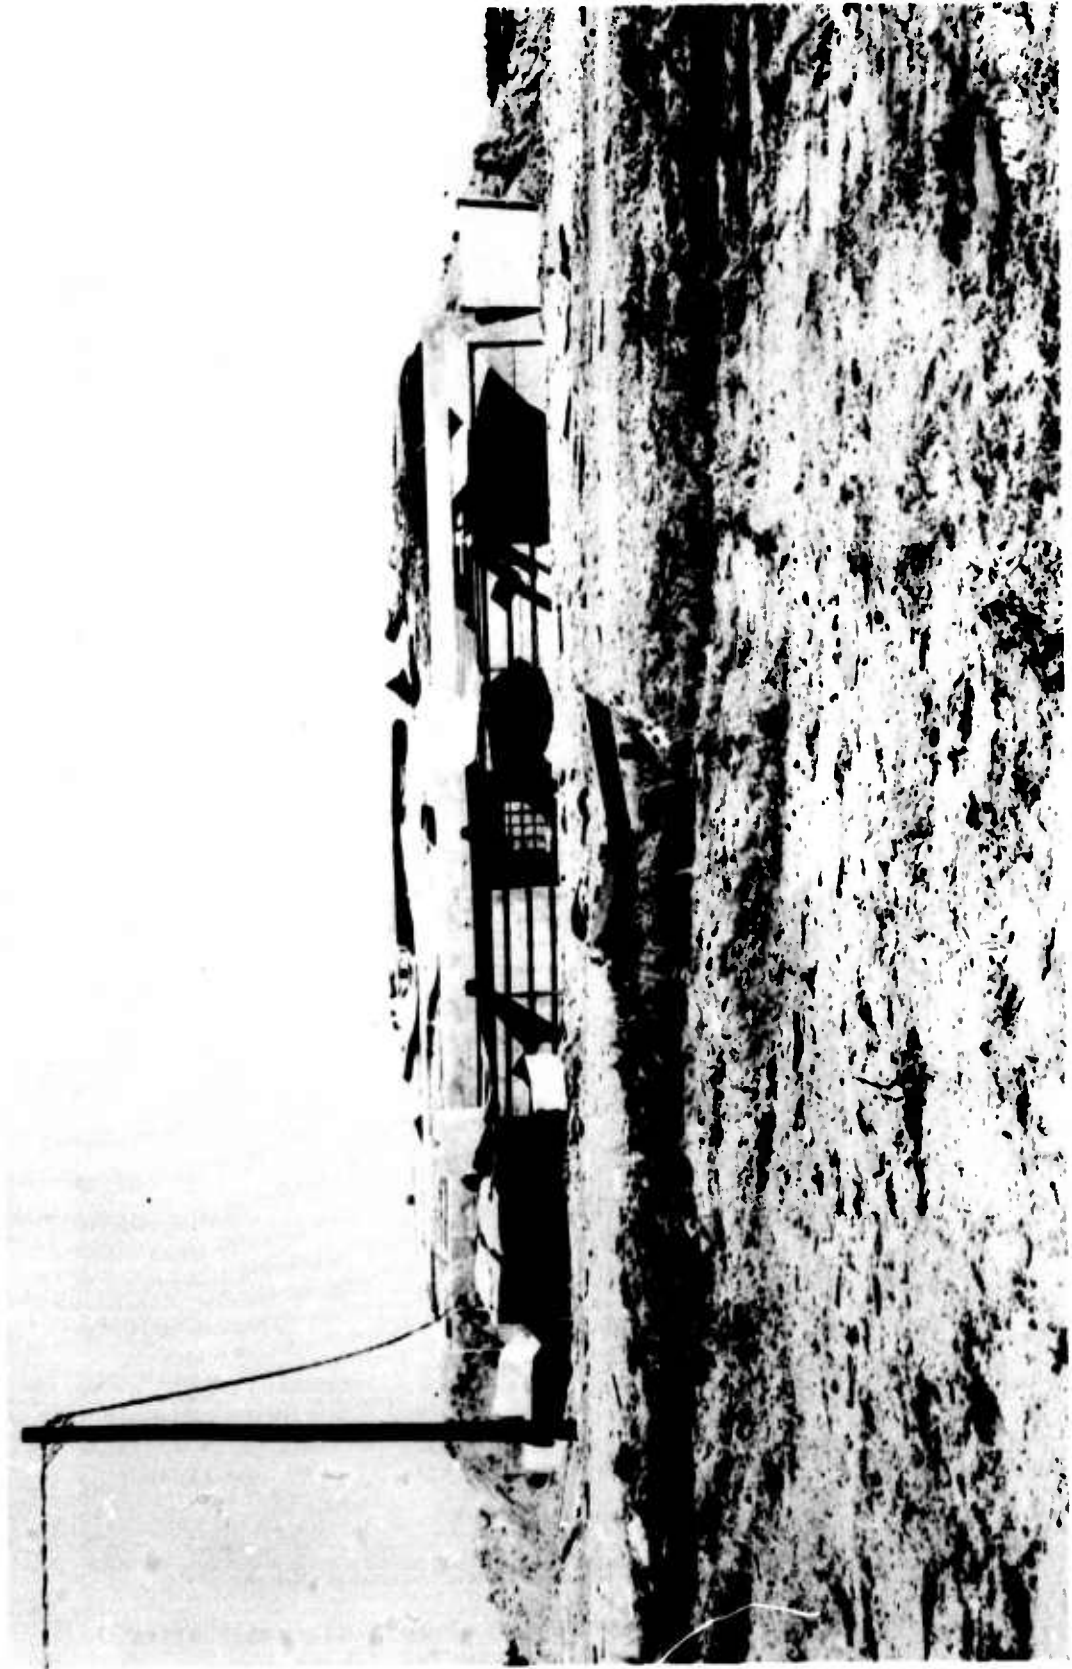
An overall posttest view of the ramp and Phase II structure is shown in Figure 5.20. All of the cementso board on the walls and virtually all of it on the roof were destroyed during the test. All aluminum roofing material was removed. The aluminum sheets seen on the ramp in Figure 5.20 fell back to that position after the test. Figure 5.21 shows a more detailed view of the ramp damage. All of the self-tapping screws remained in place as the cementso board fractured around them. The column in front of the donor bay was struck by debris from the air lock and broke away from the roof beam. It came to rest 417 ft east of the ramp. The girt attached to the column also broke away from the ramp and impacted several feet from the ramp. The impact load transmitted to the ramp also caused the beam and column immediately north of the donor bay air lock to break away from the retaining wall and to shear column baseplate bolts. The displacement of this member can be seen in Figure 5.21.

Figure 5.20. Posttest view of Phase II structure.

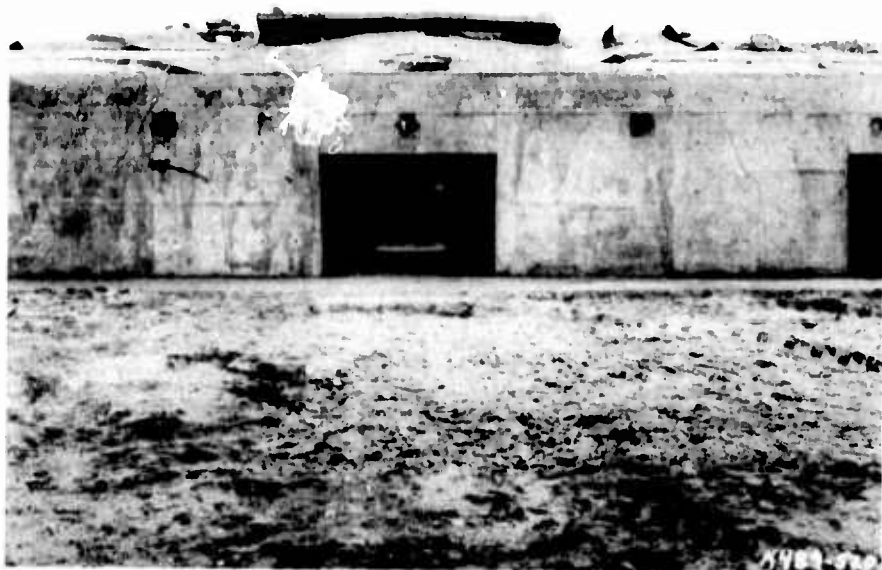
Figure 5.22. Posttest view of retaining wall after removal of ramp and debris.

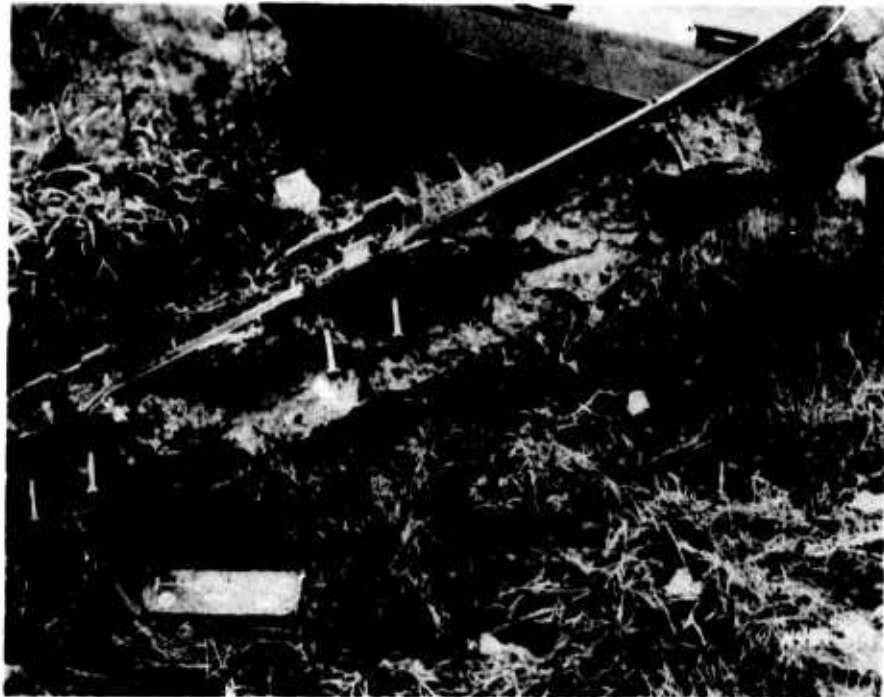
c. Detail of south side.

Figure 5.27. Damage to donor bay blast door frame and north part of bulkhead (Sheet 1 of 2).

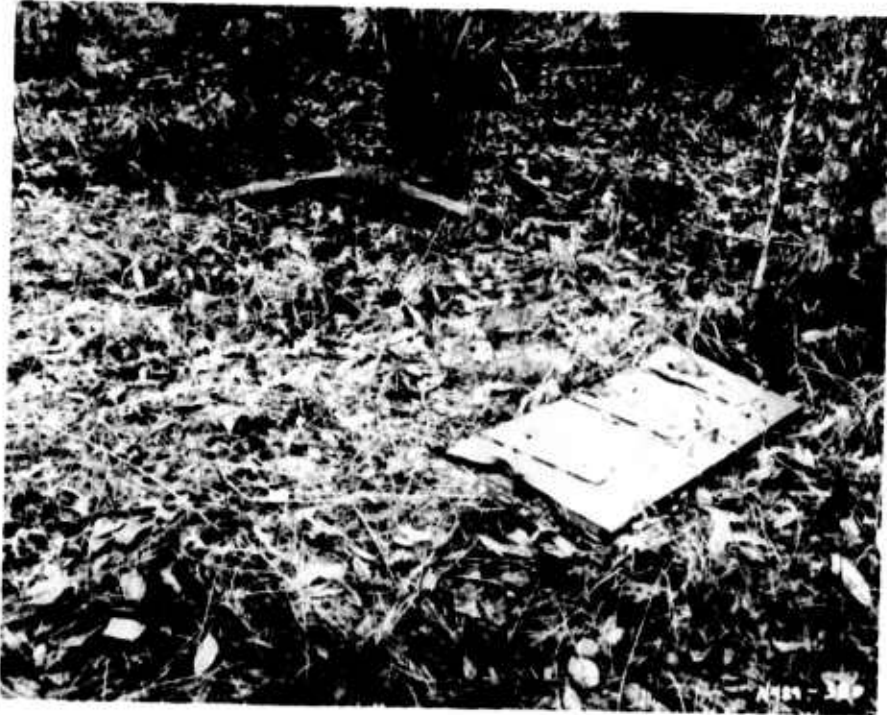
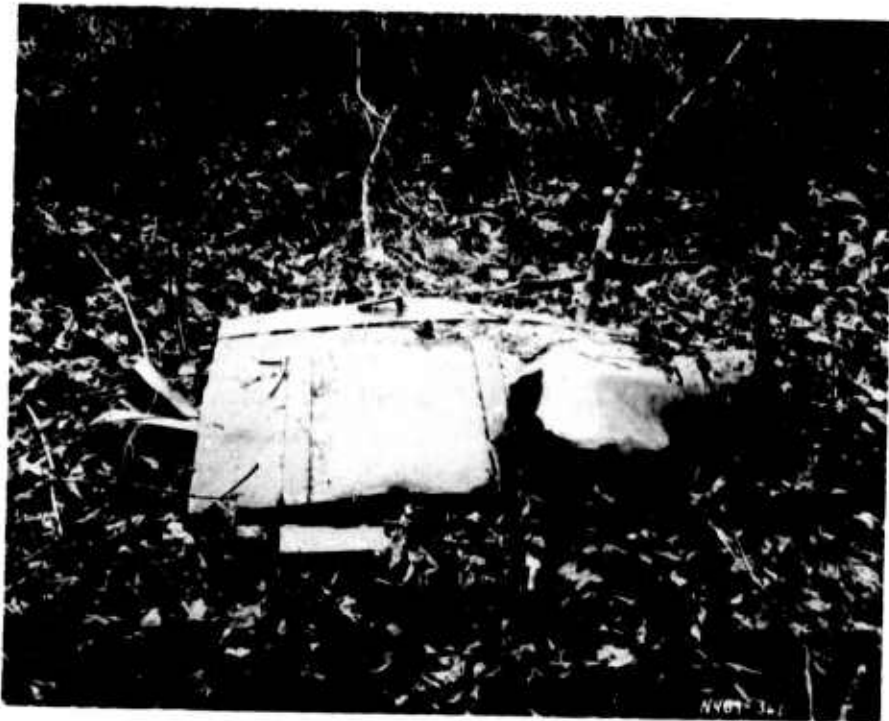
Figure 5.28. Posttest view of donor bay blast doors.
