MULTIPLE-PURPOSE PROJECT KANSAS RIVER BASIN REPUBLICAN  
RIVER KANSAS MILFO. (U) CORPS OF ENGINEERS KANSAS CITY  
MO KANSAS CITY DISTRICT S D MARKWELL ET AL. OCT 83

| REPORT DOCUMENTATION PAGE | | READ INSTRUCTIONS<br>BEFORE COMPLETING FORM |
|---|---|---|
| 4. TITLE (and Subtitle)<br>MULTIPLE-PURPOSE PROJECT KANSAS RIVER BASIN<br>REPUBLICAN RIVER MILFORD LAKE<br>OPERATION AND MAINTENANCE MANUAL<br>APPENDIX IV<br>CONSTRUCTION FOUNDATION REPORT | | 5. TYPE OF REPORT & PERIOD COVERED<br>Construction Foundation<br>Report<br>From June 1962 to Dec 1966 |

APPENDIX IV  
CONSTRUCTION FOUNDATION REPORT

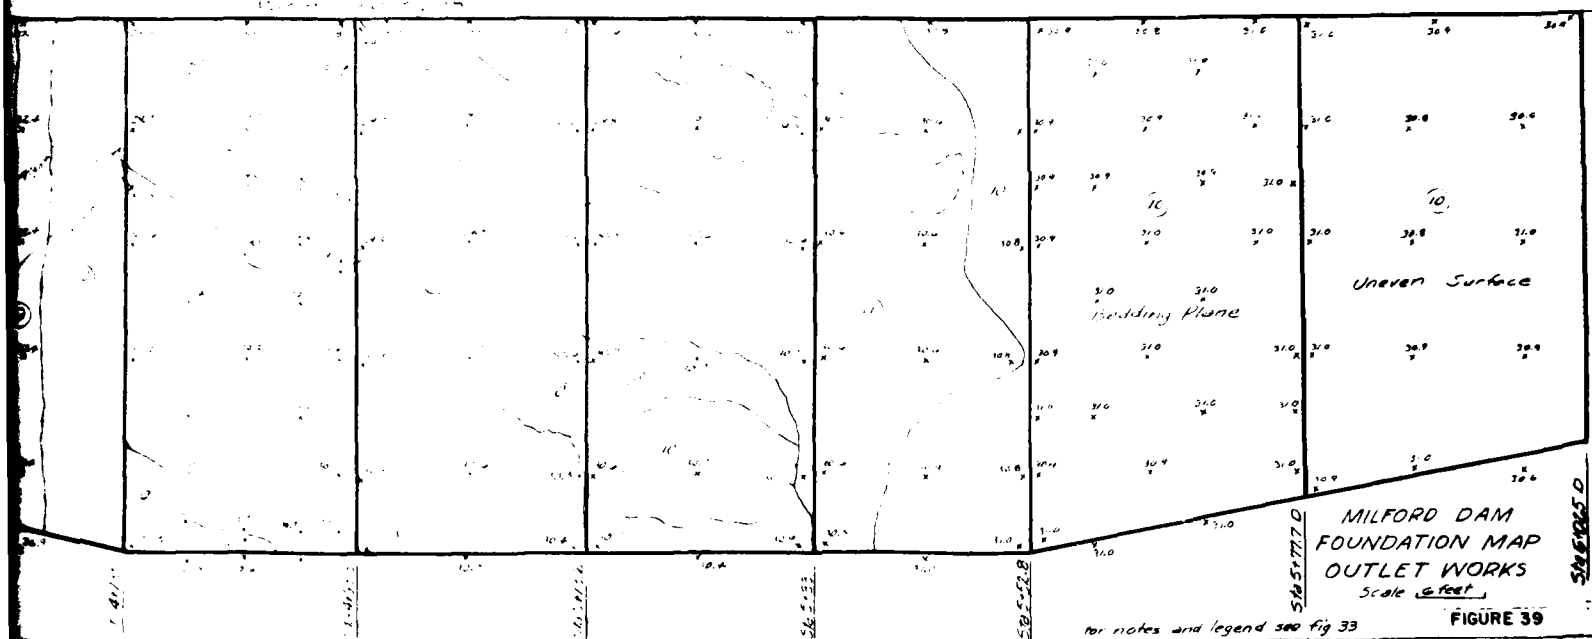
FIGURE 39

a. General. Extensive bedrock jointing was encountered during foundation preparation beneath the upstream portion of the structure. Each individual joint and fracture was mapped as to strike, condition, and seepage as shown on figures 10 thru 13 and on figures 33 thru 39. Three sets of joint trends were recognized. The major trend was N70°E and the minor trend varied from N40°W to N50°W. A third set trends N85°E and parallels the outcrop face (see figure 10). The third trend reflects the mechanical adjustment of the bedrock zone adjacent to the outcrop face due to the erosion of the river valley. All joints were vertical in the foundation and ranged from tight to open several inches. Seepage from the joints was minimal and was generally confined to the upstream sections below elevation 1075.

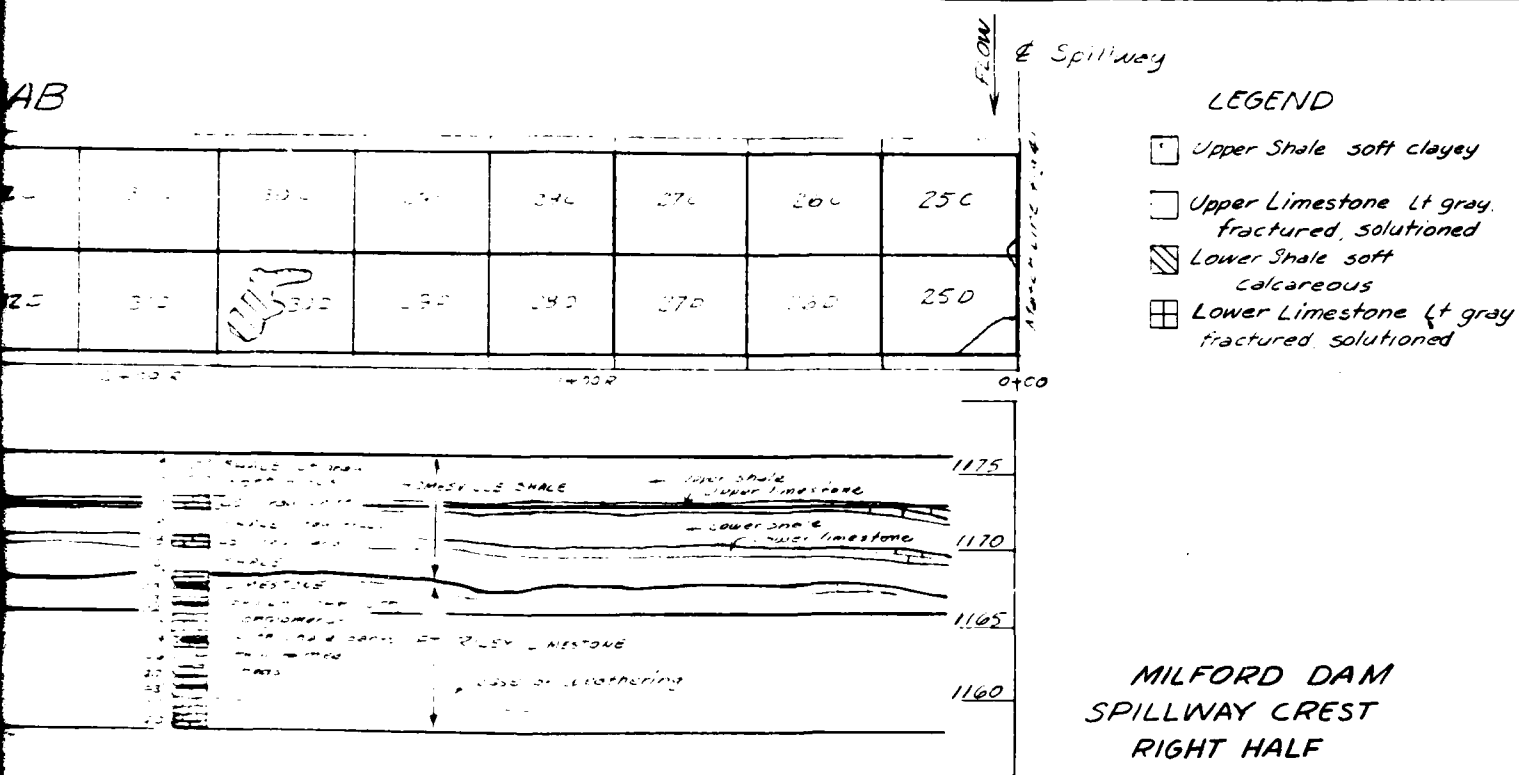
FIGURE 40

5-04. Spillway Sill Foundation. The lower Holmesville shale is the foundation for the crest slab. See foundation map plan and profile spillway, figures 40 and 41. The middle green zone in the south end and the two limestone beds of this member are the foundation toward the north end. For details of the foundation conditions beneath the main sill slab see spillway sill plan and profiles. Foundation of the upper slopes of the sill are Towanda limestone of relatively good quality. Riprap up to elevation 1085 on the north slope and 1083 on the south slope as well as the concrete slabs rest on the upper Holmesville shale.
