NAVAL CIVIL ENGINEERING LABORATORY  
Port Hueneme, California

FIELD STUDY ON MOISTURE PROBLEMS IN EXTERIOR WALLS OF  
FAMILY HOUSING UNITS AT NAVAL AIR STATION PENSACOLA, FLORIDA

February 1984

An Investigation Conducted by  
H.R. TRECHSEL ASSOCIATES  
P.O. Box 211  
Germantown, MD 20874

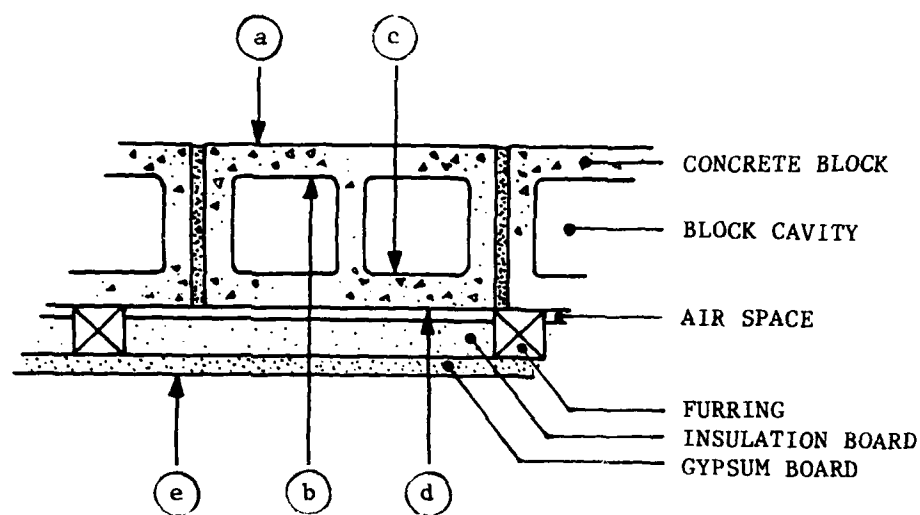
Figure 9. Surface Temperature Probe Locations

4.8.4 Surface Temperatures. Surface temperatures were measured only in November and May and only at Stations 1 and 3. The temperature was measured at the indoor and outdoor exposed wall surfaces, at the indoor face of the concrete block, and at the two faces of the wall cavities. Figure 9 gives the probe locations.

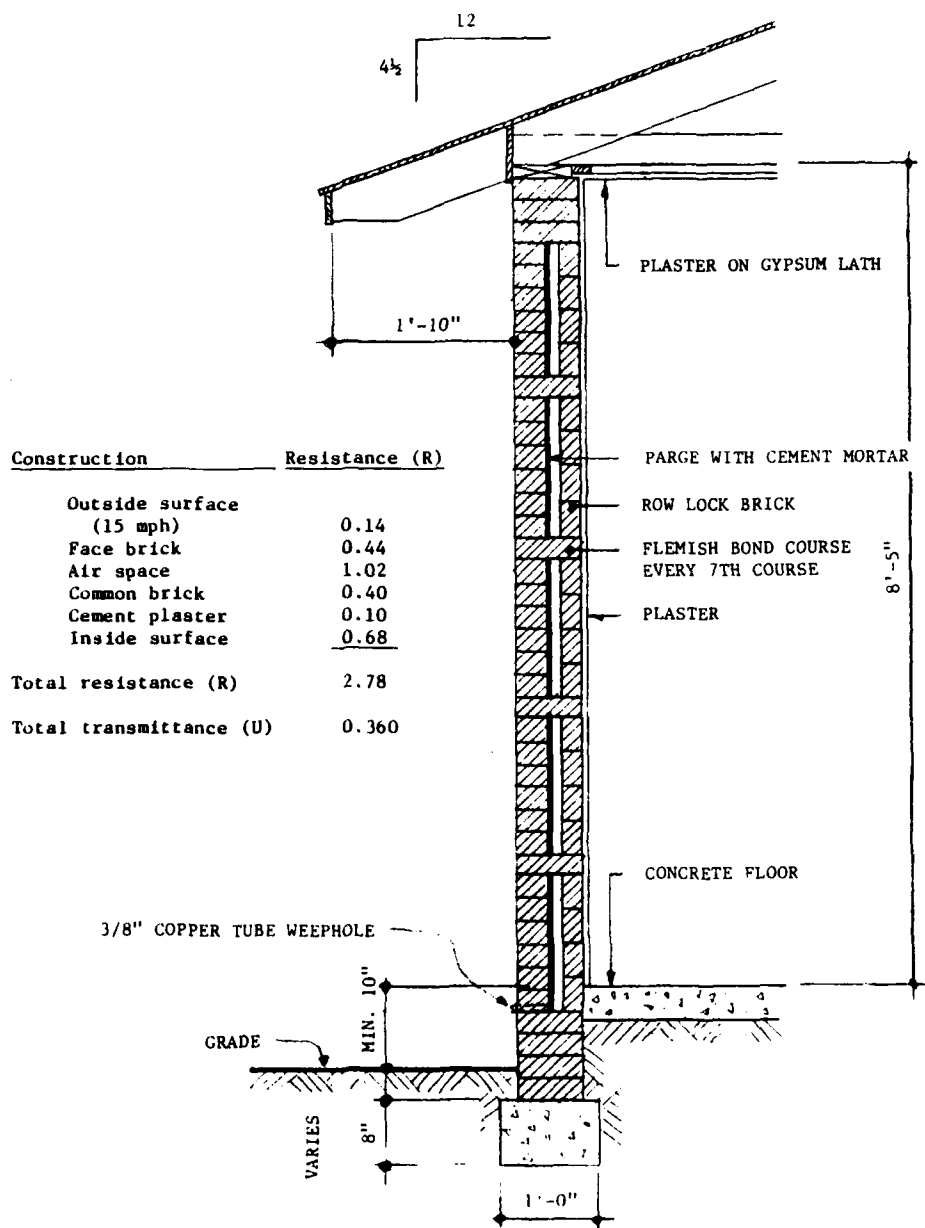
Figure 16. Wall Section Lexington Terrace

The Lexington Terrace units are two-bedroom one-story semi-detached houses. They are built on a slab on grade, and exterior walls are brick masonry cavity walls, as shown on Figure 16. Their floor area is approximately 650 square feet. The roof is asphalt shingle hip with small triangular ventilation openings. Ceiling insulation is about 3 inches, without vapor retarder. The single bathrooms have one window, but no mechanical ventilation. The kitchen is equipped with an exhaust fan. A small utility/storage room has provision for installing washer and dryer. Most dryers at least appear to be vented through the roof. The houses have central gas-fired hot-air heat, but not central air conditioning. The houses are wired for window air conditioners, and about half of the houses have at least one window unit 10/. The houses were built in 1941.

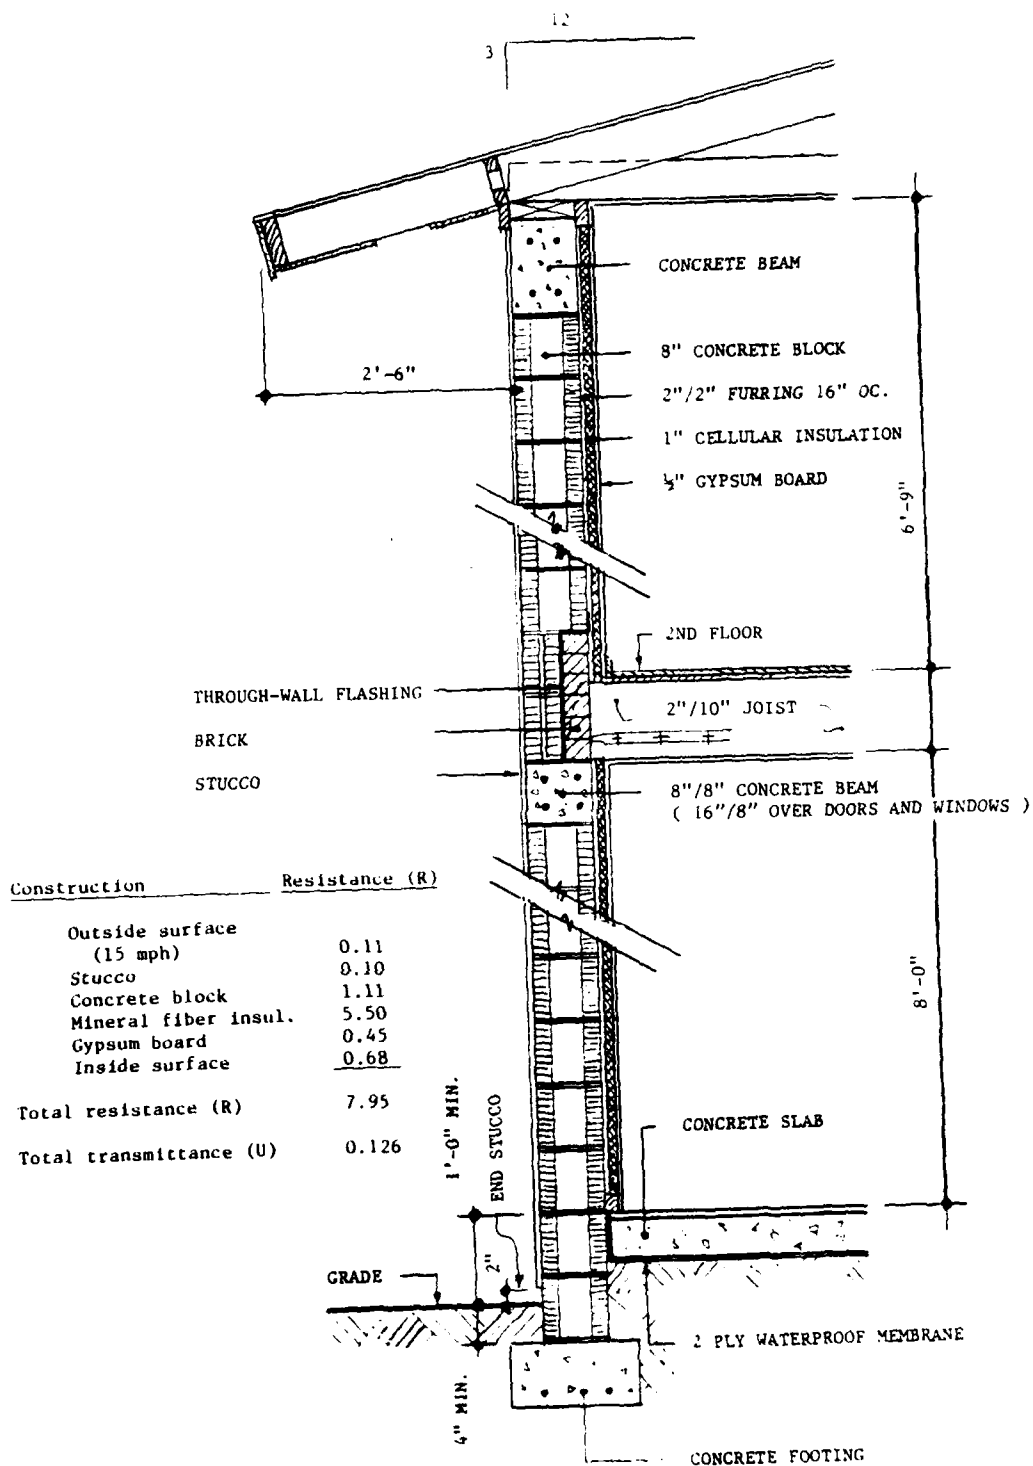
Figure 18. Wall Section Townhouses

Although the townhouses (on Base) were included in the original field visit, they were not investigated during this study except for two air-infiltration tests. Unlike Lexington Terrace and Corry Field, the townhouses are two-story rowhouses. They are larger than the Corry units. The wall sections are similar to Corry, except that the exterior has a stucco finish, as shown in Figure 18. One wall on the second floor is frame construction with wood sheathing. The houses were built about 1966. Unlike Corry and Lexington, the townhouses are in an area with large trees providing some shade and protection from driving rain.

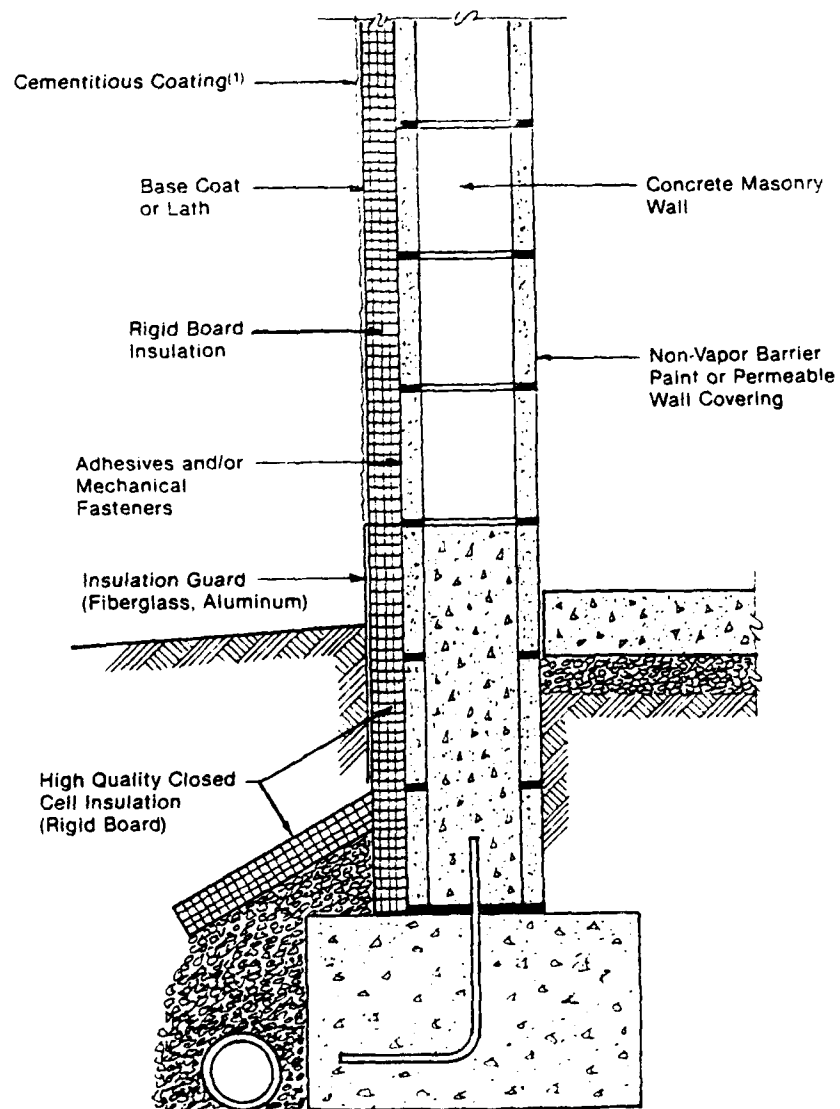
Figure 19. Concrete Block Wall with Exterior Insulation

- o An alternative high quality solution for concrete block walls would be the application of a closed-cell rigid plastic foam board on the exterior covered by a protective coating. This system has advantages resulting from placing the insulation on the building exterior and would provide a positive moisture proof shield. The system is described in a technical note by NCMA 12/. Figure 19 is reprinted from that TEK (see also Appendix 4). (Note that in this solution it is recommended that no vapor retarder be applied to the interior of the block wall.)
