REPORT NO. NADC-83123-60

## PERFORMANCE EVALUATION OF THE HI-SPEED EJECTION LIMB PROTECTION SYSTEMS (HELPS)

Ken Miller  
Aircraft and Crew System Technology Directorate  
NAVAL AIR DEVELOPMENT CENTER  
Warminster, PA 18974

PHASE REPORT  
PROGRAM ELEMENT-63216N  
Work Unit No.-W0584001

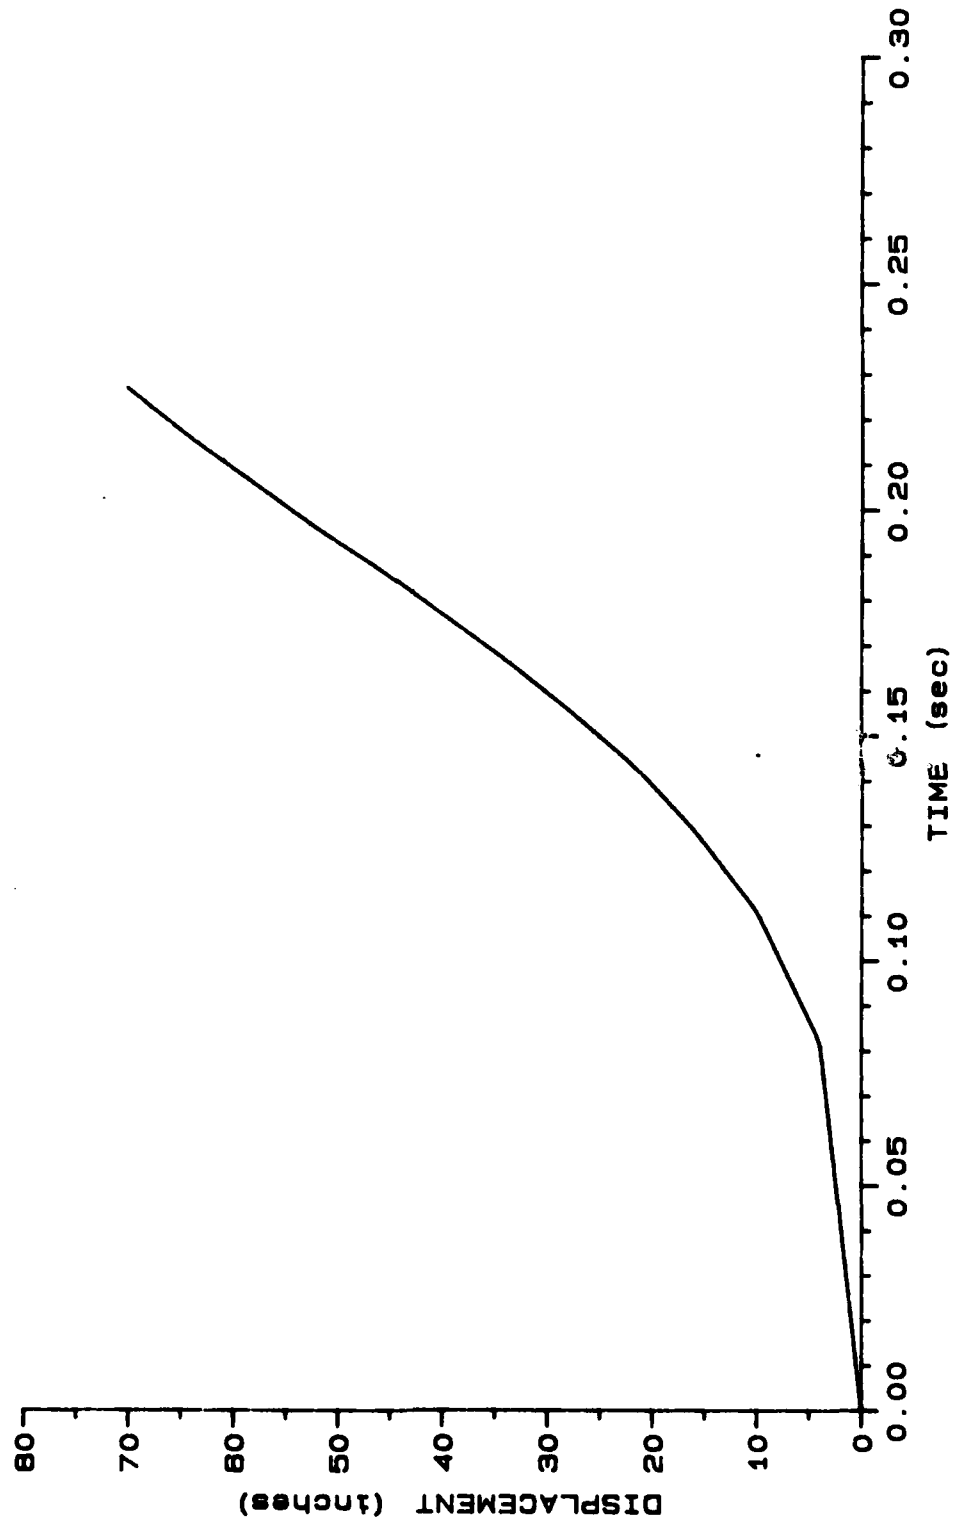
Figure 10. Seat Displacement vs Time

The ejection tower evaluation was conducted to demonstrate the ability of the HELPS to both deploy and entrap the occupants limbs during the cinch-up phase. Eight ejection tower tests were conducted in July of 1981, using both five and ninety five percentile dummies. Data from these tests are shown in table II. Typical seat displacement-vs-time curves and cinch-up pull force-vs-time curves are shown in figures 10 and 11 respectively.

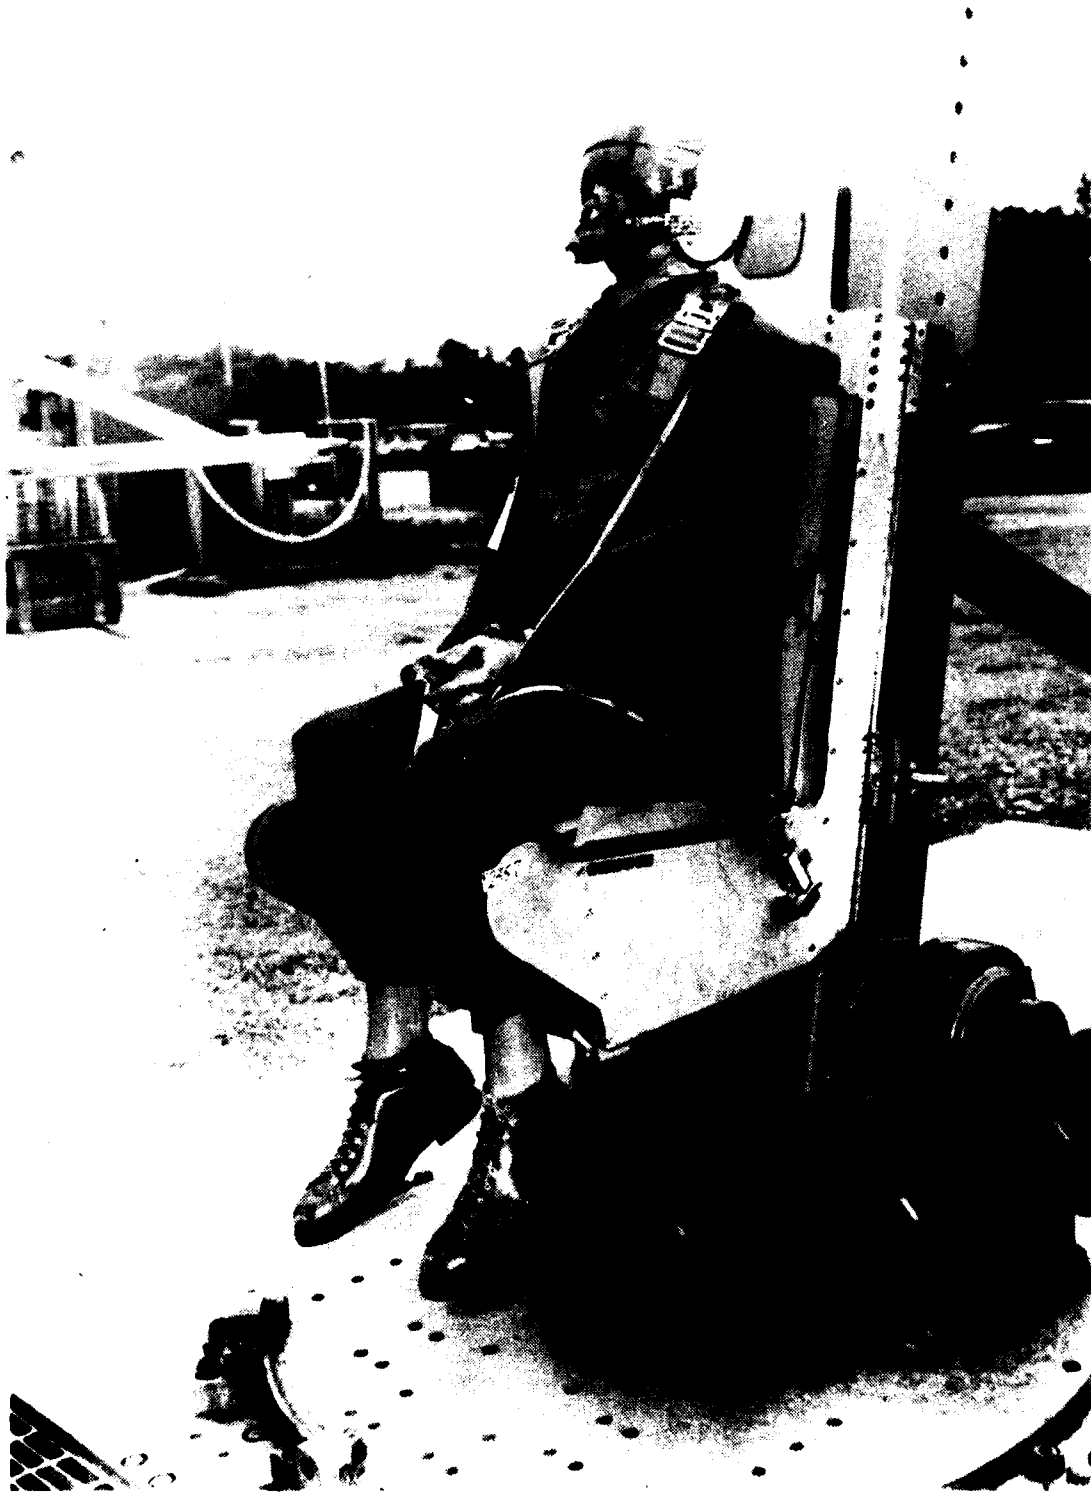
Although some undesirable limb motion occurred, the HELPS prevented the dummy's arms and legs from flailing. Considerable arm motion occurred beneath the arm restraint straps and arm restraint netting, but the arms never dislodged from the restraint. The most extreme arm motion is depicted in figures 20 thru 23 which are pre and post test photos of tests 4 and 6. Two factors contributing to this arm motion are a poor connection of the arm restraint straps to the inertia reel straps, and weak stitching holding the arm restraint netting to the seat sides and the arm restraint straps. These factors allowed the HELPS to loosen as load was being applied by the arms. Downward lateral leg displacement occurred in test 8, but the legs always remained against the front of the seat bucket. Figures 24 and 25 show this motion. This motion occurred because the strap snubber was not able to restrain the legs against the applied windblast load. As the strap pulled back through the snubber, slack was introduced throughout the system.

Recommended changes would be to provide a firmer anchor for the top of the shoulder restraint straps, a change in the length of the restraint strap, stronger seat connections, improved stitching requirements, and an improved strap snubber to maintain a tight restraint over the occupant.
