# GRANGER LAKE

## FINAL FOUNDATION REPORT

## EMBANKMENT-OUTLET WORKS-SPILLWAY

VOLUME-1  
AUGUST 1983

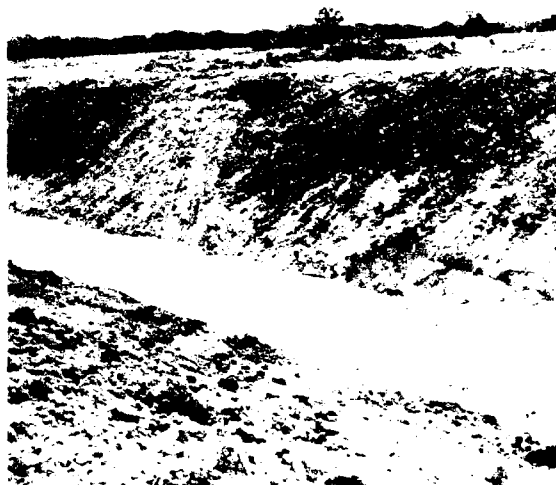
*Figure 2.* Cutoff trench, 1st contract: View of slopes cleaned dragline, looking downstream (right) in vicinity of station 43+00.

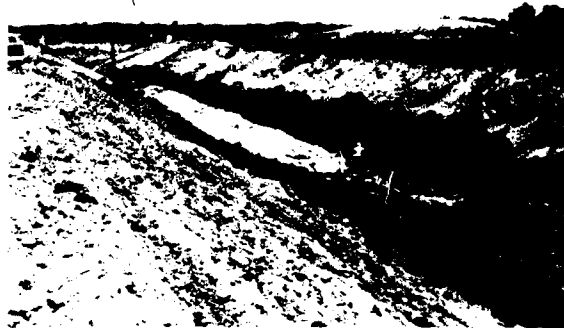
1. Cutoff Trench. Dahlstrom Corporation controlled ground water emissions from the sides of the cutoff trench solely by plating them with clay, and in so doing increased the difficulty of mapping. See figure 5. Plating was adequate to prevent entry of ground water where employed between the right abutment and about station 58+10, north of which the sand and gravel in the sideslopes were charged with river water. Here, foundation approval and mapping could be done only after pumping, and/or by pushing a wall of soil along the trench to displace water, together with plating the worst water flows with clay. Necessarily this work was done in short lengths of trench. The only other section of the cutoff trench south (right) of the San Gabriel River requiring control of ground water emissions was on the top of the right abutment between station 28+00 and station 30+10. At that location plating was only marginally effective. Under the Abrams contract (final) ground water flow was controlled by ditching the upstream toe of the trench, and by draining each section of trench toward the natural surface streams crossing the trench. Backfilling of the cutoff trench was conducted in the same manner, working toward the natural drainages, backfilling the stream channels last. Each surface stream channel crossing the trench alignment was backfilled upstream through the embankment area prior to excavating the cutoff trench, but was left unfilled downstream to allow drainage. Rarely did Abrams have to sump and pump. When required, it was usually in a local depression on the top of the shale, or as a part of closing a stream crossing. Trench backfilling procedure consisted of keeping the upstream drainage ditch open until clay backfill on the dry bottom of the trench exceeded the height of the water-bearing gravel along the upstream slope of the trench. The ditch was then cleaned and filled with compacted clay, and backfilling of the trench resumed.

*Figure 5.* Cutoff trench, 1st contract: Backfilling (near) and sealing off water with fill (distant) along trench toes. Casing of large diameter auger boring in distance.

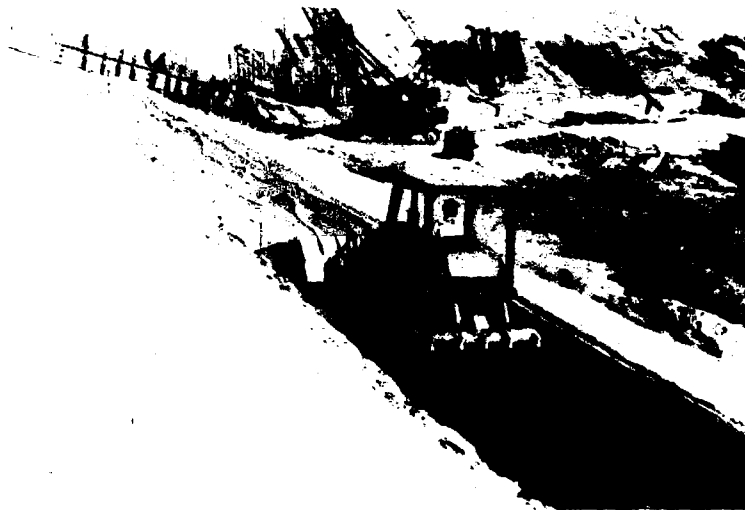
Initially, the cross drains in the chute were excavated after the drainage blanket had been placed. See figures 59, 60, and 61. Excavating the cross drains as a part of fine grading the chute slope was found to be more efficient, so separate excavation of drains was discontinued. See figures 62, 63, and 64. In contrast, none of the cross drains in the stilling basin were excavated as a part of finish grading the slab foundation. They were excavated after filter blanket sand had been placed, but before the work slab was constructed. The procedure for constructing keys in the chute was to excavate and place reinforcement and concrete through a breakout lane in the work slab. It was observed during inspection of keys, both in the chute slope and in the stilling basin, that the top 1 foot of the key sideslopes just below the drainage blanket was nearly always significantly rougher and more broken than was the remainder of the key sideslope below. This was observed both where desiccation of foundation shale was a problem and where it was not. The impression produced was that either the use of scraping tools to excavate the chute and stilling basin foundation caused a series of discontinuous breaks throughout the shale immediately below the scraped surface, or that the breakage observed was confined to the local effect of key excavation. If the former interpretation is correct, then designs for shale foundations should allow for somewhat diminished shear strength in approximately the first foot of the foundation.

*Figure 59.* Spillway, 3d contract: Excavating for a chute cross drain by initial method (see text).

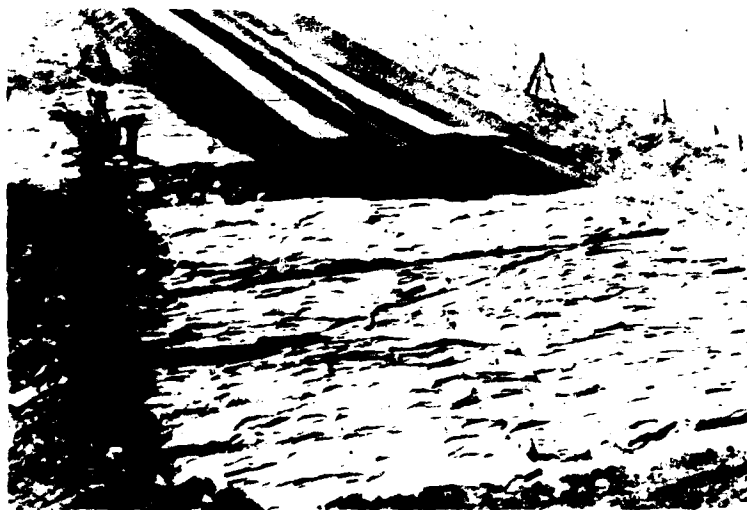
As described earlier under EXCAVATION PROCEDURES, the foundation for the chute slab was fine graded in strips extending down the chute slope. The finished shale surface of each strip was protected from desiccation by covering it with moist drainage blanket sand. On completion of excavation of each strip, moist sand was spread down the slope, usually by Caterpillar D-3 dozer having extra-wide tracks. See figures 67 and 68. The stilling basin slab foundation, upstream from station 32+95.27, was also protected by spreading moist drainage blanket sand.

*Figure 67.* Spillway, 3d contract: Sanding the chute slopes and cross drains in strips.
