HOUSATONIC RIVER BASIN
DANBURY CONNECTICUT

PADANARAM RESERVOIR DAM
CT 00067

PHASE I INSPECTION REPORT
NATIONAL DAM INSPECTION PROGRAM

JULY 1980

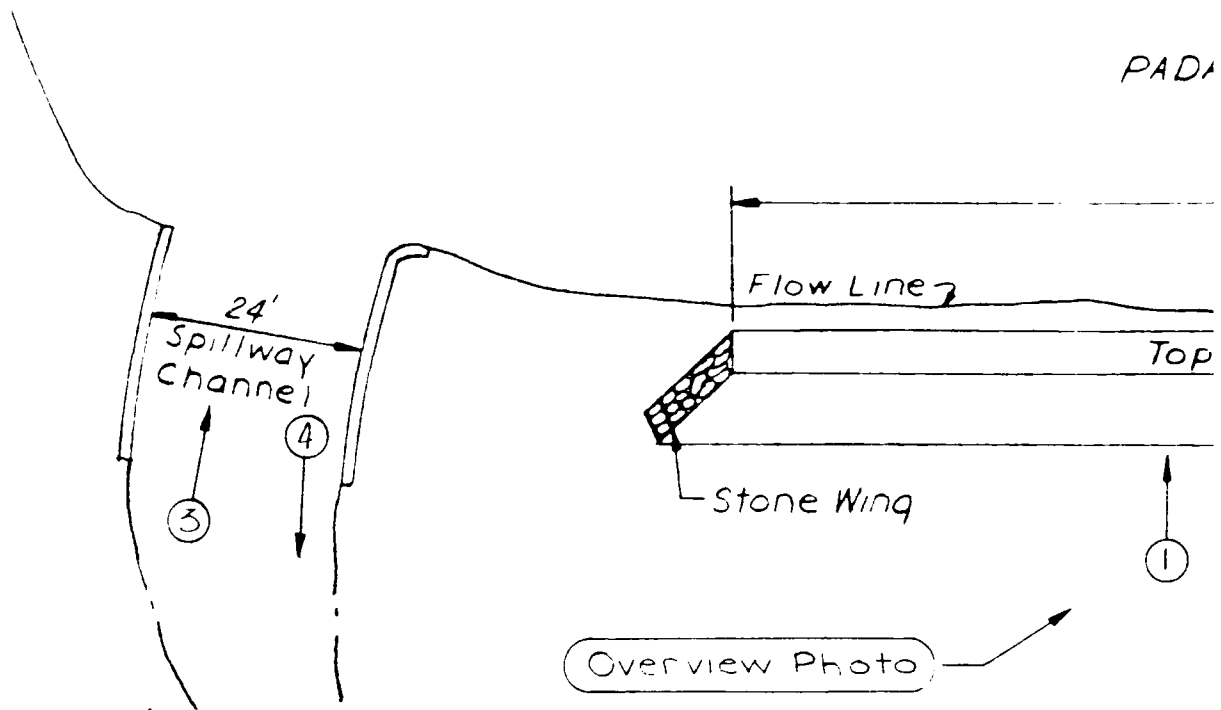
b. Dam - The dam is an earth embankment with a stone masonry faced downstream slope. The downstream face of the dam needs repointing in areas where vegetation has been growing from the joints (Photo 1). There appears to be a bulge in the masonry just to the east of the gate house. A closer look at this bulge, however, does not show any distress in the mortared joints. The alignment of the top of the dam is good (Photo 2) and no bulges are apparent. The upstream embankment is brush covered and there are areas where the riprap has moved (Photo 2). The top of the dam is level with no signs of settlement. The stone wingwall is in good condition.

PHOTO 1
DOWNSTREAM FACE OF DAM
