**BRANFORD SUPPLY PONDS DAM
CT 00116**

**PHASE 1 INSPECTION REPORT
NATIONAL DAM INSPECTION PROGRAM**

APRIL 1981

PHILIP W. GENOVESE AND
ASSOCIATES, INC.
ENGINEERS - HAMDEN, CT.

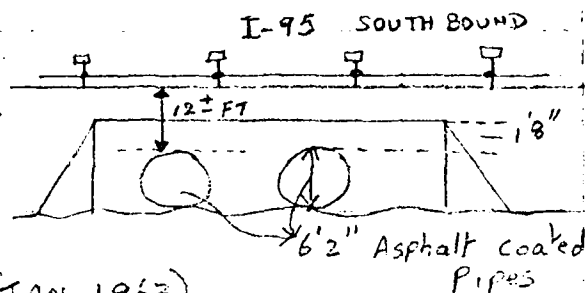
IMMEDIATELY BELOW SECTION BB, I-95 HIGHWAY CULVERT EXISTS WITH TWO 6'2" DIAMETER ASPHALT COATED PIPES WITH CONCRETE HEADWALLS. PER U S BUREAU OF PUBLIC ROADS (JAN, 1963) NDMOGRAPH FOR $\frac{H.W.}{D} = \frac{81.6}{74} = 1.1$ FROM SCALE 2

(REV. MAY 1964) DISCHARGE CAPACITY OF EACH PIPE = 260 CFS. \therefore TOTAL DISCHARGE CAPACITY FOR 2 PIPES = 520 CFS WHICH IS INADEQUATE TO CONVEY THE PEAK OUTFLOW OF 4140 CFS FROM THE 1ST REACH.

THUS, THE WATER DEPTH U/S OF THE HWY EMBANKMENT WOULD INCREASE FURTHER. HOWEVER, THE DAMMING EFFECT OF THE EMBANKMENT WOULD NOT INCREASE THE FLOOD DEPTH HIGH ENOUGH SO AS TO CAUSE DAMAGE TO FIRST FLOORS OF THE HOUSES IN THE VICINITY AND THE HIGHWAY EMBANKMENT IS HIGH ENOUGH TO PREVENT OVERTOPPING.

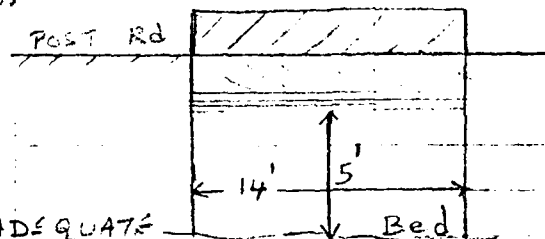
$$\text{FOR } \frac{H}{d} = \frac{7.2}{5} = 1.44$$

THUS, THE CULVERT HAS INADEQUATE CAPACITY FOR THE PEAK INFLOW IN REACH 2 AND THE POST RD COULD BE SUBJECT TO SUBMERGENCE. HOWEVER, DUE TO DAMMING EFFECT, THE INCREASE IN FLOOD DEPTH UPSTREAM IS NOT LIKELY TO BE SIGNIFICANT.
