NAUGATUCK RIVER BASIN  
TORRINGTON, CONNECTICUT

REUBEN HART RESERVOIR DAM

CT 00096

PHASE I INSPECTION REPORT  
NATIONAL DAM INSPECTION PROGRAM

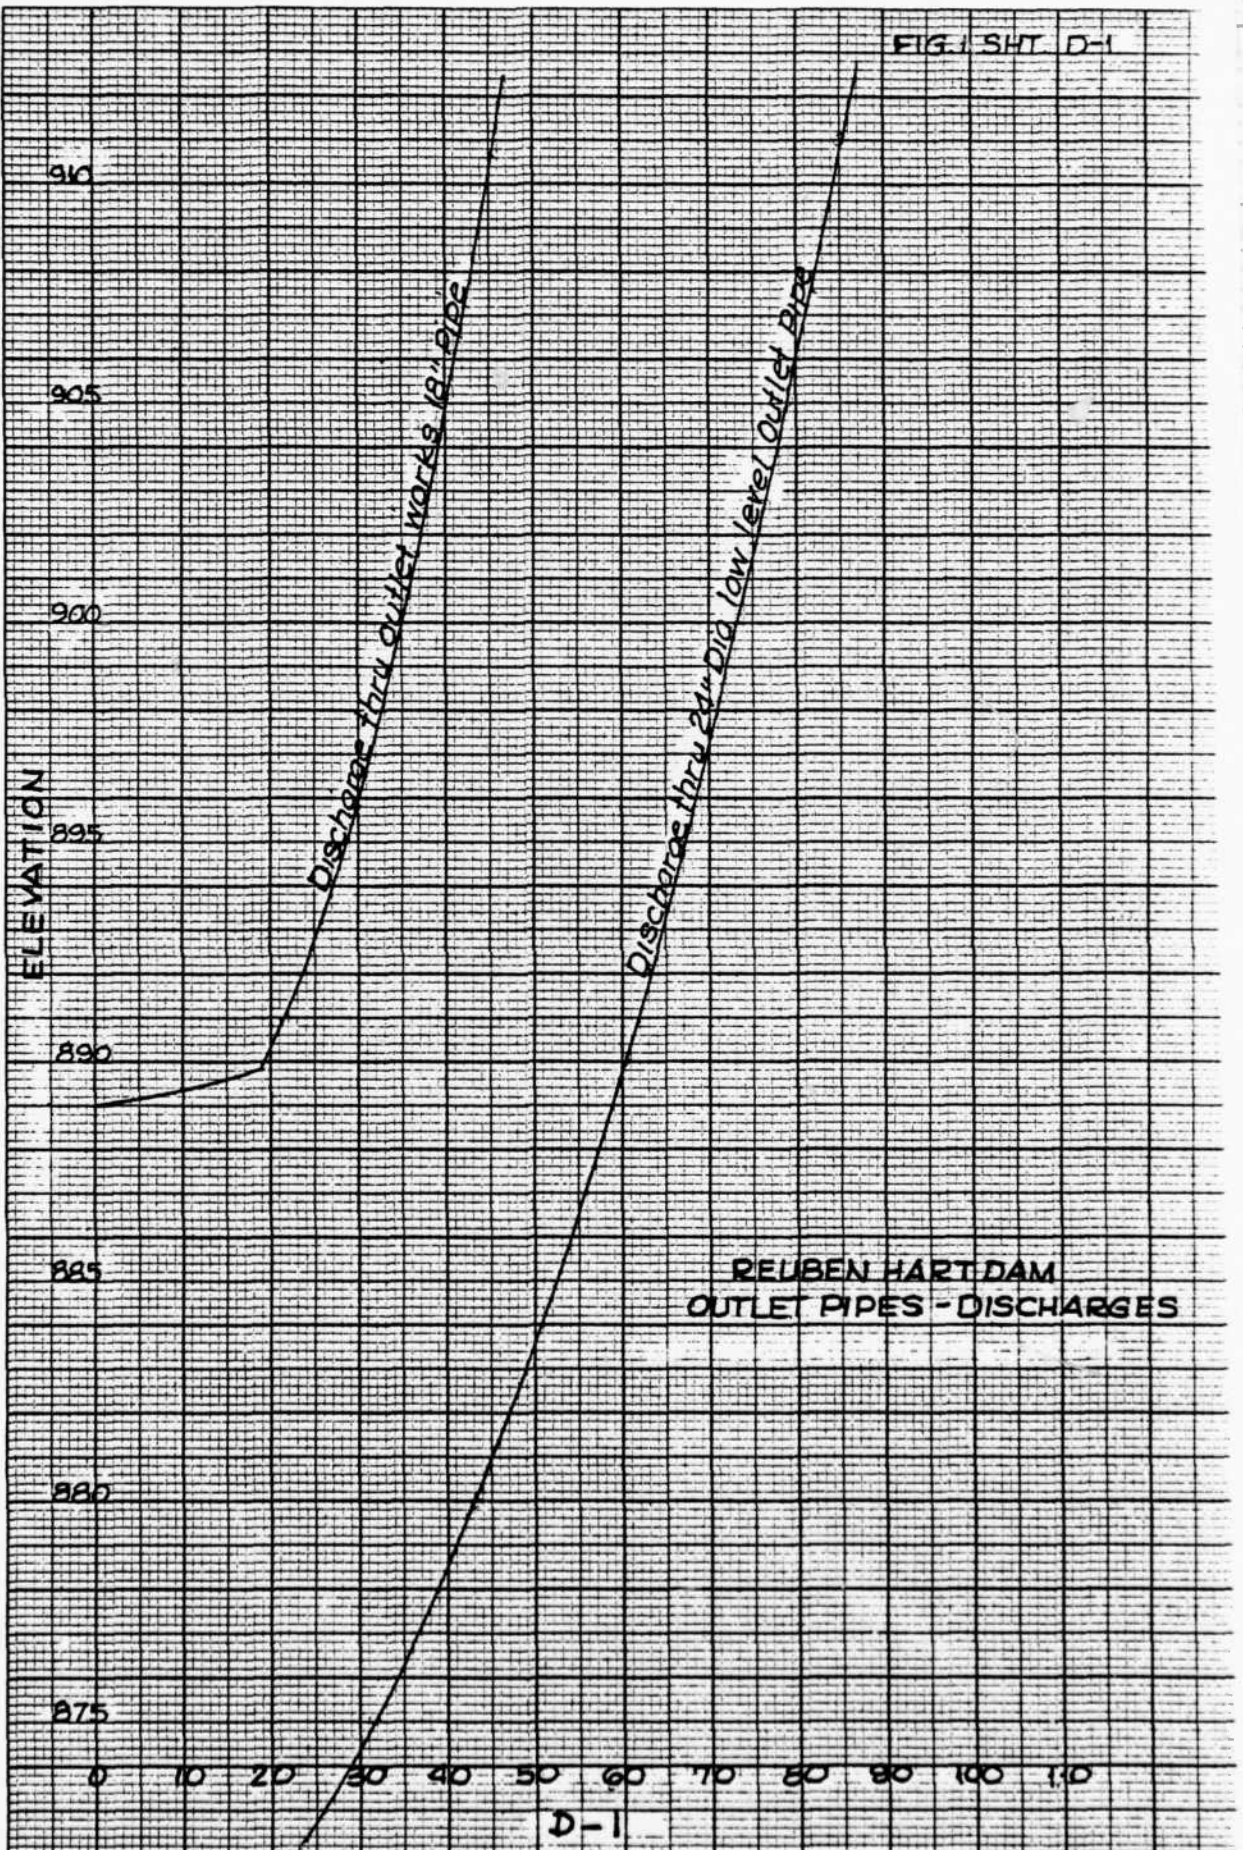
FIG. 1 SHT. D-1

level, elevation 911. For more rapid reservoir evacuation, a low level outlet pipe which served for stream diversion during construction could also be opened, to release up to about 85 cfs at normal reservoir level. The low level pipe is said not to have been opened since construction was completed. Capacity curves are shown on Figure 1, Appendix D, Sheet D-1.

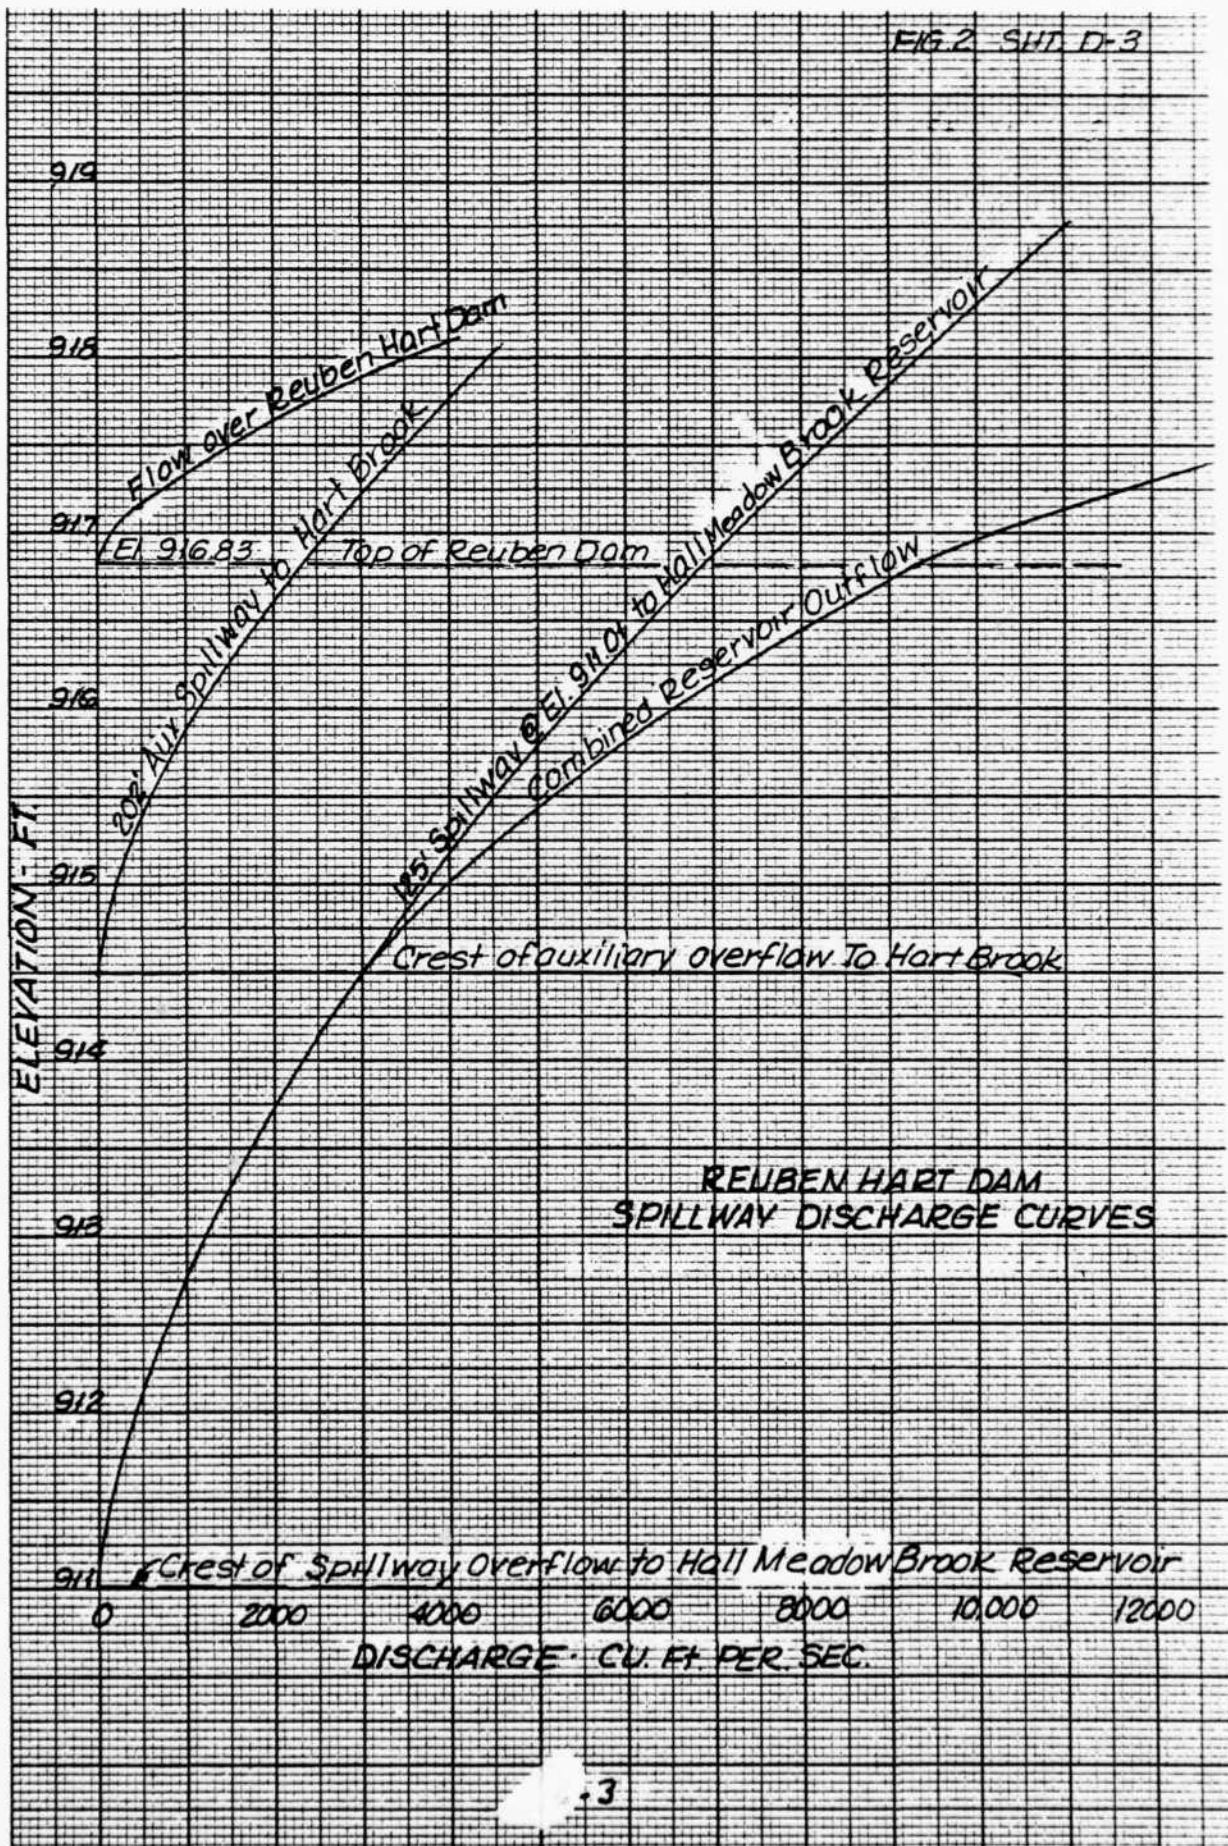
FIG. 2 SHD D-3

With the modifications to the spillway which were made in 1960, the spillway capacity was considerably increased. With head to top of dam, the computed service spillway release into Hall Meadow Brook reservoir is about 7,000 cfs; the discharge over the auxiliary crests into the original spillway channel is about 2,300 cfs. Spillway capacity curves are shown on Figure 2, Sheet D-3.
