LOWER HOUSATONIC RIVER BASIN
SEYMOUR, CONNECTICUT

GREAT HILL RESERVOIR DAM
CT 00087

PHASE I INSPECTION REPORT
NATIONAL DAM INSPECTION PROGRAM

AUGUST 1978

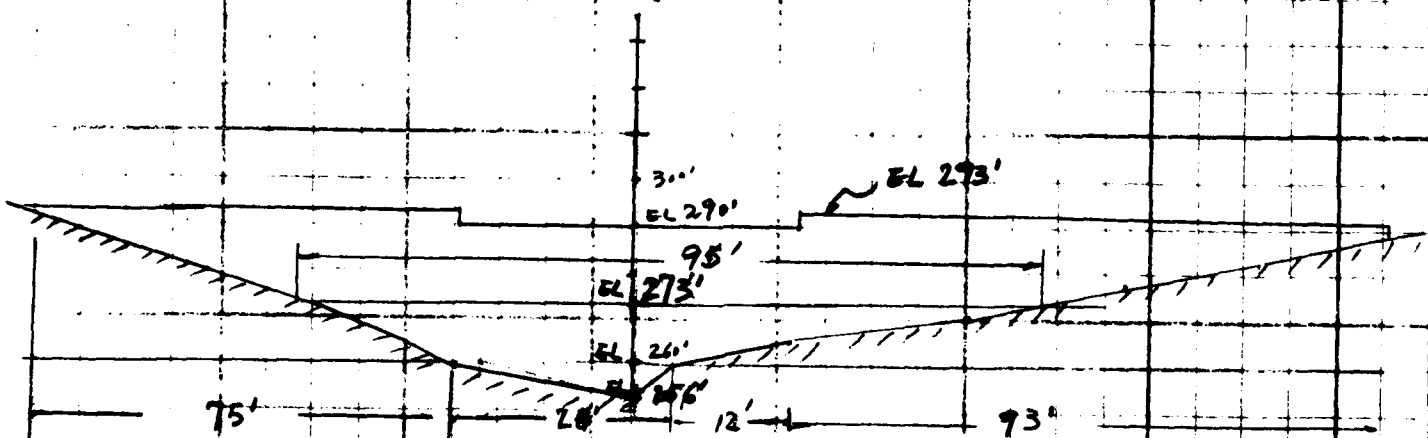
APPROX CROSS SECTION OF DAM (NOT TO SCALE)

ESTIMATION OF BREACH WIDTH MADE ON PLAN FURNISHED BY BIRMINGHAM WATER CO. AUG 16, 1909. APPROX AT EL 273'

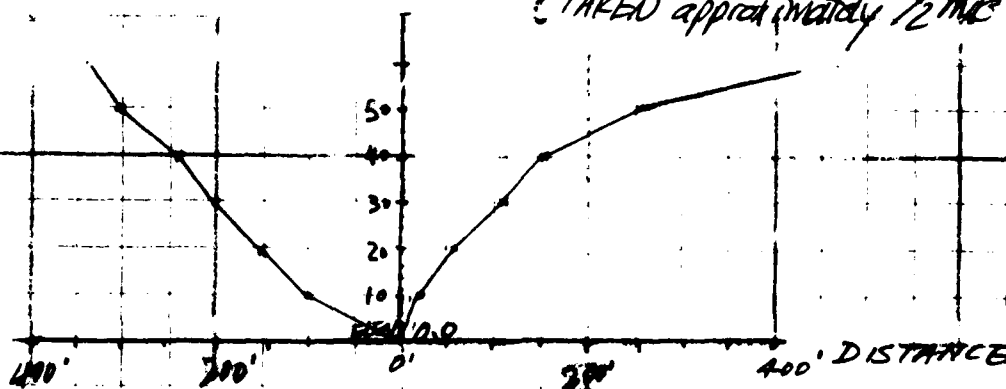
(FROM U.S.G.S, LONG HILL QUADRANGLE SHEET)

(TAKEN approximately 1/2 mile downstream)
