**PRITCHARDS POND DAM
CT 00033**

**NAUGATUCK RIVER BASIN
WATERBURY, CONNECTICUT**

**PHASE I INSPECTION REPORT
NATIONAL DAM INSPECTION REPORT**

Name of Dam : Pritchards Pond Dam
Identification Number : CT 00033
Town : Waterbury
County and State : New Haven County, Connecticut
Stream : Hopeville Pond Brook
Owner : Risdon Manufacturing Company, 2100 South Main Street,
Waterbury, Connecticut
Date of Inspection : December 3, 1980

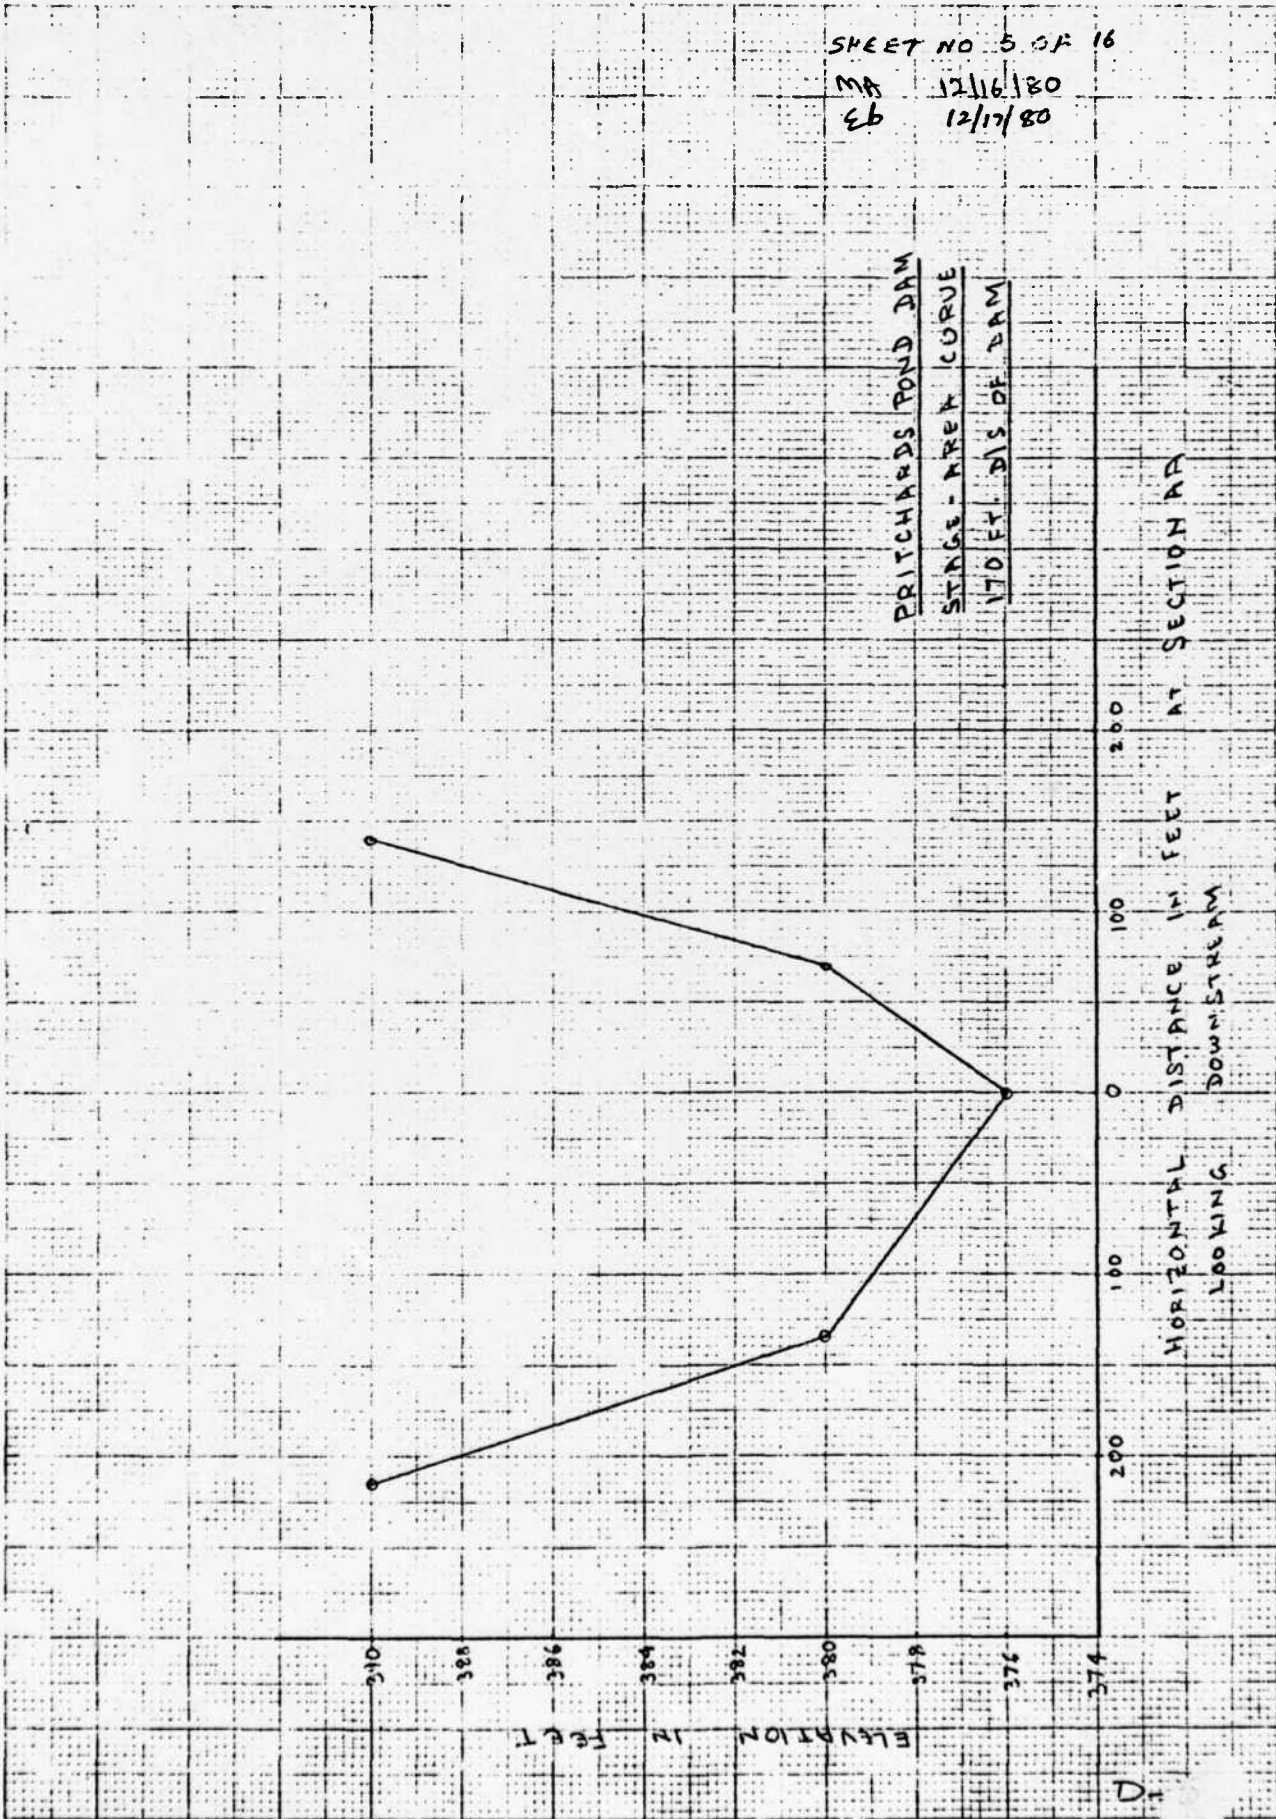
PRITCHARDS POND DAM
STAGE - DISCHARGE CURVE

THUS, AT SECTION AA, NO SERIOUS FLOOD HAZARD IS LIKELY TO OCCUR.

IT IS HOWEVER, NOTED THAT THE CULVERT ON SPRING LAKE RD. IS INADEQUATE TO ACCOMMODATE THE ENTIRE PEAK OUTFLOW AT DAM FAILURE.

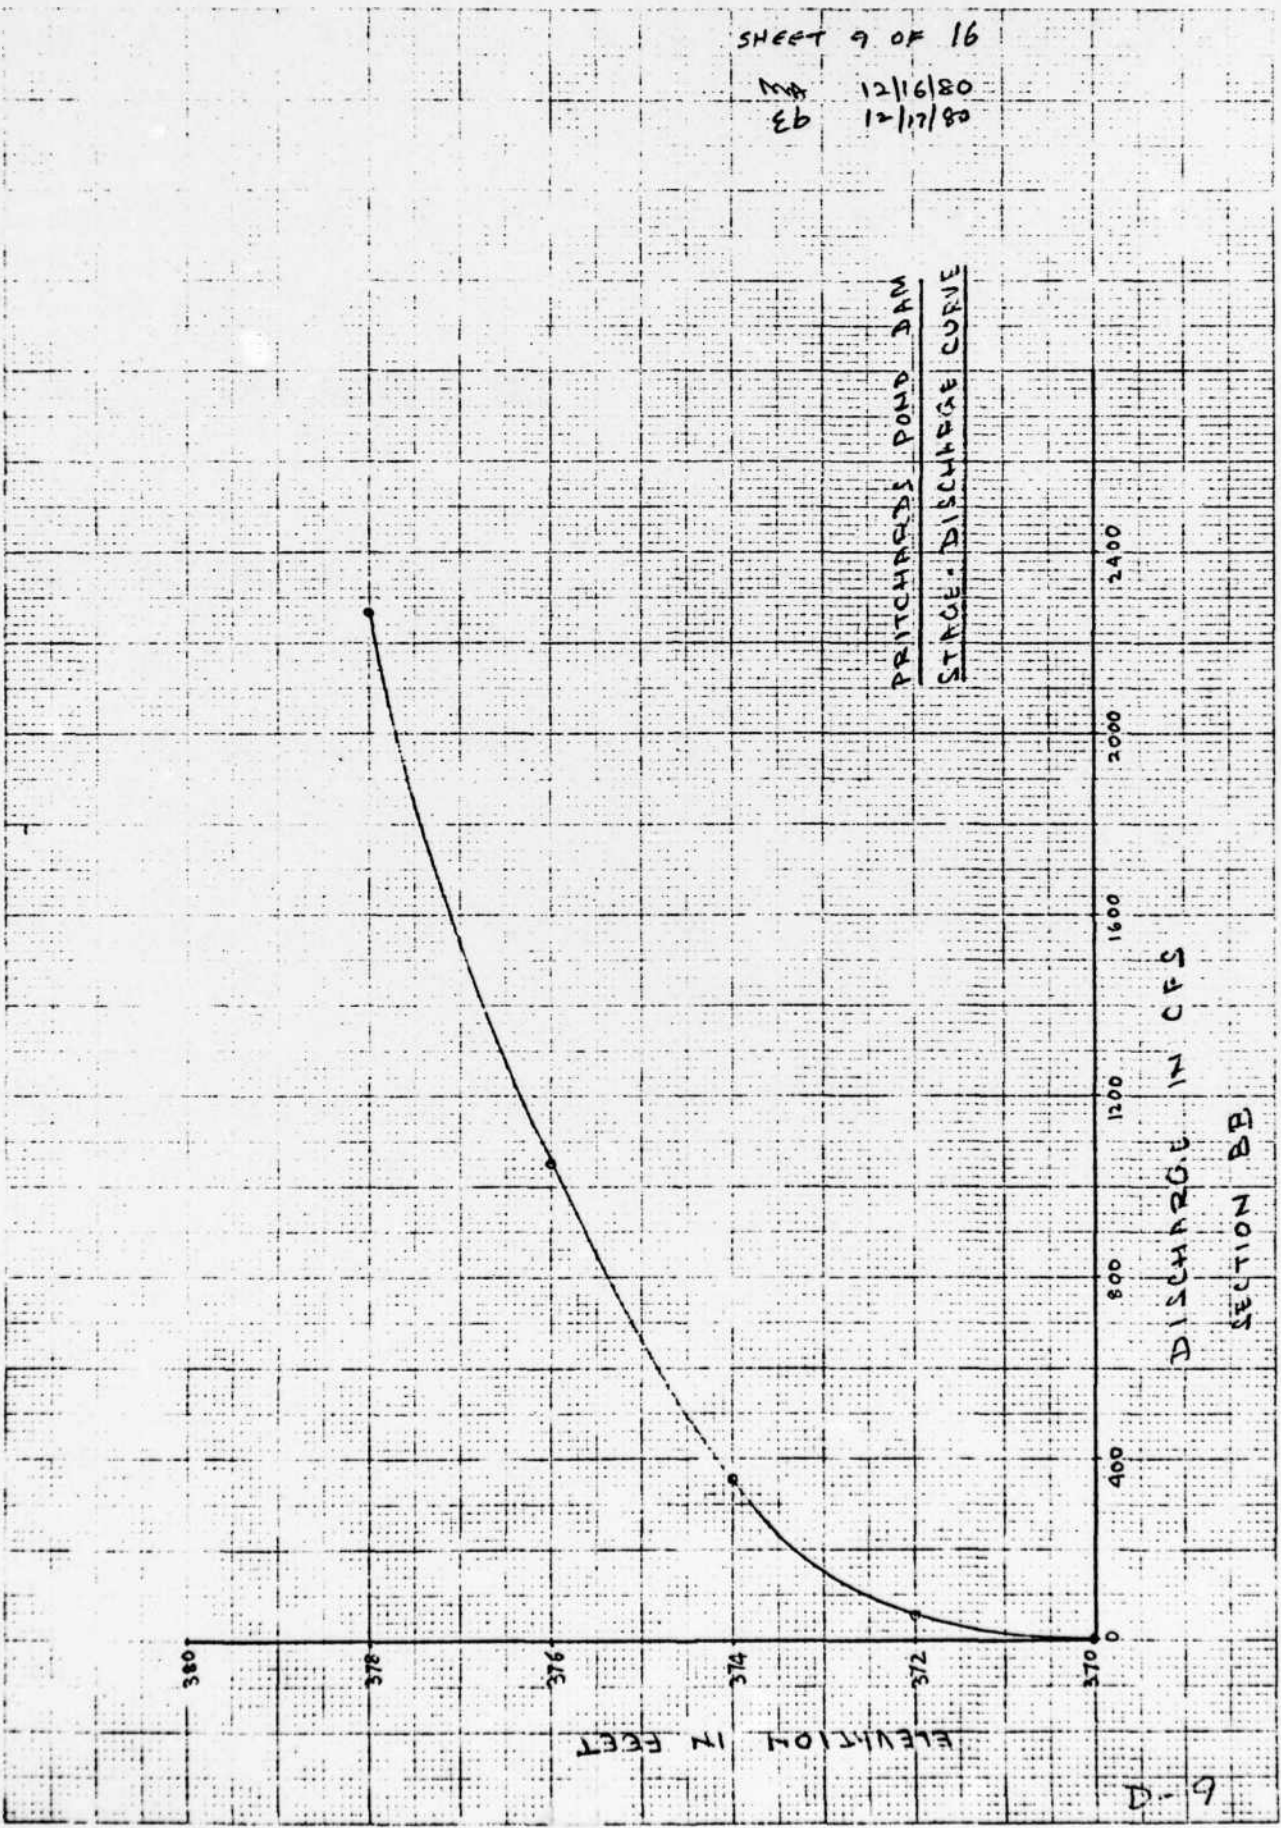
DISCHARGE IN CFS
SECTION BE

THE TWO HOUSES ADJACENT TO THE SMALL POND LOCATED AT SECTION BB ARE HIGHER THAN THE ESTIMATED FLOOD STAGE; THEREFORE ARE NOT LIKELY TO BE IMPACTED BY DAM FAILURE:
