NAUGATUCK RIVER BASIN  
NAUGATUCK, CONNECTICUT

**THURSTON POND DAM  
CT 00129**

**PHASE I INSPECTION REPORT  
NATIONAL DAM INSPECTION PROGRAM**

DECEMBER 1980

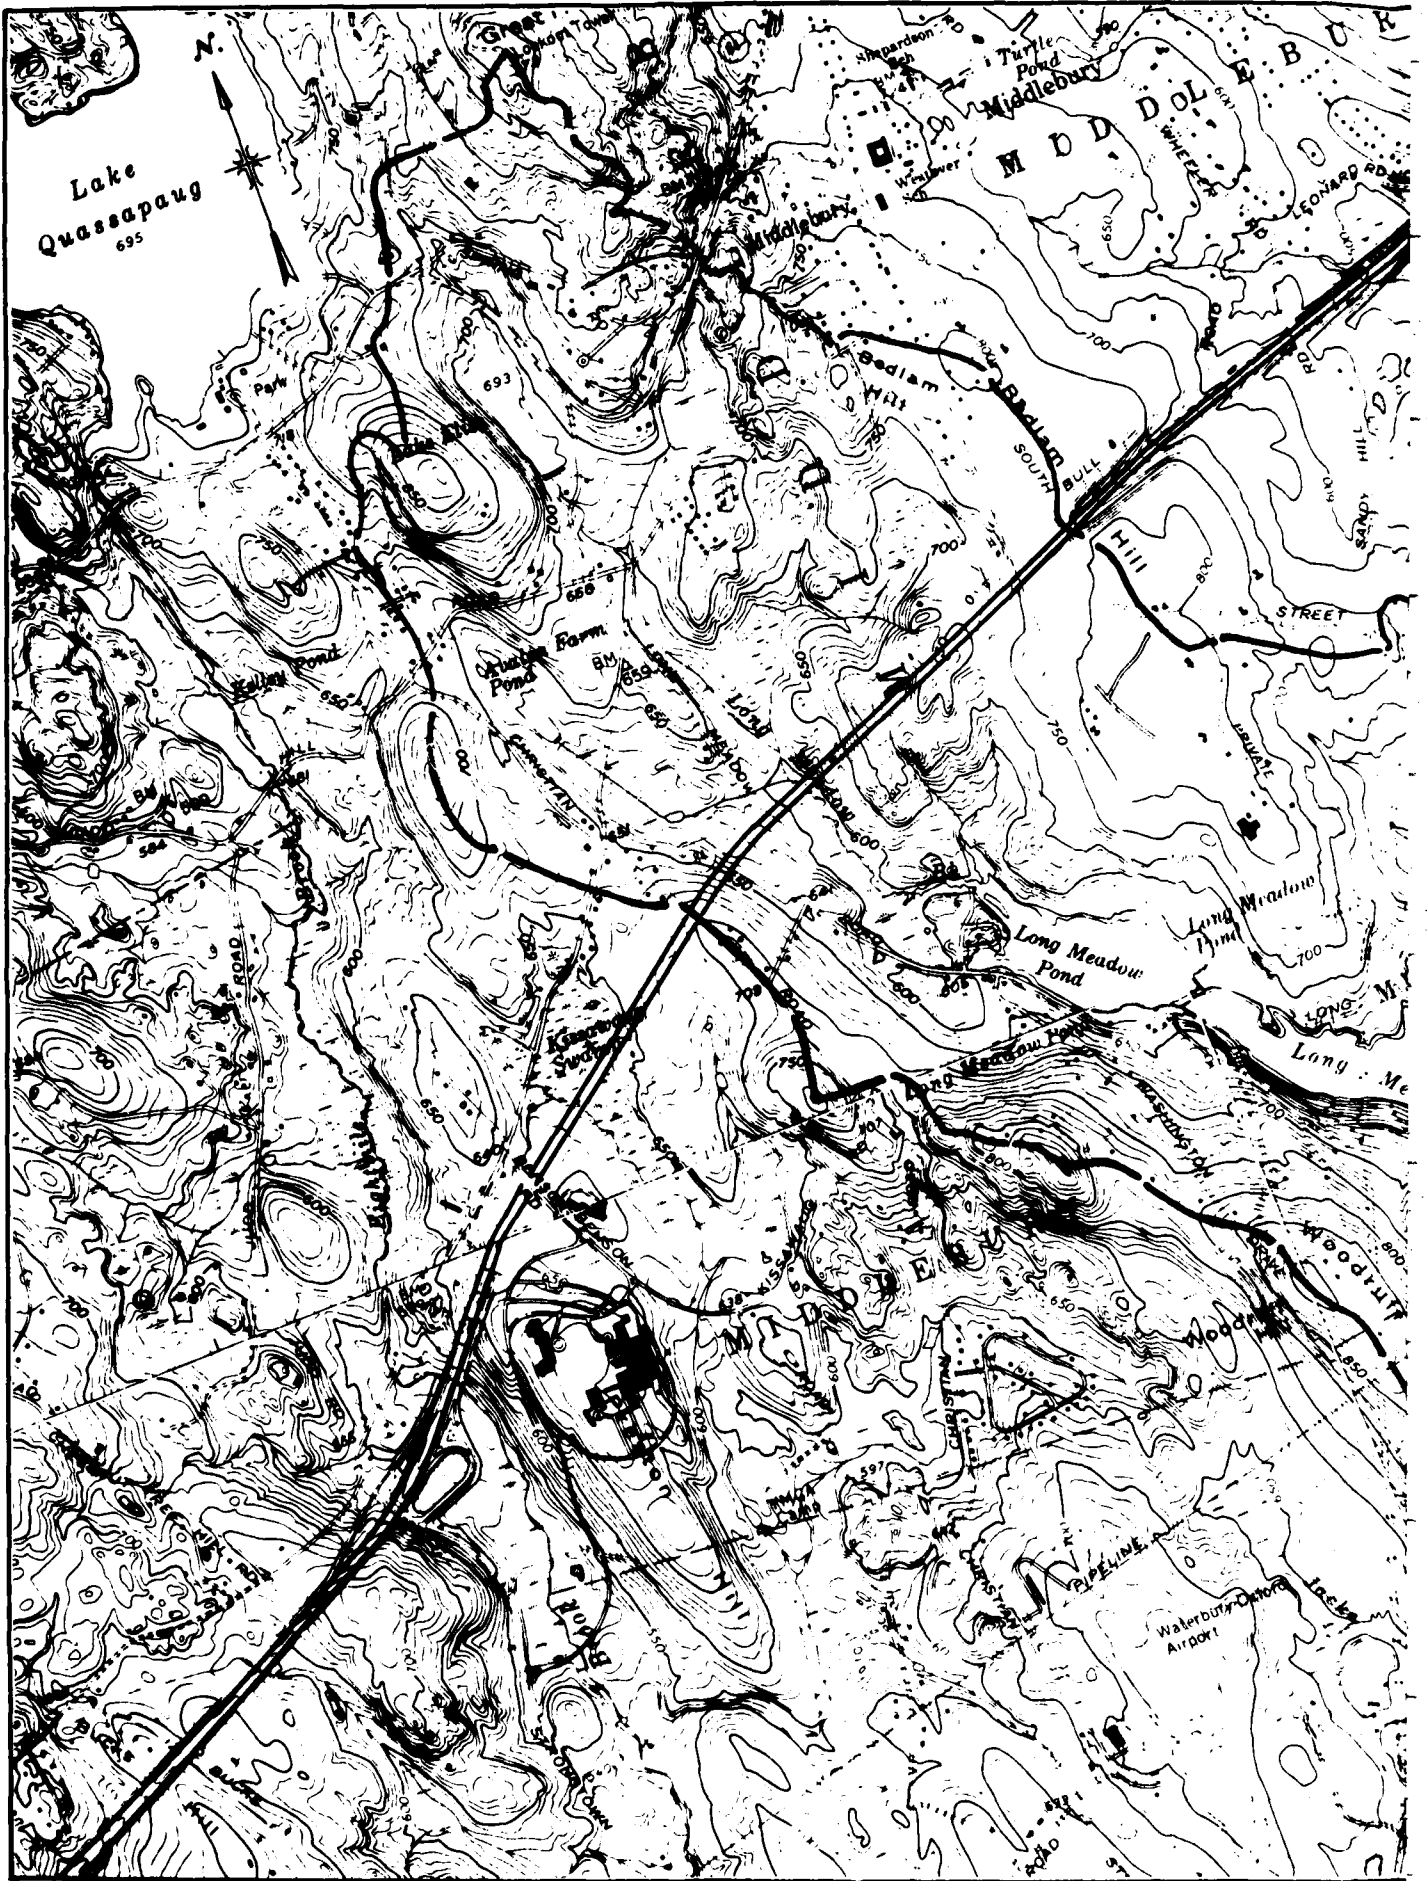
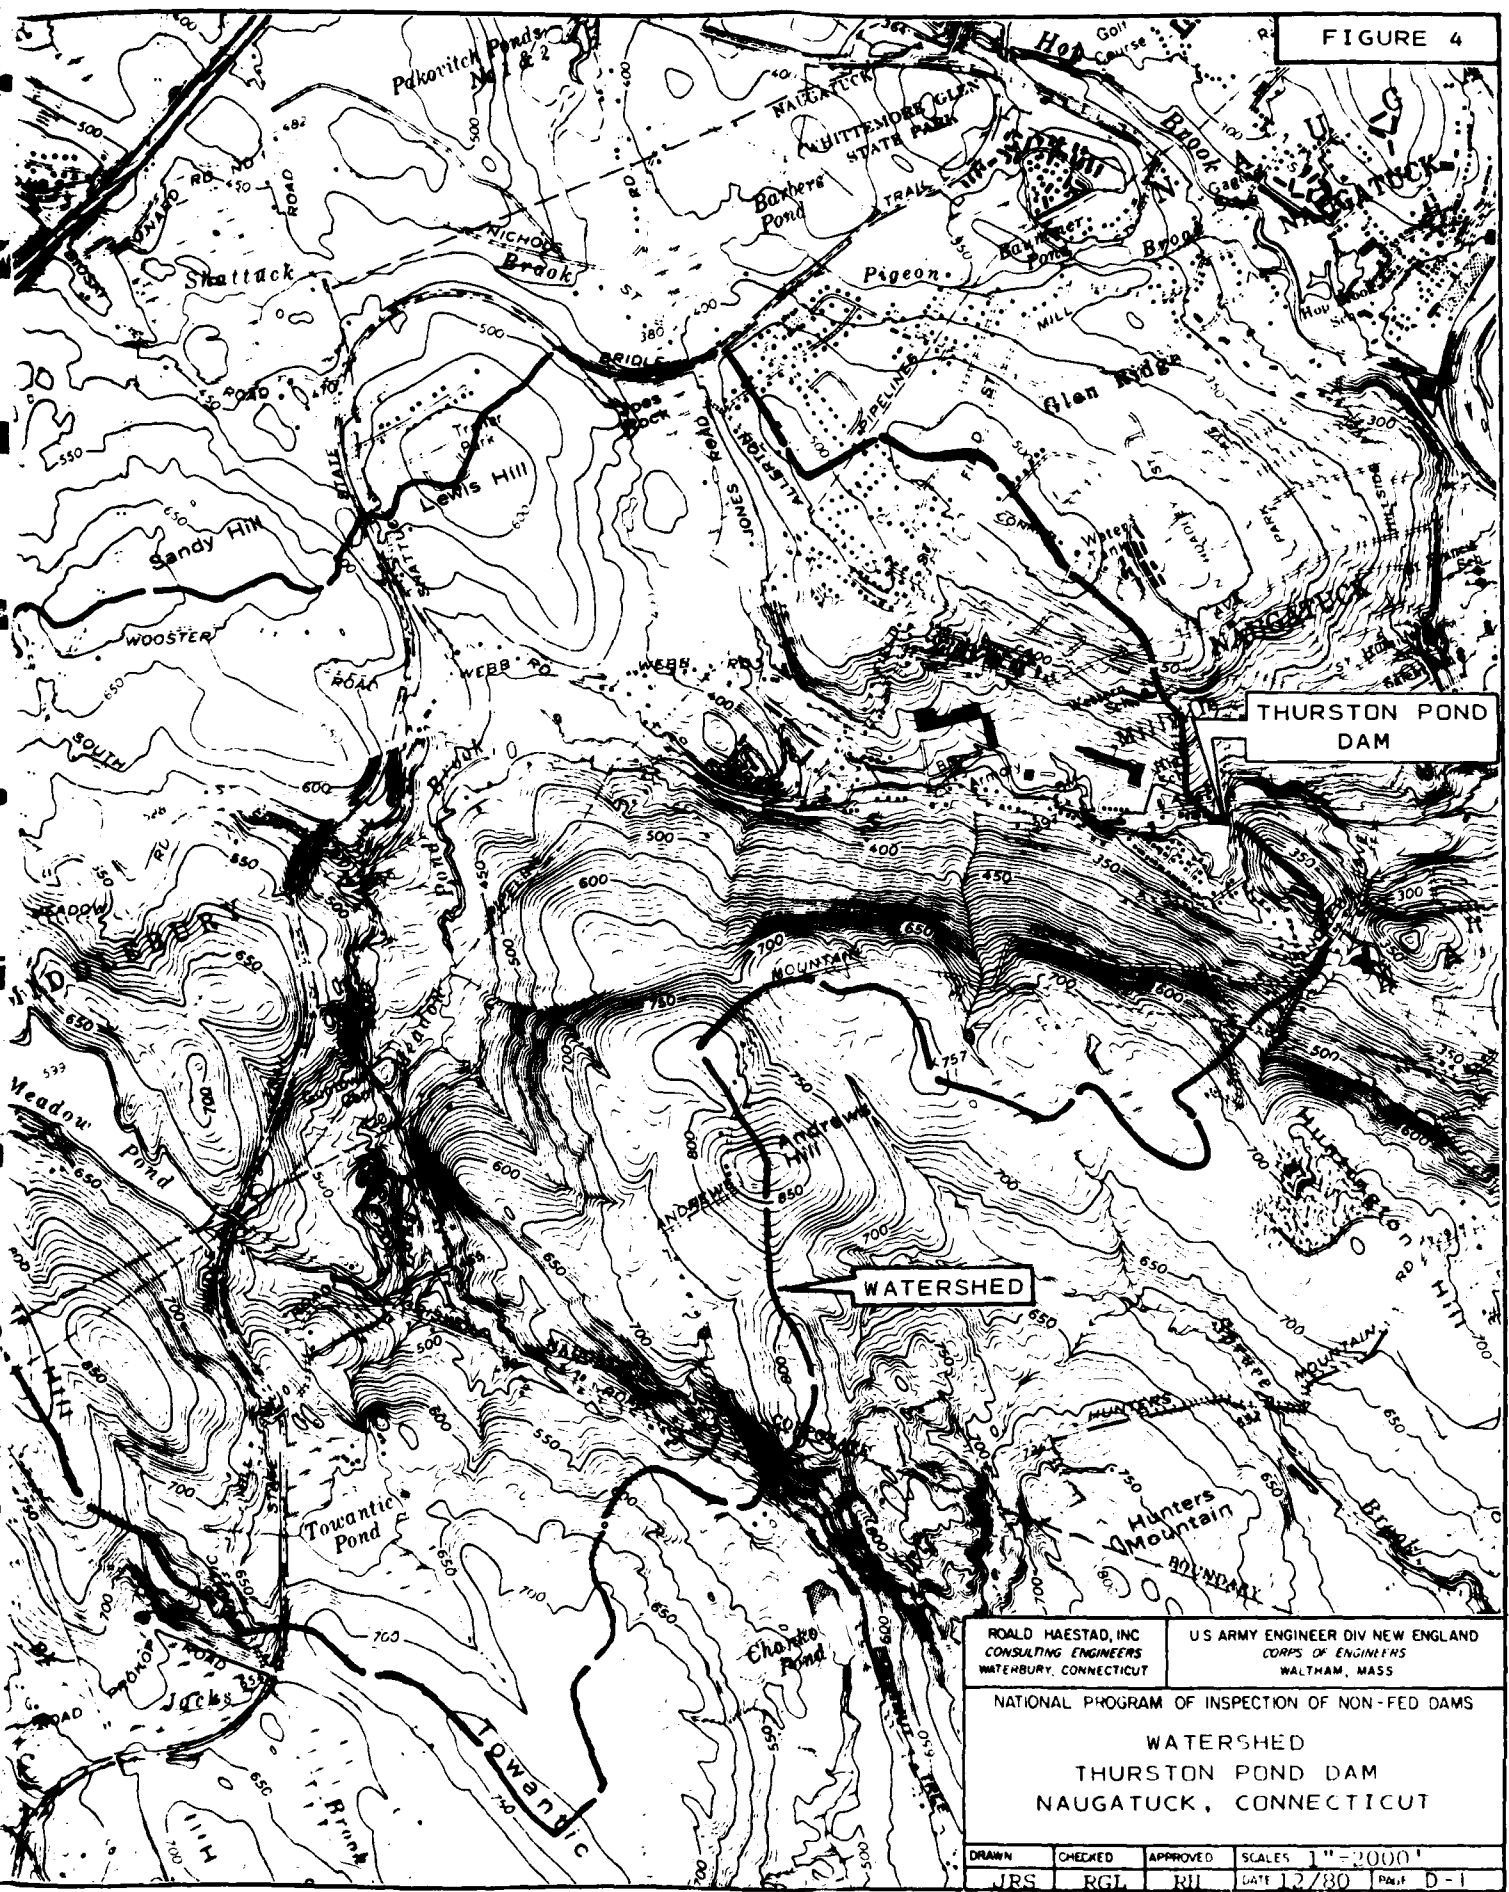
FIGURE 4

The tributary watershed area is 7.8 square miles of "rolling" wooded hills with scattered residential development, except for the section along Rubber Avenue within one mile of the dam which has substantial commercial development. The watershed elevations range from 970 feet at the northwest end to 275 feet at the dam. There are several ponds within the watershed, but only Long Meadow Pond is of significant size (Figure 4, page D-1).

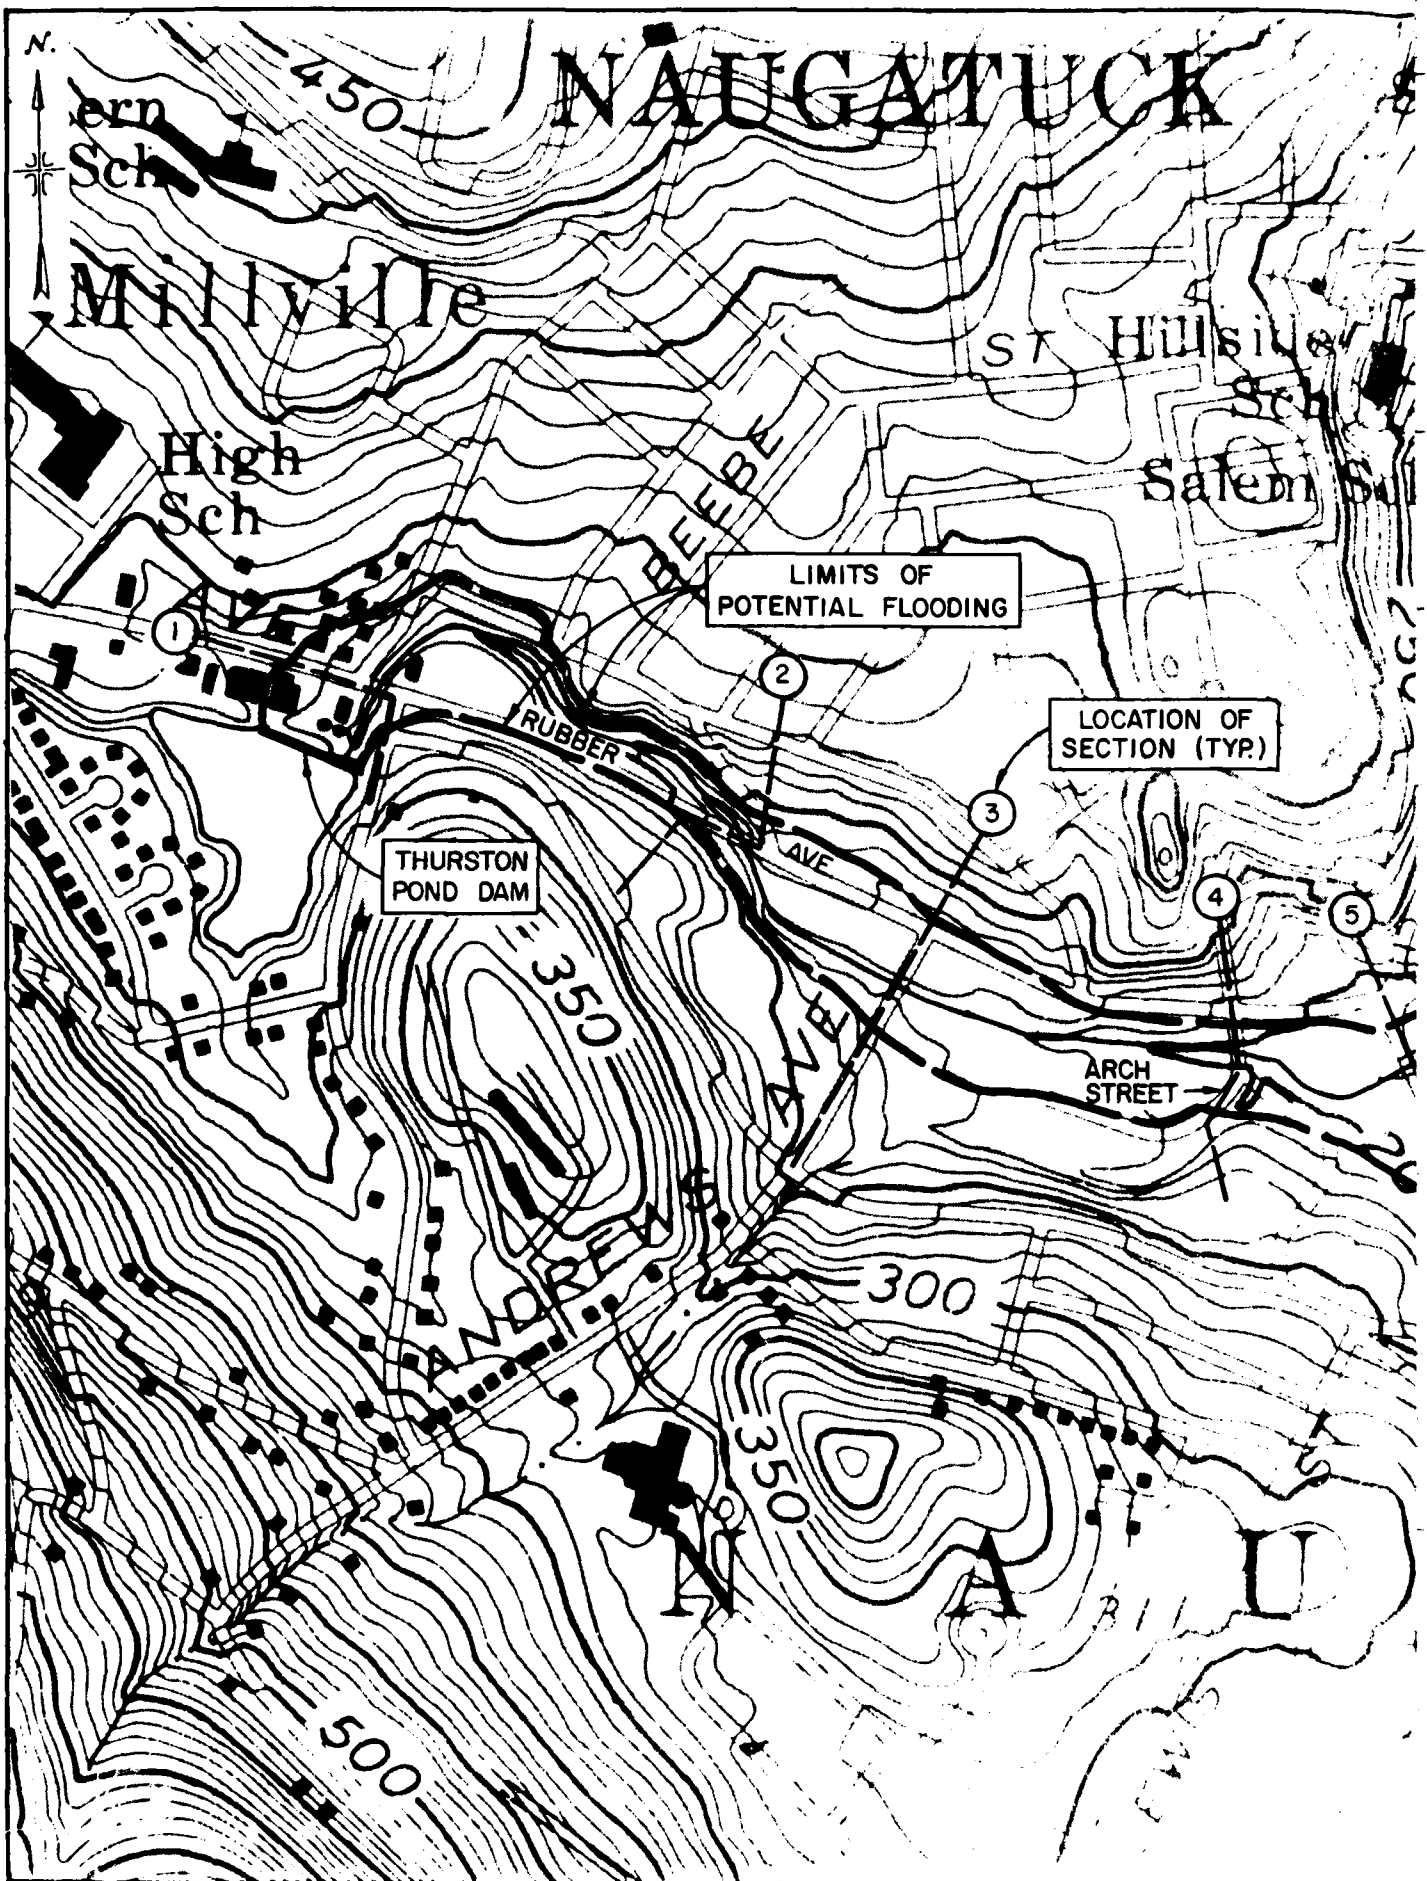
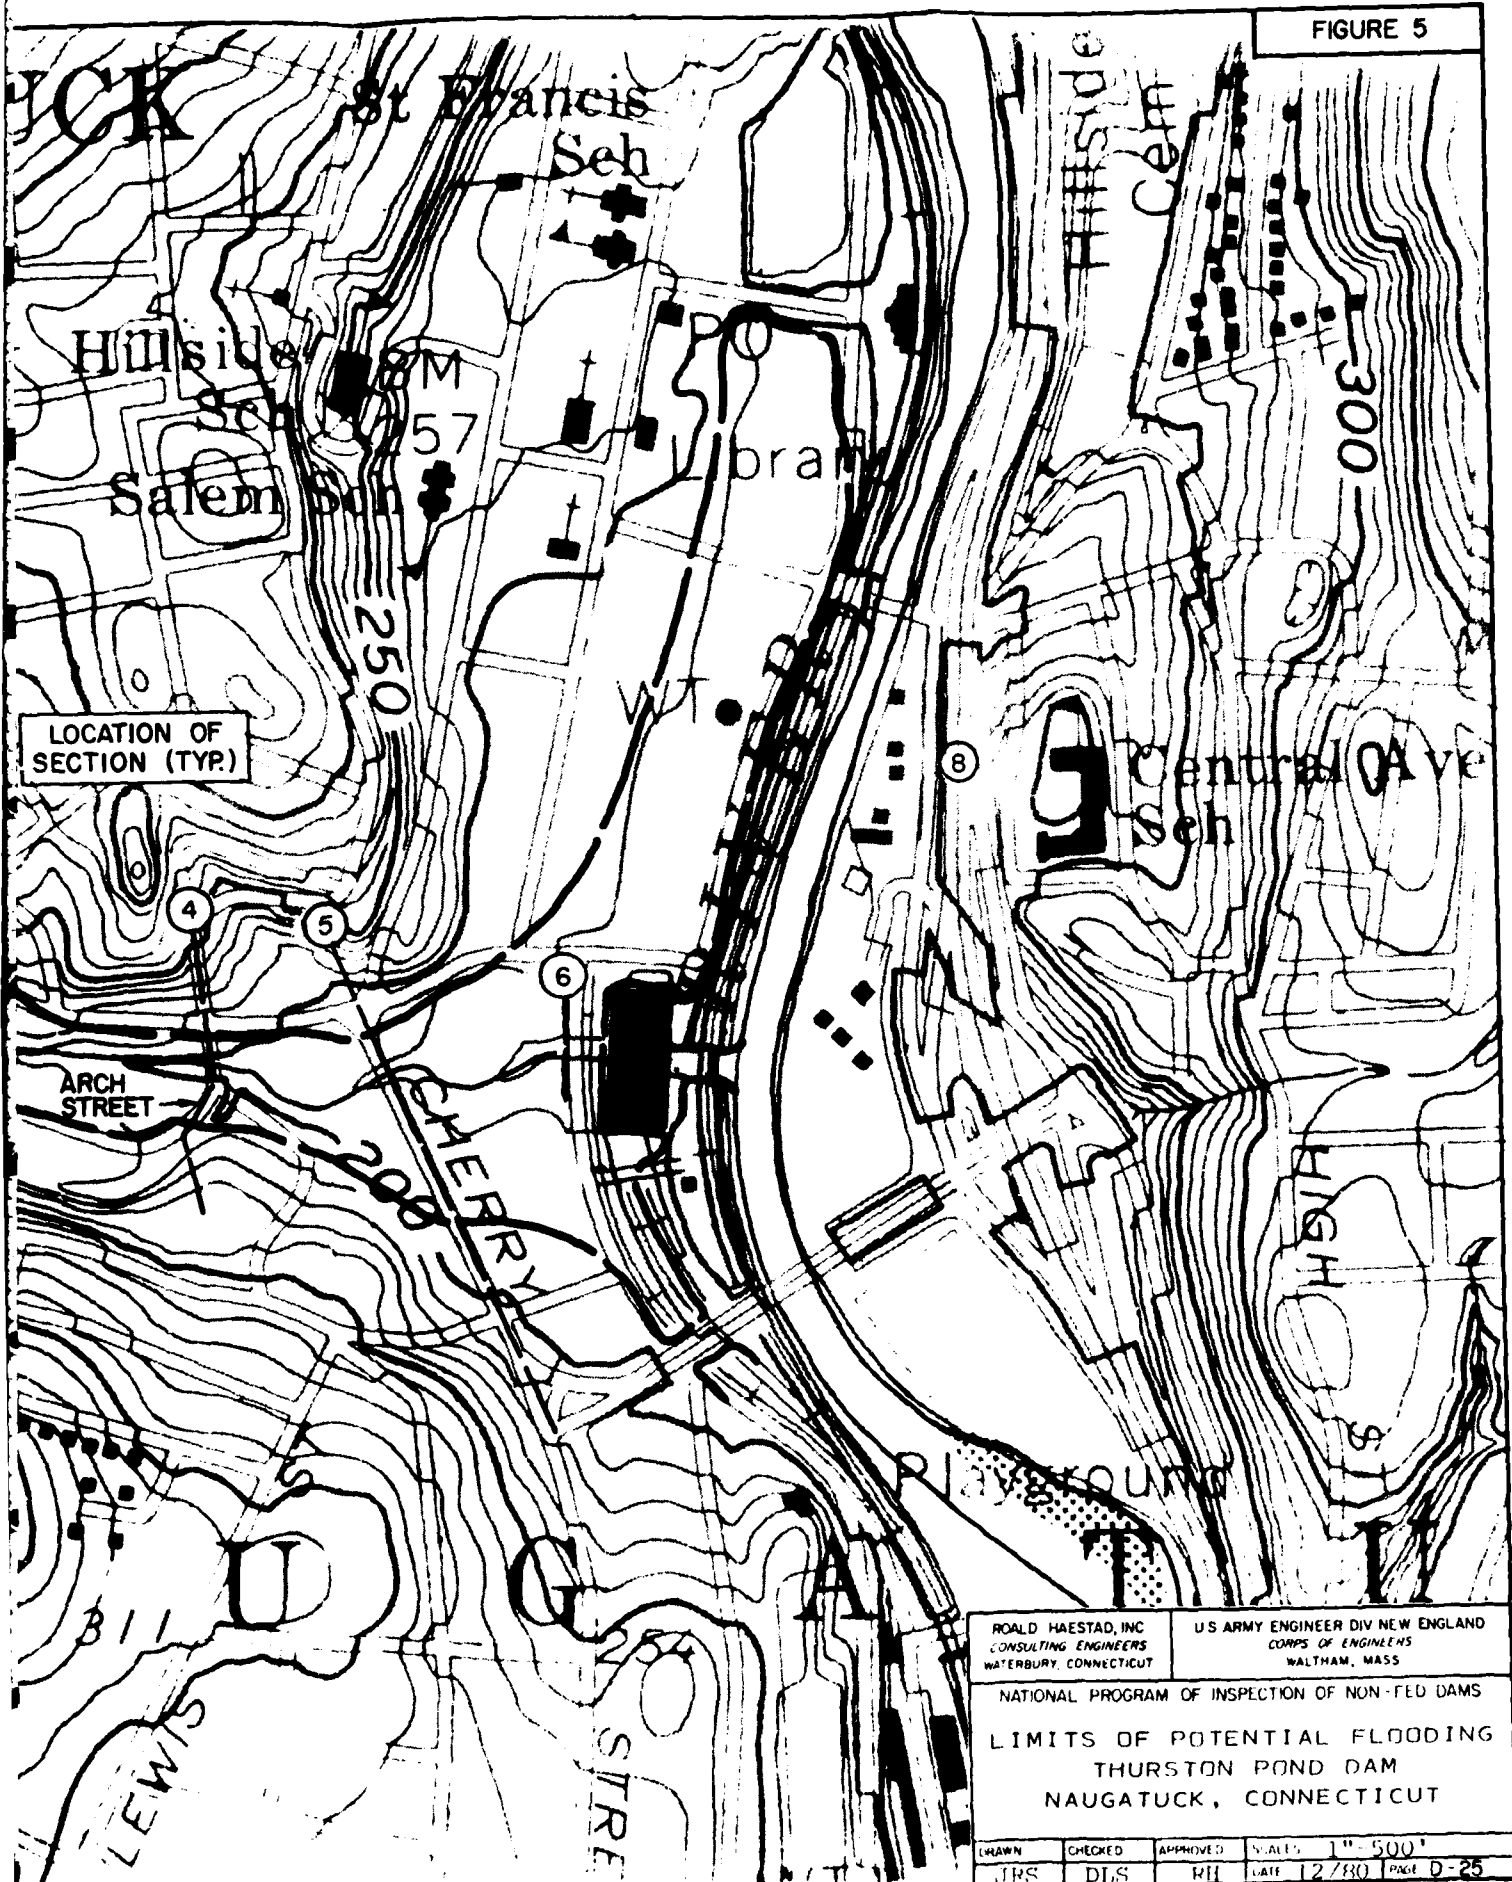
FIGURE 5

Based on the Corps of Engineers' Recommended Guidelines for Safety Inspection of Dams, the hazard classification for the dam is "High". A dam failure could result in the loss of more than a few lives and extensive property damage. A dam failure analysis indicates that a breach of Thurston Pond Dam would overtop Rubber Avenue by approximately 8 feet, flooding commercial structures to a depth of approximately 6 feet above floor level. The flood waters would continue downstream, overtopping several streets by up to 7 feet. Downstream of Andrew Avenue and Cherry Street industrial complexes would be flooded by up to 3 feet (see Figure 5, page D-25).

The peak outflow at Cherry Street Section 5 (see Figure 5, page D-25) is approximately 6,500 cfs. Downstream of Cherry Street the stream flows within 2 arched corrugated metal pipe culverts beneath a large industrial complex. The peak capacity of the 2 culverts is approximately 3,200 cfs. The flood waters would overtop the channel banks and flow overland to the Naugatuck River, flooding the industrial complex.
