CONNECTICUT RIVER BASIN
BERLIN, CONNECTICUT

LOWER HART POND DAM CT 00247

PHASE I INSPECTION REPORT
NATIONAL DAM INSPECTION PROGRAM

FEBRUARY, 1981

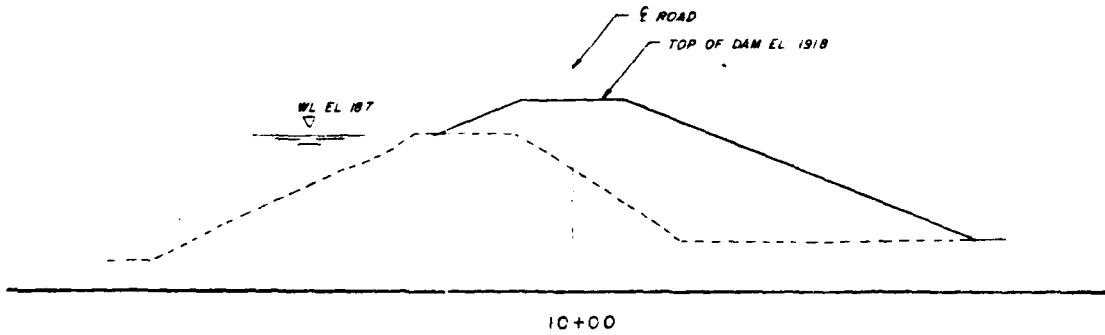
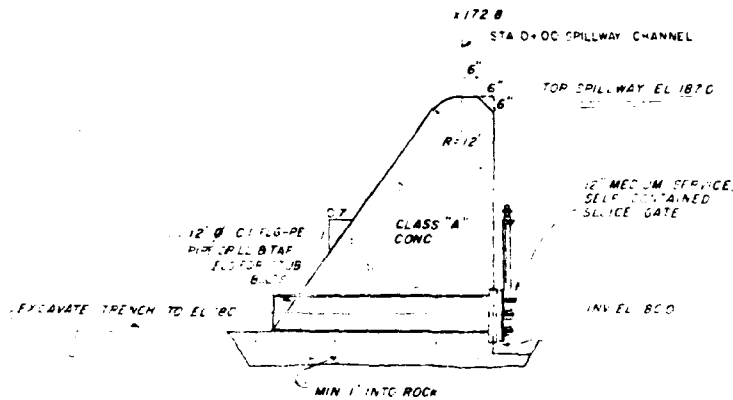
SPILLWAY AND DRAIN DETAIL
SCALE 3/8" = 1'-0"

c. Appurtenant Structures - There are two 12-inch low-level discharge pipes that to pass through the base of the dam. Controls for these pipes are in manholes on the downstream side of the embankment. The location of the outlets could not be found. There is also a discharge pipe through the spillway, but the inlet is silted up and its condition unknown (Plate 2 - Spillway and Drain Detail, Photo 8).

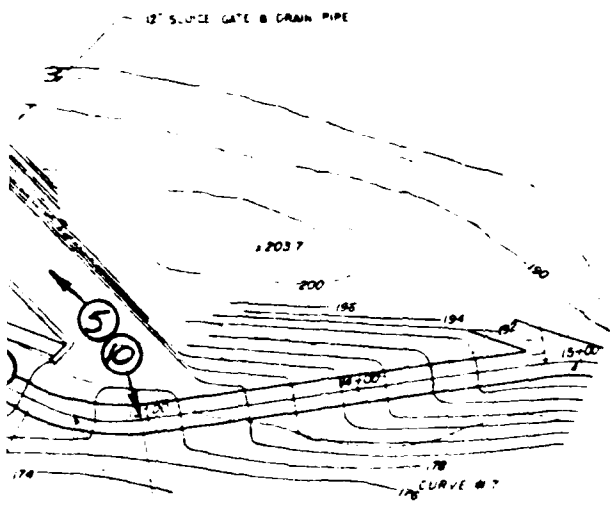
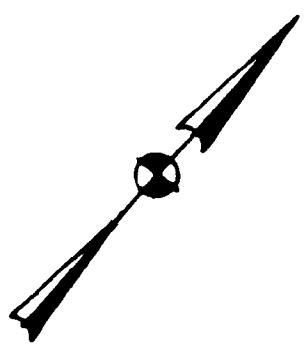
PHOTO LOCATION PLAN

Just below the toe of the dam and in the vicinity of the outlet of the low-level discharge pipes, there is a seepage flow (Photo 4), the amount of which could not be determined (See Photo Location Map - Plate 3 for location). This flow is clear and shows no signs of particle movement. Also, the outlet of the low-level discharge pipes could not be found. However, in the approximate vicinity

where the outlet should be, according to the plans, there is now a depression (Photo 3 - See Location Map - Plate 3 for location).

It is recommended that the owner engage the services of a qualified registered engineer experienced in the design of dams to investigate the seepage through the dam, investigate the depression at the outlet of the discharge pipe, supervise the removal of trees from the embankment, and study the possibility of putting the control gate on the upstream side of the embankment. It is also recommended that the owner remove brush from the upstream face, repair the discharge gate, check the erosion on the embankment, establish a formal warning system and initiate a maintenance program and an annual technical inspection.
