FARMINGTON RIVER BASIN  
HARWINTON, CONNECTICUT

**BRISTOL RESERVOIR NO.4 DAM  
CT 00364**

**PHASE I INSPECTION REPORT  
NATIONAL DAM INSPECTION PROGRAM**

JUNE 1981

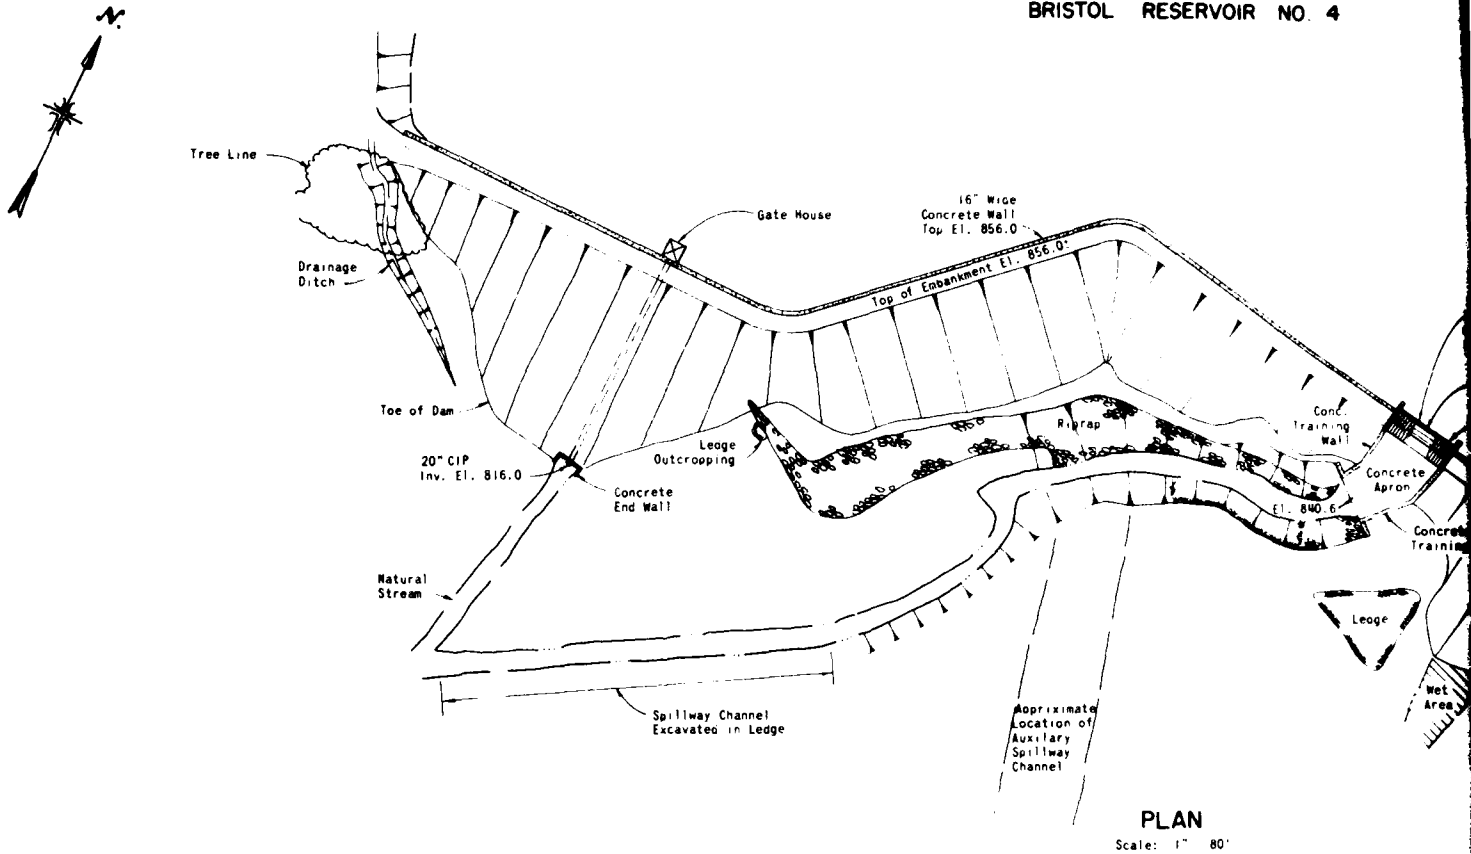
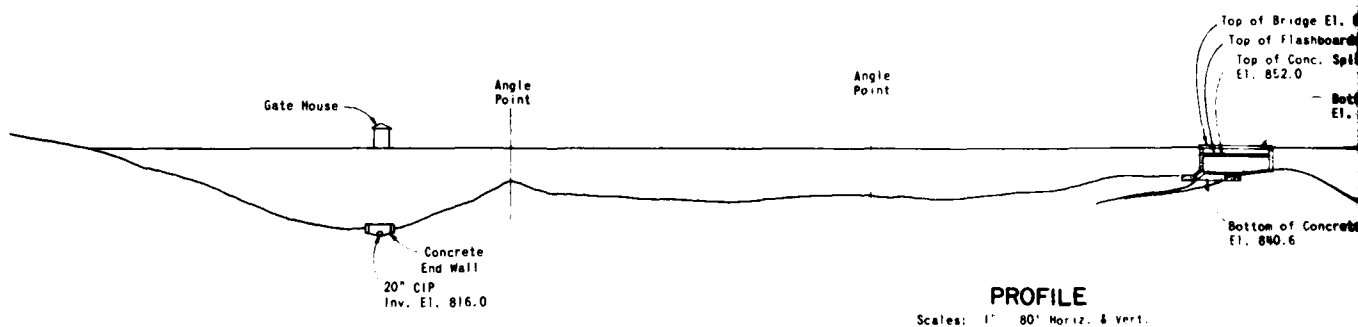
FIGURE 2

The dam consists of an earth embankment structure with a maximum height of 40 feet and a total length of 970 feet including a 29.7 foot long overflow spillway. In plan the dam essentially has three angle points along its axis and roughly takes the shape of the letter "W". Approximately 285 feet from the left end of the dam, the axis turns approximately 90° to the right and then proceeds approximately 335 feet to a second angle point. The overflow spillway is located near the center of this 335 foot long section. At the second angle point the axis turns approximately 45° to the left and proceeds 160 feet to the third angle point where it deflects approximately 45° back to the right and continues for 190 feet to the right abutment. The outlet works are located 130 feet from the right abutment in this final section of the dam. See Figure 2, page B-1 in Appendix B.

The overflow spillway consists of a concrete broad-crested weir with concrete training walls. The top of the dam is 4 feet above the top of the spillway and 2.9 feet above the top of 13-inch high flashboards which are normally in place. The flashboards consist of removable timber planks resting against steel pins in the spillway crest. A steel beam and wood deck bridge spans the spillway. The spillway discharge normally flows through a narrow channel excavated into ledge which discharges into a natural streambed below the outlet works. Large spillway flows discharge through an auxiliary channel approximately 100 feet downstream of the dam. See Figure 2, page B-1 in Appendix B.

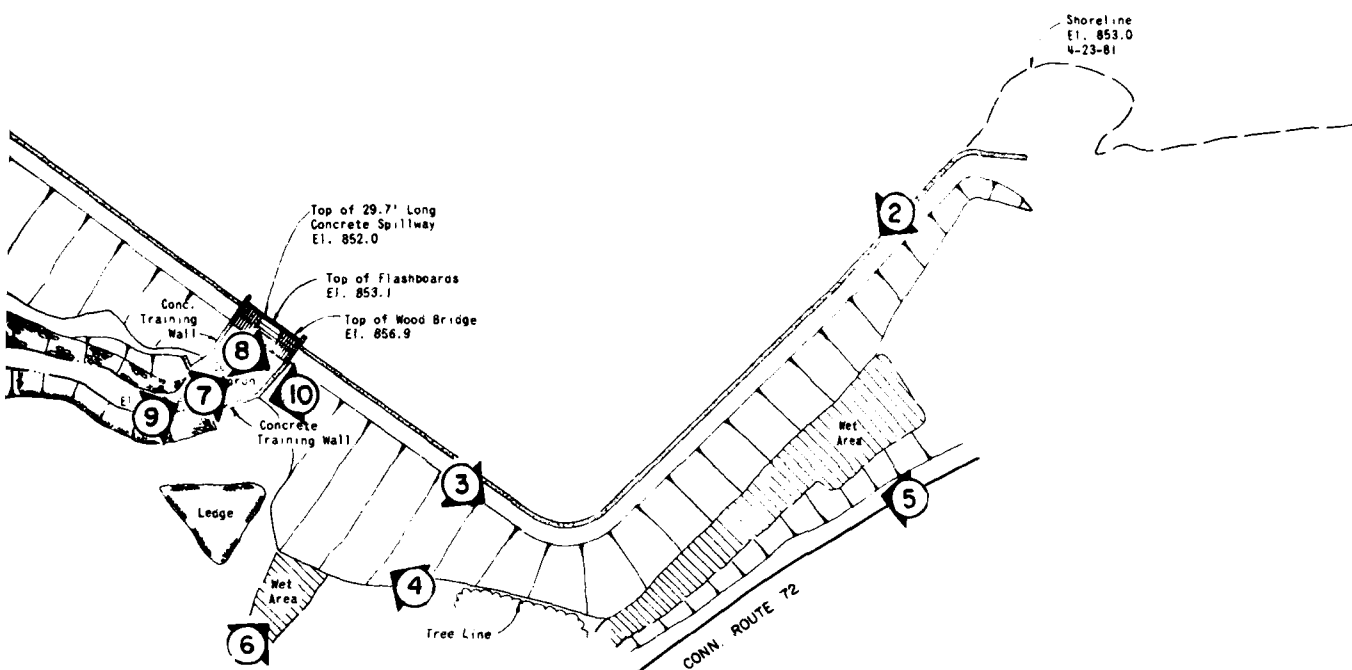
PHOTO NO. 2

The upstream slope of the dam, below the water level, is protected by a layer of riprap slope paving which appears to be in good condition, Photo 2. A concrete facing has been placed at the junction of the upstream slope with the corewall along portions of the dam. The facing is cracked and broken, Photo 2. The upstream face of the concrete corewall appears to be in good condition.
