**CONNECTICUT RIVER BASIN  
AVON, CONNECTICUT**

**STUB POND DAM**

**CT 00265**

**PHASE 1 INSPECTION REPORT  
NATIONAL DAM INSPECTION PROGRAM**

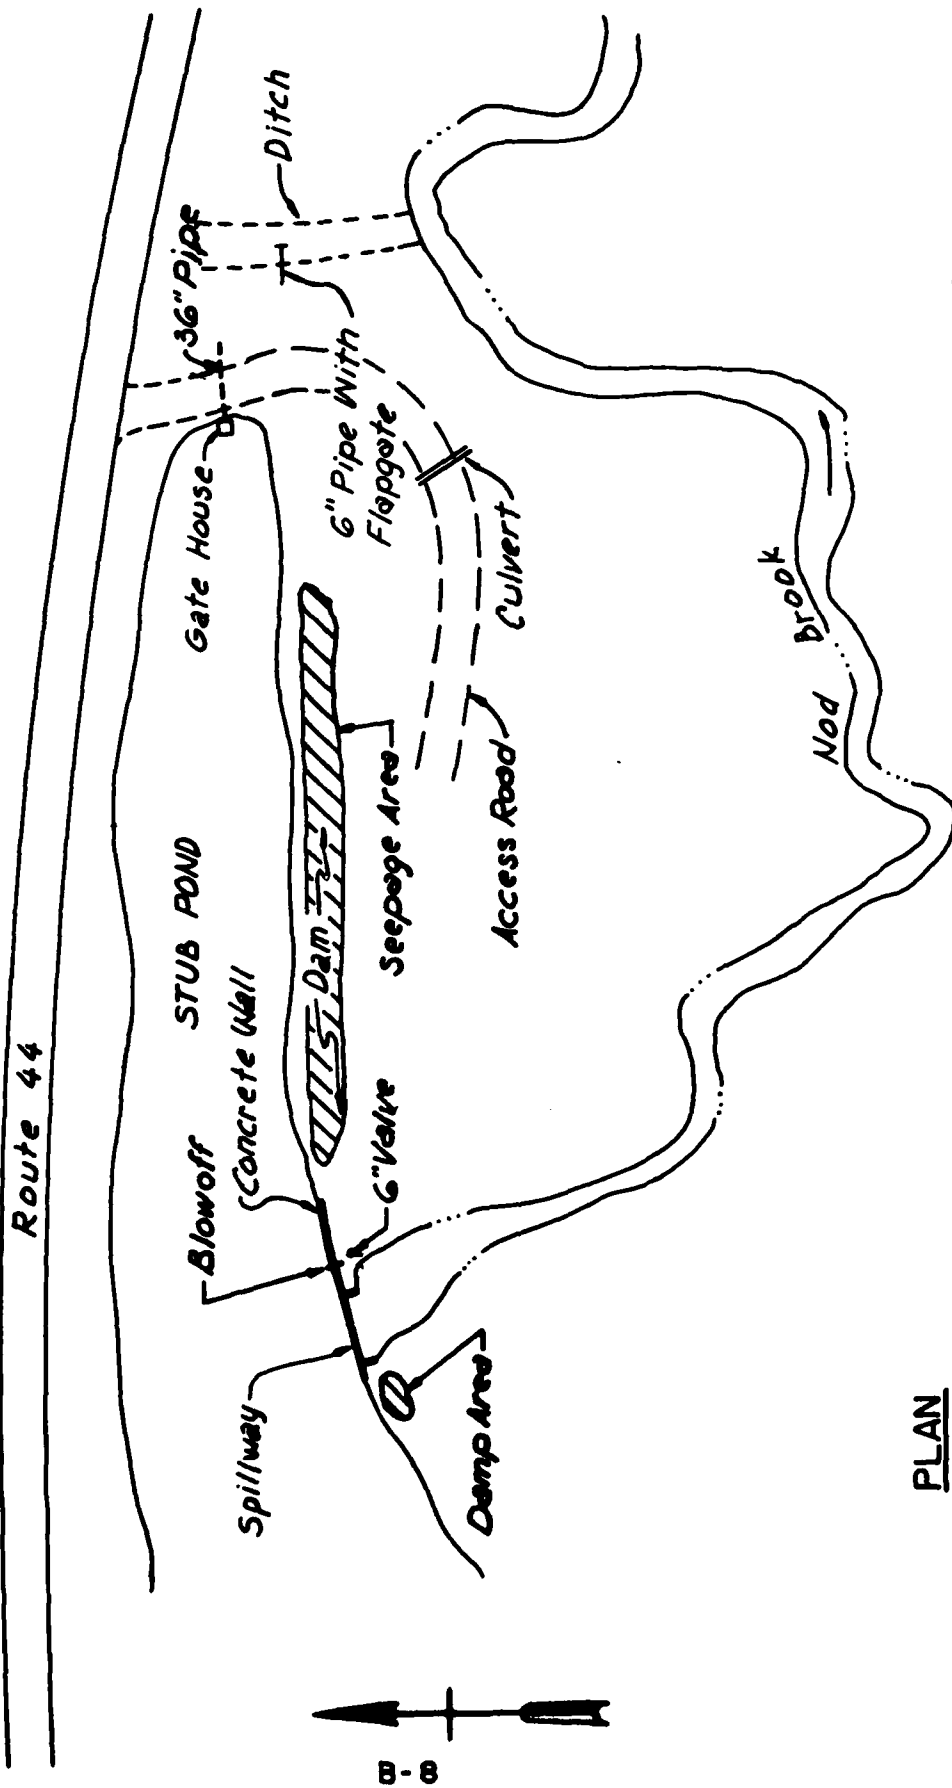
B-8

There is also a 6 inch pipe through the concrete wall which is controlled by gate valves on the upstream and downstream side of the wall. This pipe connects to an abandoned 6 inch water supply pipe of the Avon Water Company. Possibly, this pipe outlets at a ditch to the east of the gate house where a 6 inch C.I. pipe with flap gate was observed (See Plan Page B-8).
