CONNECTICUT RIVER BASIN  
EAST HAMPTON, CONNECTICUT  
**BEVINS POND DAM**  
**CT 00360**

PHASE I INSPECTION REPORT  
NATIONAL DAM INSPECTION PROGRAM

AUGUST, 1980

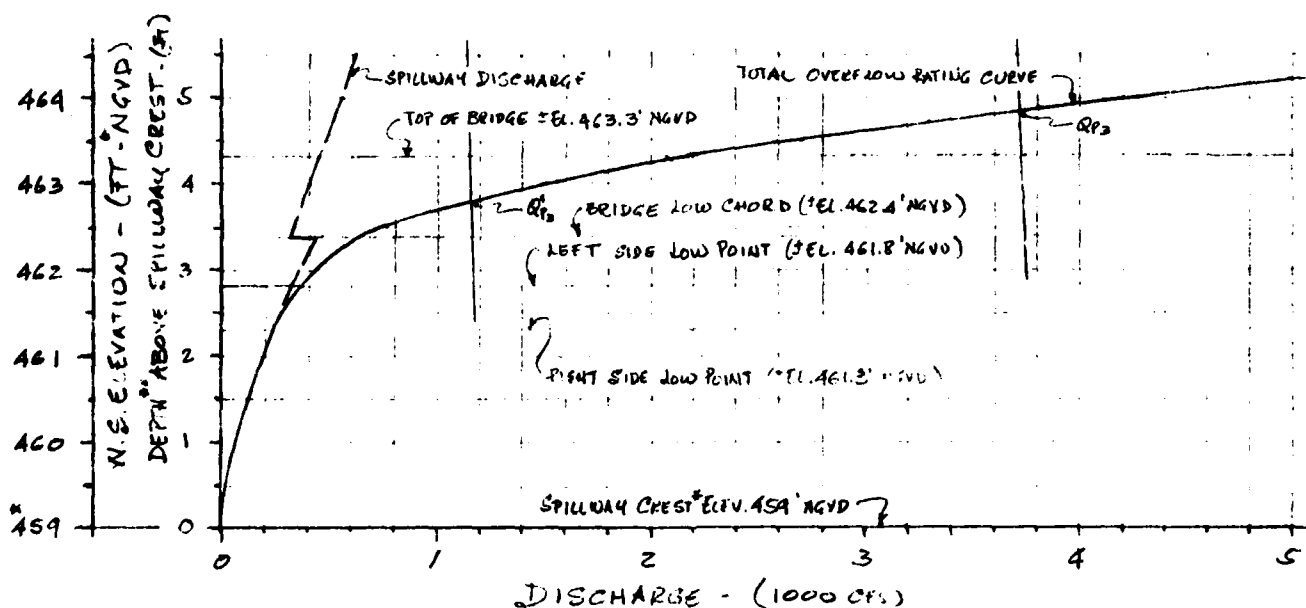
### (iii) BEVINS POND DAM - OUTFLOW RATING CURVE

THEREFORE, THE TOTAL OUTFLOW IS APPROXIMATED BY THE COMBINATION OF ALL THE APPLICABLE FORMULAE ON ITEMS (1') TO (7')

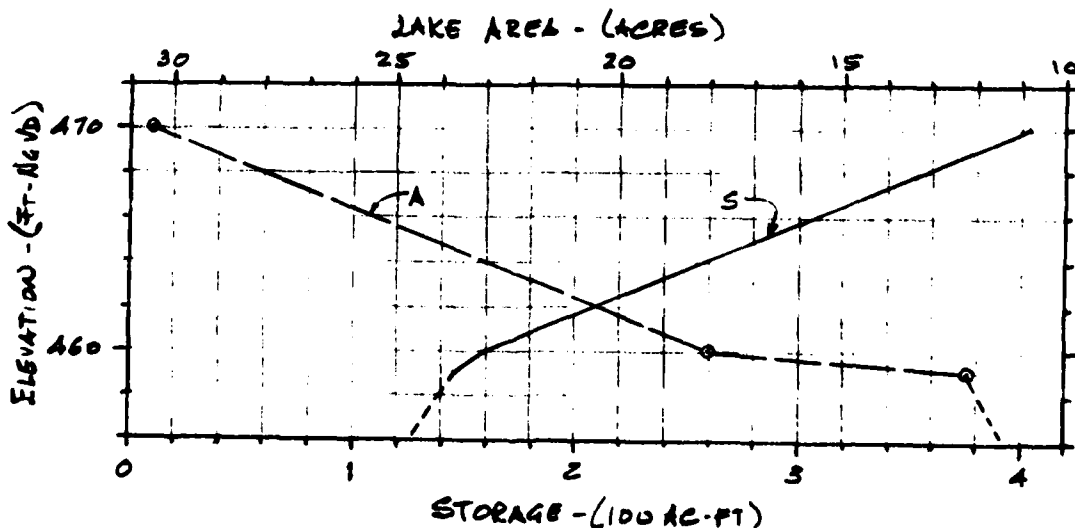
## 4) LAKE AREA/STORAGE CURVES - BEVINS POND

© AREAS FROM USGS MIDDLE HADDAM/MOODUS, CT QUAD. SHEETS. SEE PP. D-6 (AREAS) AND D-10 (STORAGE). D-7<sup>B</sup>
