QUINNIPIAC RIVER BASIN  
MERIDEN/CHESHIRE, CONNECTICUT

BROAD BROOK DAM  
CT. 00301

PHASE I INSPECTION REPORT  
NATIONAL DAM INSPECTION PROGRAM

SEPTEMBER 1978

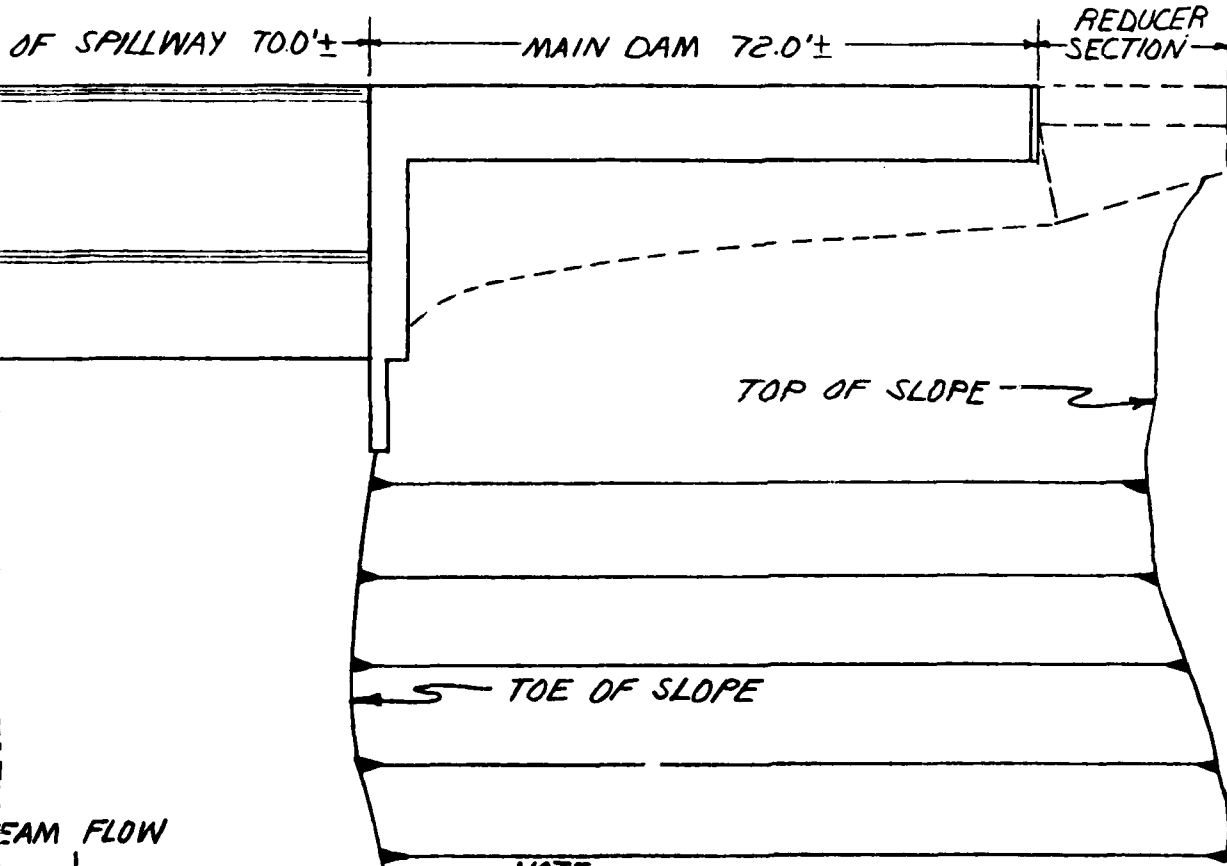
PLATE-1

On the east bank of the downstream side of the dam for a distance of about 200' ± there are wet spots that seem to flow at a fairly steady rate approximately 10 to 30 gallons/min. These wet areas are noticeable over the entire lower half of the slope and the approximate limits have been delineated on Plate 1, Appendix B. This bank has been completely overgrown with trees and underbrush.

The east bank on the downstream side of the dam shows signs of fairly heavy seepage. This condition should be investigated further.
