CONNECTICUT RIVER BASIN  
PLYMOUTH, CONNECTICUT

OLD MARSH POND DAM

CT 00285

PHASE I INSPECTION REPORT  
NATIONAL DAM INSPECTION PROGRAM

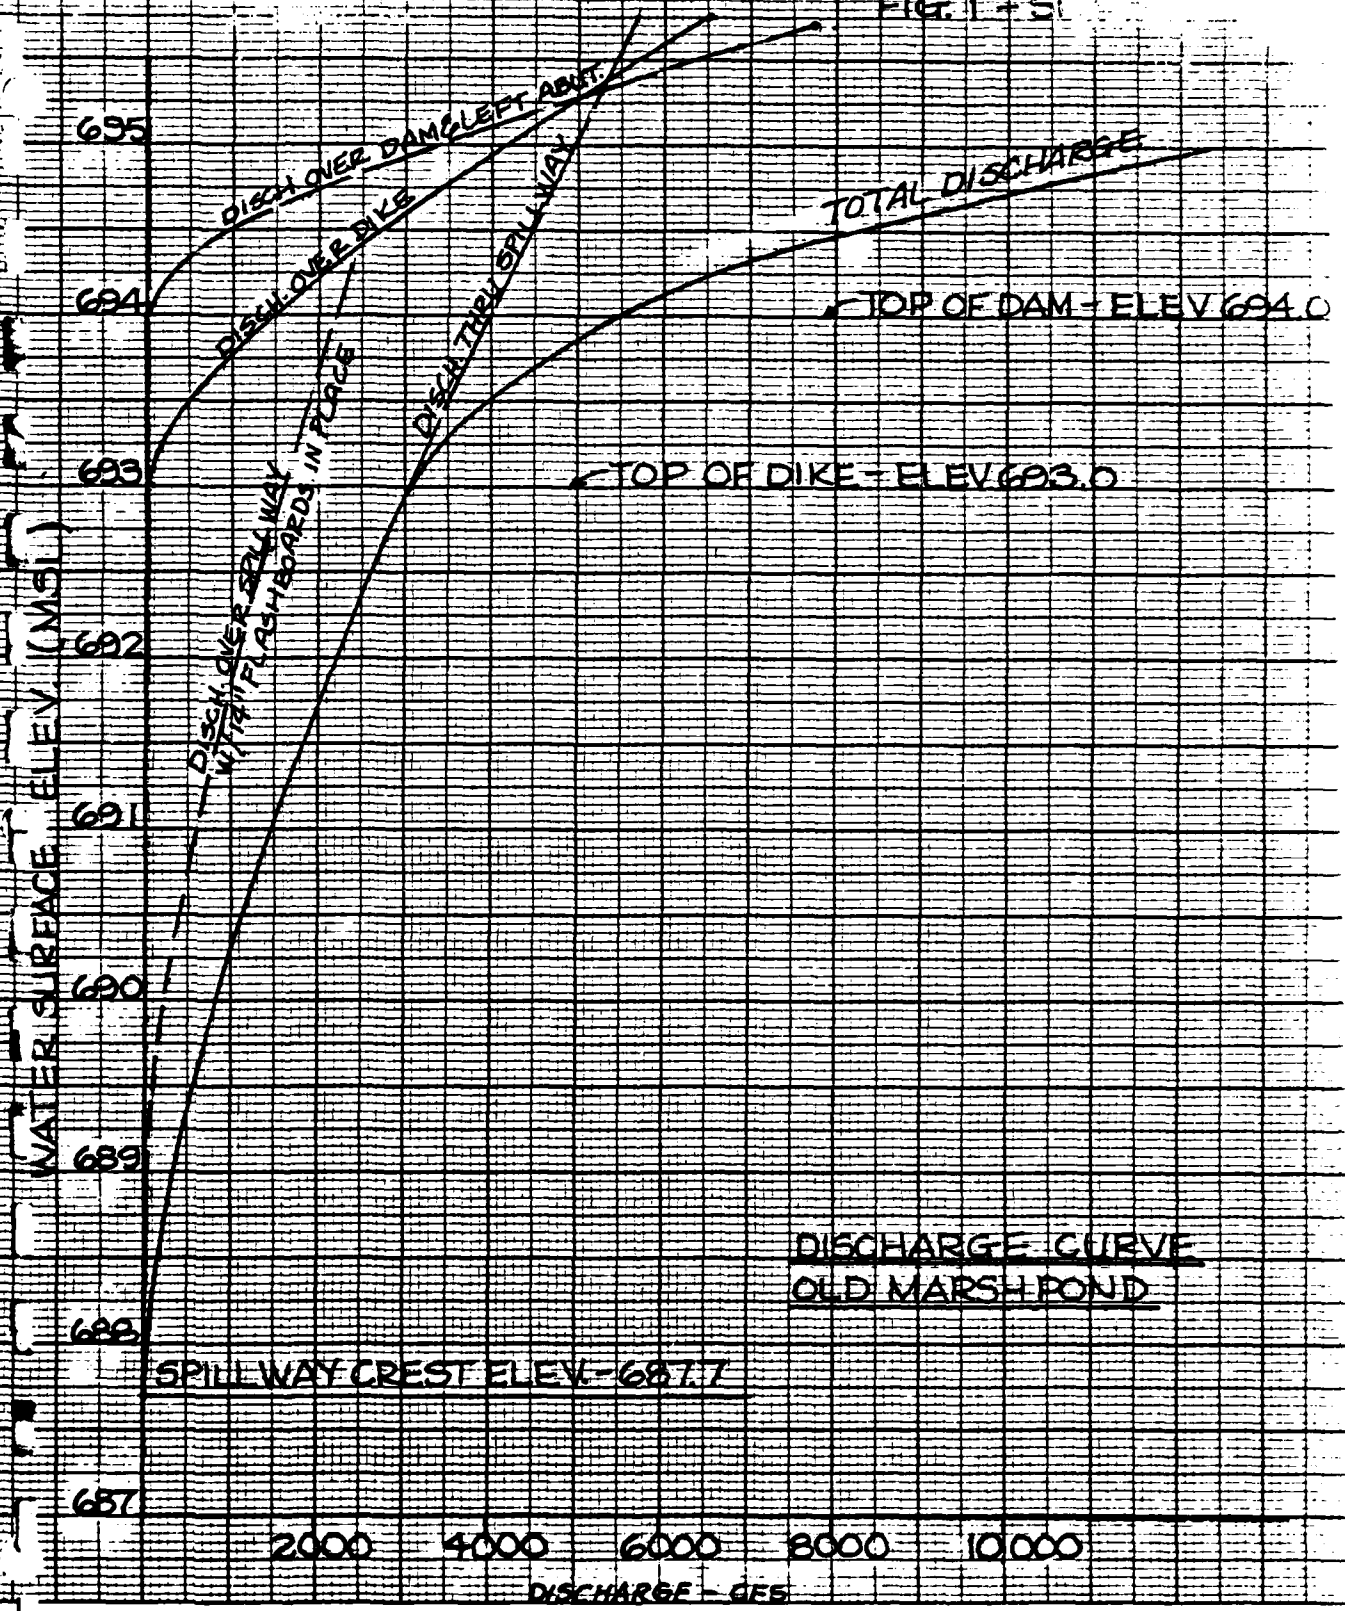
FIG. 1 - S.I.

The spillway at Old Marsh Pond Dam is an ungated ogee overflow 60 ft. in length, which appears to have been designed for a capacity of about 900 cfs at 2.4 ft. surcharge head. The spillway control will be able to handle about 3,500 cfs with reservoir to top of dike, elevation 693; and about 4,000 cfs with reservoir to top of dam, elevation 694. Discharge curves and computations are shown on Figure 1 and sheets D-1 to D-3, Appendix D.

With the flashboards in place, the spillway capacity for heads up to reservoir level 692 will be reduced by more than half the capacity without the flashboards; for a head to reservoir level 694 the spillway capacity will be 55 percent of that of an unobstructed crest. A discharge curve for flow over the crest with the flashboards installed is shown on Fig. 1, Sheet D-1, Appendix D.

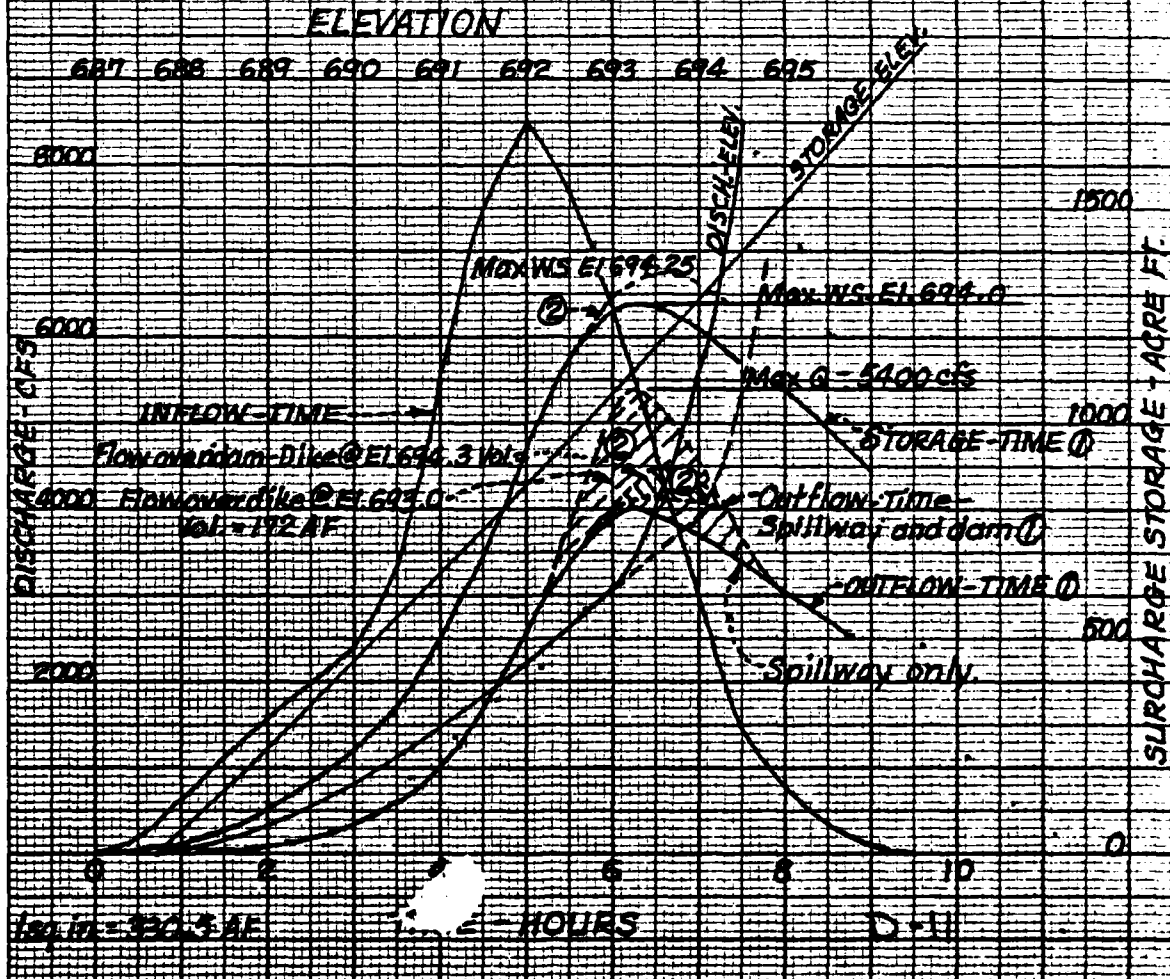
FIG. 5 - SHT D-12

A flood routing of a 0.75 PMF through the reservoir and spillway results in a maximum surcharge to elevation 693.0, the top of the dike. This flood routing is shown on Figure 5, Sheet D-12. Floods in excess of this magnitude will result in an overtopping of the dike.

S.D. MARSH POND RESERVOIR  
FLOOD ROUTING OF 0.75 PMF THRU RESERVOIR AND SPILLWAY
