| REPORT DOCUMENTATION PAGE | | READ INSTRUCTIONS<br>BEFORE COMPLETING FORM |
|---|---|---|
| 4. TITLE (and Subtitle)<br>Silver Lake Dam | | 5. TYPE OF REPORT & PERIOD COVERED<br>INSPECTION REPORT |
| NATIONAL PROGRAM FOR INSPECTION OF NON-FEDERAL DAMS | | 6. PERFORMING ORG. REPORT NUMBER |
| 11. CONTROLLING OFFICE NAME AND ADDRESS<br>DEPT. OF THE ARMY, CORPS OF ENGINEERS<br>NEW ENGLAND DIVISION, NEDED<br>424 TRAPELO ROAD, WALTHAM, MA. 02254 | | 12. REPORT DATE<br>June 1979 |

### SILVER LAKE DAM

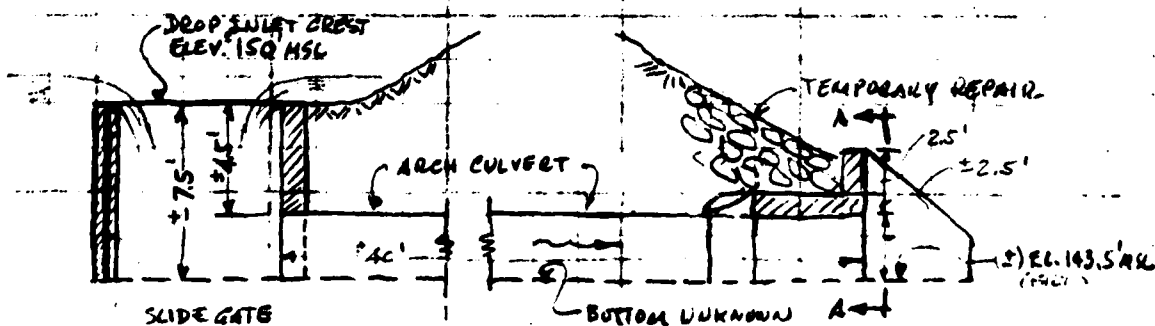
THE OUTLET STRUCTURE OF SILVER LAKE DAM IS A (±) 9.5' X 9.5' SQUARE SHAPED DROP INLET SPILLWAY. THE CREST (ELEV. (±) 150' MSL) IS (±) 1' BROAD. THE BOX (SHAFT) IS (±) 7.5' TO 8' DEEP AND DISCHARGES THRU AN ARCH-CULVERT-TYPE CONDUIT (±) 40' LONG. THE CHORD AT THE BASE OF THE ARCH, AT THE OULET, IS (±) 7' AND THE RISE (±) 2.5'. AT LEAST AT THE OULET, THE CULVERT IS SILTED TO THE CHORD OF THE ARCH AND THEREFORE, THE ACTUAL TYPE, SHAPE AND DEPTH OF THE INVERT OF THE CULVERT (CONDUIT) IS UNKNOWN. HOWEVER, FROM ROUGH MEASUREMENTS AT THE INLET, UNDER OVERFLOWING CONDITIONS, IT IS ESTIMATED THAT THE MAXIMUM HEIGHT OF THE CONDUIT IS (±) 3'. THE <sup>1</sup>/<sub>2</sub> (LAKE) FACE OF THE INLET BOX INCLUDES A WOODEN SLIDE GATE (±) 2'-10" WIDE AND, PRESUMABLY, (±) AS HIGH AS THE SHAFT, i.e., (±) 7'.

DROP INLET SPILLWAY APPROXIMATE LONGITUDINAL CROSS SECTION

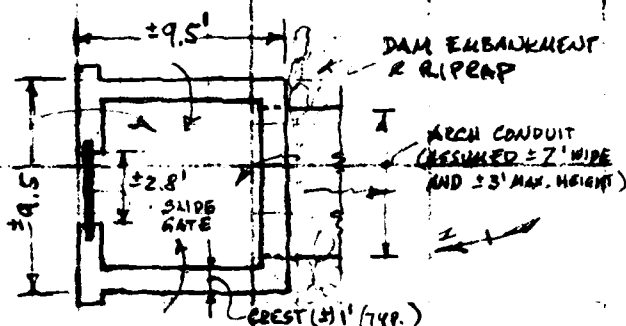
THE HEIGHT BETWEEN THE DROP INLET CREST (ELEV. (+) 150.0' MSL) AND THE TOP OF THE DAM (ELEV. (+) 154.5' MSL) IS  $H = 4.5'$ . A 3' HIGH PIPE RAILING SURROUNDS THE INLET.

DROP INLET SPILLWAY  
PLAN

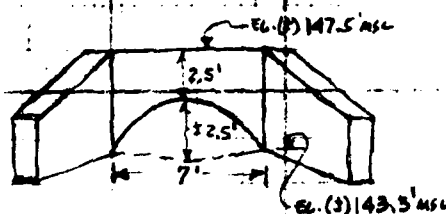
CONDUIT OUTLET  
FRONT VIEW (A-A)
