**WILLIAMS POND DAM
CT 00900**

**PHASE I INSPECTION REPORT
NATIONAL DAM INSPECTION PROGRAM**

Identification Number:	CT 00900
Name:	Williams Pond Dam
Town:	Glastonbury
County and State:	Hartford County, Connecticut
Stream:	Hubbard Brook
Date of Inspection:	May 18, 1981

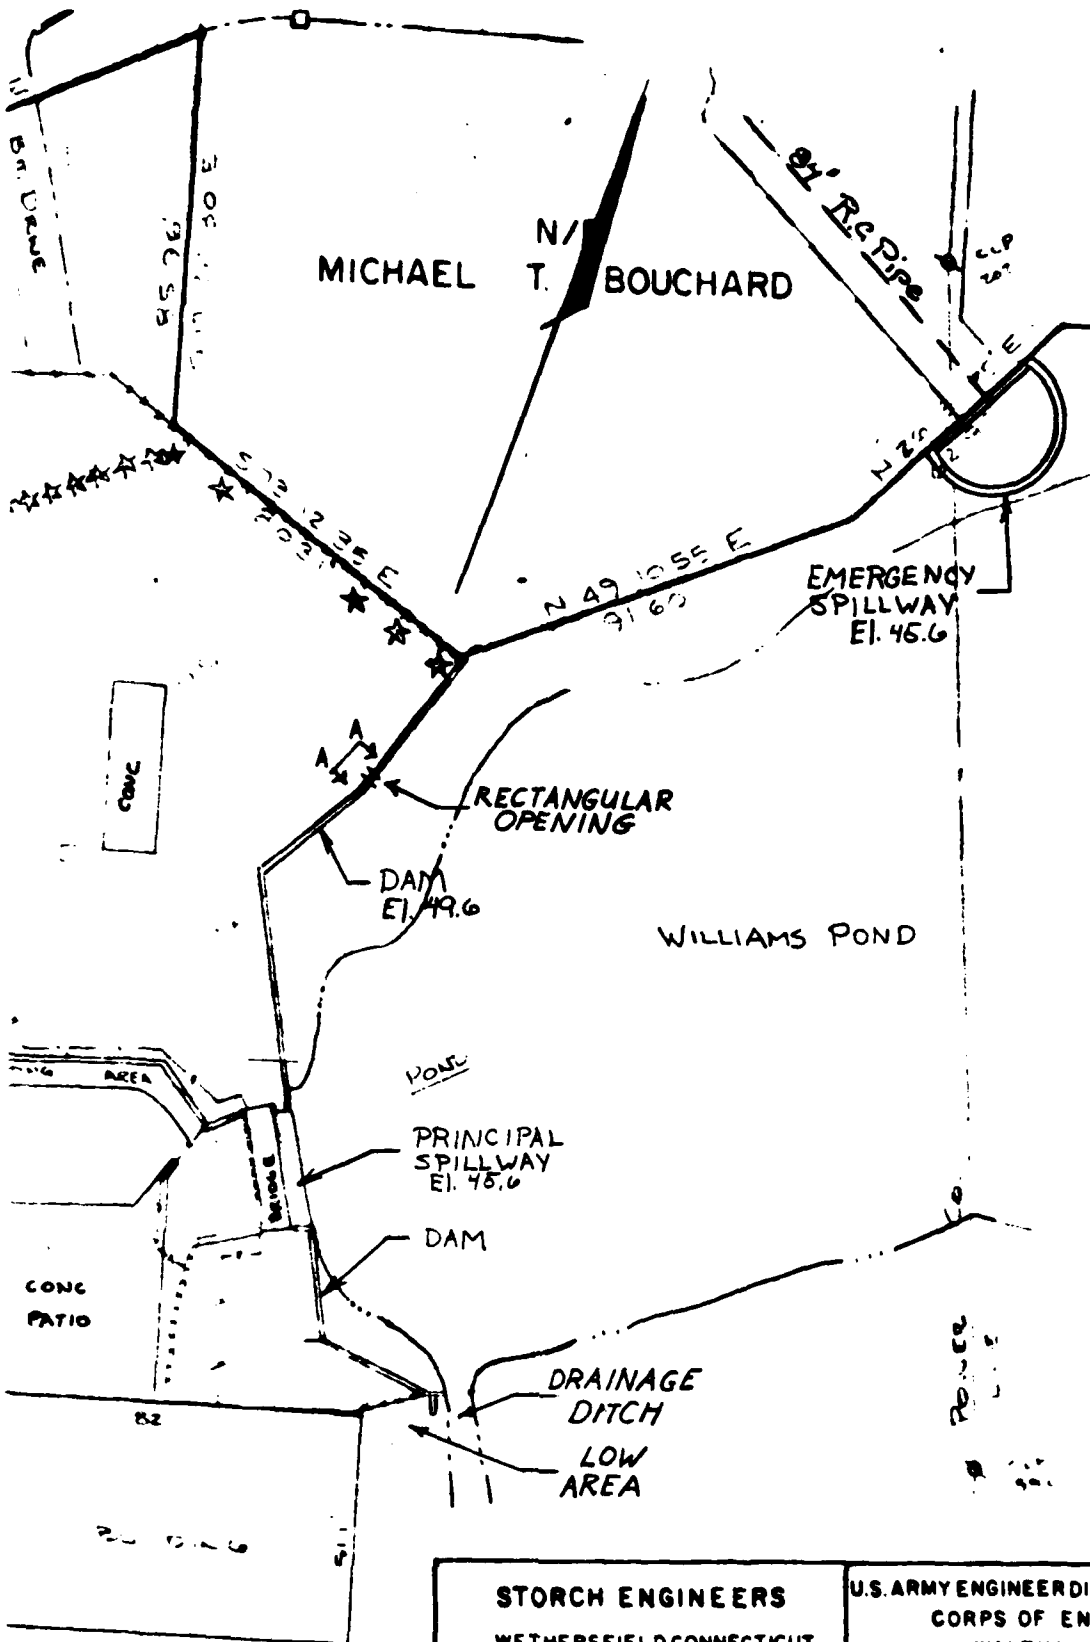
PLATE 1

The stone masonry on the downstream face in the vicinity of the spillway needs repointing (Overview Photo). Spalling is evident along the entire length of the concrete wall. There is a small rectangular opening (less than 1 square foot) through the base of the wall near the northern end of the dam (Plate 1). This will allow approximately 540 gpm of water to flow through the opening and onto the grass covered crest of the dam. (See computations Appendix D).

of dam (Photo 3, Plate 1). There was a dike at this location at one time (Plate 3) that tied into an adjacent hill. The dike was removed during construction of the drainage ditch and the rehabilitation of the apartments. This low area would cause overtopping before the water reaches the top of dam elevation. There was no seepage passing through the dam.

e. Downstream Channel - The downstream channel runs under a concrete patio for a distance of 150 feet where it emerges as a 3 foot high by 7 foot wide channel with stone masonry side walls (Plate 1, Photo 8). The entrance where it passes under the patio is approximately 25 feet from the dam and is cluttered with debris (Photo 7). The channel winds around an apartment complex and passes under numerous walkways and footbridges along its route.
