REPORT DOCUMENTATION PAGE		READ INSTRUCTIONS BEFORE COMPLETING FORM
1. REPORT NUMBER CT 00484	2. GOVT ACCESSION NO.	3. RECIPIENT'S CATALOG NUMBER
4. TITLE (and Subtitle) West Side Dam NATIONAL PROGRAM FOR INSPECTION OF NON-FEDERAL DAMS		5. TYPE OF REPORT & PERIOD COVERED INSPECTION REPORT

Inclosed is a copy of the West Side Dam (CT-00484) Phase I Inspection Report, prepared under the National Program for Inspection of Non-Federal Dams. This report is based upon a visual inspection, a review of the past performance and a brief hydrological study of the dam. I approve the report and support the findings and recommendations described in Section 7 and ask that you keep me informed of the actions taken to implement them. This follow-up action is vitally important.

WEST SIDE DAM
BLACKBERRY RIVER
NORFOLK, CONNECTICUT
CT 00484
17 NOVEMBER '80

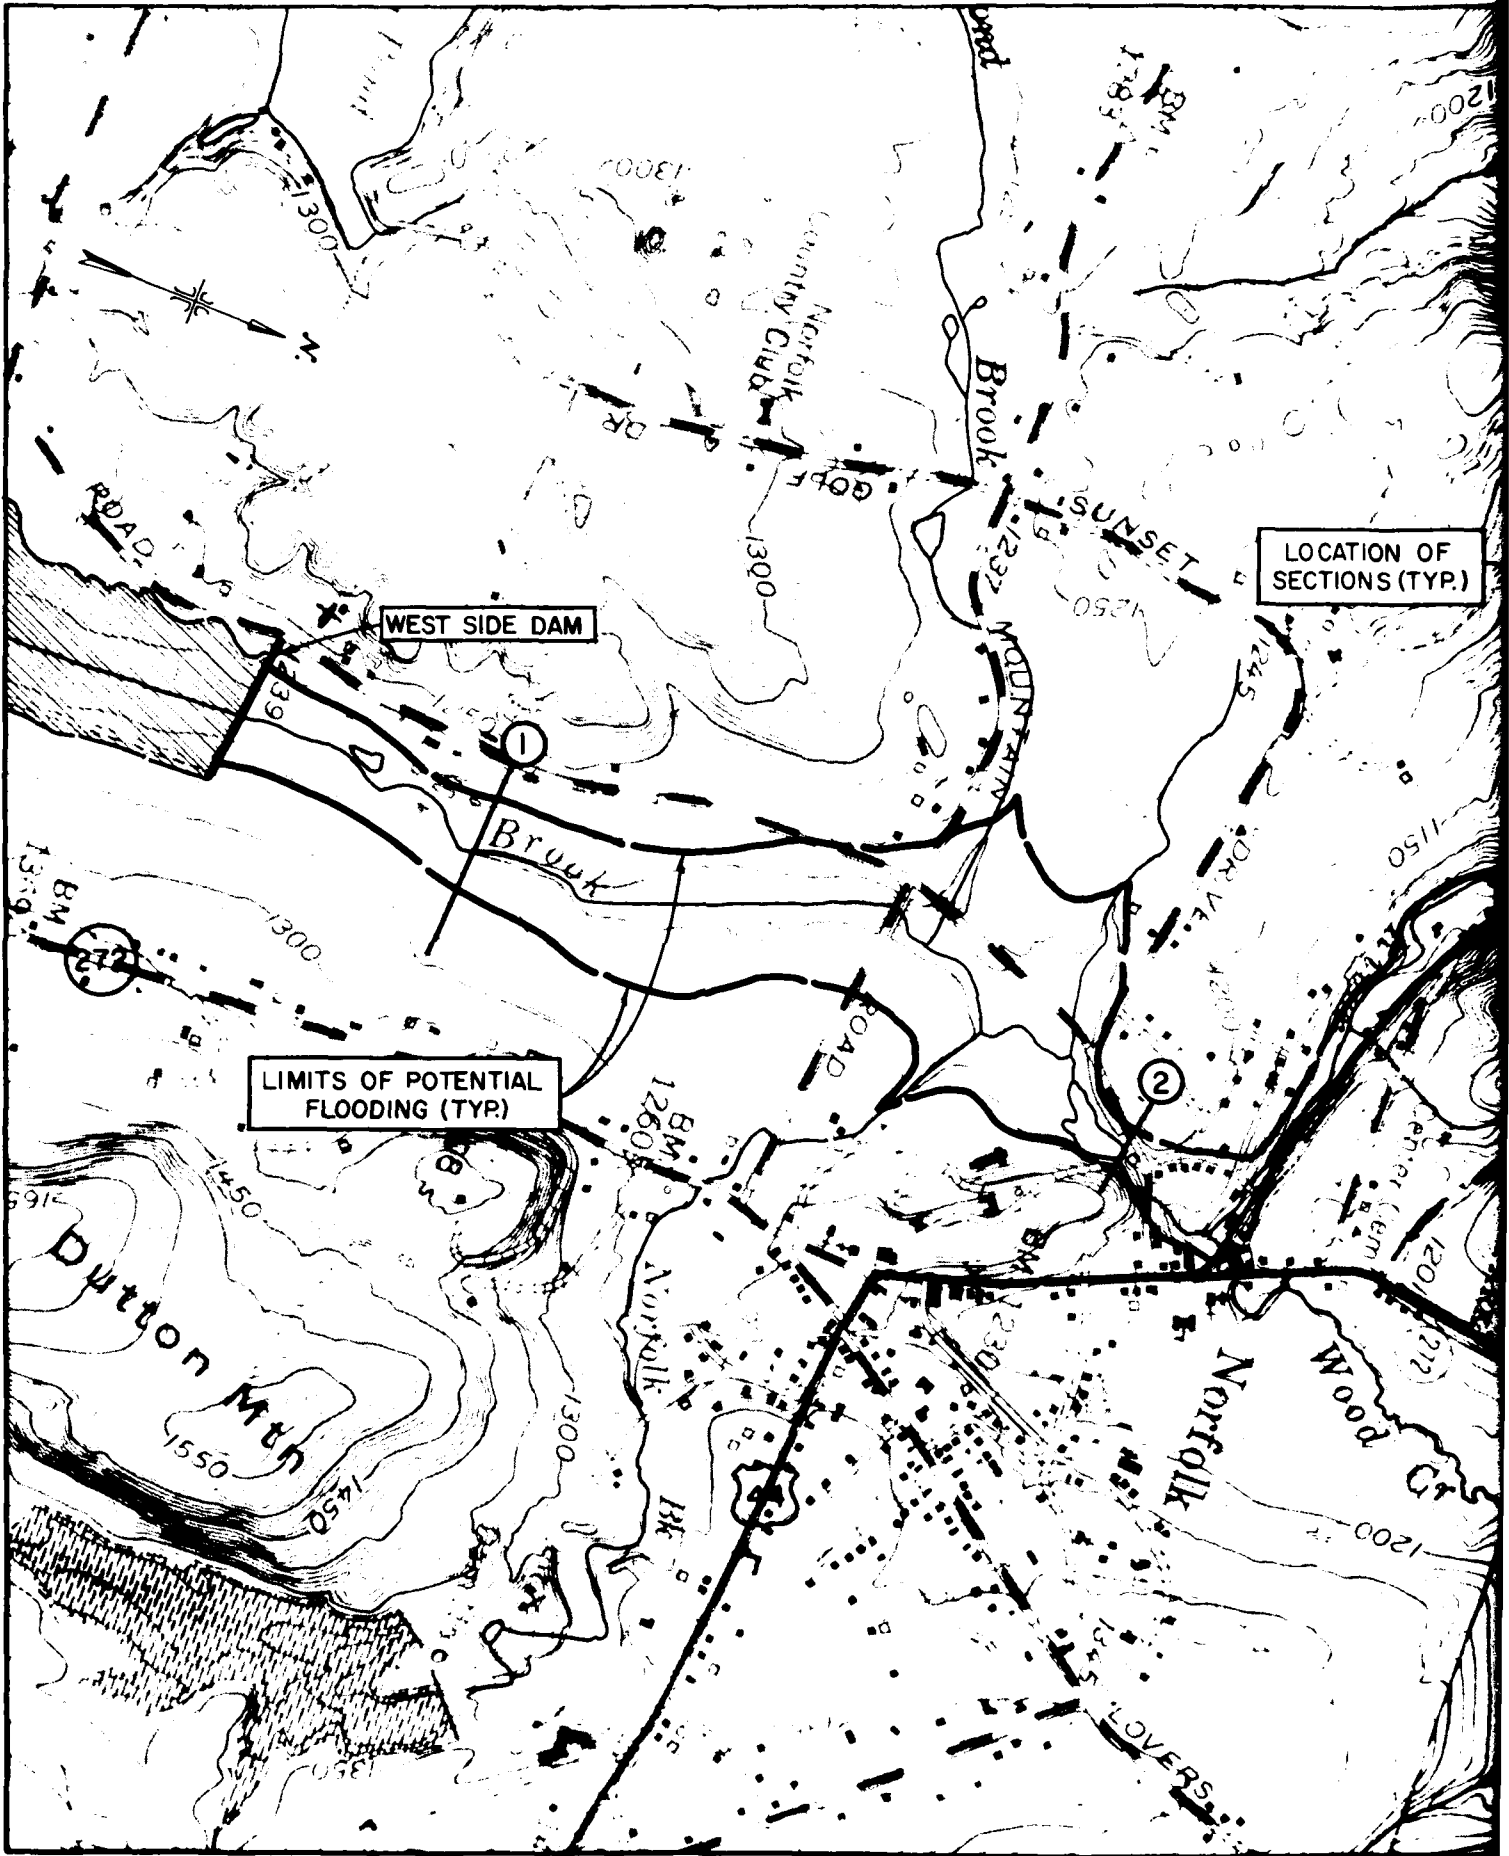
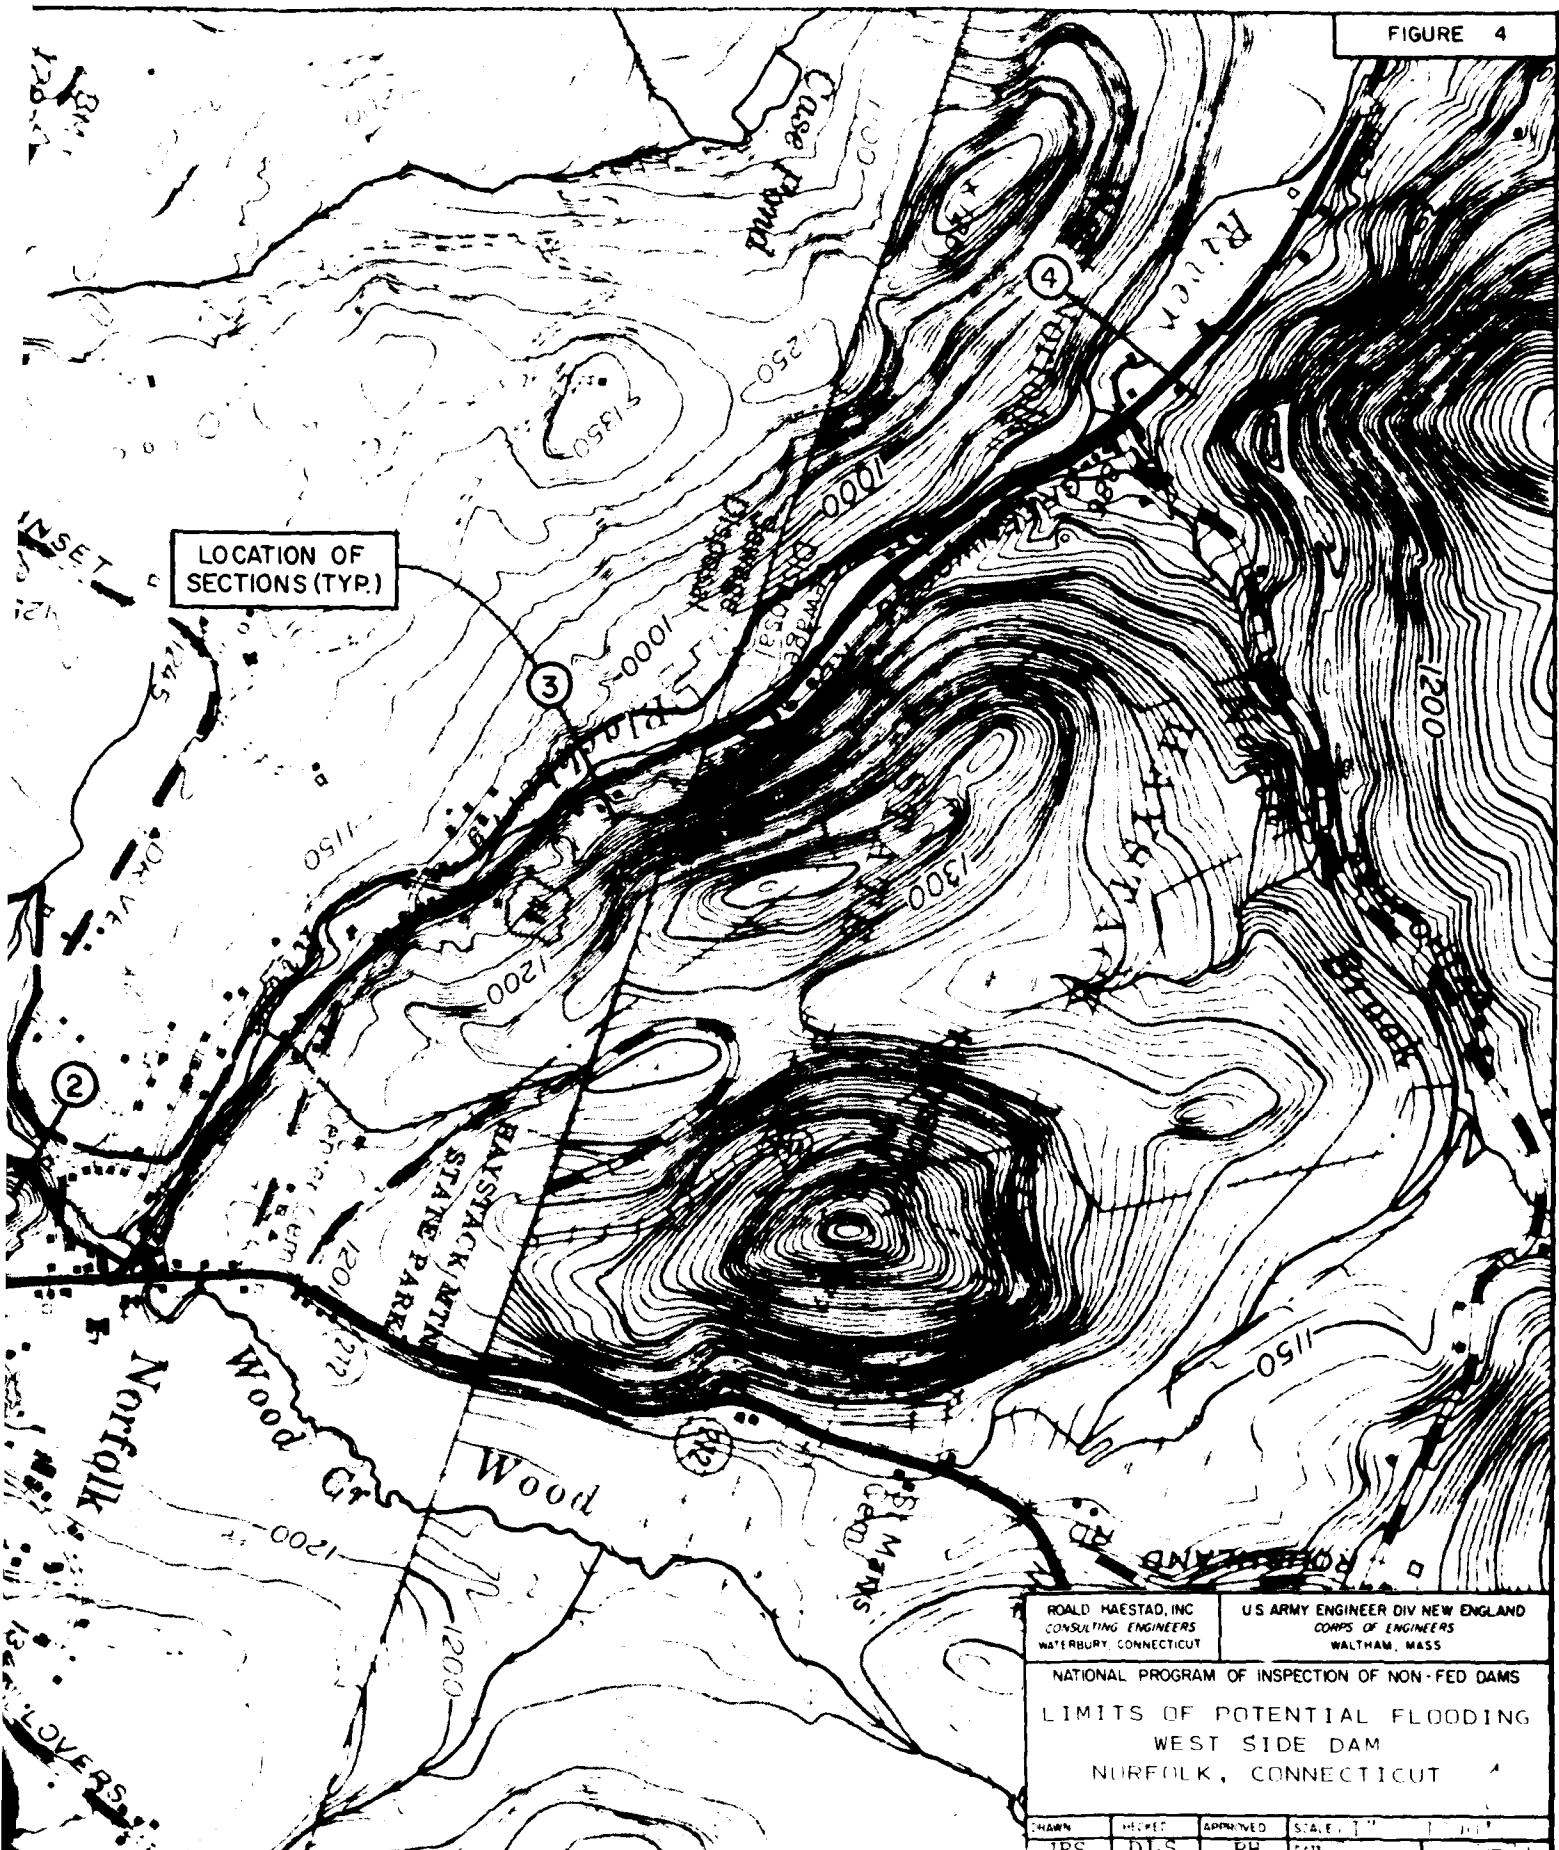
FIGURE 4

The calculated dam breach, 20 feet high by 240 feet wide, would release up to 28,000 cfs into Spaulding Brook. The flood waters would travel 1,200 feet downstream where a number of structures at a religious institution including a multi-family residence, a dining hall and farm buildings would be flooded up to a depth of 10 feet. The flood waters would continue downstream, overtopping a small dam by 9 feet, and flood several residential homes from 2 feet to 10 feet deep. The flood waters would join the Blackberry River and flow at an average depth of 9.5 feet. The low lying homes along the river banks would be flooded up to a depth of 2 feet. See Figure 4, page D-24.
