ASHFORD, CONNECTICUT  
**ASHFORD LAKE DAM**  
**CT 00462**

PHASE I INSPECTION REPORT  
NATIONAL DAM INSPECTION PROGRAM

AUGUST 1980

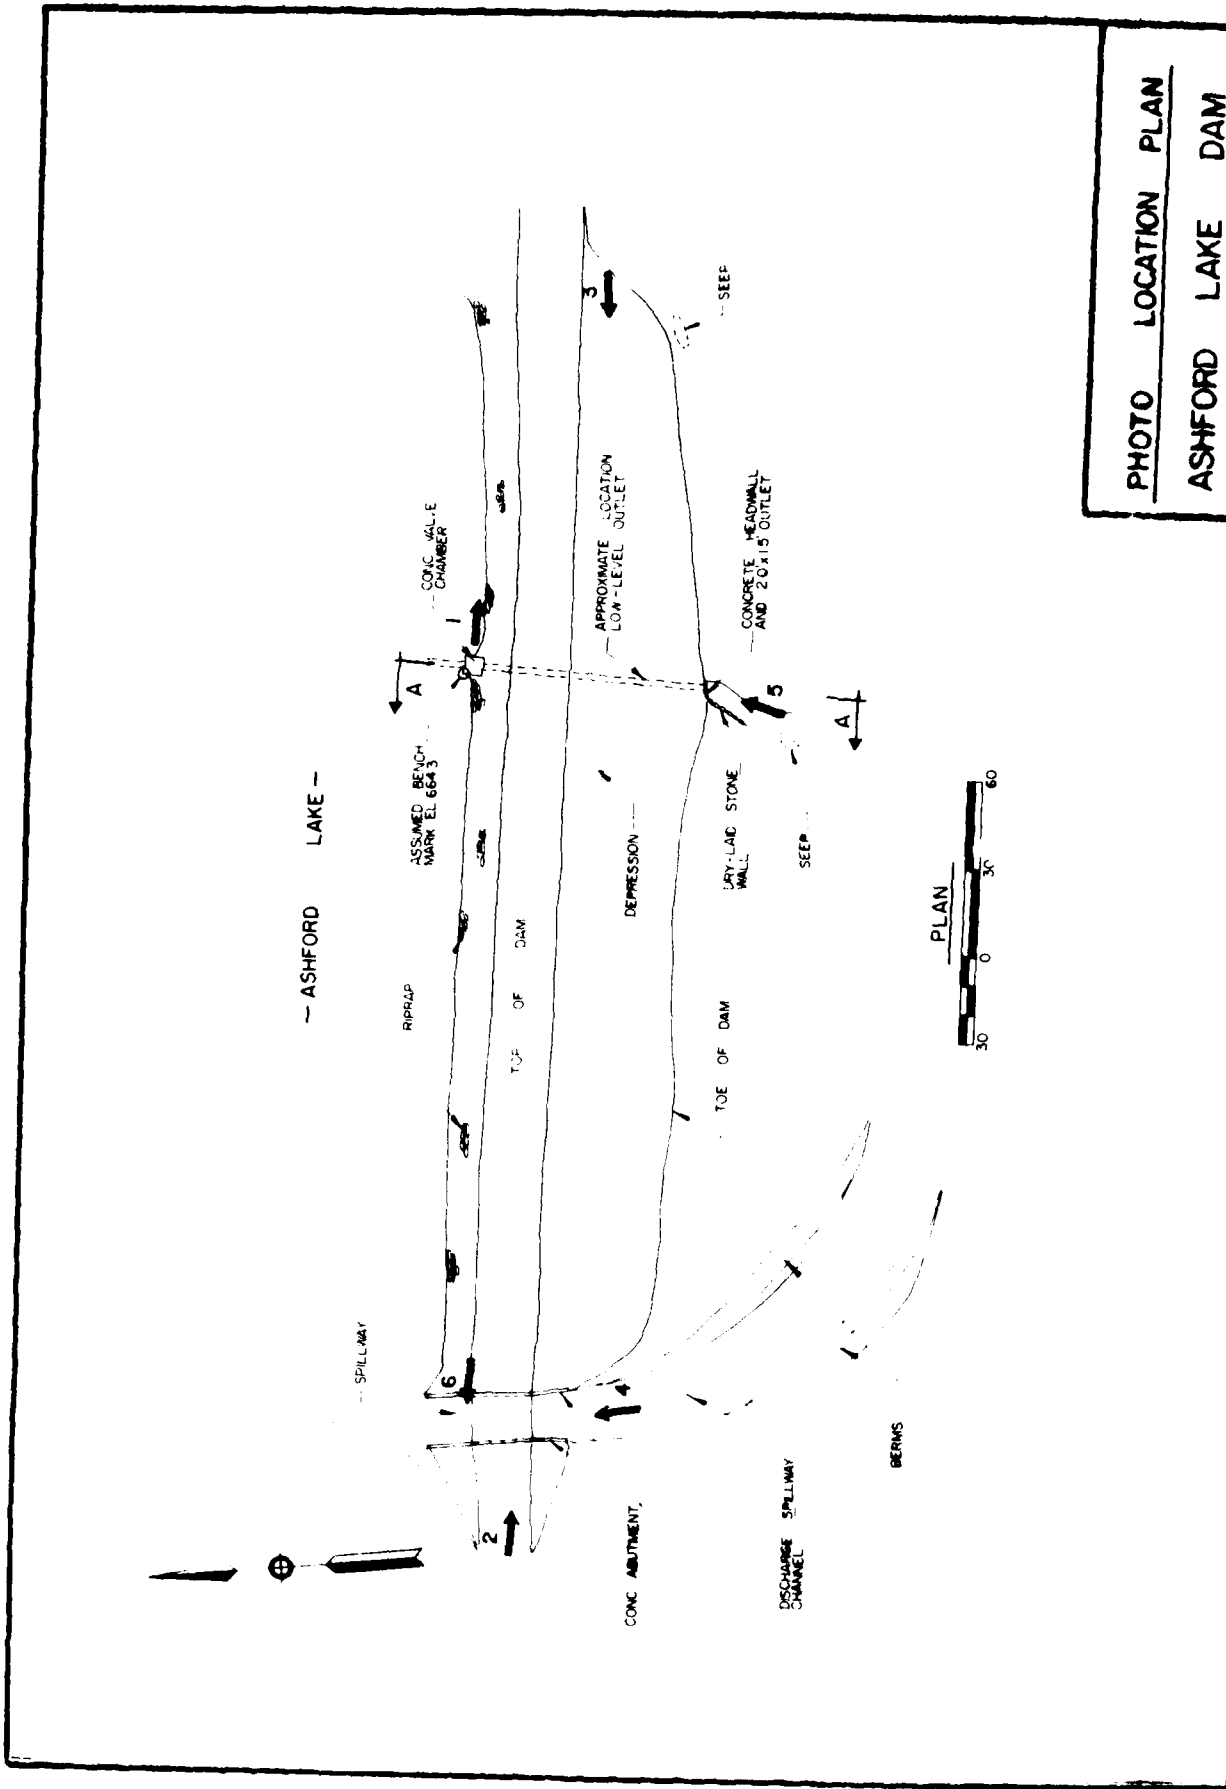
Upstream Slope - The upstream slope has dumped riprap to within 3+ feet of the crest. The strip between the riprap and the top of the dam is covered with weeds and brush, and has several areas eroded by trespassing (Photo 1). Several areas along the water had missing riprap, causing this part of the slope to be quite irregular (Photo 1).

Photo 1 - Erosion and riprap on upstream slope of dam taken from gate structure (March 1980).
