CONNECTICUT RIVER BASIN  
WESTBROOK, CONNECTICUT  
**MESSERSCHMIDT POND DAM**  
**CT 00392**

PHASE I INSPECTION REPORT  
NATIONAL DAM INSPECTION PROGRAM

NOVEMBER, 1979

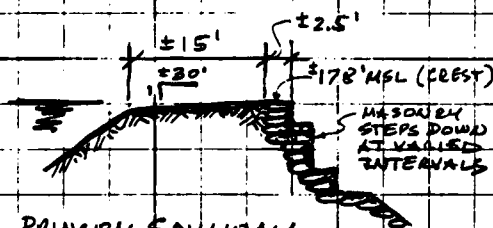
PRINCIPAL SPILLWAY  
TYPICAL CROSS SECTION

THE PRINCIPAL SPILLWAY, TO THE RIGHT OF THE FACTORY BUILDING IS A STONE MASONRY BROAD CRESTED WEIR (±) 63' LONG WITH SLUICING U/S FACE AND VERTICAL (STEPPED) D/S FACE. (SEE SKETCH). THE BREADTH OF THE CREST IS (±) 2.5'. THE HEIGHT OF THE RIGHT SIDE WALL (STONE

MASONRY WITH A (±) 1.5' HIGH CONCRETE CAP) IS (±) H=4.5'; THE LEFT SIDE WALL (CONCRETE MASONRY WALL ALONG THE FACTORY BLDG.) IS H=2'.
