CONNECTICUT RIVER BASIN
SOUTH BARRE, MASSACHUSETTS

SOUTH BARRE MILL POND DAM
MA 00091

PHASE I INSPECTION REPORT
NATIONAL DAM INSPECTION PROGRAM

AUGUST 1978

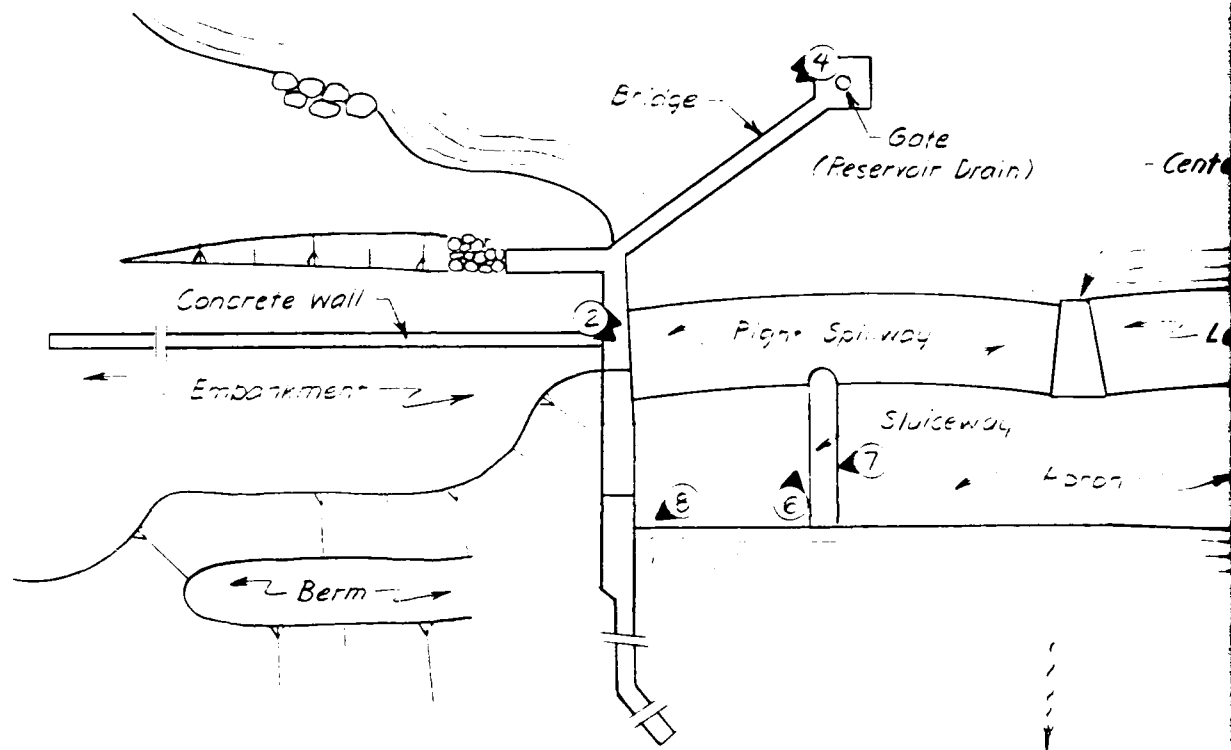
SOUTH BARRE MILL POND

1. Plan sketch developed from 1944 drawing by H.M. Turner (Fig. 2) and from Haley & Aldrich, Inc. field observations.
2. See Appendix B-1 for more detailed plan and sections.

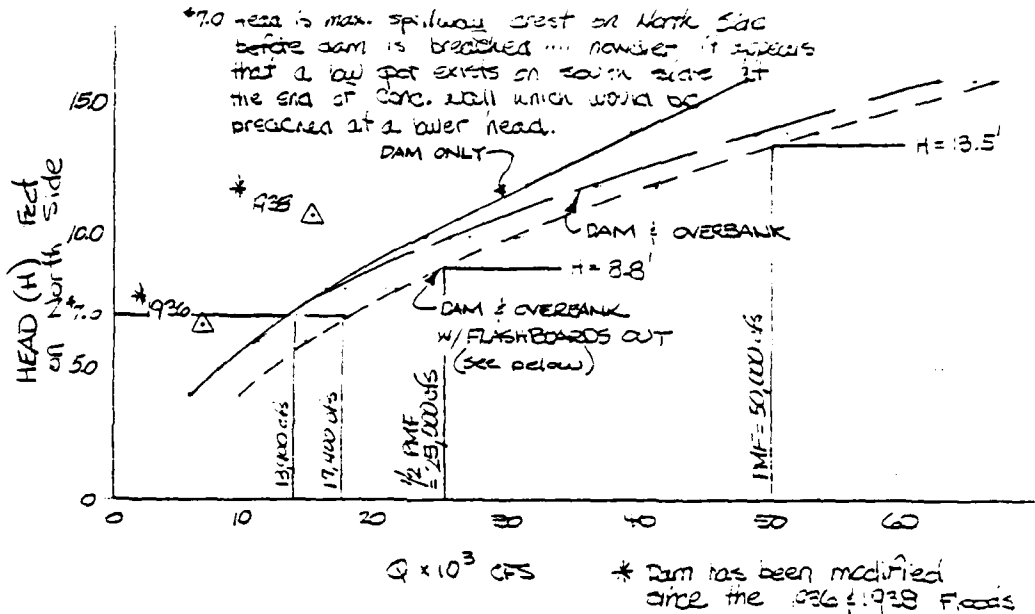
A+ PMS (50,000 cfs) Crest Elev. = 13.8 ft. above crest of dam and 6.5 ft. above overbank water embankment. Substantial flooding of dwelling units immediately downstream of dam will occur on both banks as a result of this over-topping of the coxks.
