CONNECTICUT RIVER BASIN
COLRAIN, MASSACHUSETTS

KENDALL CO. NO. I DAM
MA 00047

PHASE I INSPECTION REPORT
NATIONAL DAM INSPECTION PROGRAM

JANUARY 1981

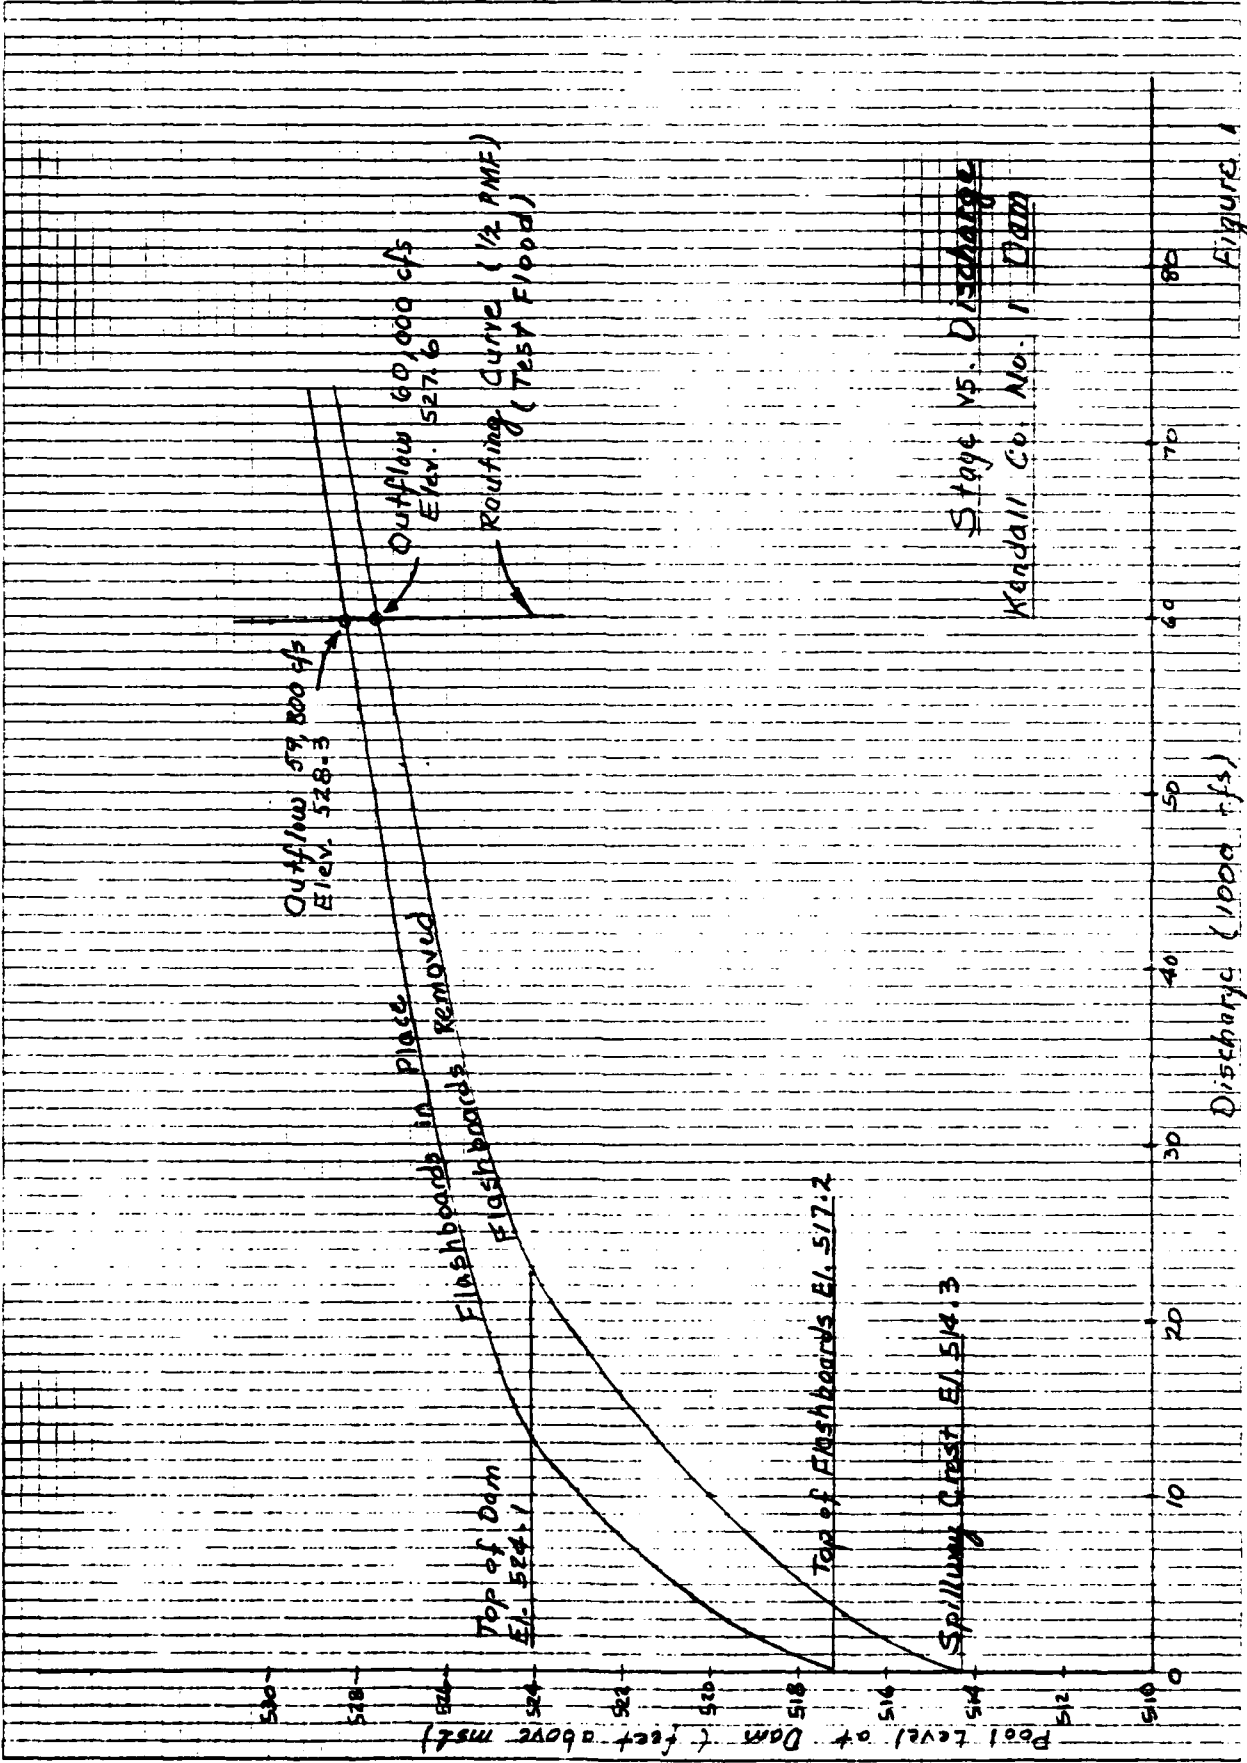
From results shown on Figure 1 (next sheet):

depth overtopping = 3.5' for 1/2 PMF

Stage vs. Discharge
Kendall Co. No. 1 Dam

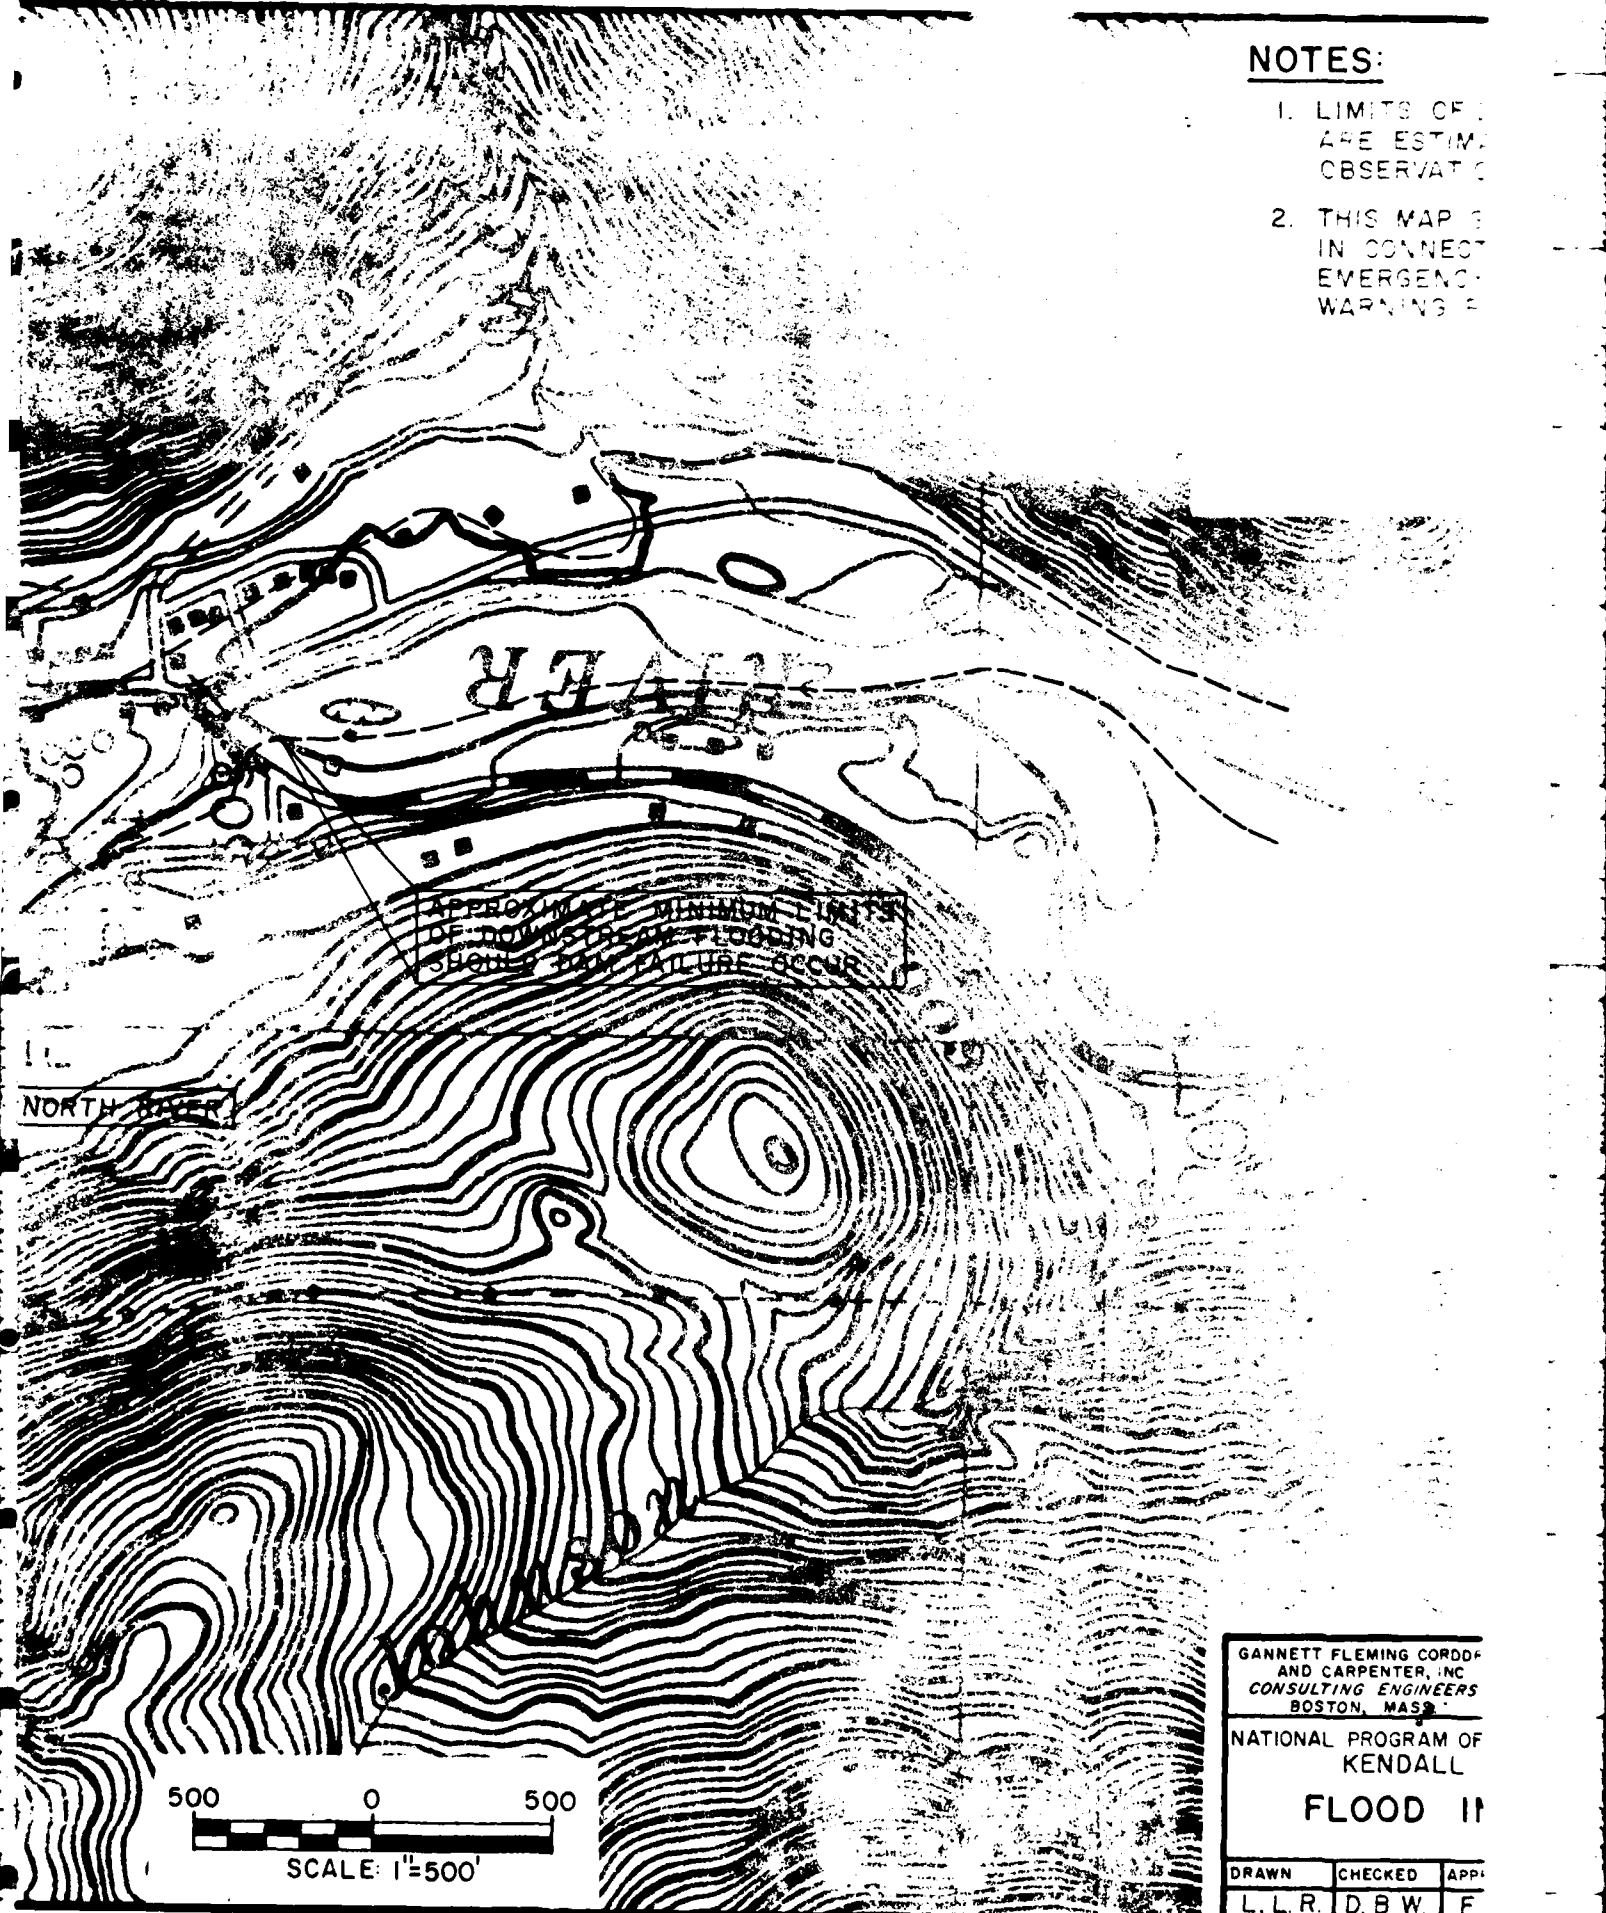
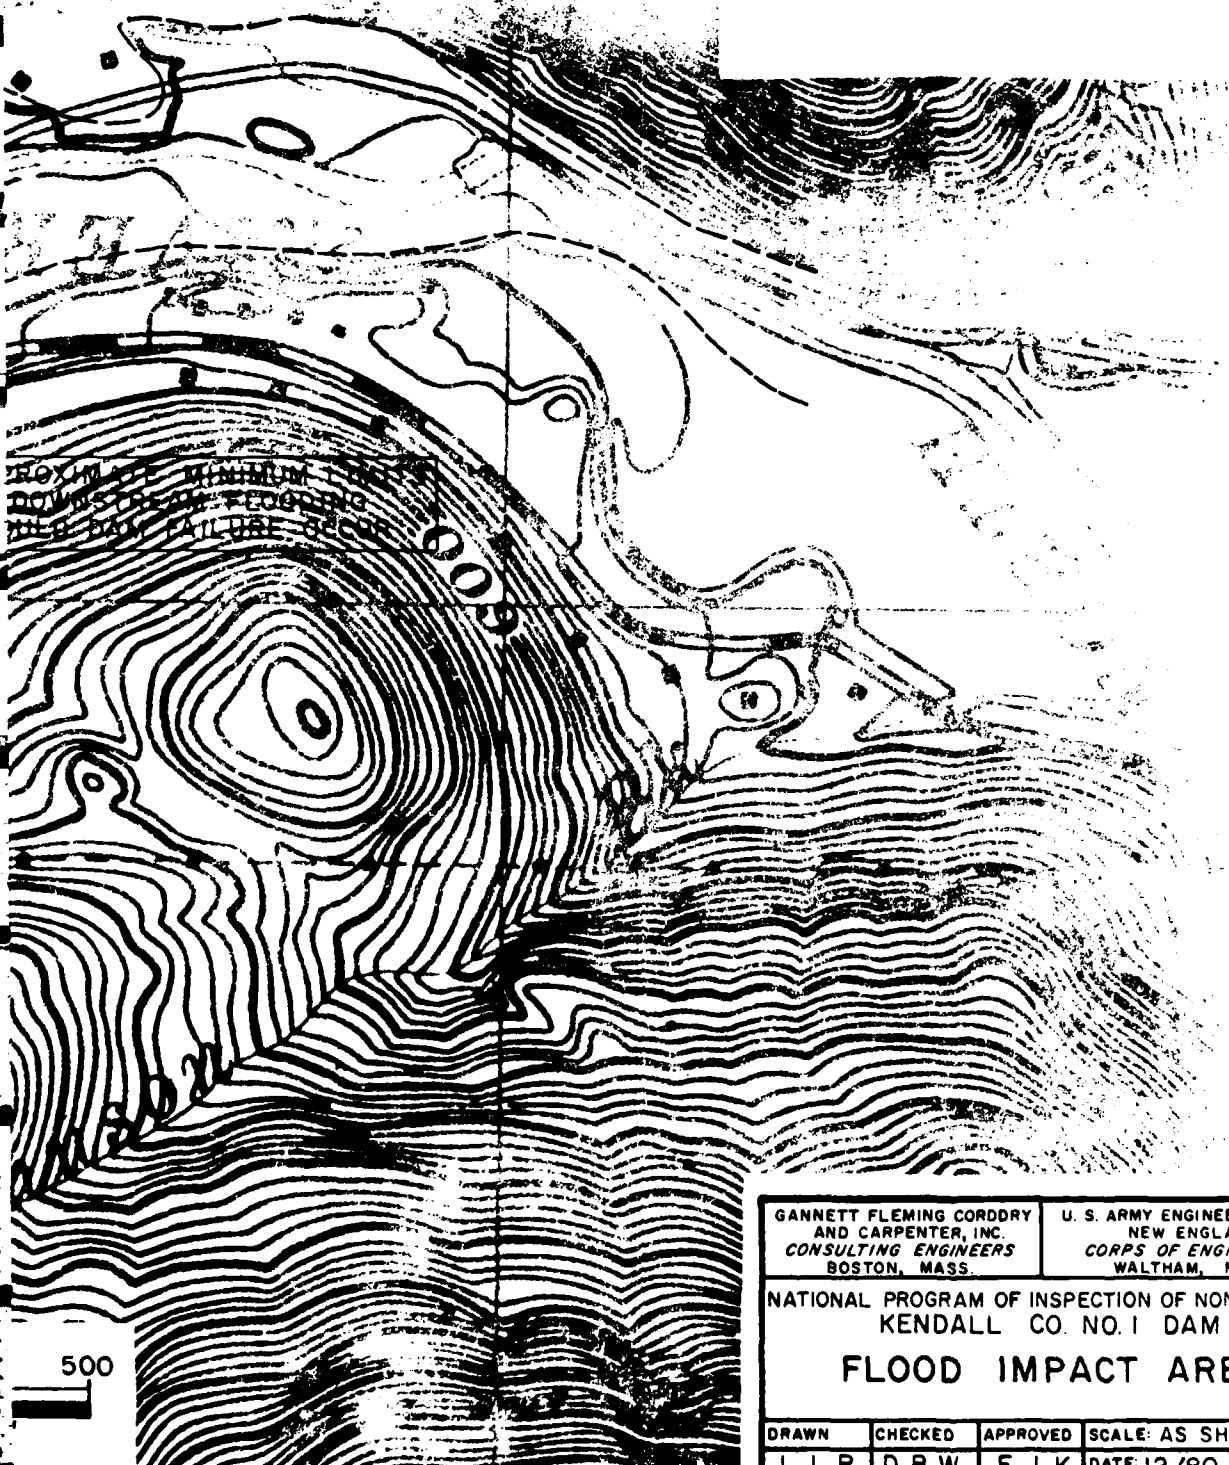
FIGURE 5

is estimated that flooding depths would be in the range of one to three feet. It was judged that a few lives could be lost as a result of dam failure. For this reason, the dam has been placed in the "significant" hazard category. The probable flood impact area is shown in Appendix D (Figure 5).

The rise in water surface at the damage center is sufficient to substantially increase downstream damages.

Since only property damage is involved, hazard classification is "significant" hazard.
