CONNECTICUT RIVER BASIN  
GARDNER , MASSACHUSETTS

PERLEY BROOK RESERVOIR DAM  
MA 00119

PHASE I INSPECTION REPORT  
NATIONAL DAM INSPECTION PROGRAM

JUNE 1980

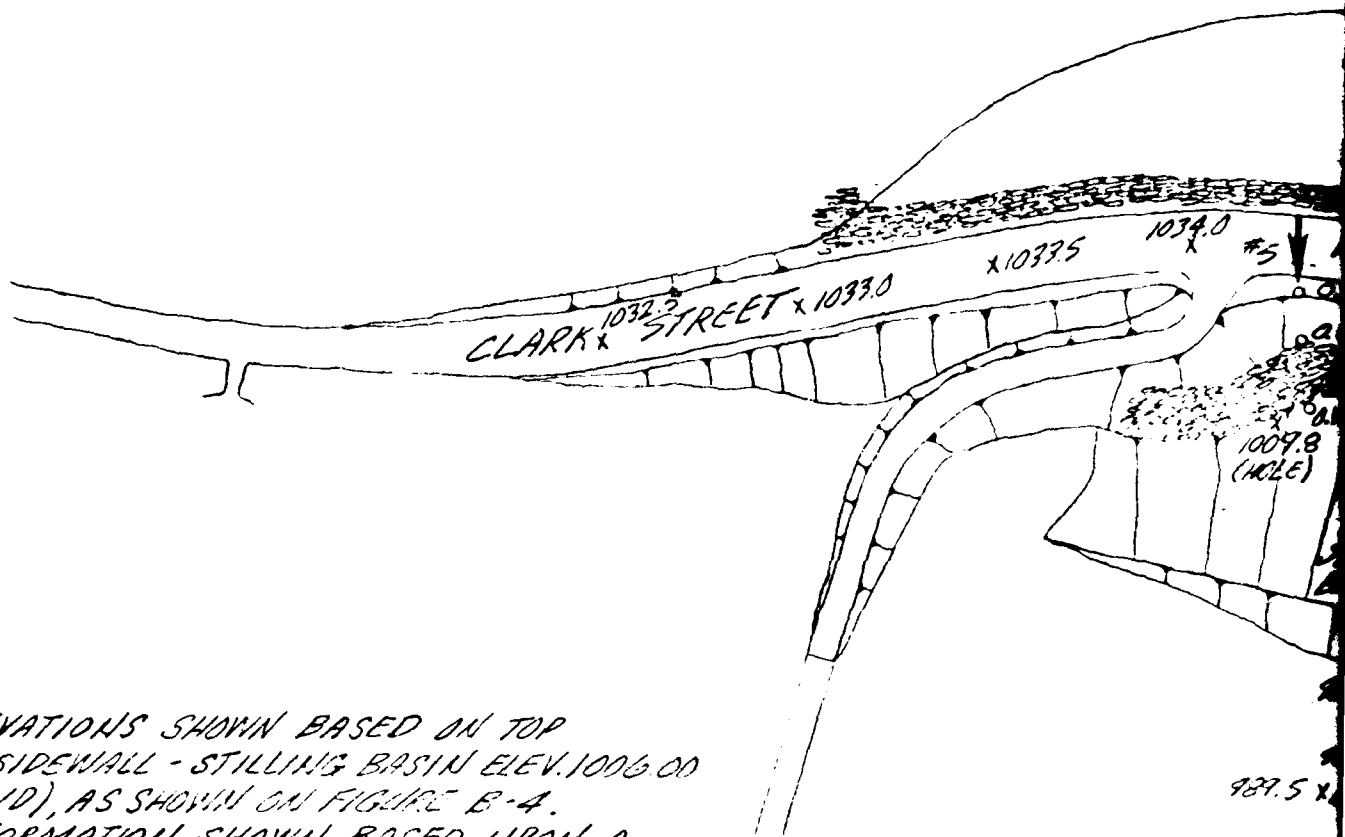
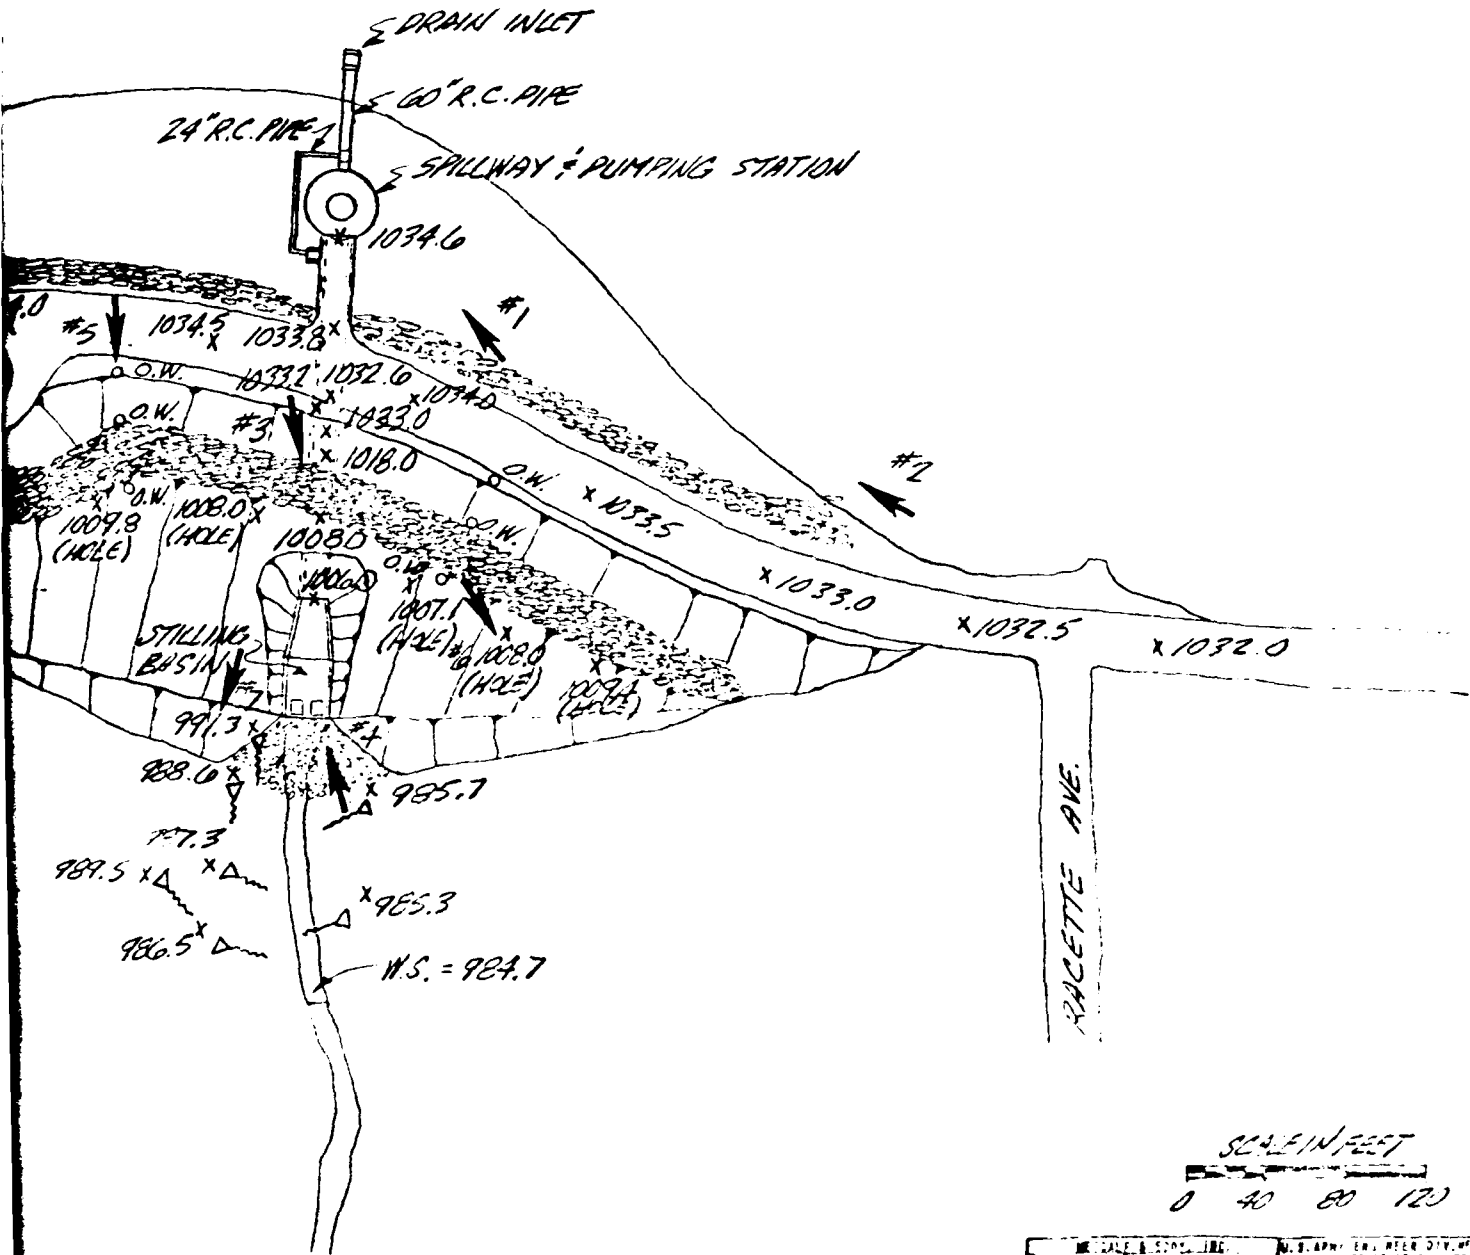
M. J. SALE & SONS, INC. CIVIL ENGINEERS BALTIMORE, MD.	U.S. ARMY CORPS OF ENGINEERS PERLEY DIVISION BALTIMORE, MD.
NATIONAL PROGRAM OF INSPECTION OF NON-FED. DAMS	
<b>PERLEY BROOK RESERVOIR DAM</b> FIGURE B-1 PLAN OF DAM	
TRIBUTARY CONNECTICUT RIVER	MARCH 1965
SCALE: AS SHOWN	DATE: MAY, 1967

1. ELEVATIONS SHOWN BASED ON TOP OF SIDEWALL - STILLING BASIN ELEV. 1006.00 (NGVD), AS SHOWN ON FIGURE B-4.
2. INFORMATION SHOWN BASED UPON A FIELD INSPECTION ON MAY 12, 1980.
3.  $\nabla$  INDICATES SEEPAGE.
4.  $\overline{A}$  INDICATES LOCATION AND DIRECTION OF VIEW FOR PHOTOGRAPHS.
