NATIONAL PROGRAM FOR INSPECTION OF NON-FEDERAL DAMS  
SOUTH VILLAGE DAM (MA.) (U) CORPS OF ENGINEERS WALTHAM  
MA NEW ENGLAND DIV NOV 79

SOUTH VILLAGE DAM  
MA 00107

PHASE I INSPECTION REPORT  
NATIONAL DAM INSPECTION PROGRAM

NOVEMBER 1979

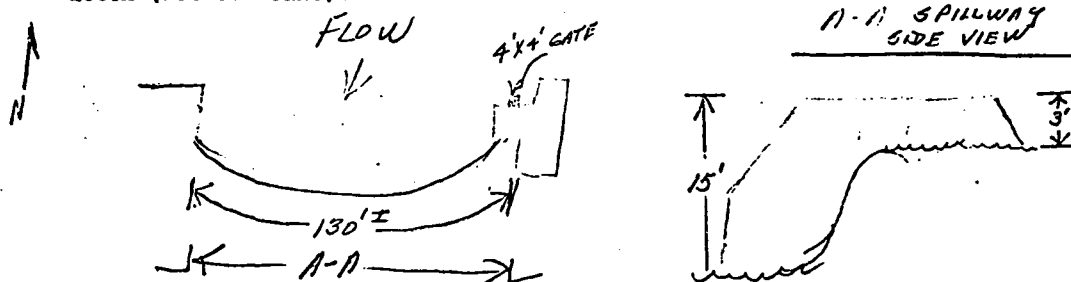
4' X 4' GATE AT EASTERLY END OF DAM SPILLWAY - NOT  
IN USE. GATE CONTROLS RUSTED & ROTTED. SPILLWAY  
HAS SOME FLASHBOARDS ON TOP BUT NOT CONTINUOUS.
