BLACKSTONE RIVER BASIN  
MILLBURY, MASSACHUSETTS

RAMSHORN POND DAM  
MA 00145

**PHASE I INSPECTION REPORT  
NATIONAL DAM INSPECTION PROGRAM**

JULY 1978

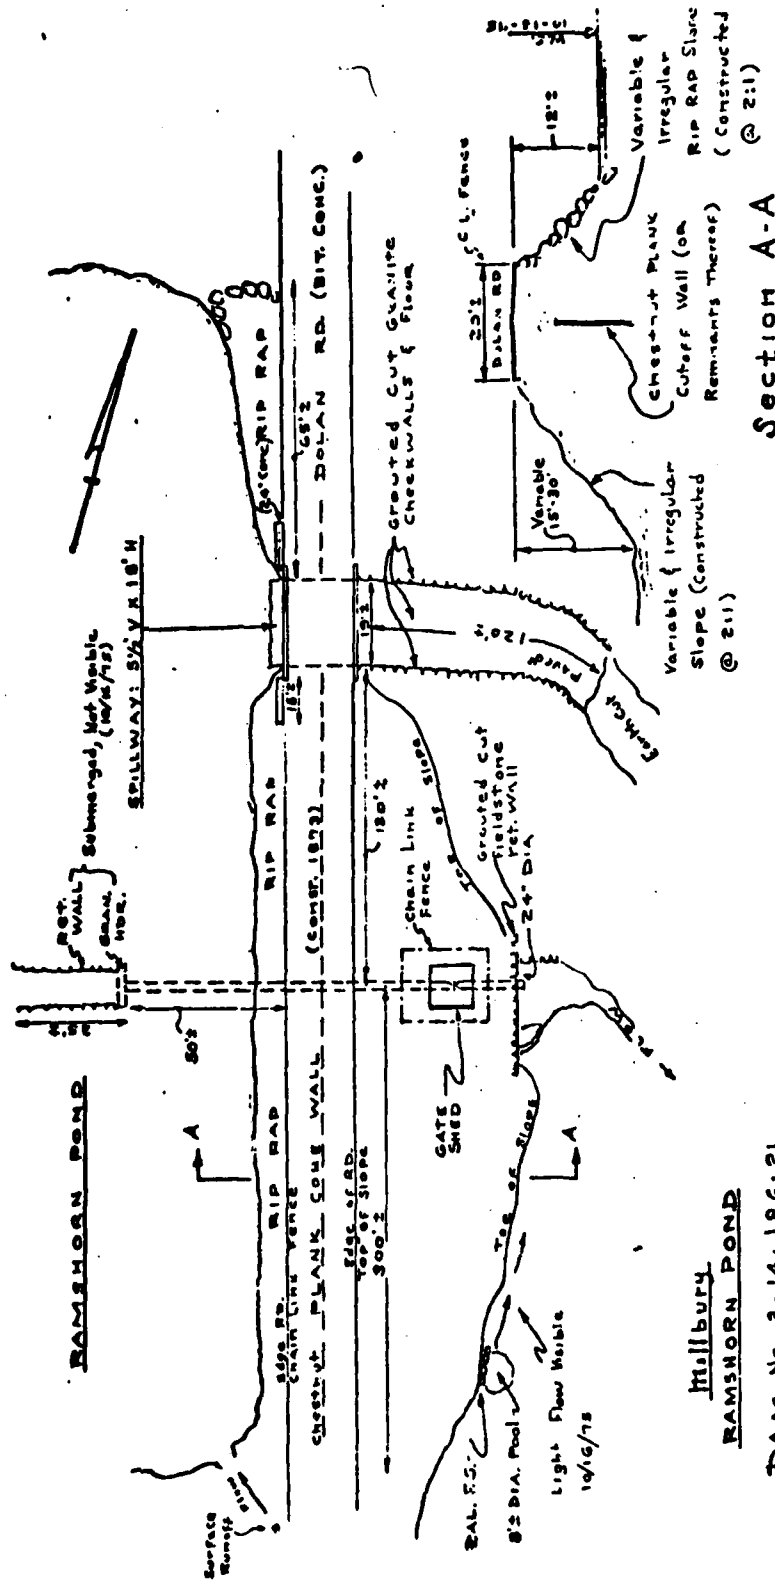
Section A-A

12-④ (Continued)

of an old Stone box Sluice, But The  
1939 Plan (on Record @ The County Engineers)  
which Shows The dam Substantially in It's  
Present Form, Shows No Such Structure.  
There is light Flow out of This pool  
Northward along The descending Toe of  
The d.S. Slope.
