AMMRC MOBILE ACCELERATOR NEUTRON RADIOGRAPHY SYSTEM  
OPERATIONS AT U.S. ARMY YUMA PROVING GROUND

Interim Technical Report  
Report No. 3-41000/4R-110

15 April 1984

LTV AEROSPACE AND DEFENSE COMPANY  
Vought Missiles and Advanced Programs Division  
P.O. Box 225907  
Dallas, Texas 75265

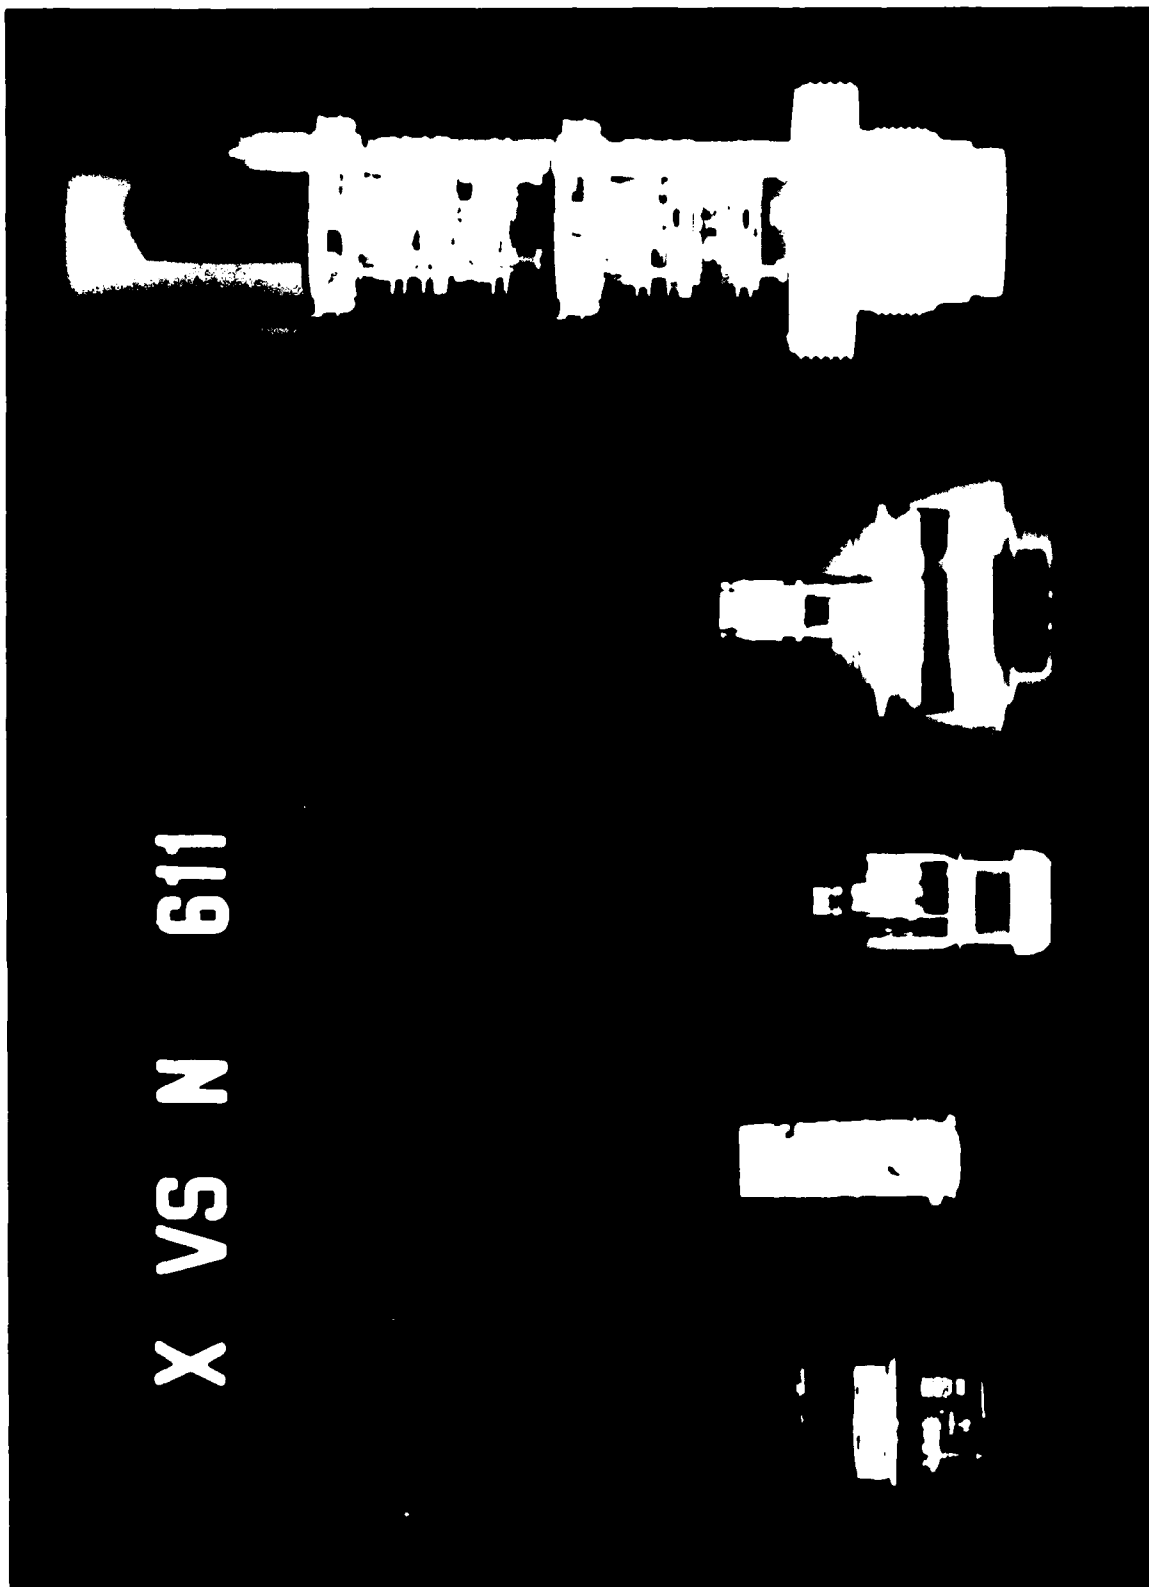
Figure 11 is an illustration of additional types of fuzes which, along with others, are the specimens for radiographs 11X and 11N. From left to right in the radiographs are: M734 fuze, M567 fuze, 2.75 rocket fuze, M84 fuze, and a special three-fuze assembly. Again, the X-ray, Figure 11X shows good images of the S&A's. However, no explosive charges are imaged and there is a lack of penetration of the lowest fuze in the three-fuze assembly.

Figure 11X. X-Ray Radiograph of (Left to right) M734 Fuze, M567 Fuze, 2.75 Rocket Fuze, M84 Fuze, and a Special Three-Fuze Assembly

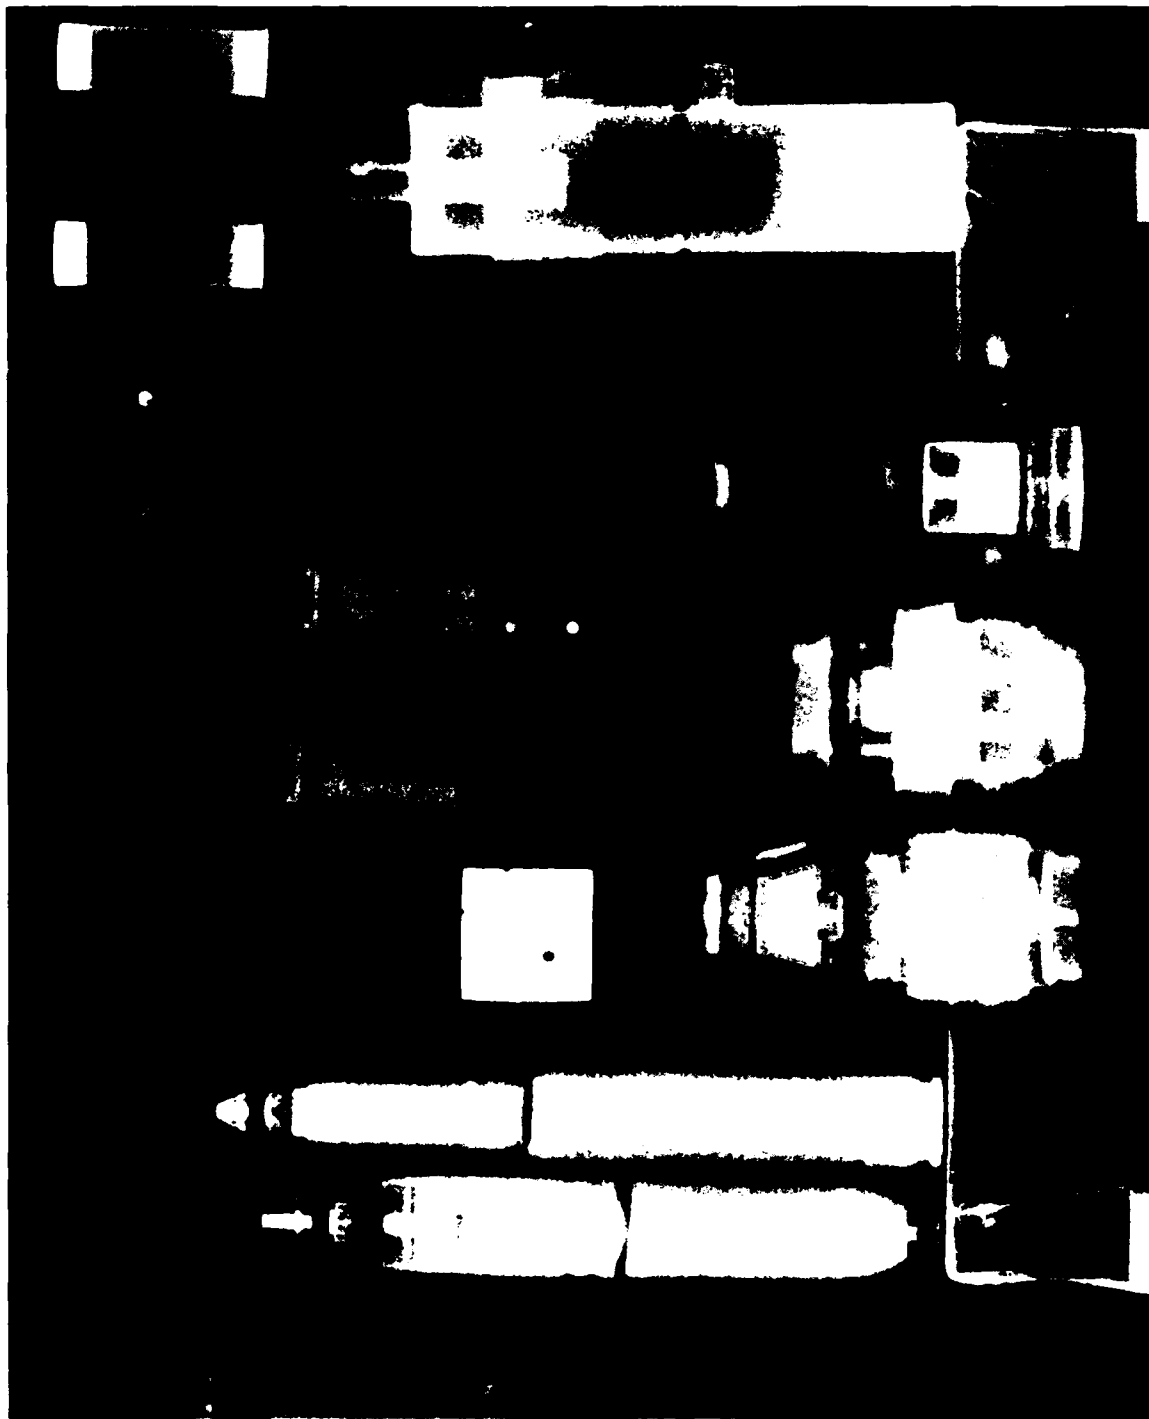
Figure 18N. Neutron Radiograph of Various Ordnance Devices (Items Appearing in Figures 10N through 17N). Film/Converter: DuPont NDT 91/Vought DC-4

Figure 18N : An example of results obtained with a very fast film/screen combination: DuPont NDT 91/Vought DC-4. Exposure time was 15 minutes (4 to 5 minutes with normal tube output), overall density 1.95. Although the very fast film produces a grainy picture, the high density and good contrast resulting from this film/screen combination provides radiographic information useful for many applications.

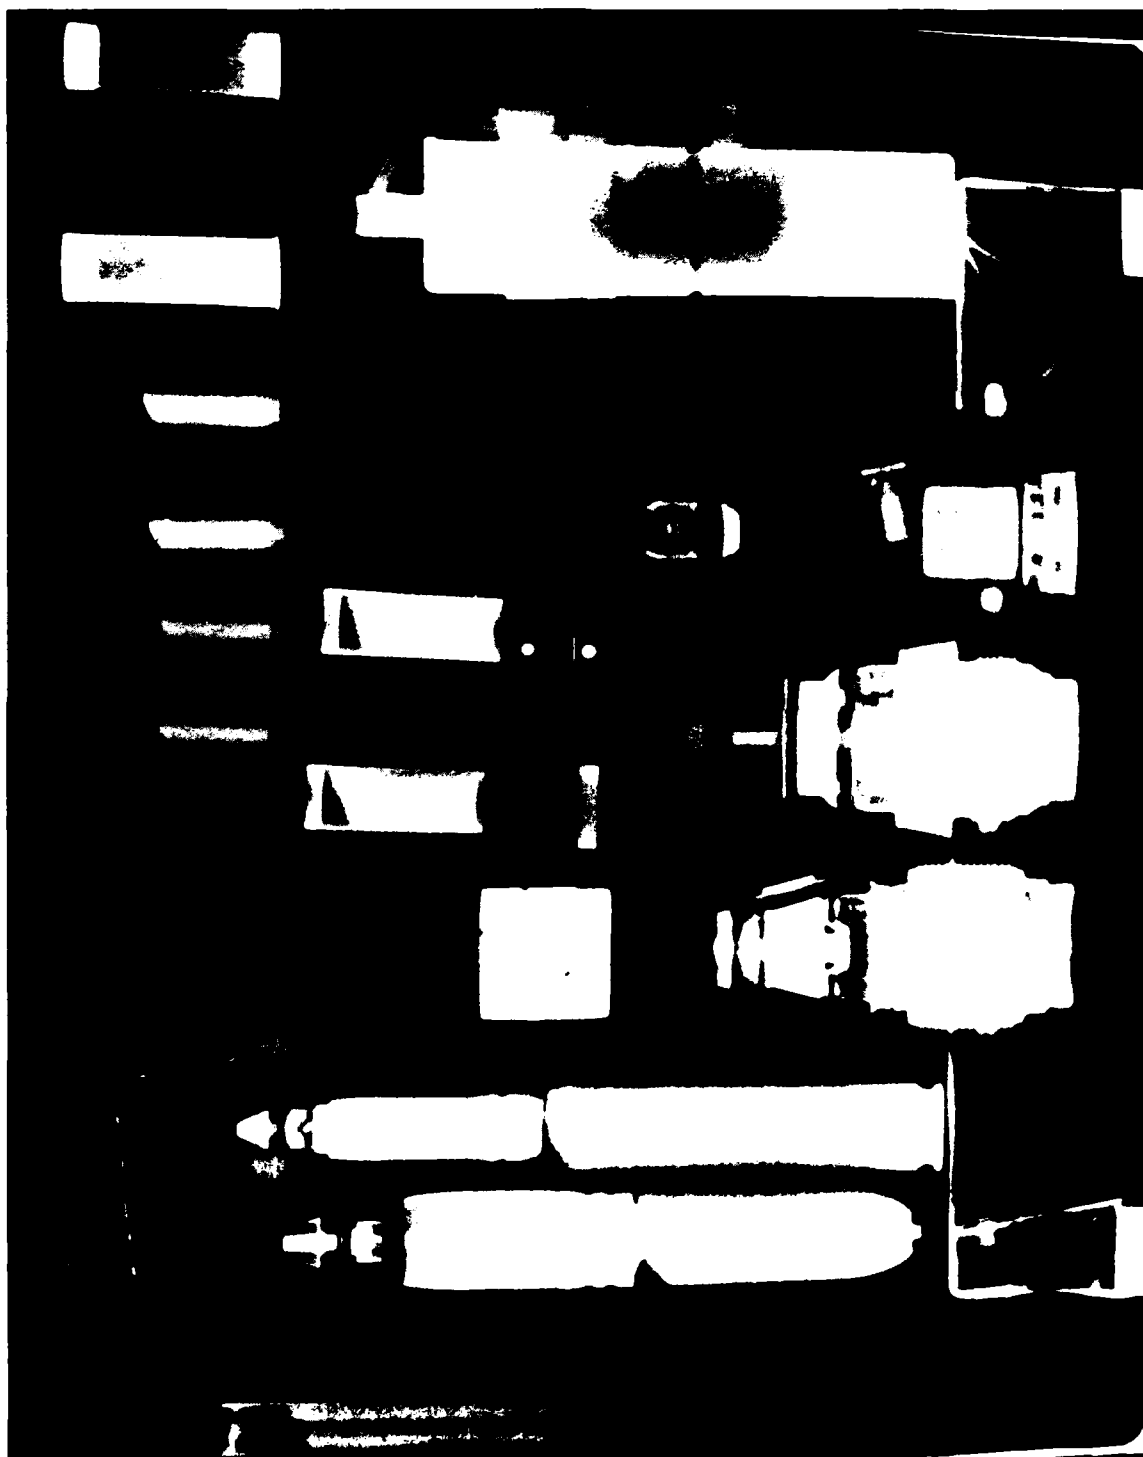
Figure 19N. Neutron Radiograph of Various Ordnance Devices (Items Appearing in Figures 10N through 17N). Film/Converter: DuPont NDT 75/Vought DC-4

Figure 19N: Film/screen - DuPont NDT-75/Vought DC-4; exposure time - 2.5 hr (40 to 50 minutes with normal tube output); film density, 2.88. As seen by the radiograph, the NDT 75 is much slower when used with the DC-4 screen, but provides a high density, high contrast neutron image with significantly less grain than the NDT 91. This combination shows considerable potential for future use with mobile neutron radiography systems.

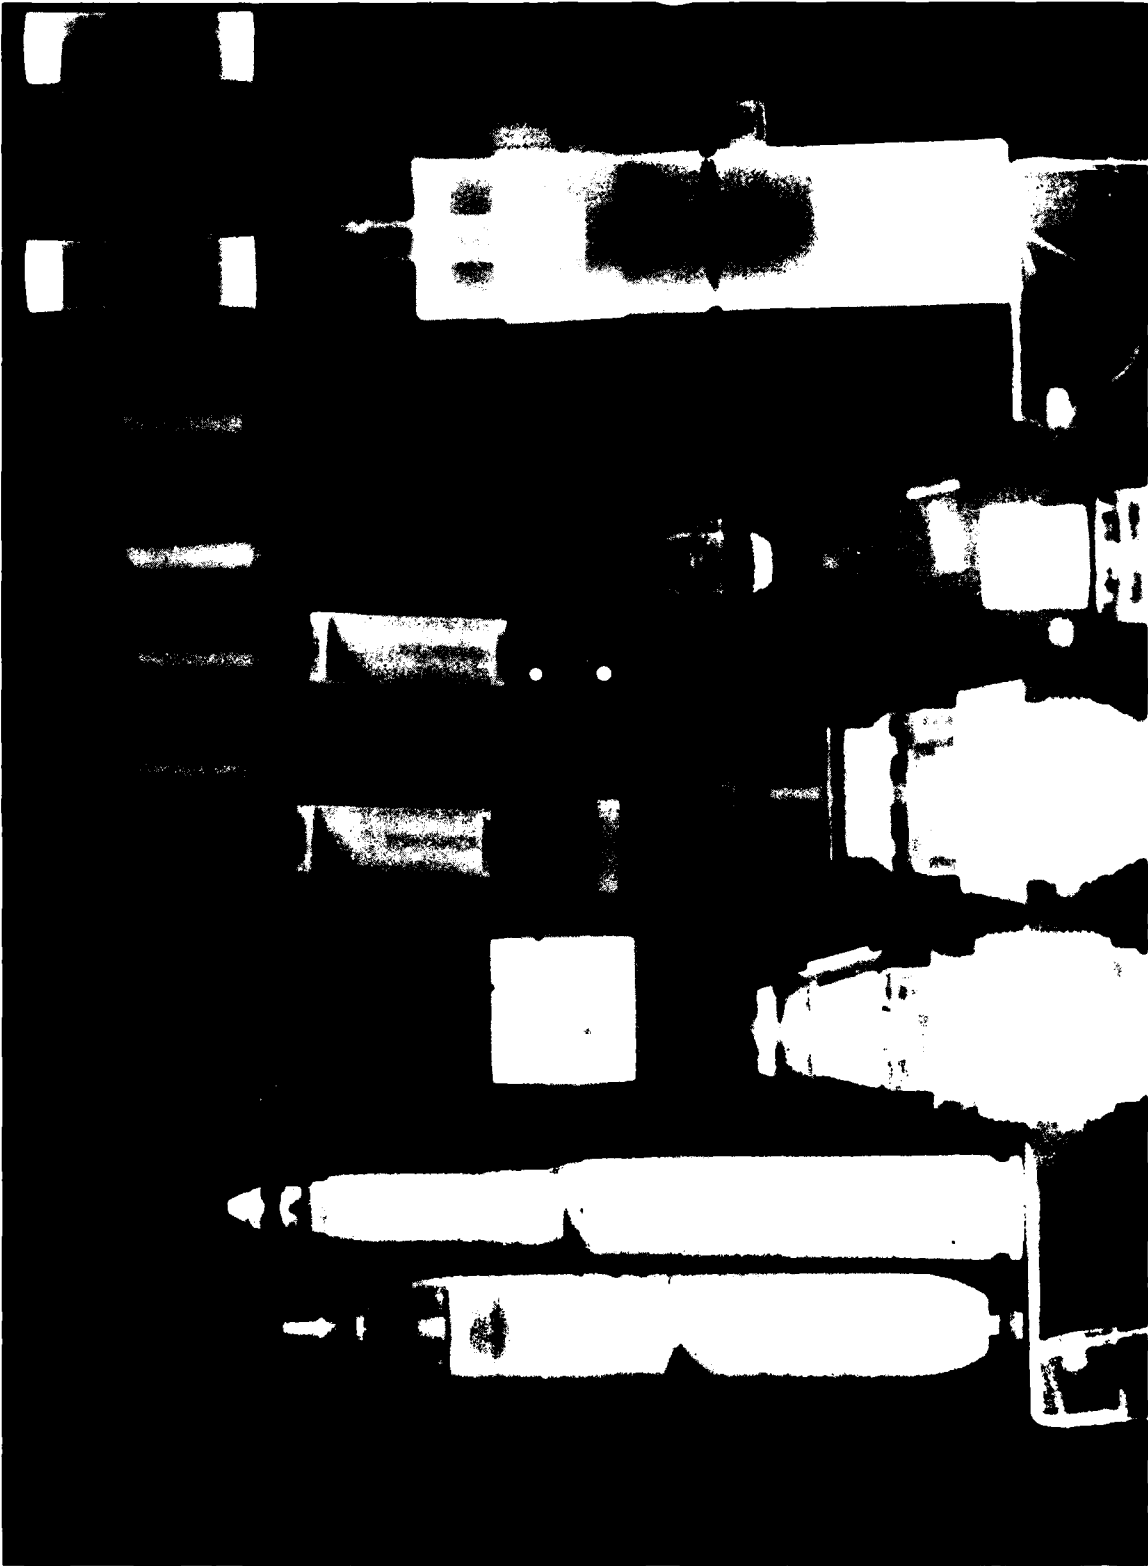
Figure 21N. Neutron Radiograph of Various Ordnance Devices (Items Appearing in Figures 10N through 17N). Film/Converter: DuPont NDT 55/Vought DC-4

Figure 21N: DuPont NDT 55/Vought DC-4; exposure time 3 hours (45 minutes to 1 hour with normal tube output); film density 0.96. The radiographic result is seen to be similar to that of NDT 65, used with this converter screen. However the substantial increase in exposure time required to produce a given film density is not offset by the slight gain in image sharpness over the NDT 75 film, and hence does not appear to be as useful for mobile neutron radiography.
